**Tailings Management at Omai  
Gold Mines Ltd., (OGML)  
*Catalyst for Change***

Abrelle Poole  
OGML Environmental Coordinator

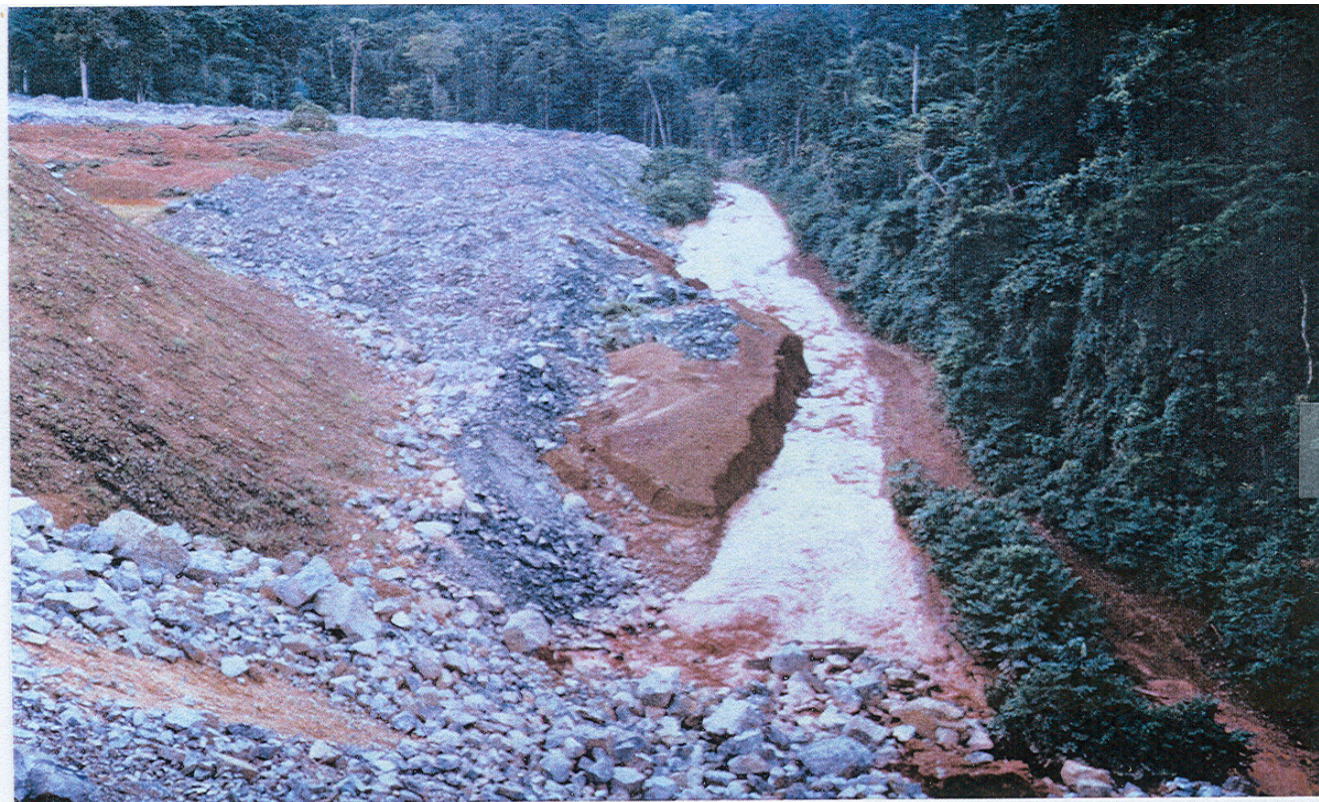
- Occurred August 19<sup>th</sup>-24<sup>th</sup>
- A major seepage through the tailings dam into the Omai River was discovered followed by a second breach observed also directly discharging effluent to the river

AUGUST 21, 1995 - Seepage flow at toe of north end of the main dam.

- Emergency response initiated:
  - Installation of pumps to transfer effluent to Fennell Pit
  - Building a coffer dam to stop main dam leakage
  - Building a diversion to route discharge to Fennell Pit
  - Filling sink holes on the upstream face of the affected dam to halt discharge
  - Informing Government and stakeholders
  - Water quality monitoring conducted throughout the incident
- **Emergency response actions were SUCCESSFUL in halting the discharge after 100 HOURS**

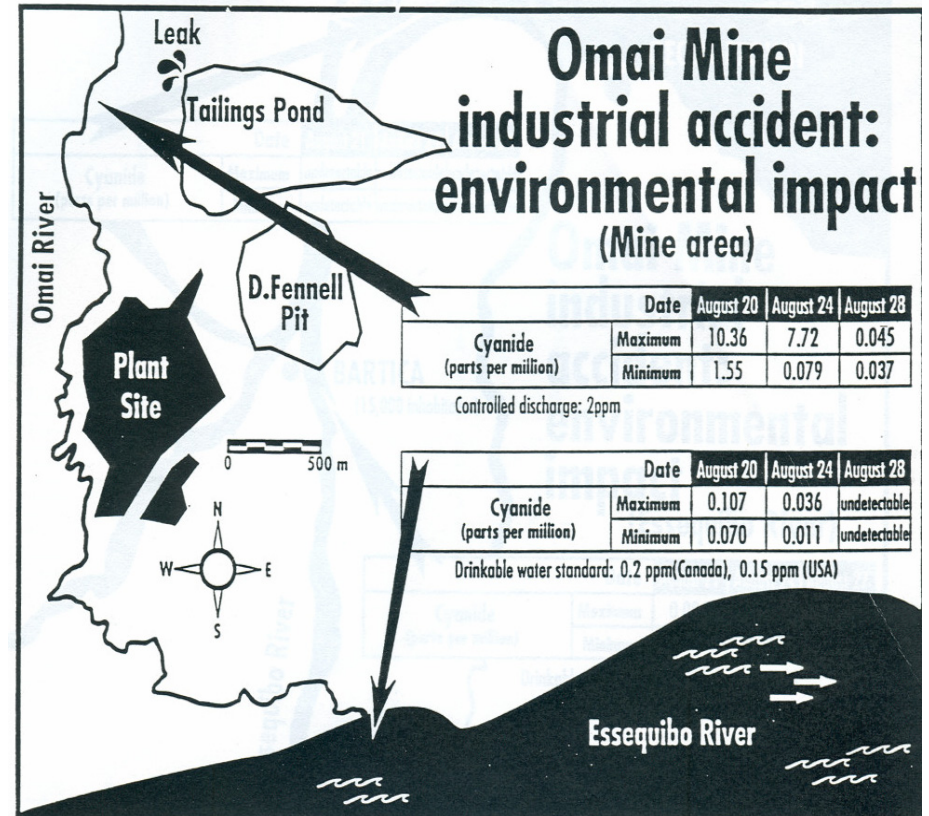
During the week following the Omai Mine accident, cyanide levels above the 0.15 ppm American standard and the 0.20 ppm Canadian standard for drinking water were recorded only in the section of the Omai River crossing a six-kilometre stretch of uninhabited land. The level exceeded the norm from Sunday, August 20, to Thursday, August 24. Since then, the leak of cyanide-lainted water has been stopped and concentrations in the Omai River have quickly dropped, reaching 0.04 ppm on Monday, August 28.

In the Essequibo River, the data from continuous monitoring between August 20 and August 24, 1995 at 10:30 AM, indicated low concentrations of cyanide, well within the drinking water standards of Canada (0.20 ppm) and United States of America (0.15 ppm). Since August 27, concentrations have been undetectable.

Over a distance of approximately 80 miles in the Essequibo River (Omai-Bartica) no dead fish nor animals were found.

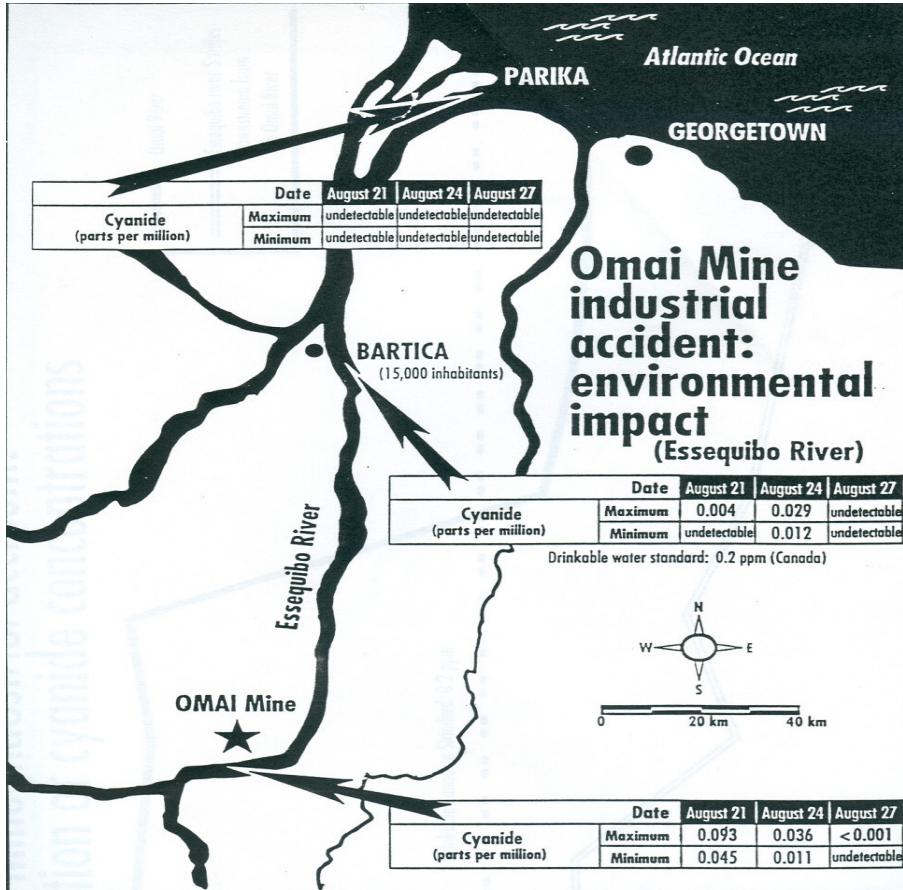
During the week following the Omai Mine accident, cyanide levels above the 0.15 ppm American standard and the 0.20 ppm Canadian standard for drinking water were recorded only in the section of the Omai River crossing a six-kilometre stretch of uninhabited land. The level exceeded the norm from Sunday, August 20, to Thursday, August 24. Since then, the leak of cyanide-tainted water has been stopped and concentrations in the Omai River have quickly dropped, reaching 0.04 ppm on Monday, August 28.

In the Essequibo River, the data from continuous monitoring between August 20 and August 24, 1995 at 10:30 AM, indicated low concentrations of cyanide, well within the drinking water standards of Canada (0.20 ppm) and United States of America (0.15 ppm). Since August 27, concentrations have been undetectable.

Over a distance of approximately 80 miles in the Essequibo River (Omai-Bartica) no dead fish nor animals were found.

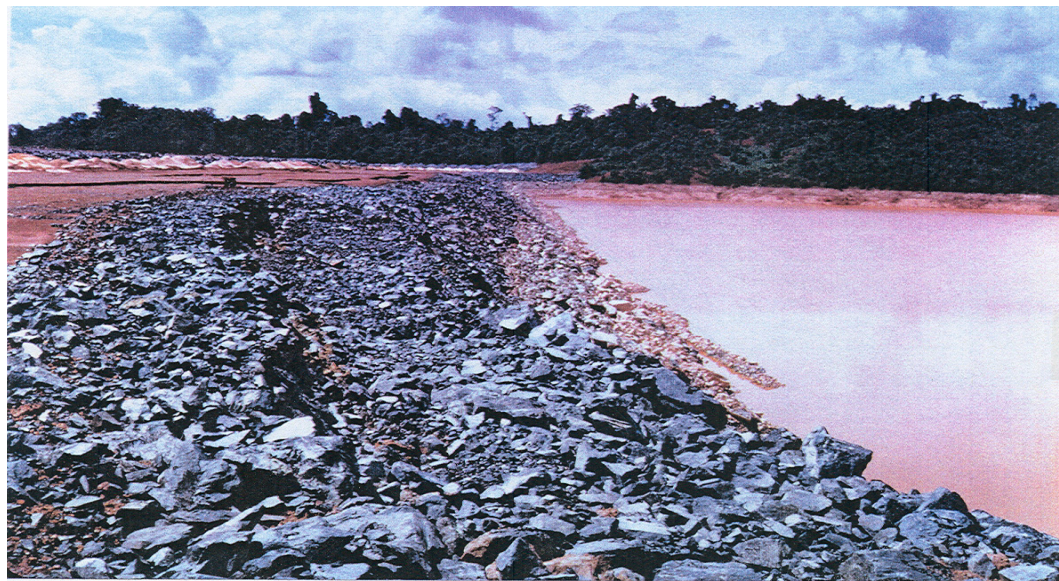
- Failure caused by “Massive loss of core integrity resulting from piping”
- Diversion conduit (pipe culvert) and/or surrounding materials contributed to failure
- Gradation did not allow filter compatibility causing internal erosion of filter sand
- Immediate measurable environmental effects relatively modest
- Dam failure and operations stoppage widely viewed as catastrophe for Guyana

AUGUST 23, 1995 - Upstream face of main dam.  
Note: Vertical scarps developed above sinkhole  
thought to be in the original area of failure.

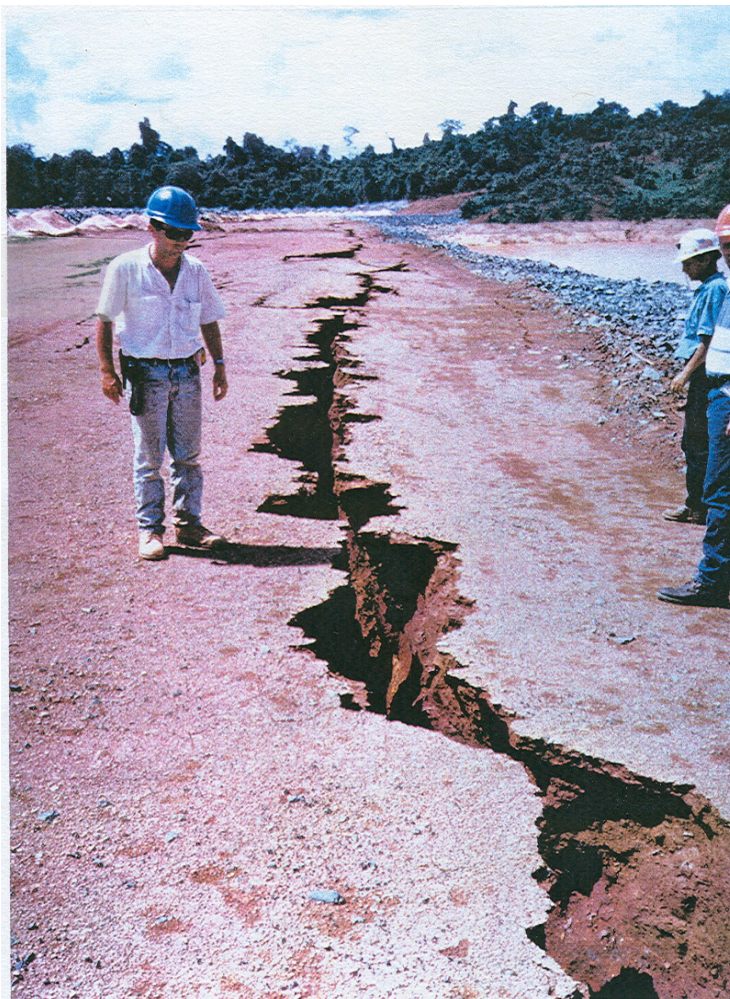
AUGUST 21, 1995 - Close-up of cracking in core.

- Little vertical displacement shortly after failure.
- Pronounced lateral displacement (spreading)

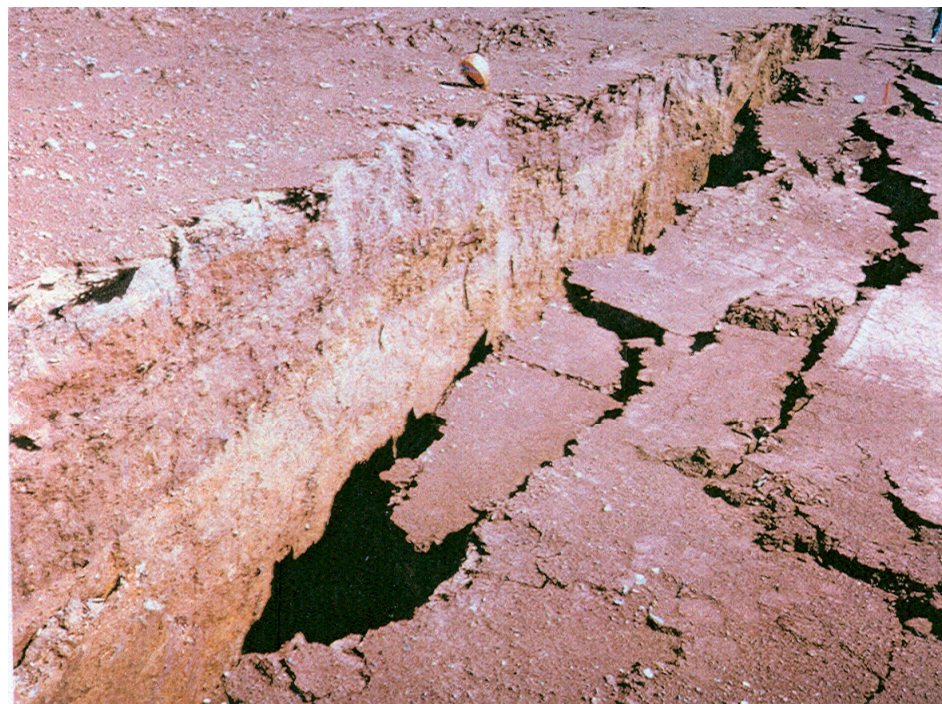
AUGUST 23, 1995 - Cracks in core at about dam center.

- Horizontal and vertical displacement.
- Layering in compacted saprolite core.

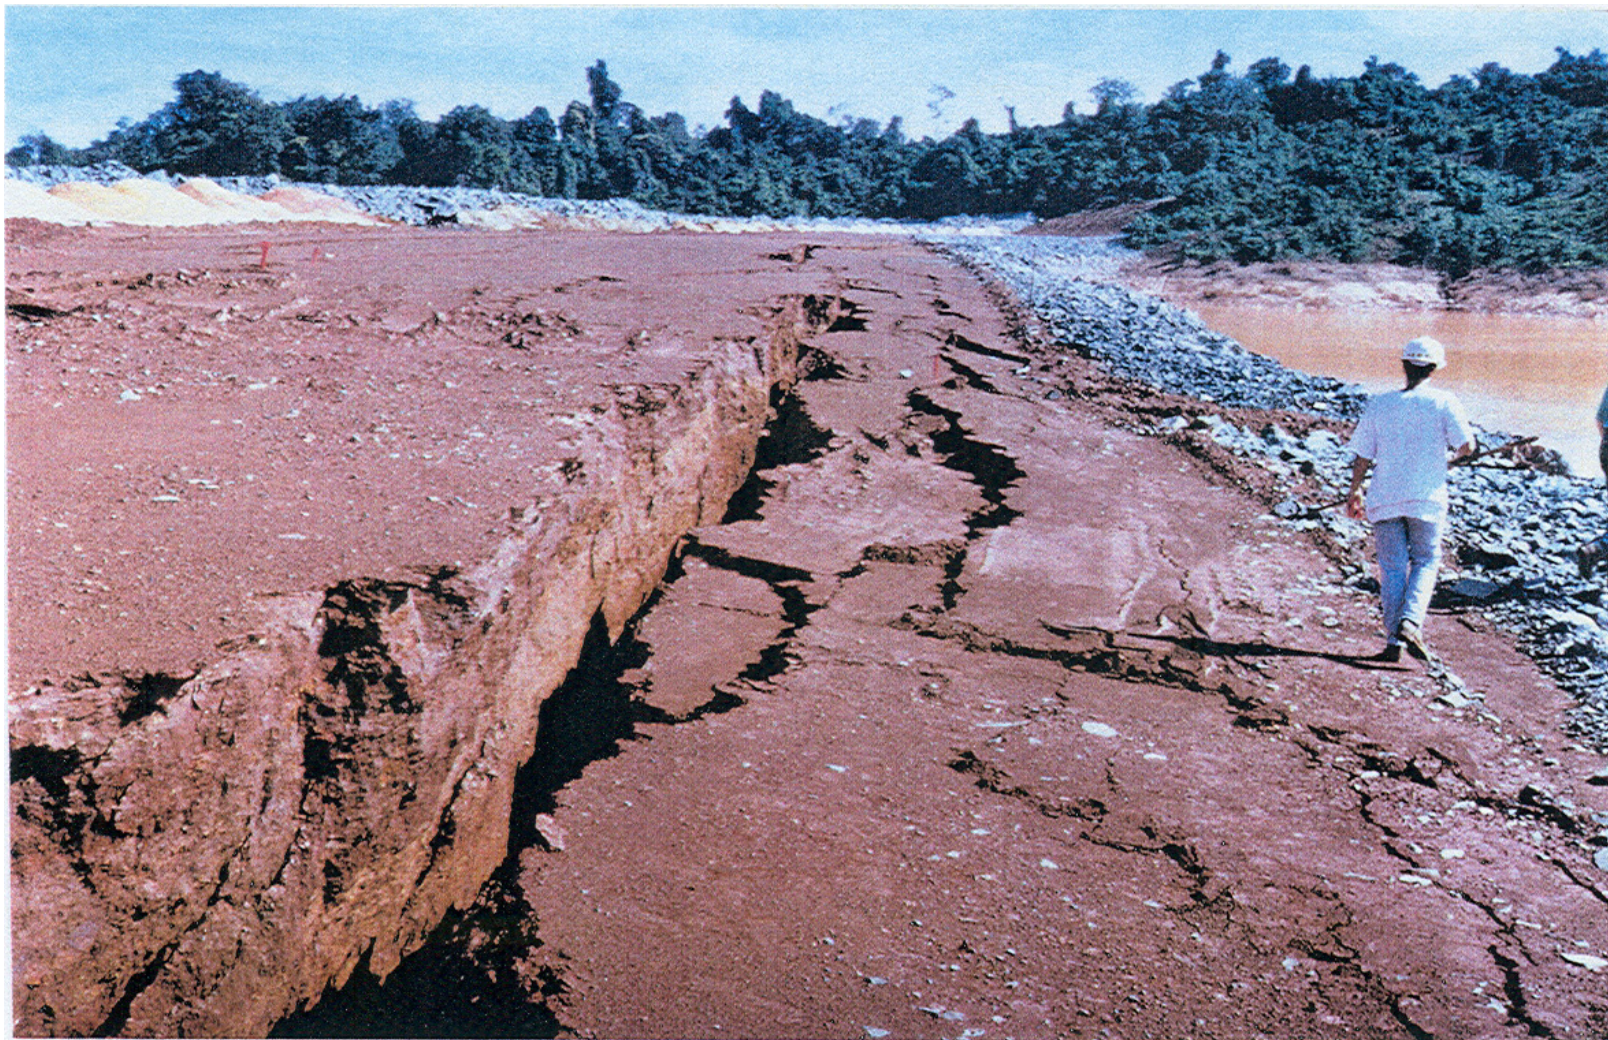
AUGUST 23, 1995 - Upstream face of dam.

Note: Enlarged cracking and vertical displacement has developed over 2 days.
