The Ongoing Rehabilitation of Ontario's Kam Kotia Mine: An Abandoned Acid Generating Tailings Site

Christopher D. Hamblin

**Project Coordinator
Abandoned Mines Rehabilitation Fund
Ministry of Northern Development & Mines
Ontario, Canada**

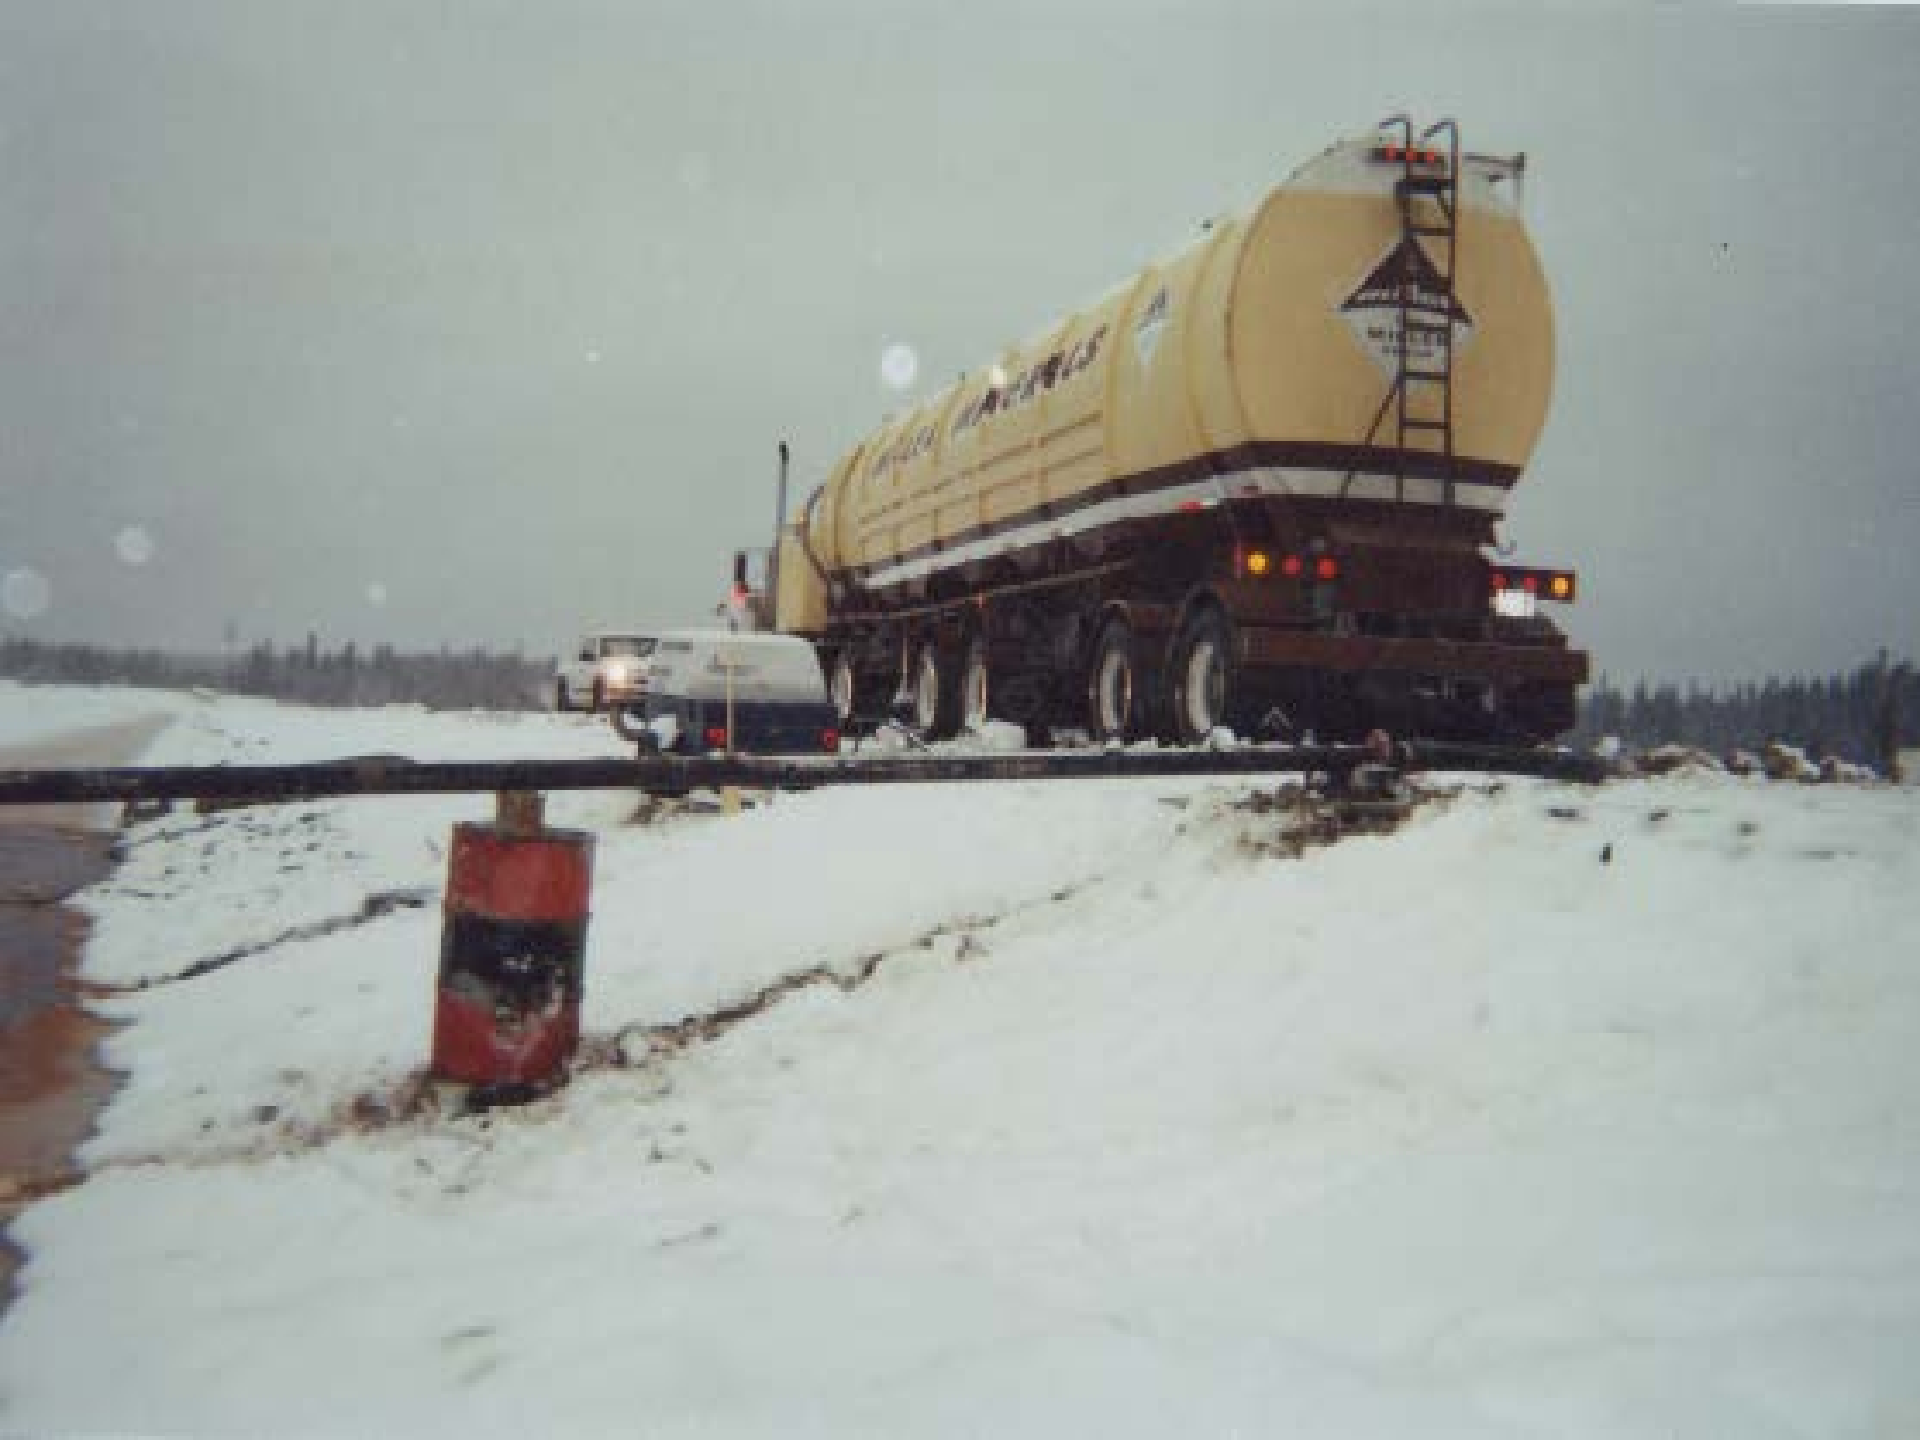
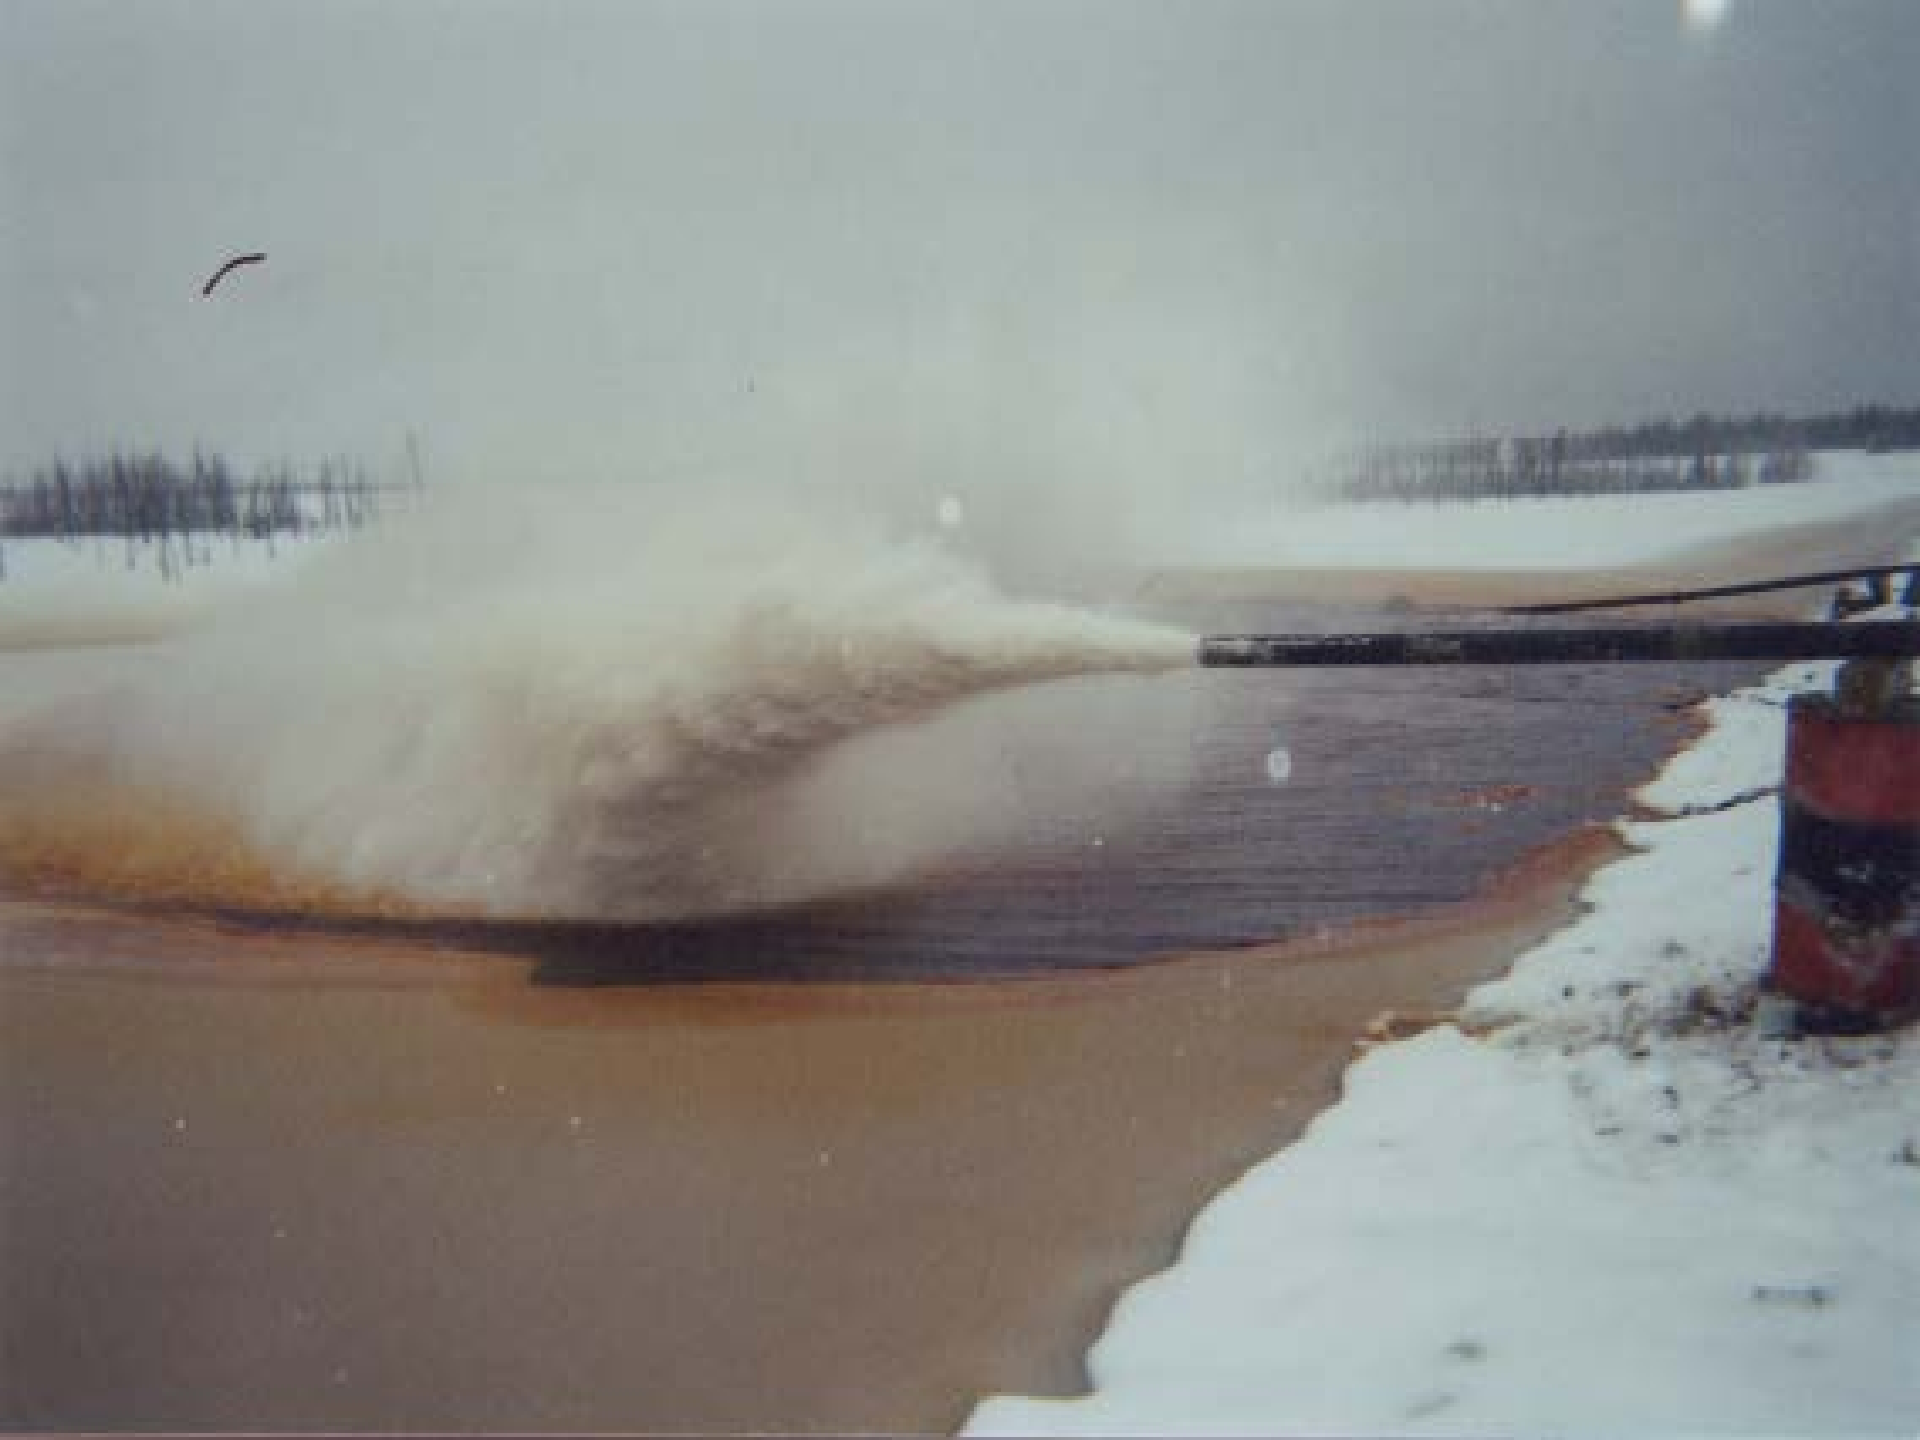
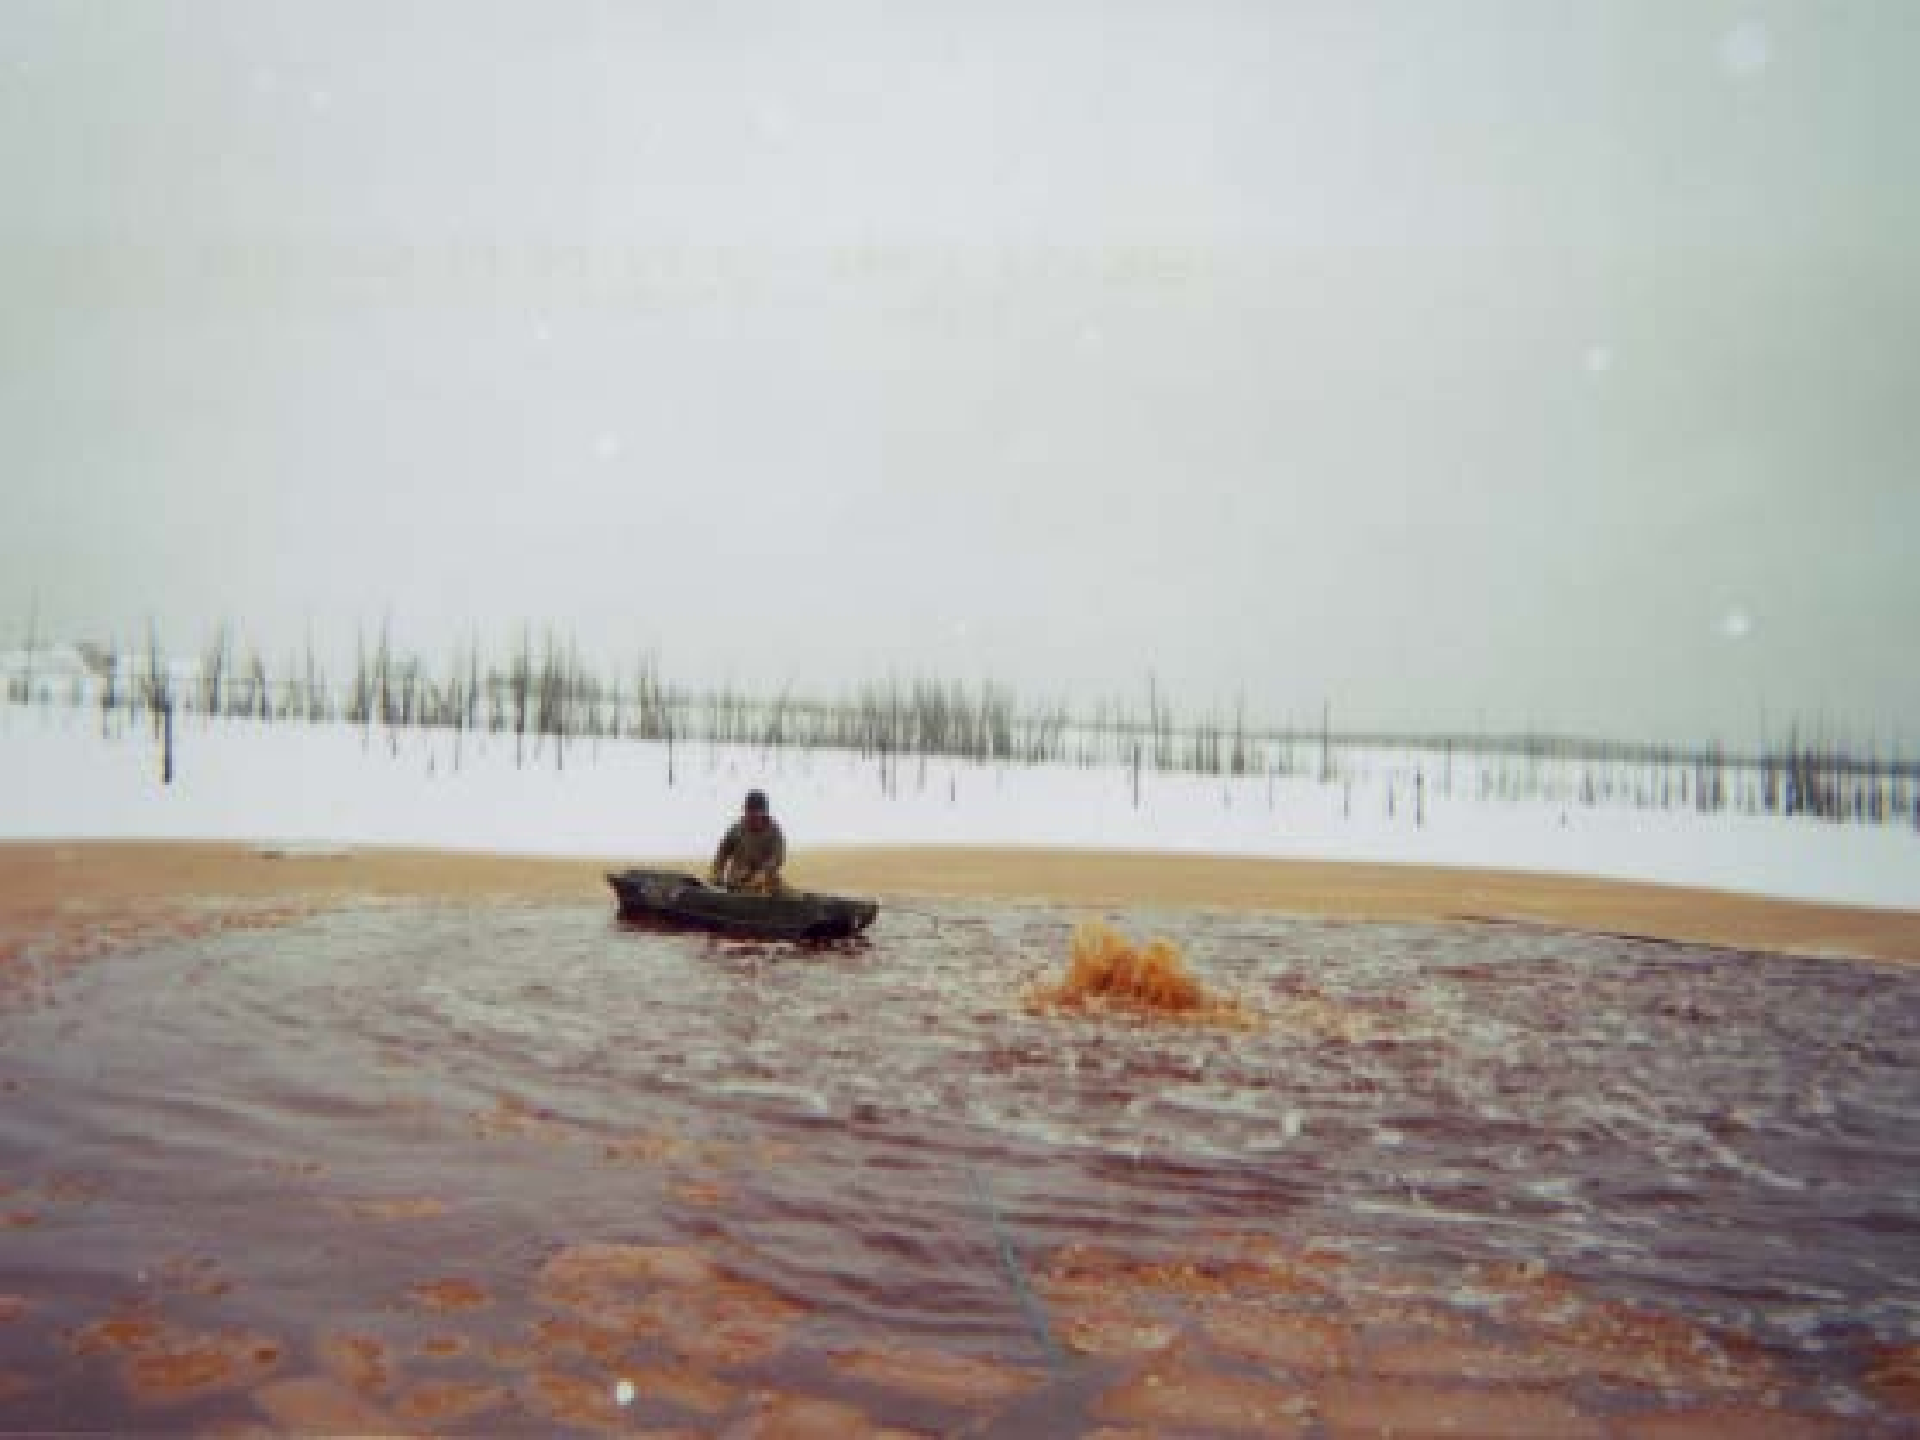
Contaminated NUT Area Water

- Efforts were made to conduct the “in-situ” treatment of the NUT “Pond” during the winter of 2003/04.
- After 706 tonnes of lime were added to the Pond, caustic (e.g. NaOH) was used.
- Over 2,000 tonnes of caustic were also added.
- Managed to raise the pH sufficiently to allow the discharge of the contaminated water for ~ 3 hours.
- Eventually ceased the treatment after having spent \$1.8 million.

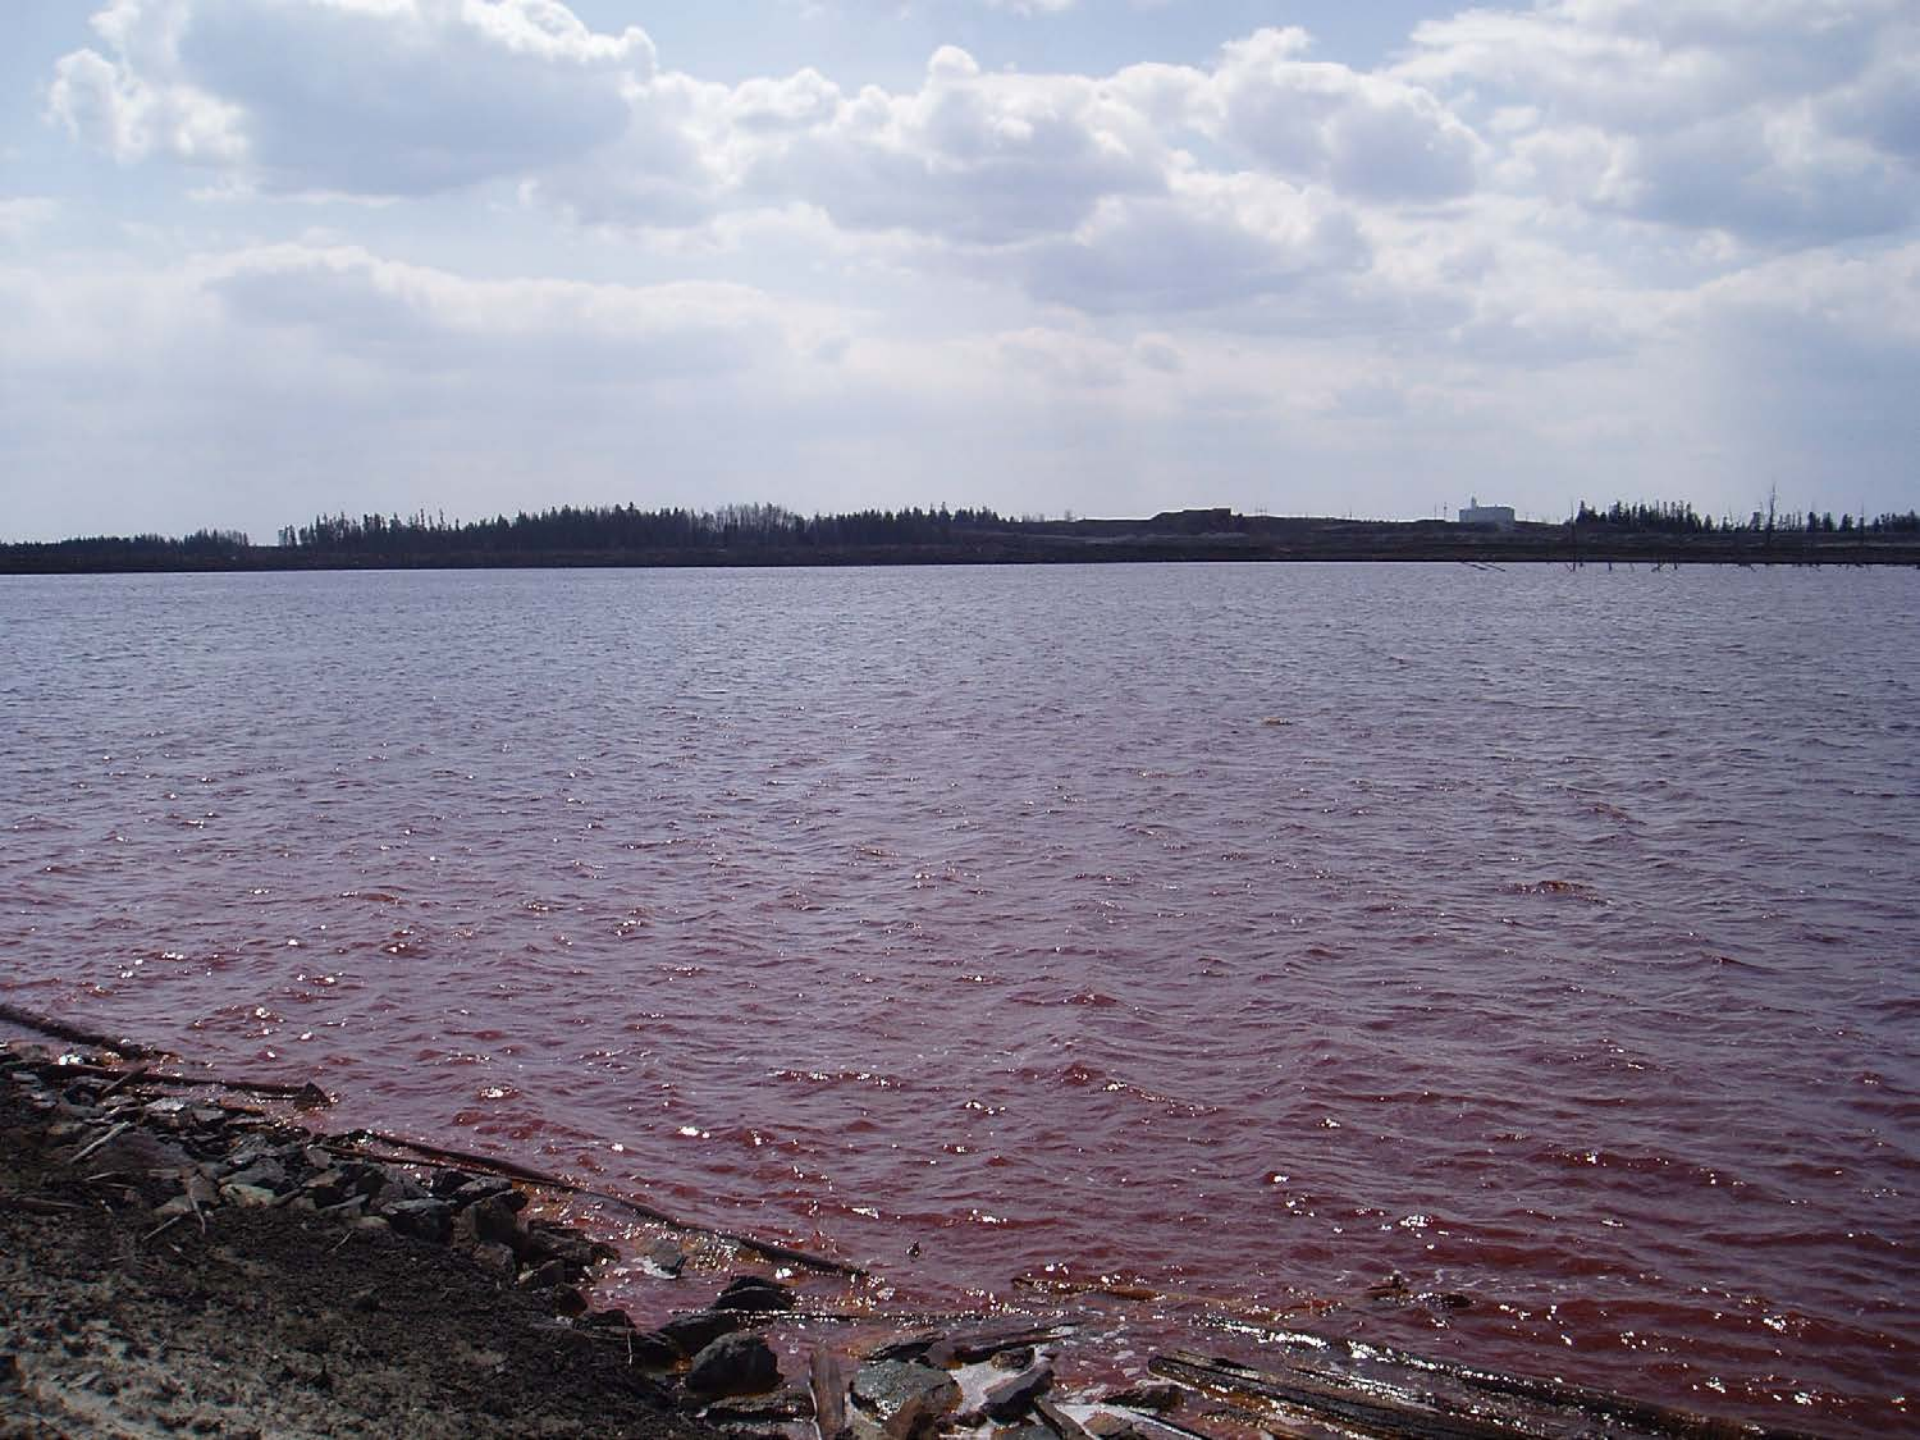
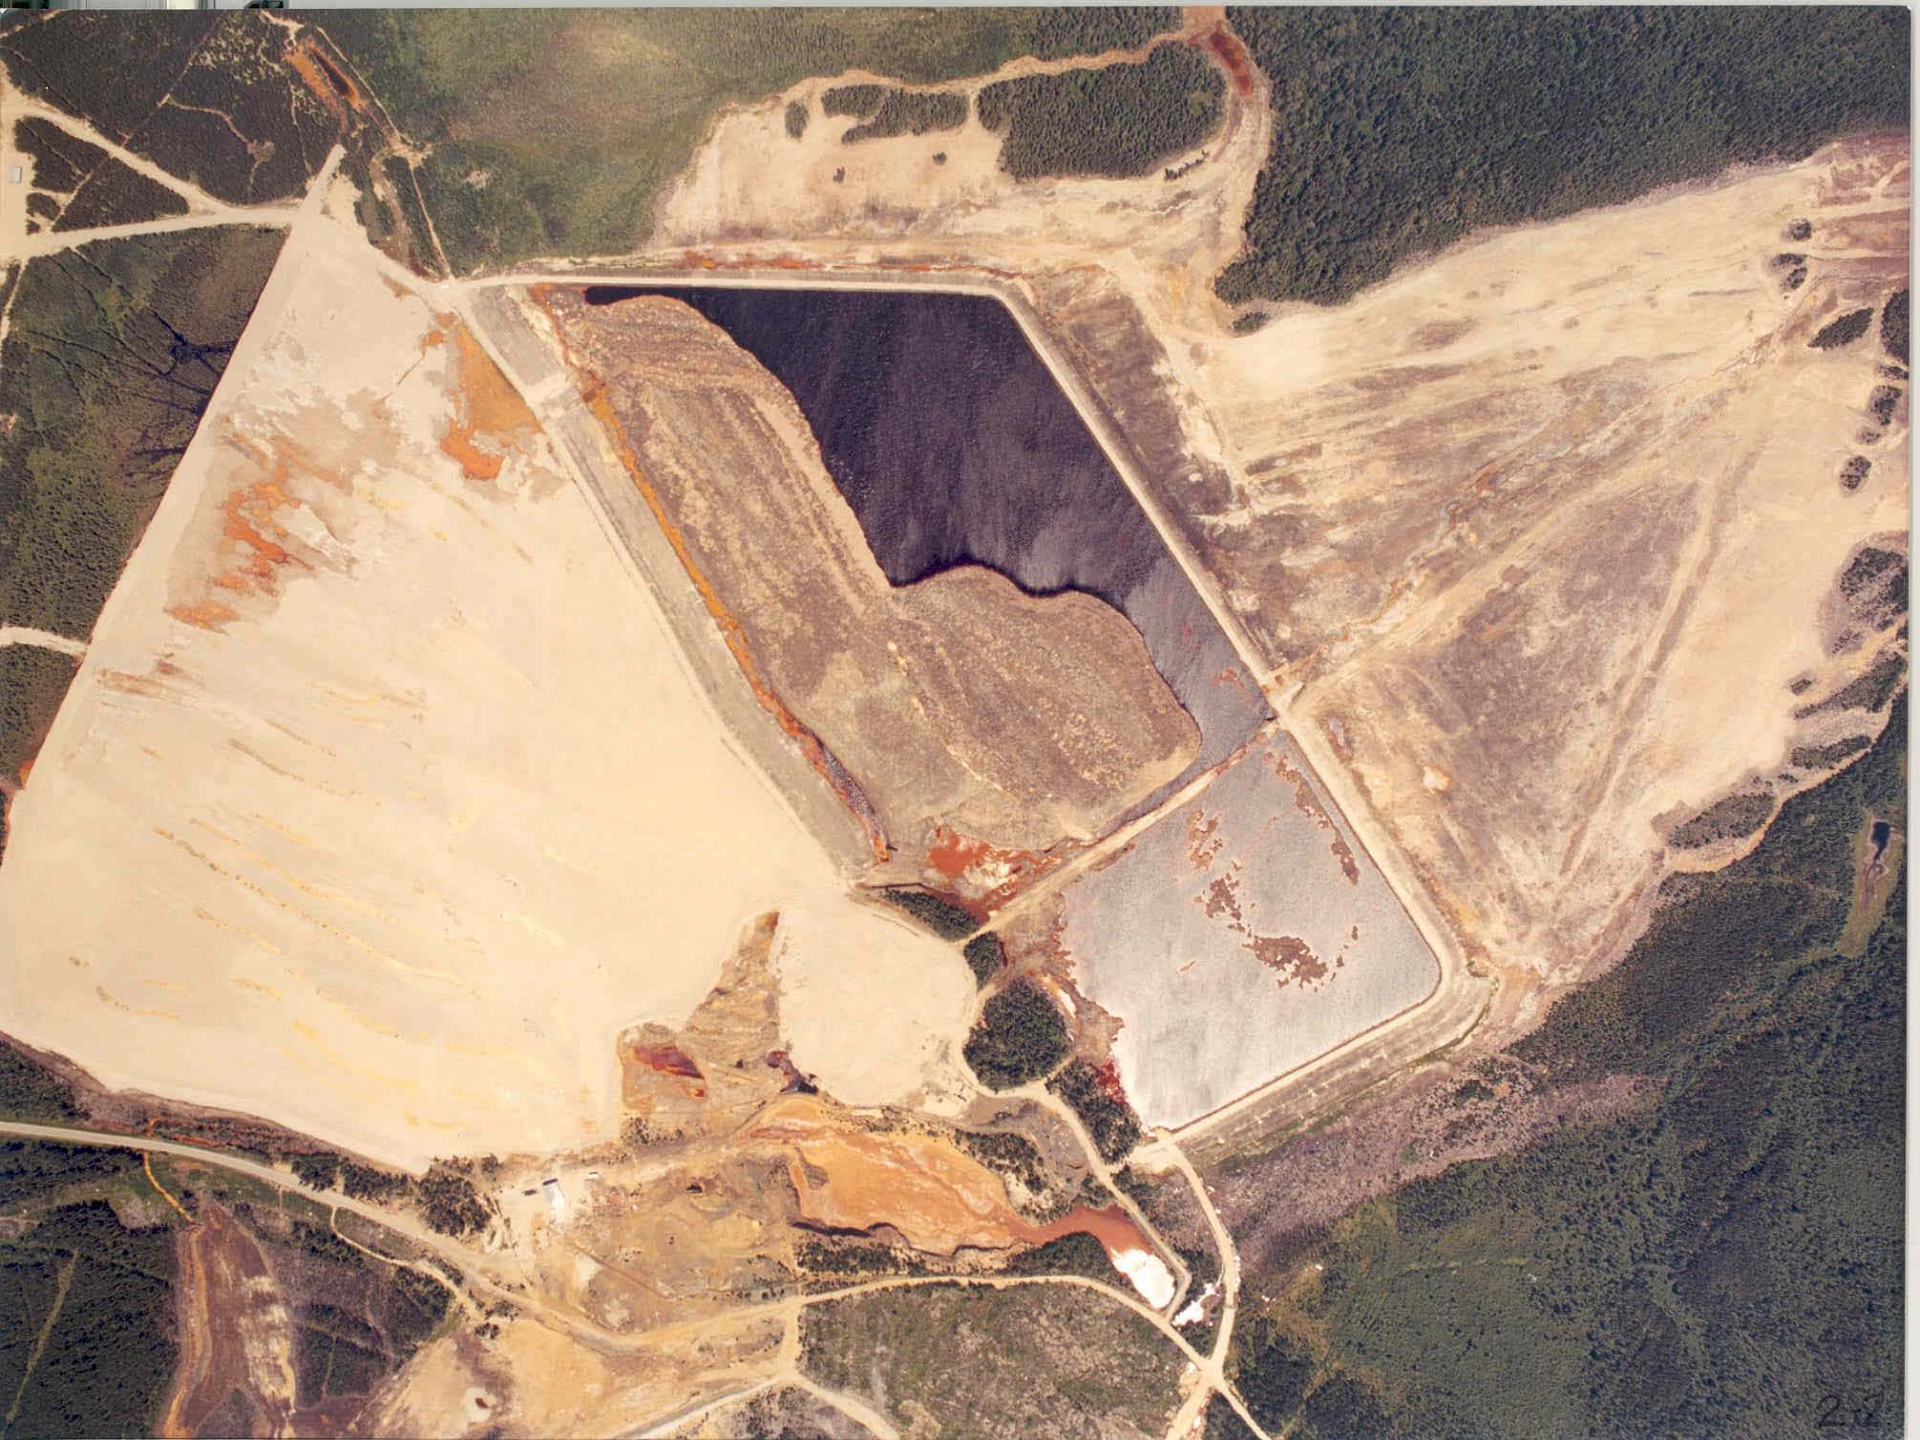
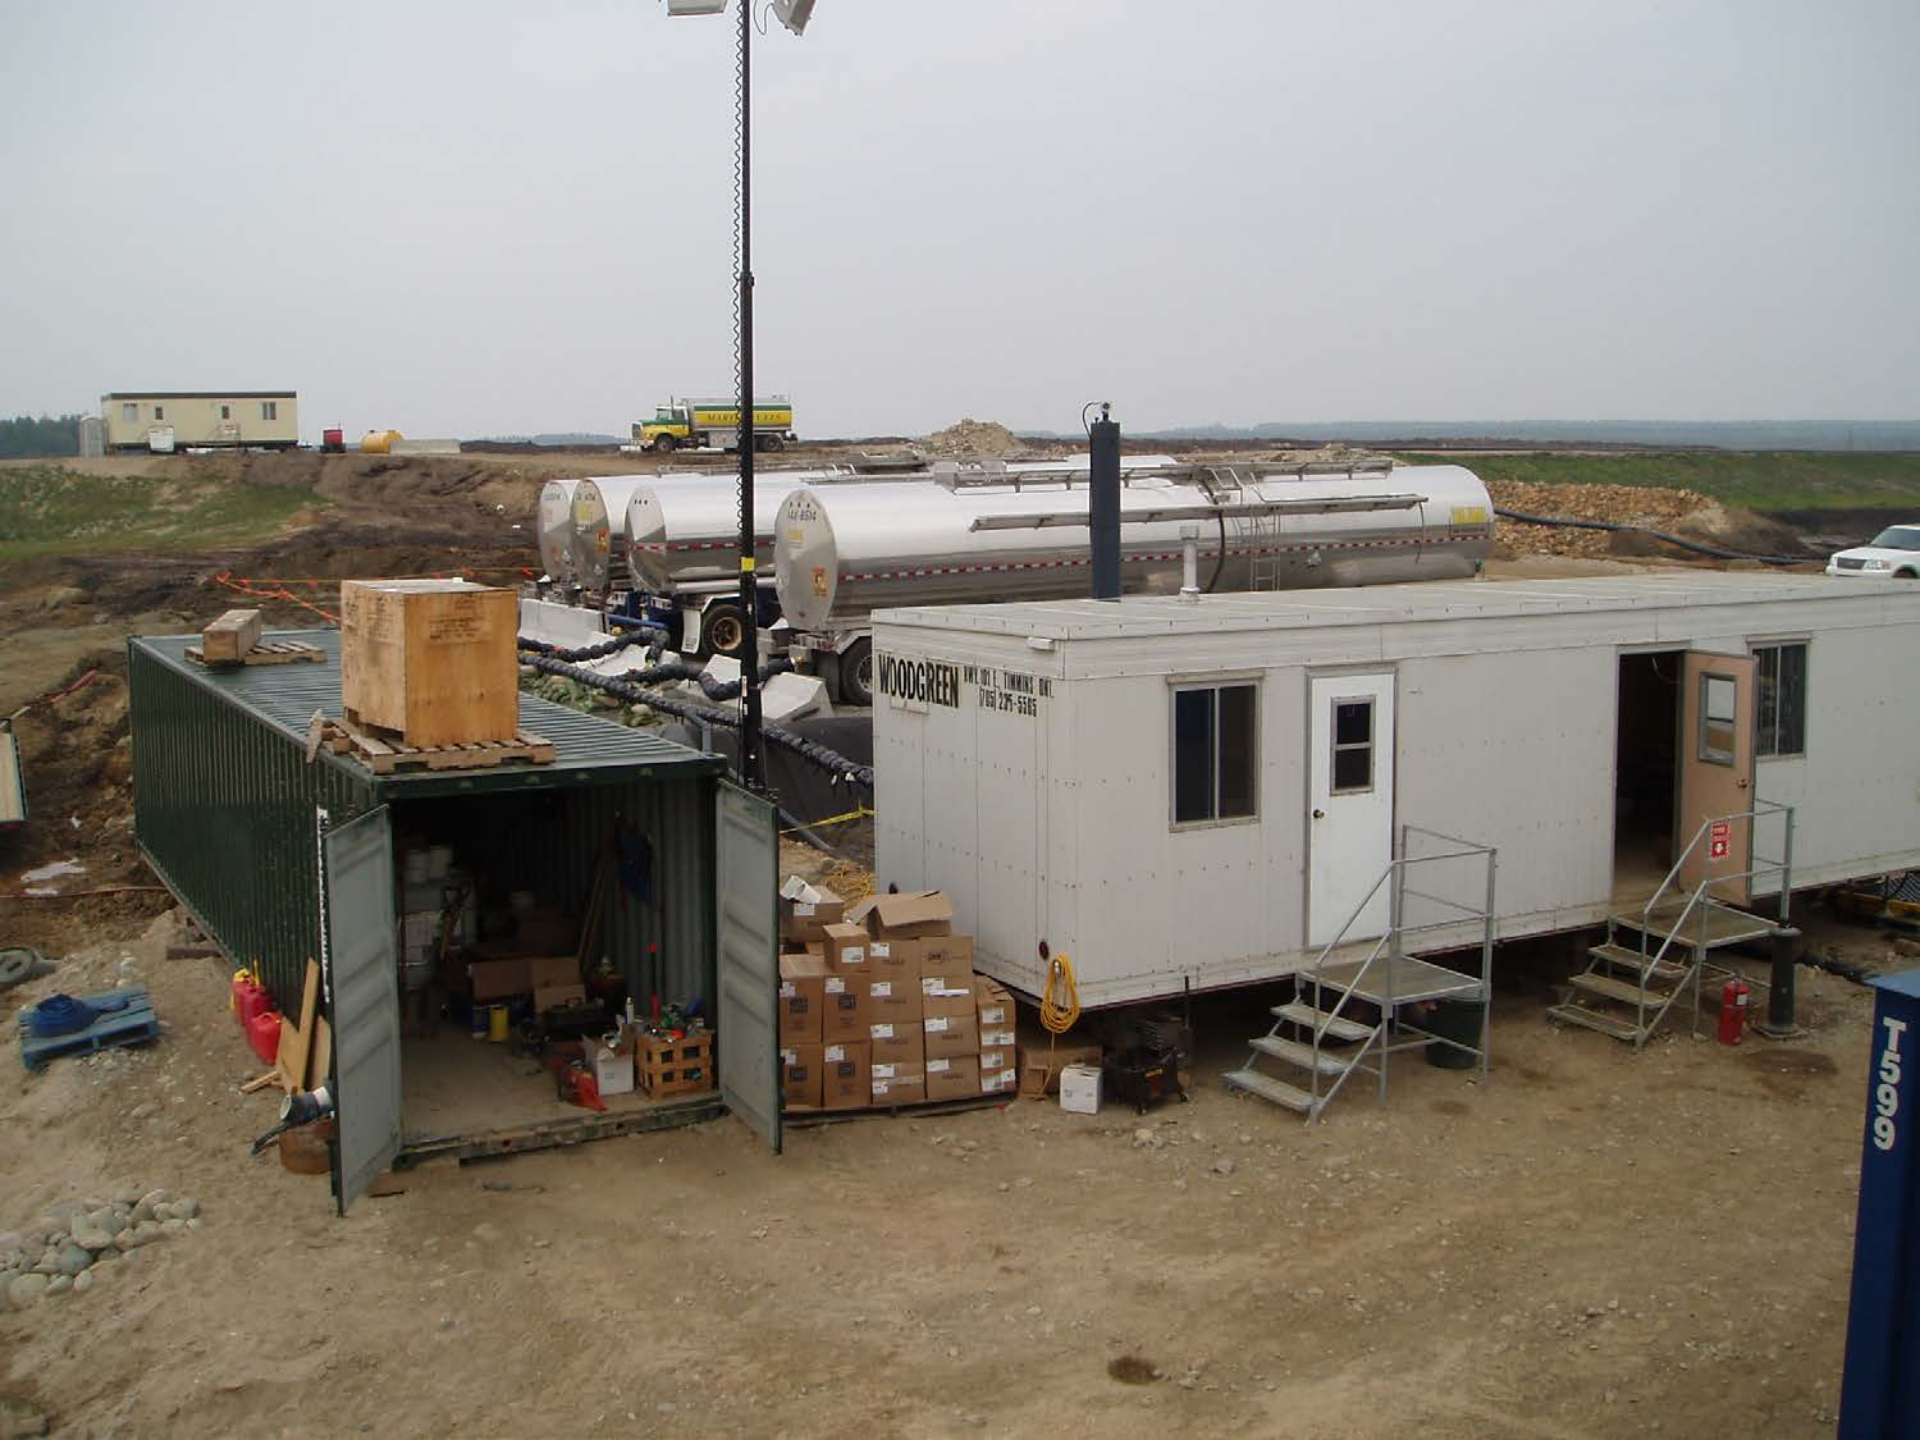
Contaminated NUT Area Water

- A contract was awarded in the spring of 2005 to conduct the treatment and discharge of the contaminated NUT water and to place the stacked NUT tailings into their proper location.
- The work was completed successfully.
 - the NUT impoundment area was emptied by the end of the fall of 2005.
 - the tailings in the NUT were leveled by the end of the winter of 2005/06.
- The final cost of this contract was \$9.4 million.
