The Ongoing Rehabilitation of Ontario's Kam Kotia Mine: An Abandoned Acid Generating Tailings Site

Christopher D. Hamblin

**Project Coordinator
Abandoned Mines Rehabilitation Fund
Ministry of Northern Development & Mines
Ontario, Canada**

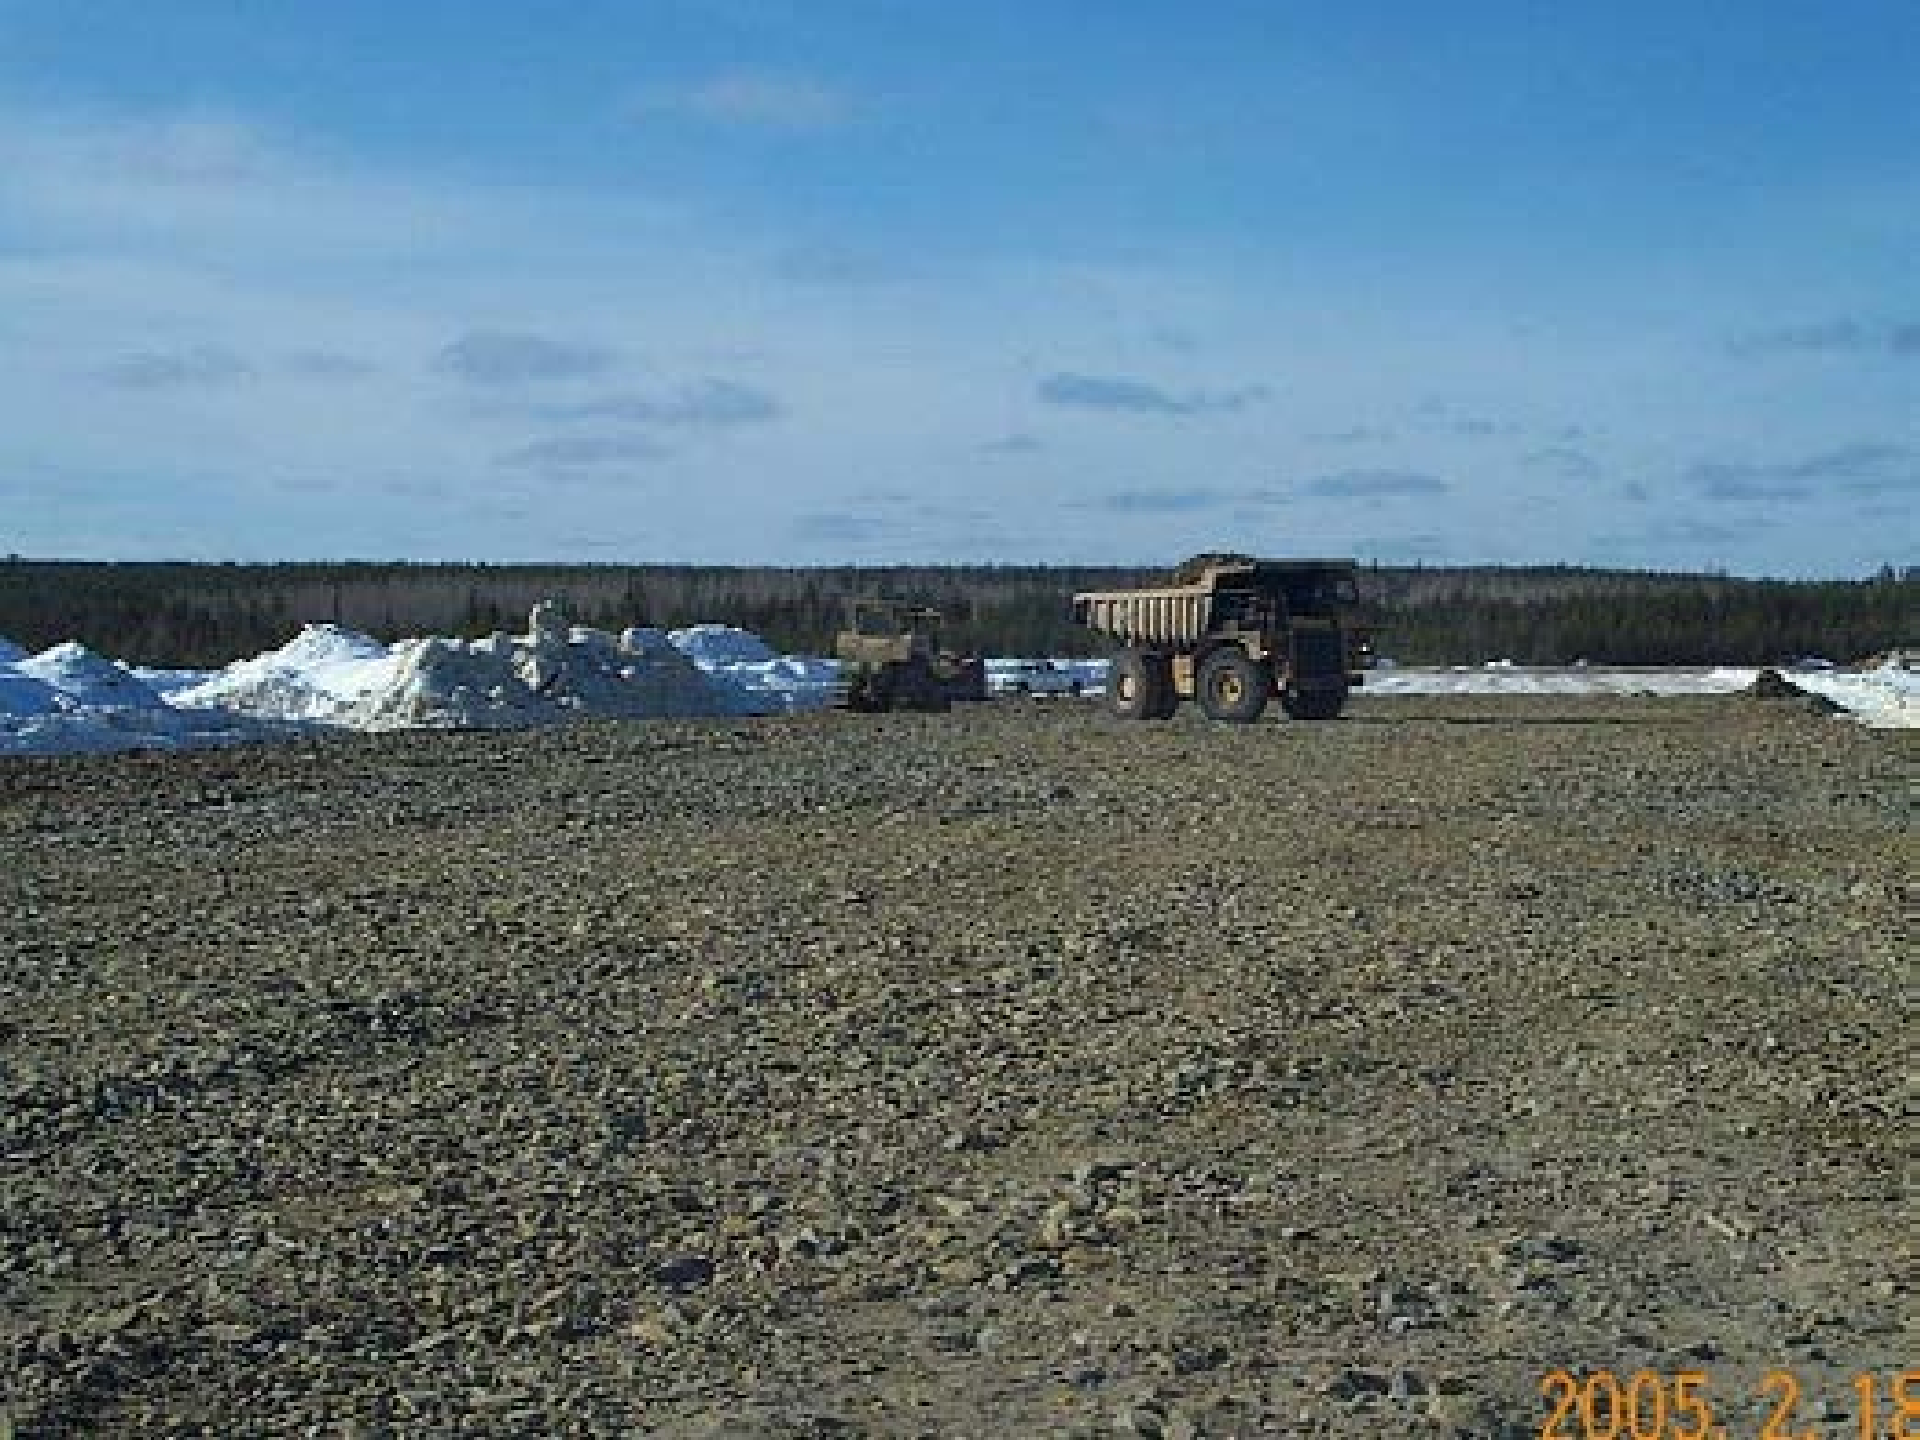
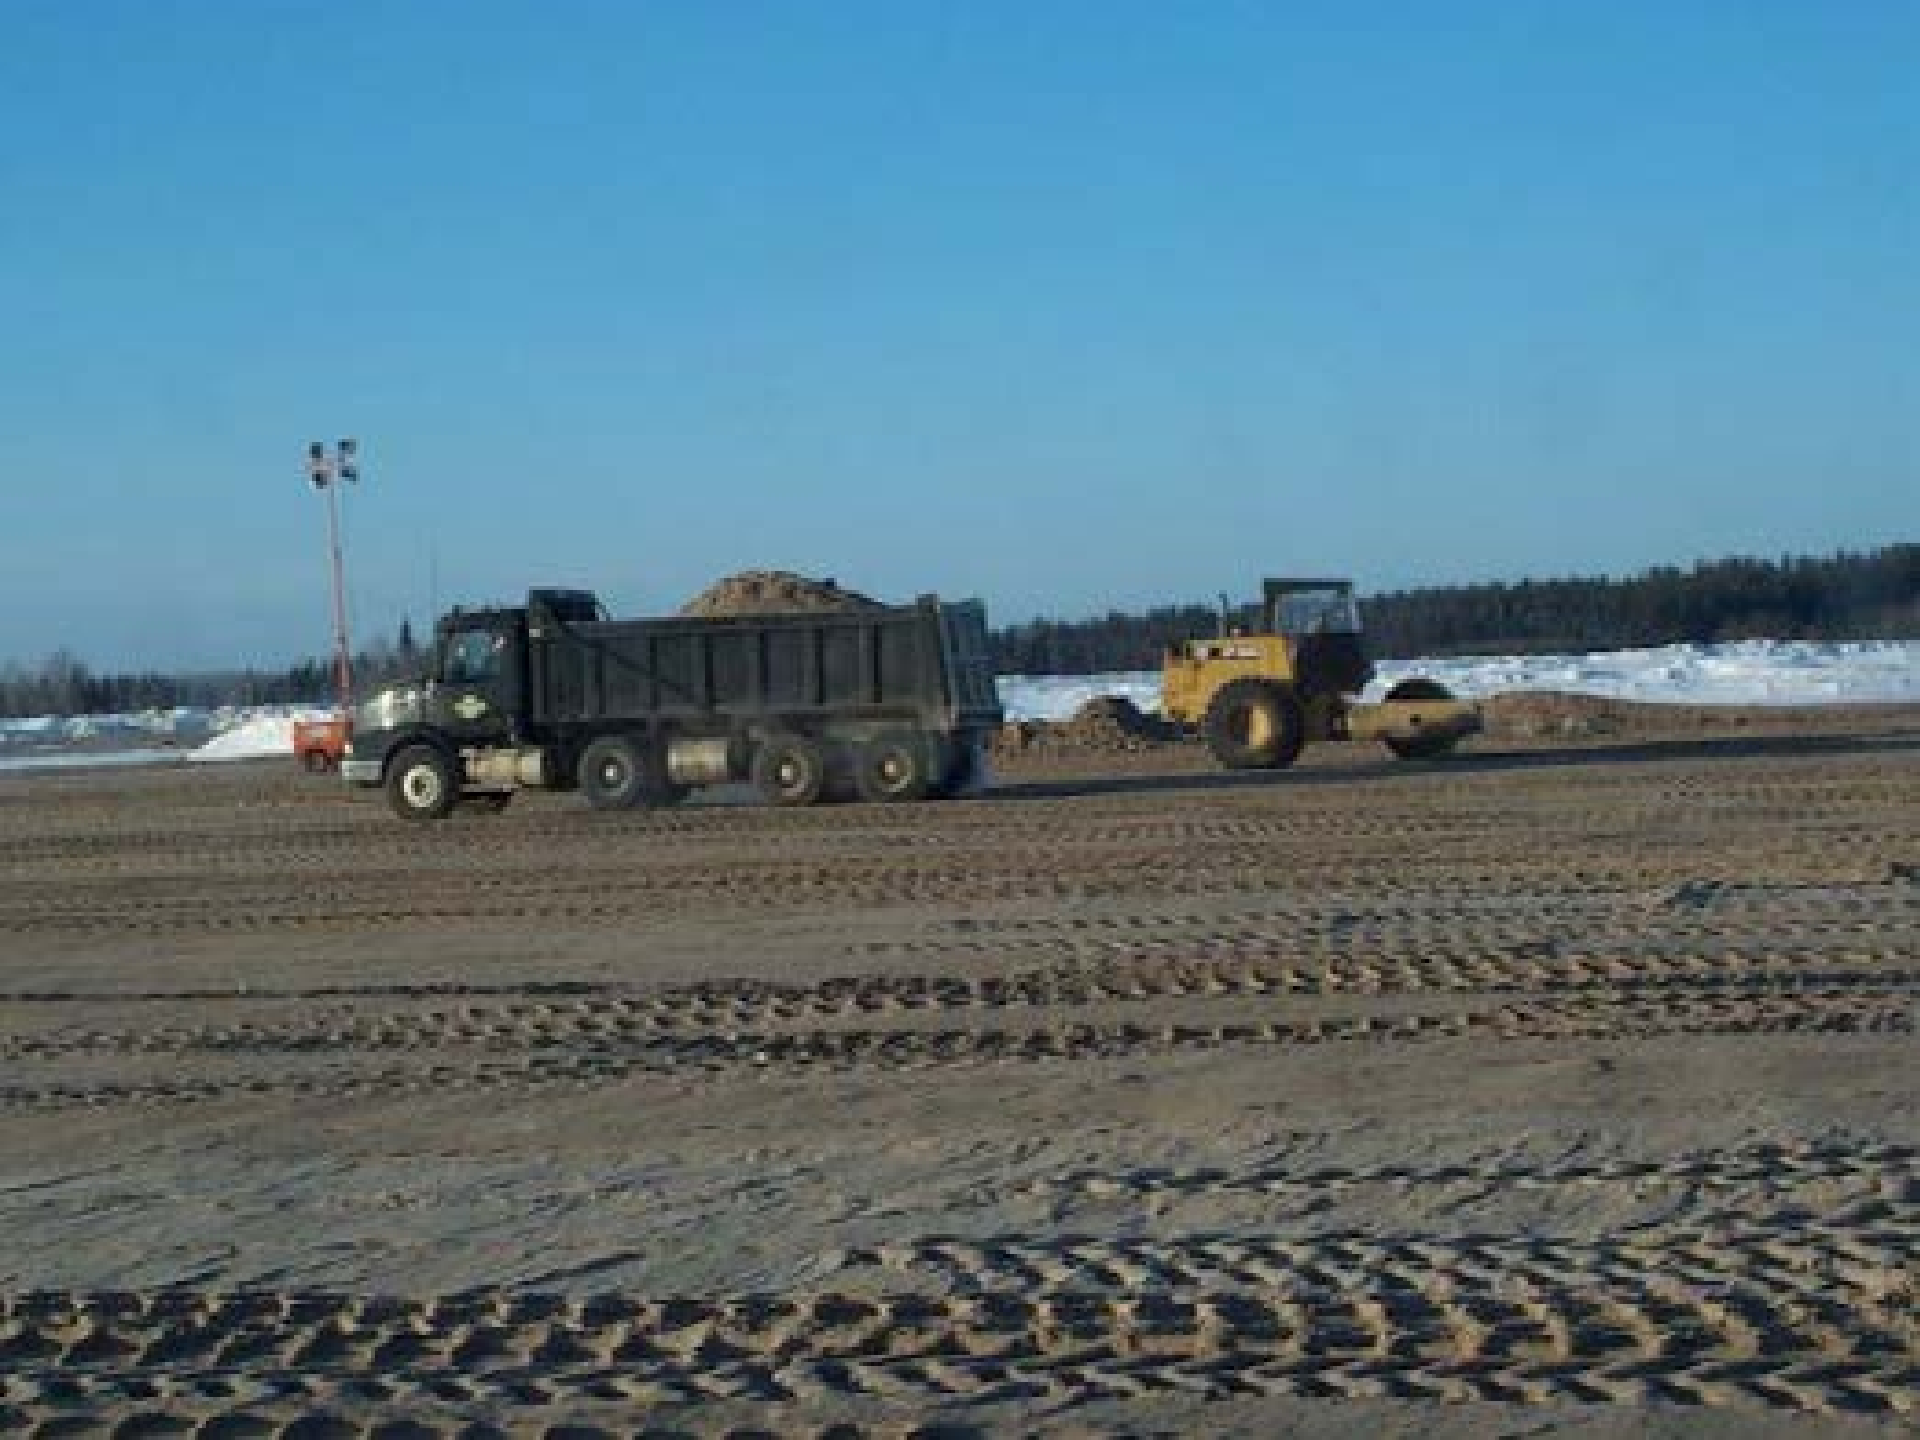
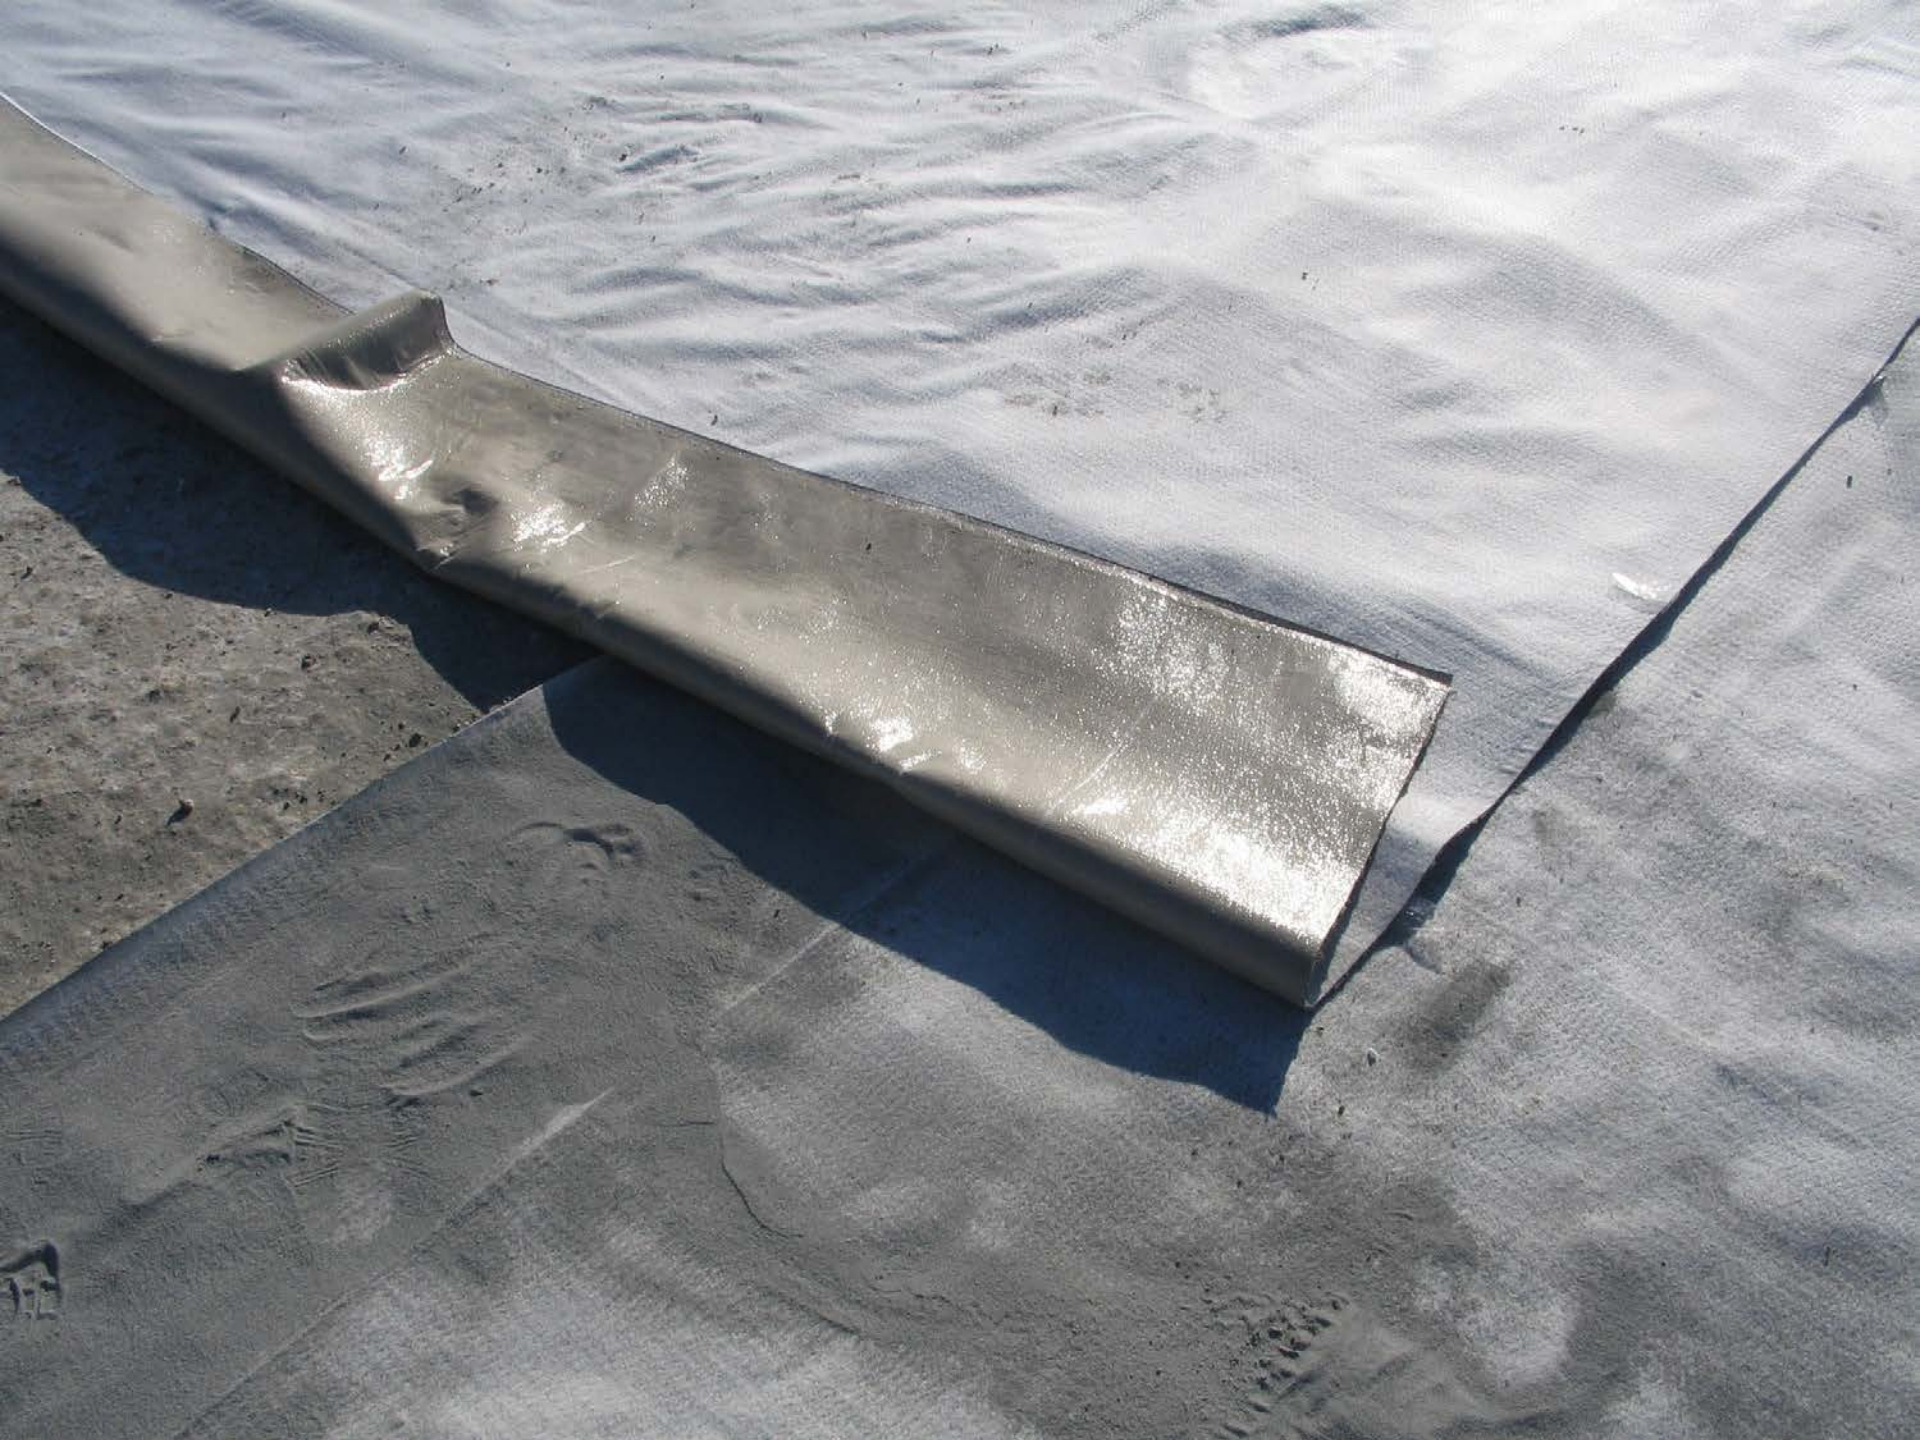
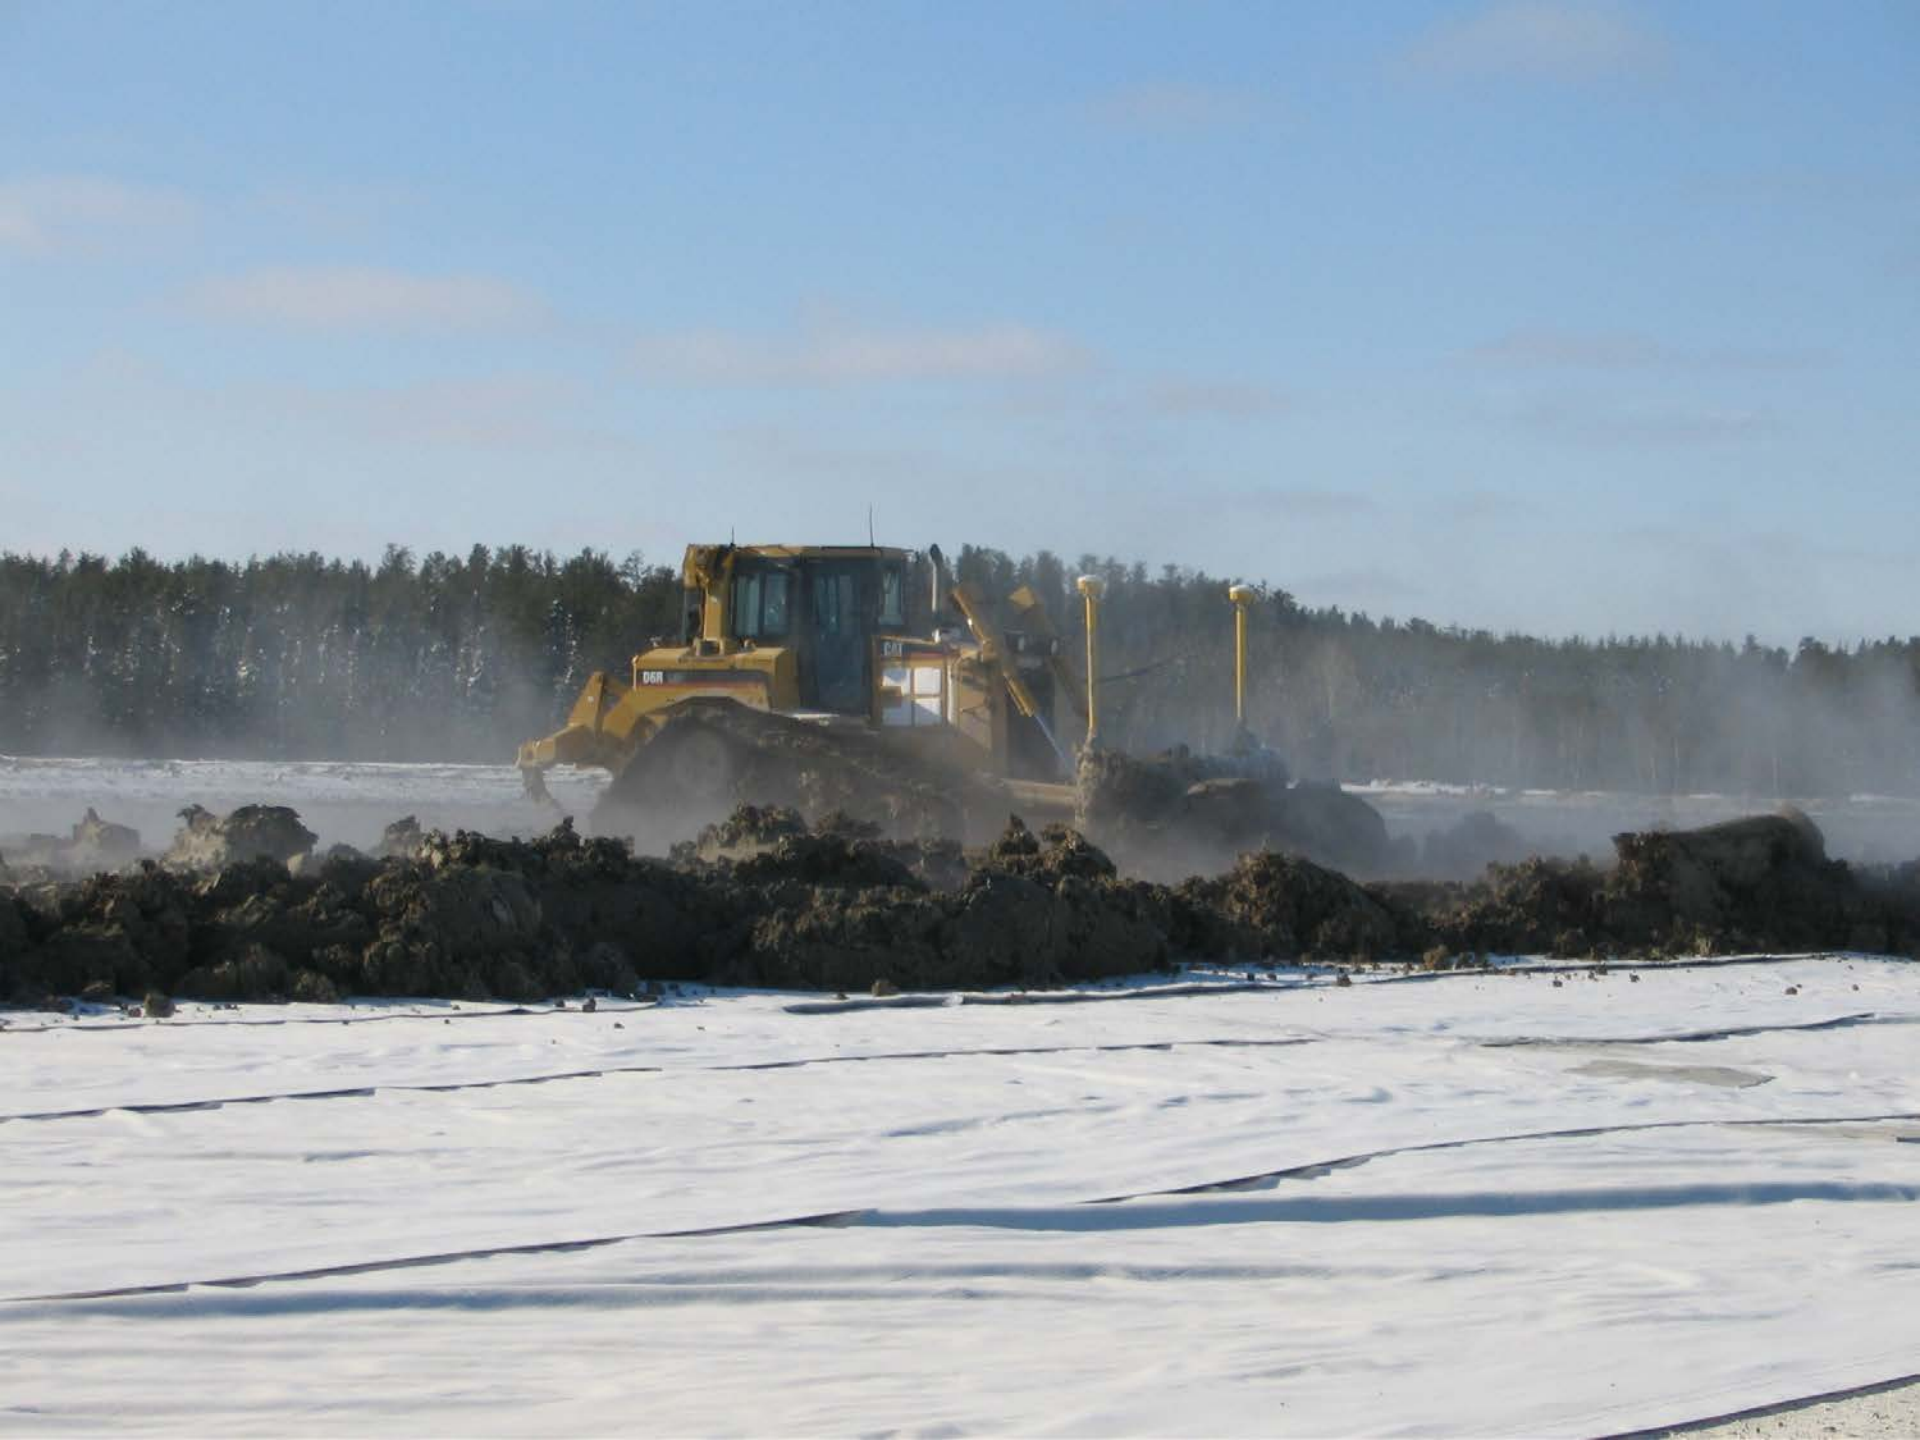
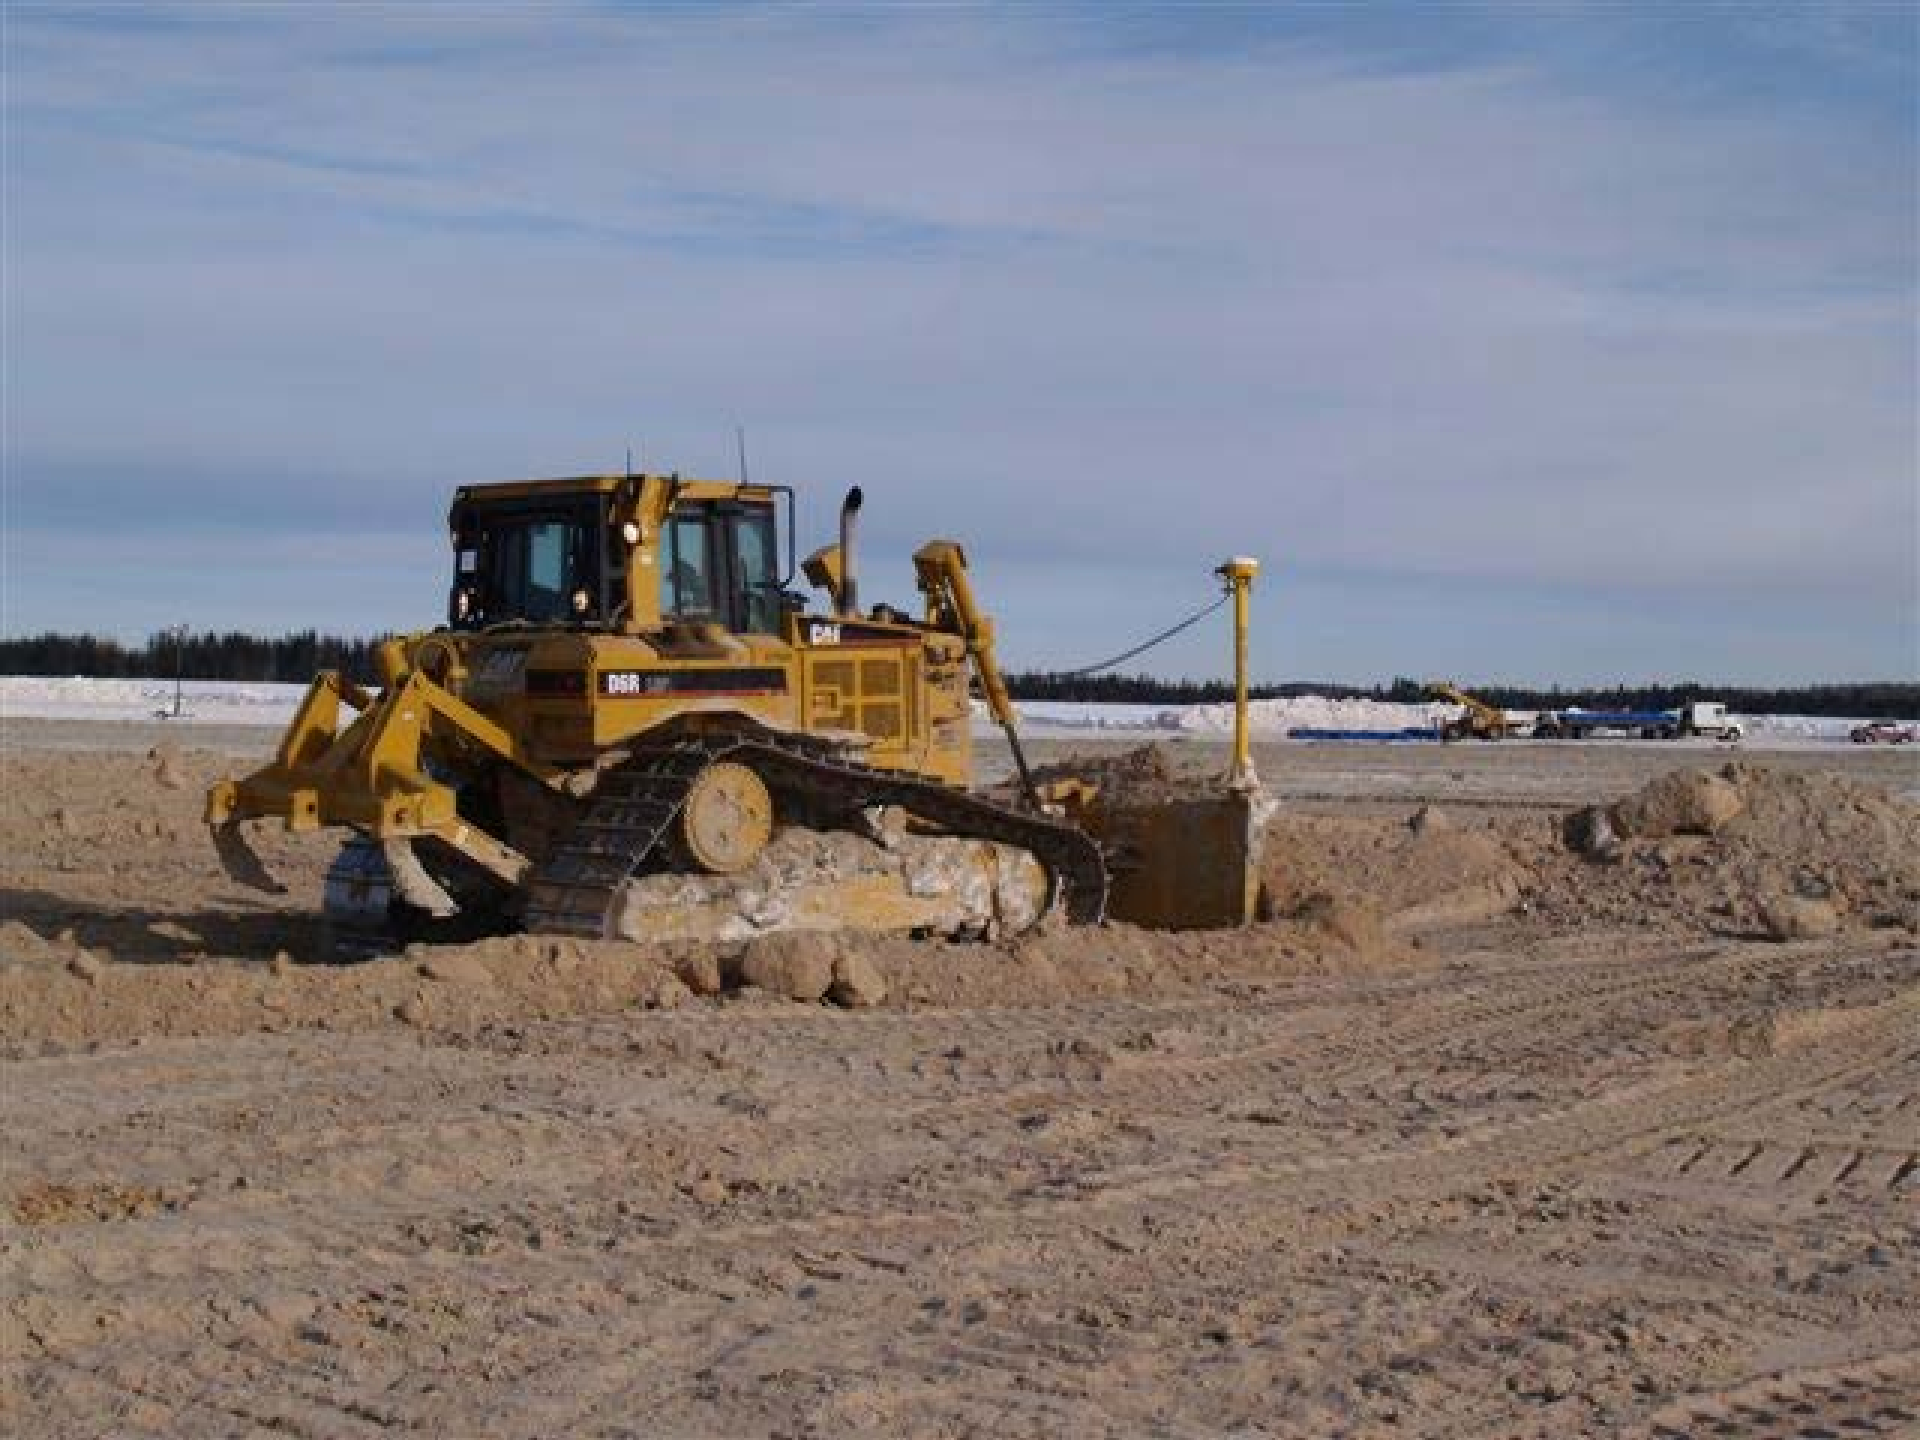
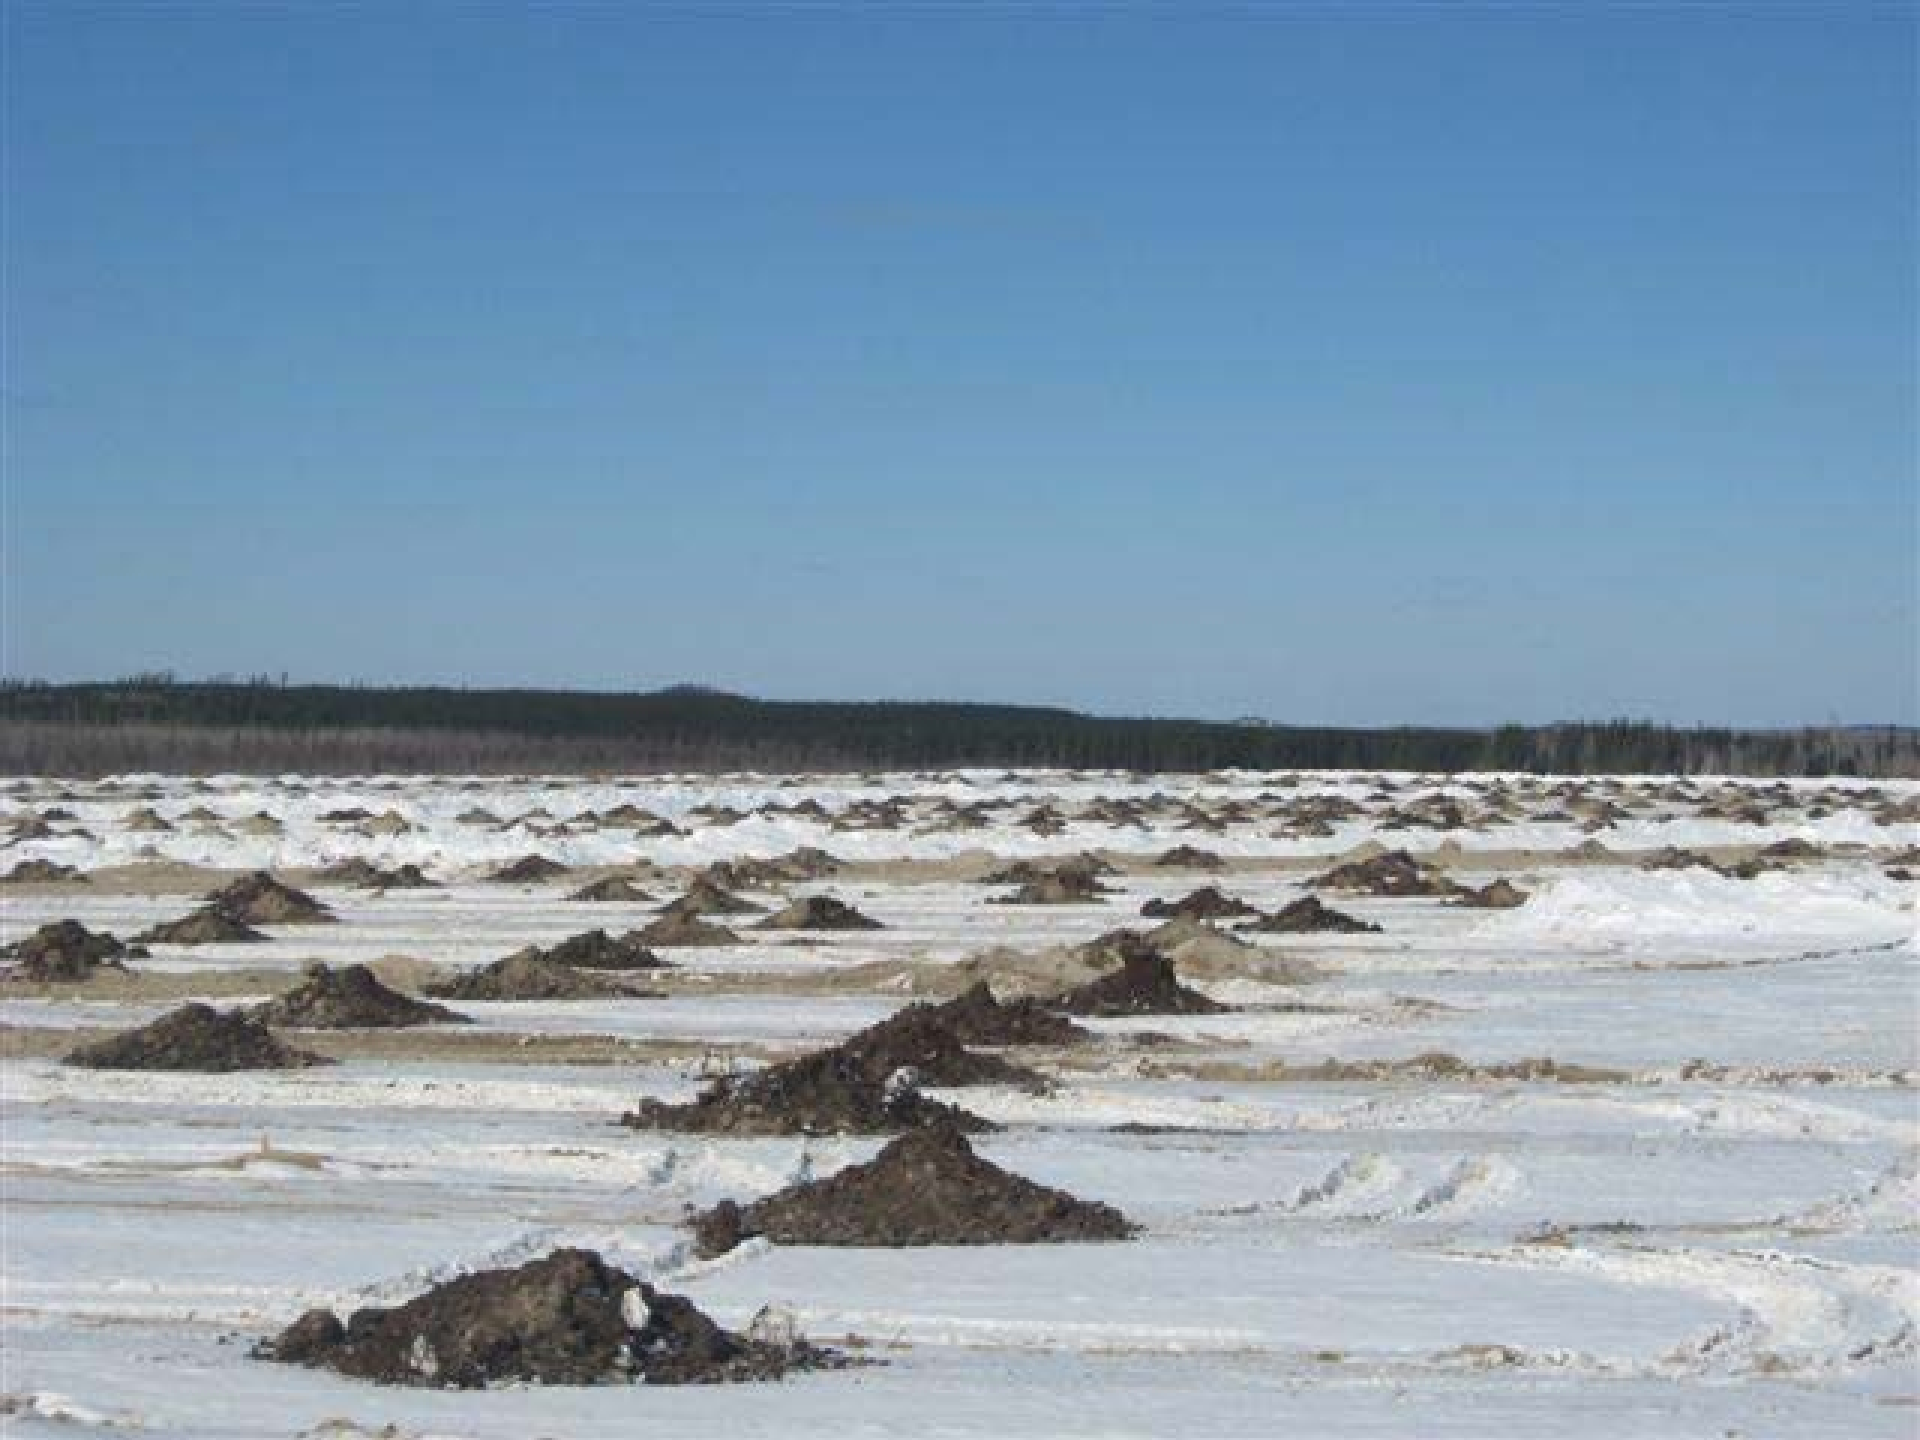
NIT Area Cover

- The construction of the NIT area engineered “dry” cover is part of the Phase “E” rehabilitation requirements.
- In order for the KKM rehabilitation work to continue until the contaminated water was dealt with, the first two layers of that cover – the capillary break – were constructed during the winter of 2004/05, at a cost of \$3.4 million.
- The NIT area cover completion project is now nearing completion, at an additional cost of \$12.6 million.
