The Ongoing Rehabilitation of Ontario's Kam Kotia Mine: An Abandoned Acid Generating Tailings Site

Christopher D. Hamblin

**Project Coordinator
Abandoned Mines Rehabilitation Fund
Ministry of Northern Development & Mines
Ontario, Canada**

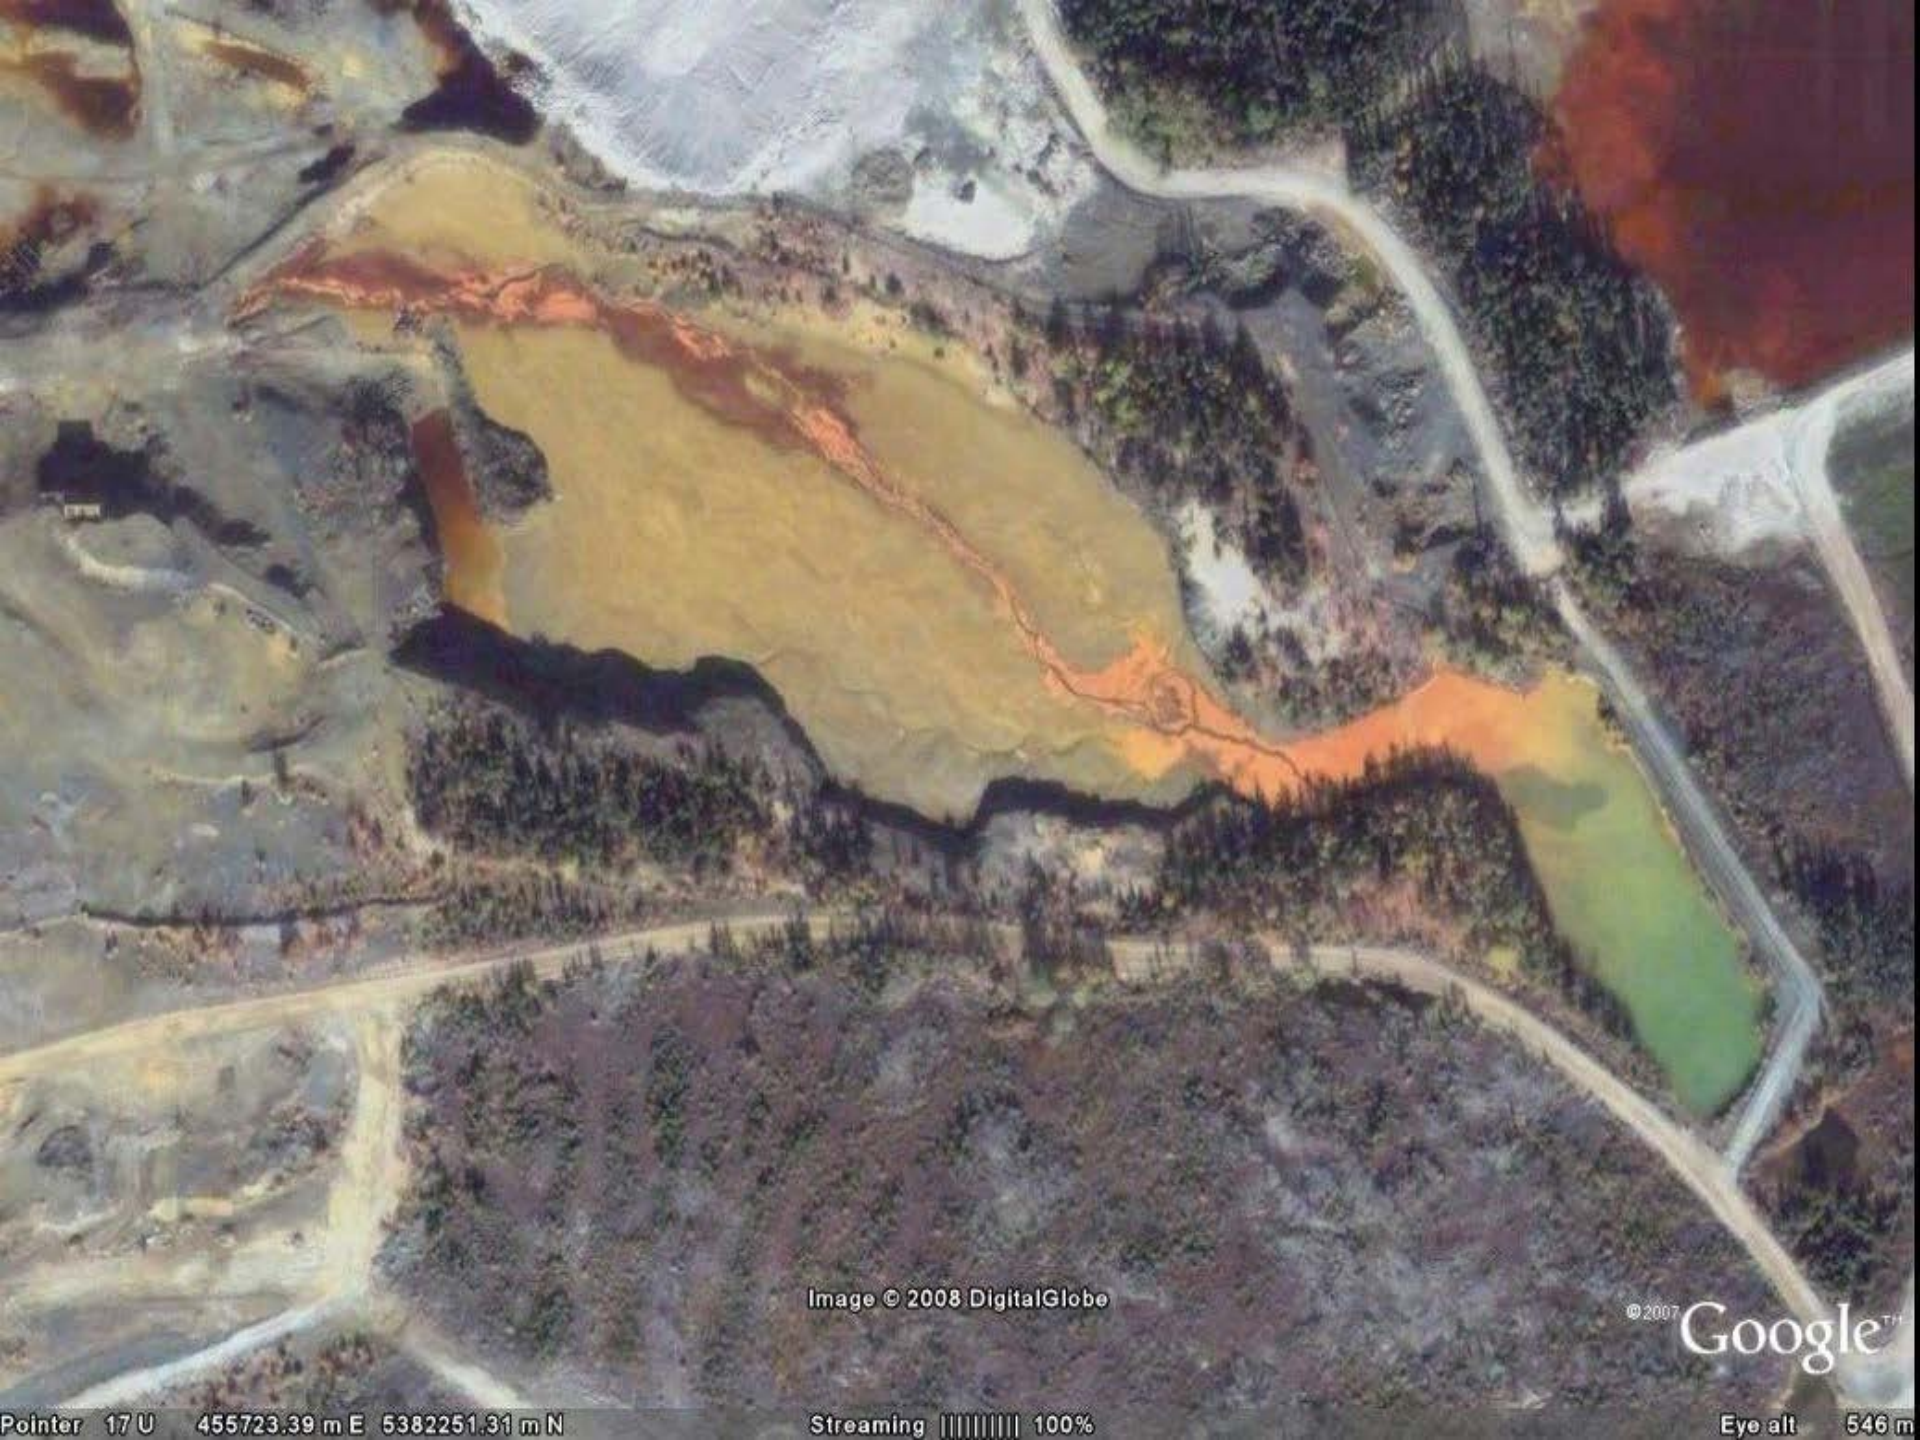
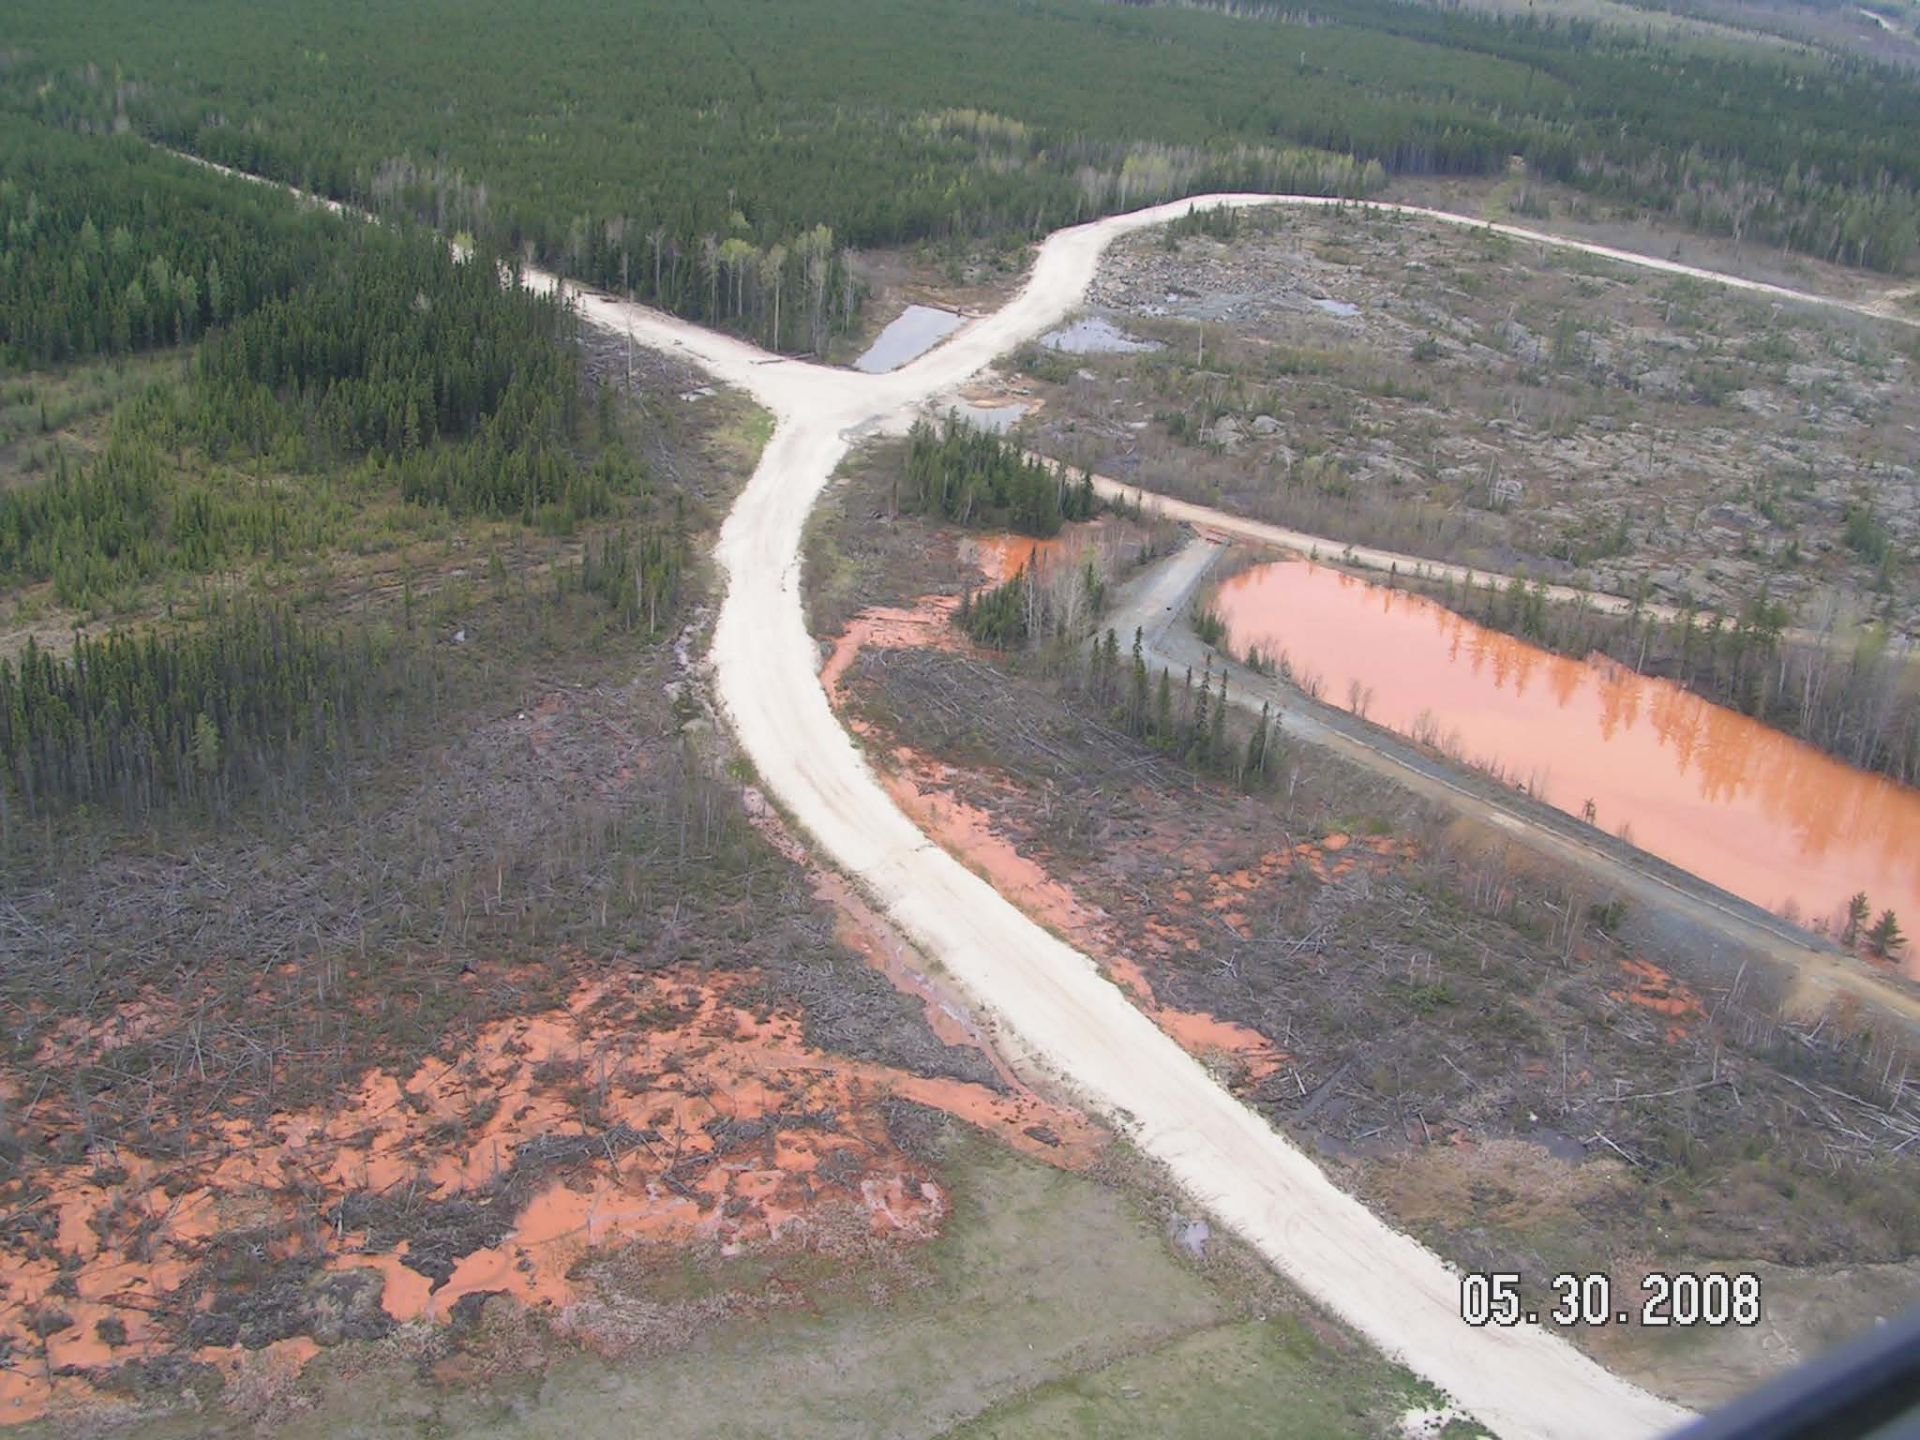
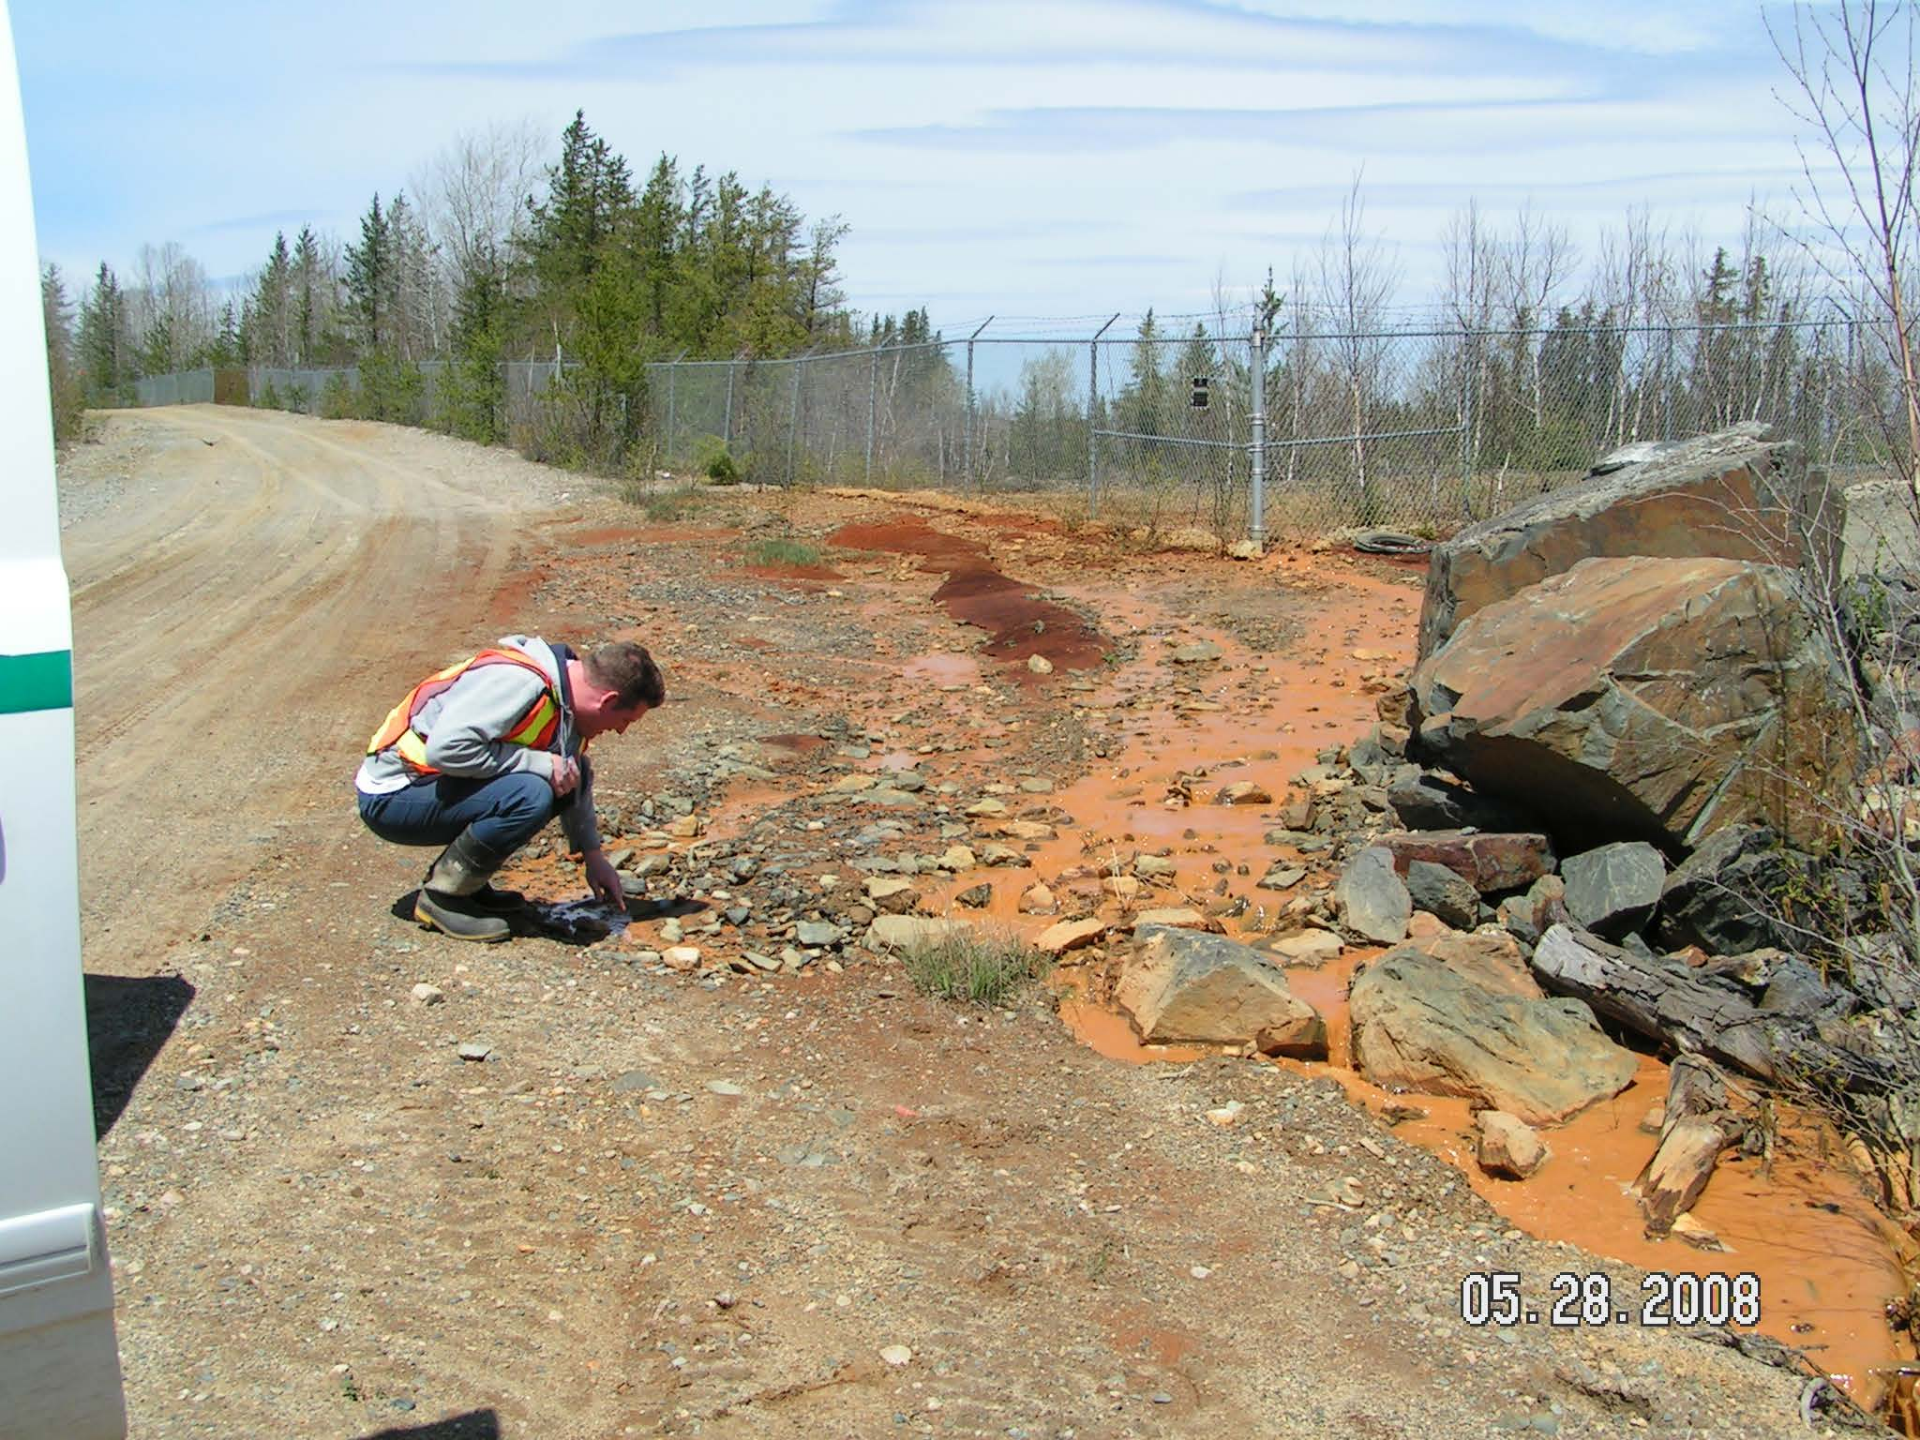
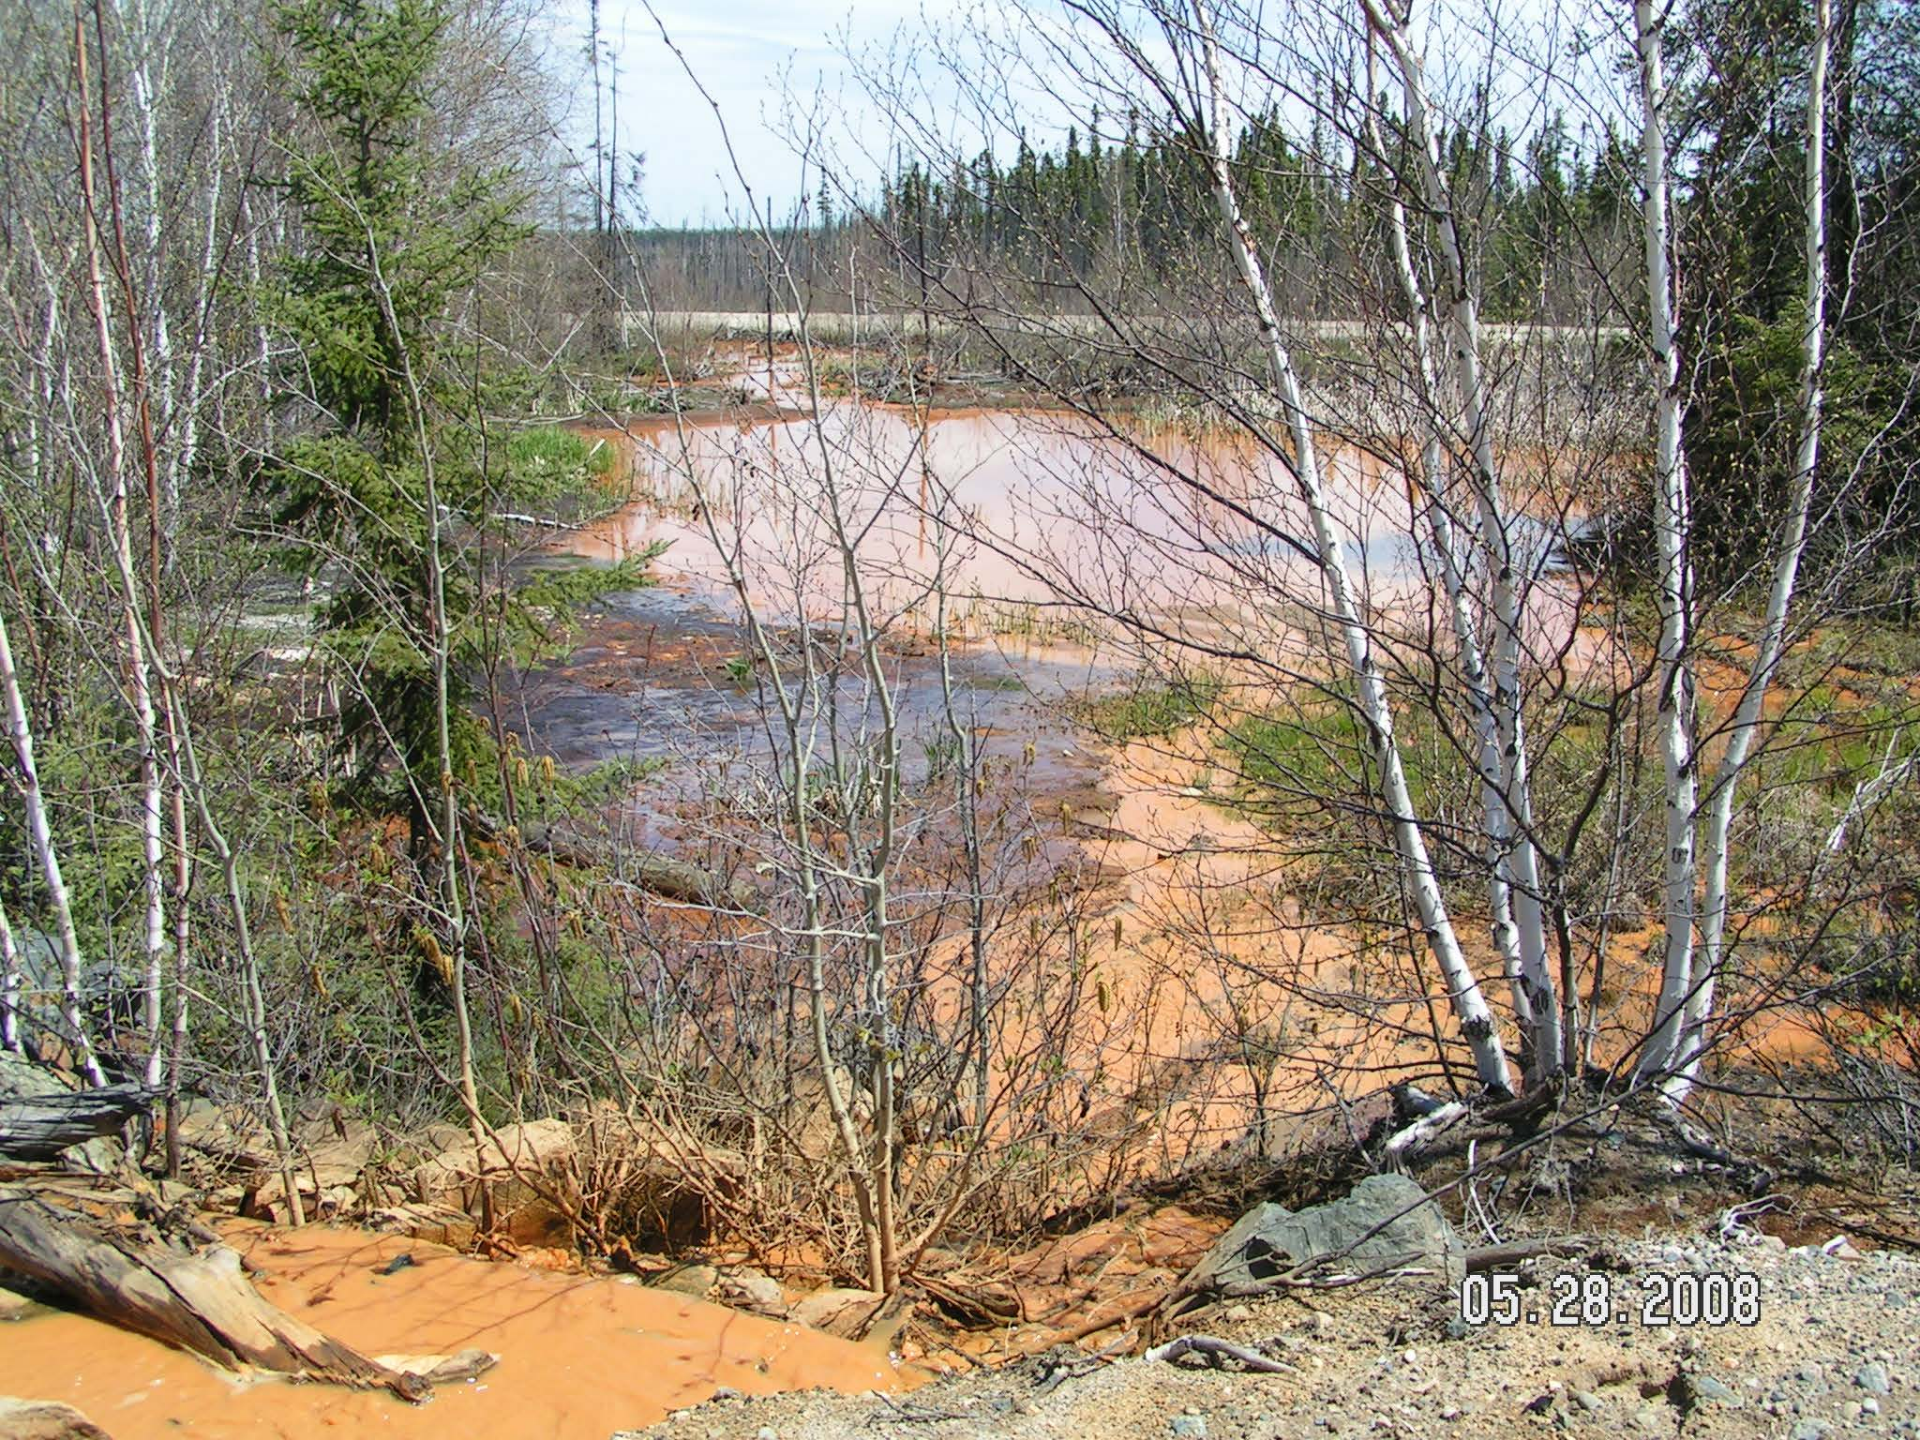
Speaking of Unforeseen...

On Thursday afternoon, May 29, 2008, the Ministry of the Environment (MOE) reported that sludge from the Lime Plant was spilling out of the Kam Kotia open pit.

- The open pit has been selected as the storage location for the sludge until a more permanent solution is determined during the Phase “E” engineering study.
- While clear, supernatant water has previously spilled from the pit during peak flow times, this is the first time that we have lost sludge as well.

Sludge Discharge Point

Old Kam Kotia Pit Full of Tailings (& Sludge)

Proposed Ditch to Discharge at this Location

Excavate New Ditch Along this Line

Use This Pond as a Temporary Decant Area. Note that the pond elevation is a few feet lower than the tailings in the pit

Construct Small Berm from Roadbed Material to Facilitate Silt Screen Installation for Controlling any Remaining Sludge Discharge
