16th Annual BC/MEND ML/ARD Workshop

**Soil, Geomembrane, and  
Non-Traditional Dry Covers**

# Aldermac Mine Site Restoration

**December 3<sup>rd</sup> 2009**

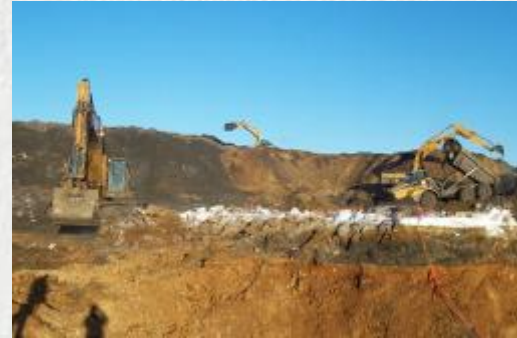
Placement of tailings  
in a mound

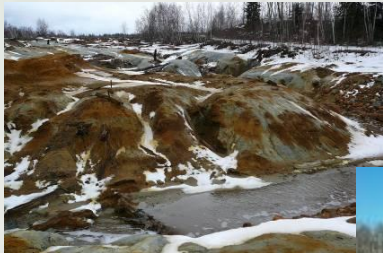
Excavated Intermediate Sector

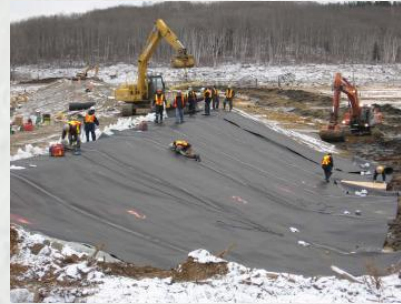
Impermeabilisation of dikes

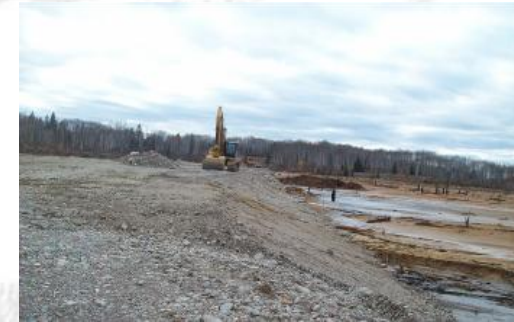
Placement of the monolayer

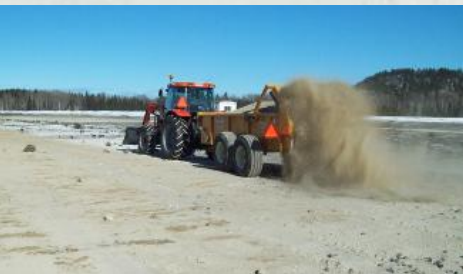
Liming of th tailings

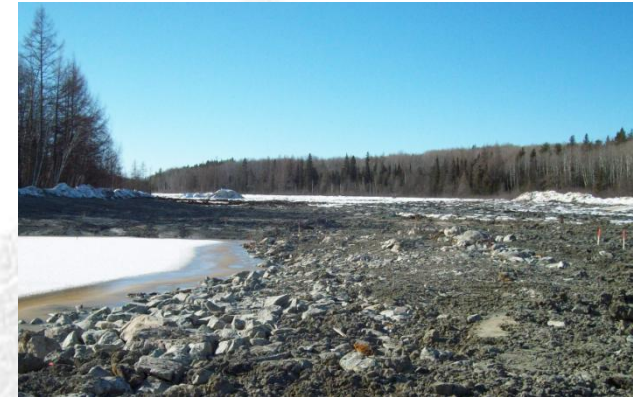
Stream 1 cleaned of its tailings

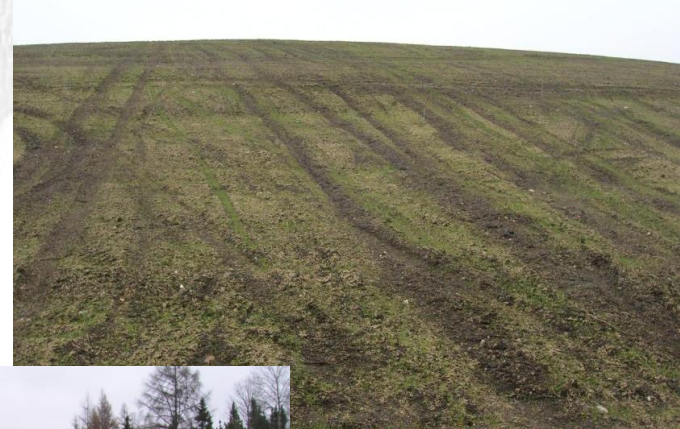
South Sector - Seeded impervious cover

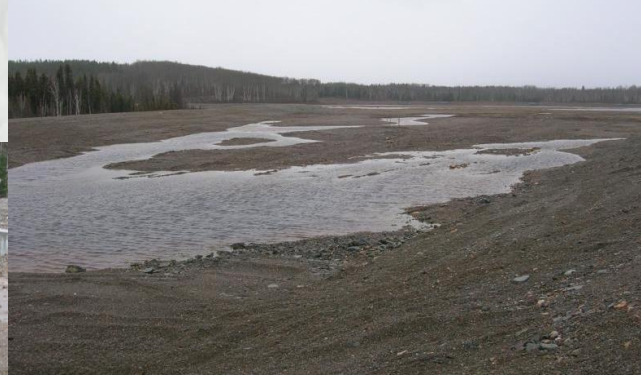
North Sector - Terrace 2

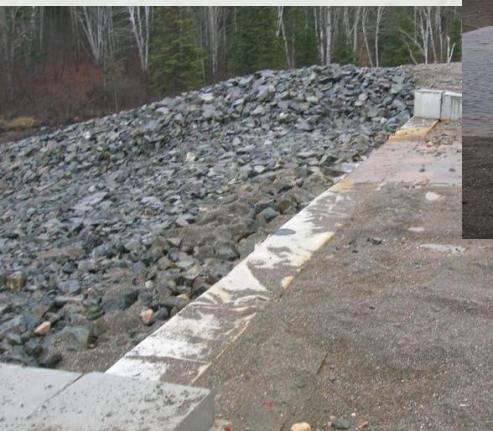
North Sector - Spillway

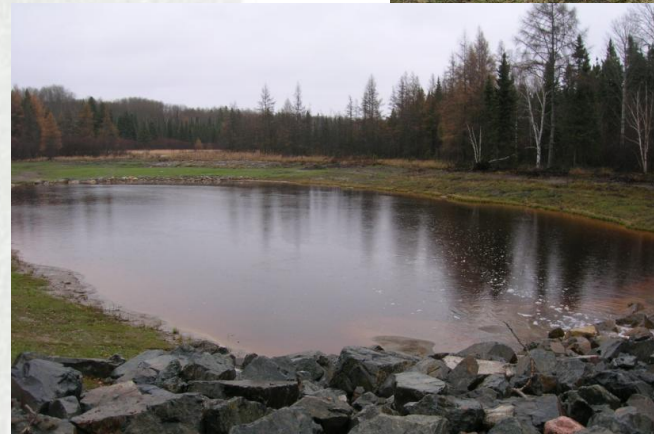
Stream 1 Sector - Settling basin

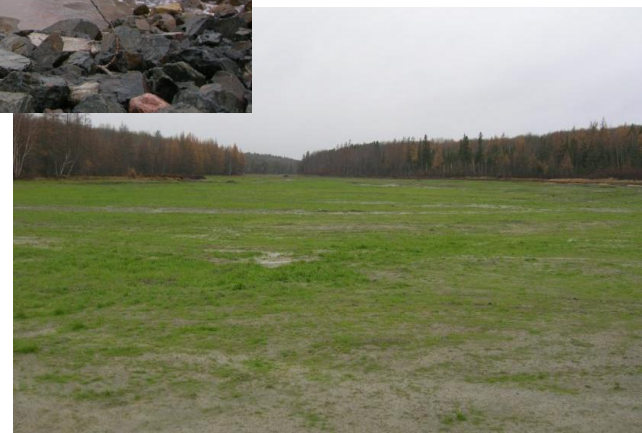
Stream 1 Sector -  
Seeded area
