# Performance of Denison Mine Tailings Management Areas (TMAs) Fifteen Years Following Decommissioning

Nand K. Davé

BC-MEND ML/ARD Workshop, Nov./Dec. 2011

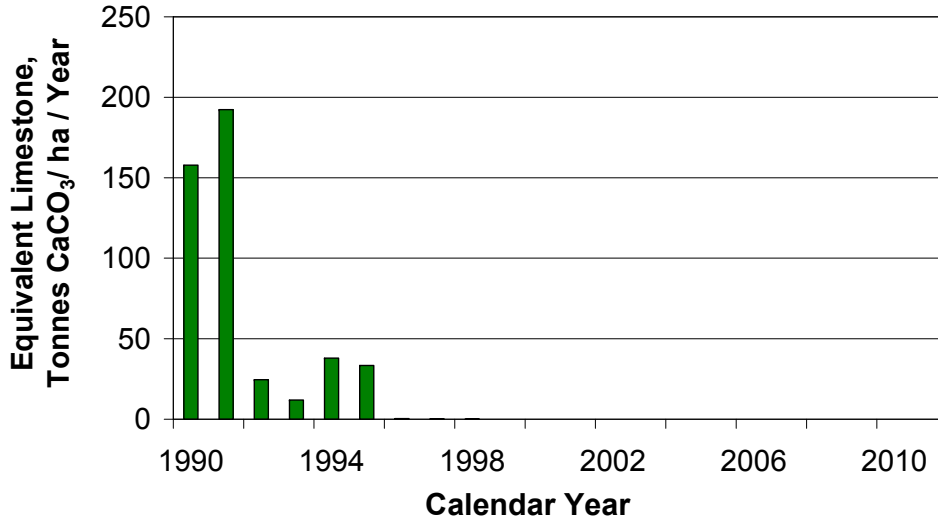
Denison TMA-1& 2  
Yearly Total Equivalent Limestone Consumption  
Per Unit Area (1990-2011)

Acid generation reduced to less than 0.01% of operating phase

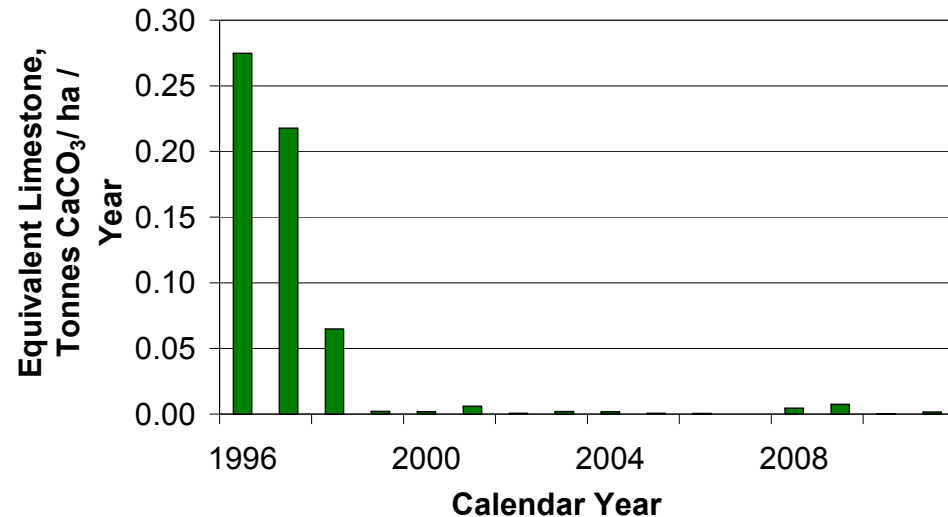
Denison TMA-1& 2  
Yearly Total Equivalent Limestone Consumption  
Per Unit Area (1996-2011)

Acid generation reduced to less than 0.5% following decommissioning

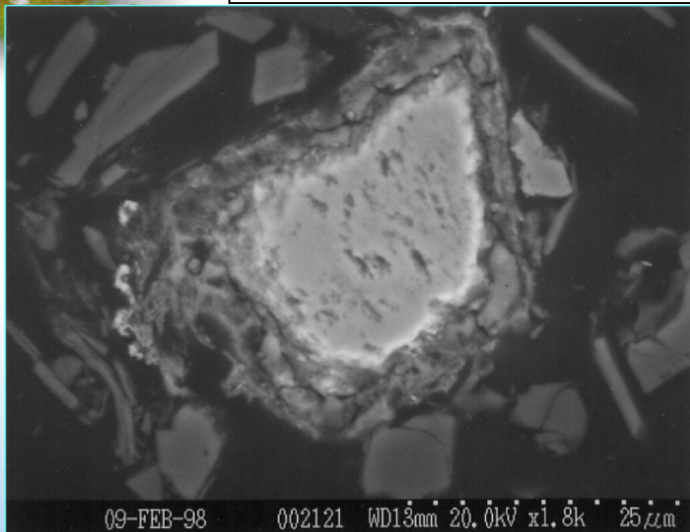
Hydrated Fe  
Sulphate

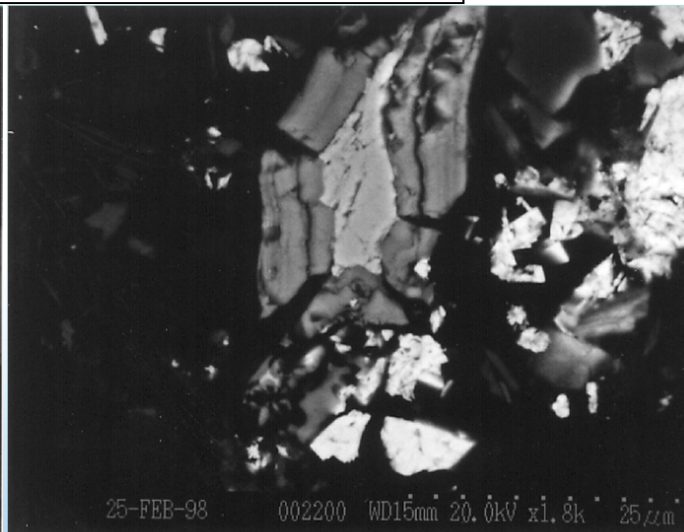
Goethite

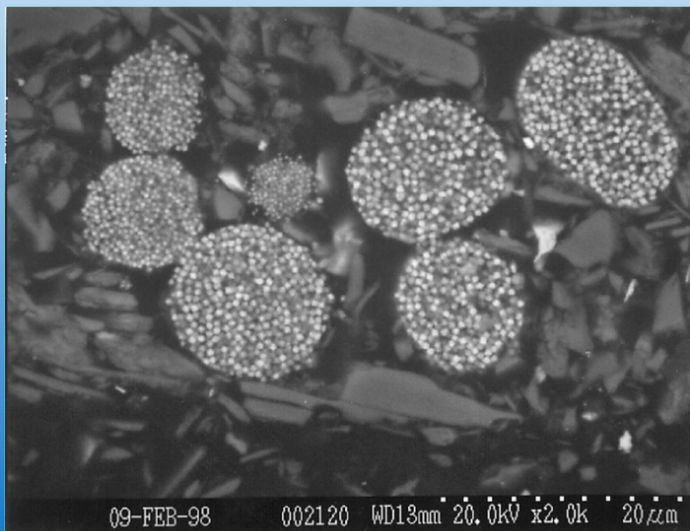
Framboidal  
pyrite

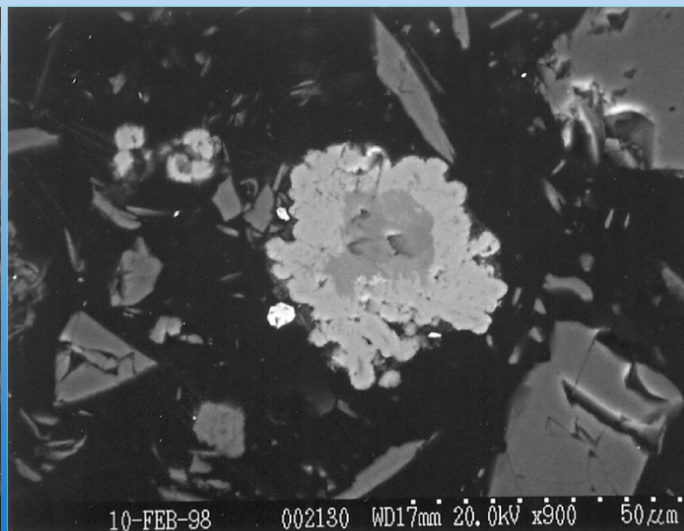
Calcian  
siderite
