The Flooded Tailings Impoundment at the Equity Silver Mine

W.A. Price¹ and M. Aziz²

THE FLOODED TAILINGS IMPOUNDMENT AT THE EQUITY SILVER MINE

ABSTRACT

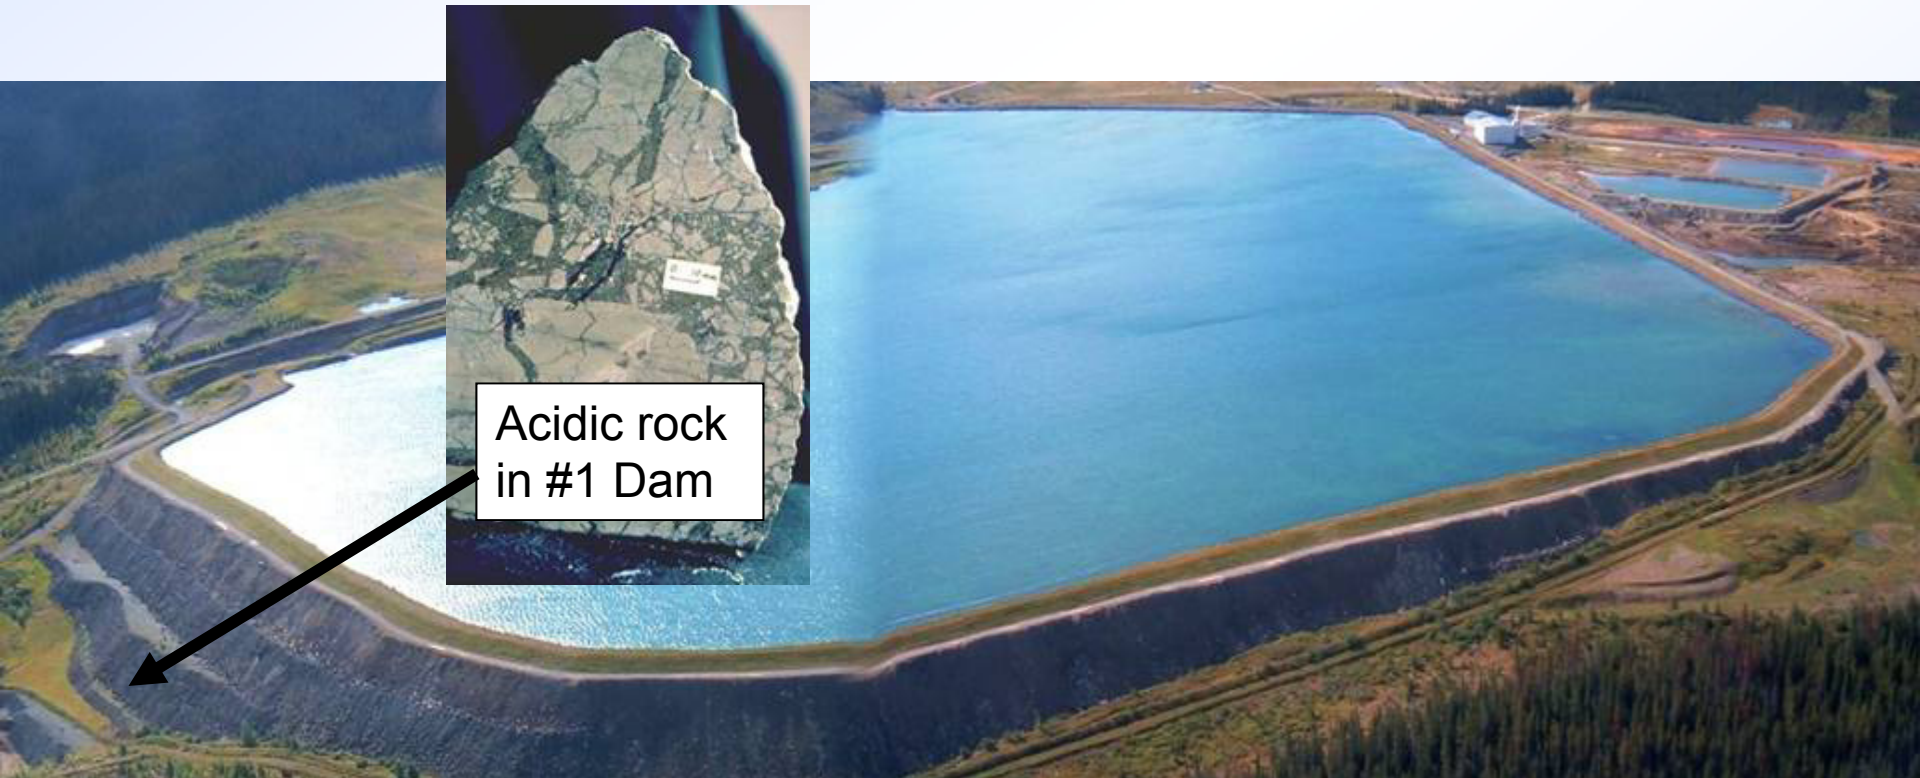
Acidic rock
in #1 Dam

The mine initially did not recognize ARD potential and used potentially acidic rock (PAG) to construct lower lifts of Dam #1.

Seepage through #1 Dam contacts acidic waste rock and becomes acidic.

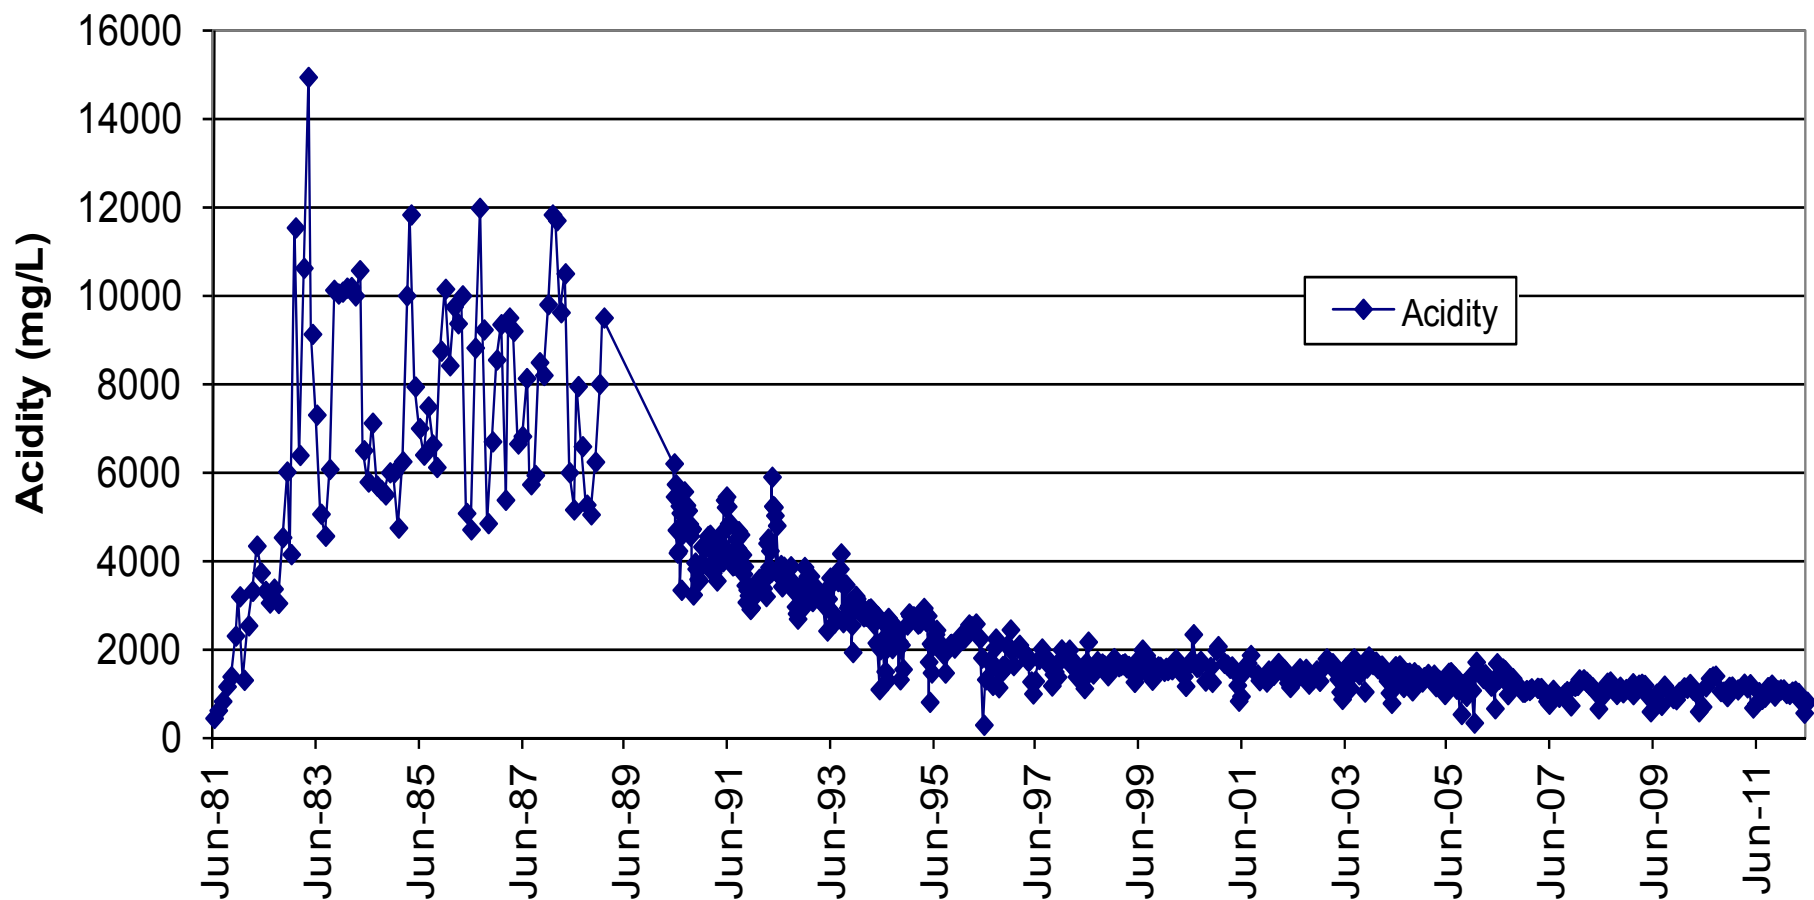
#1 Dam Seepage - Acidity over Time

Acidity in seepage from #1 Dam increased rapidly and has exceeded 10,000 mg CaCO₃eq /L. Since 1989, acidity has steadily decreased and is now less than 1,500 mg CaCO₃eq /L.

A decrease in drainage acidity is not observed in drainage from the waste rock dumps. Explanations for the decrease in #1 Dam acidity are the much smaller mass of rock and higher ratio of drainage to exposed rock than the waste rock dumps.

Improvements to #1 Dam collection system have included diversion ditches to reduce the volume of drainage and purchase of a diesel generator to provide power for the pumps in the event of an ice storm or cause of a power failure.

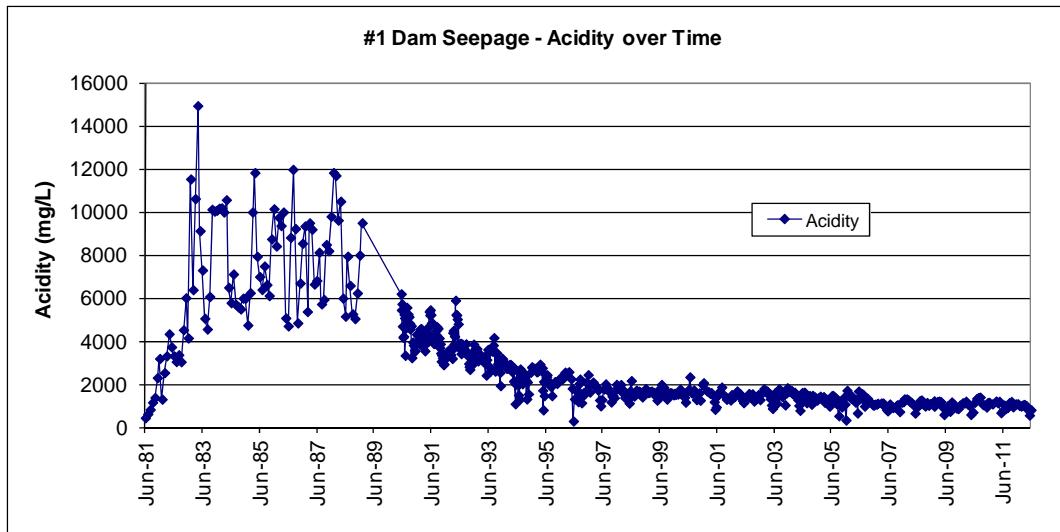
Figure 2. Concentration of acidity in drainage from #1 Dam

Acidity from the #1 Dam Seepage Pond increased rapidly from 1981 to 1982 and exceeded 10,000 mg CaCO₃ eq /L from 1983 to 1989. Since 1989, acidity has steadily decreased and is now less than 1500 mg CaCO₃ eq /L. A decrease in drainage acidity has not been observed in drainage from the waste rock dumps. Explanations for the decrease in acidity from the #1 Dam are the much smaller mass of rock, depletion of finer, more reactive sulphides and a higher ratio of drainage to exposed rock than the large waste rock dumps. The average volume of seepage from the #1 Dam is 68,076 m³/yr. This is 20% of the total volume, but only 4% of the acidity load that the site needs to treat. Improvements to the collection of acid water below the #1 Dam have included diversion ditches to reduce the volume of uncontaminated drainage that is collected and purchase of a diesel generator to provide power for the pumps in the event of a power failure. A portable pump was added to increase pumping capacity during extremely high run-off in 2011.

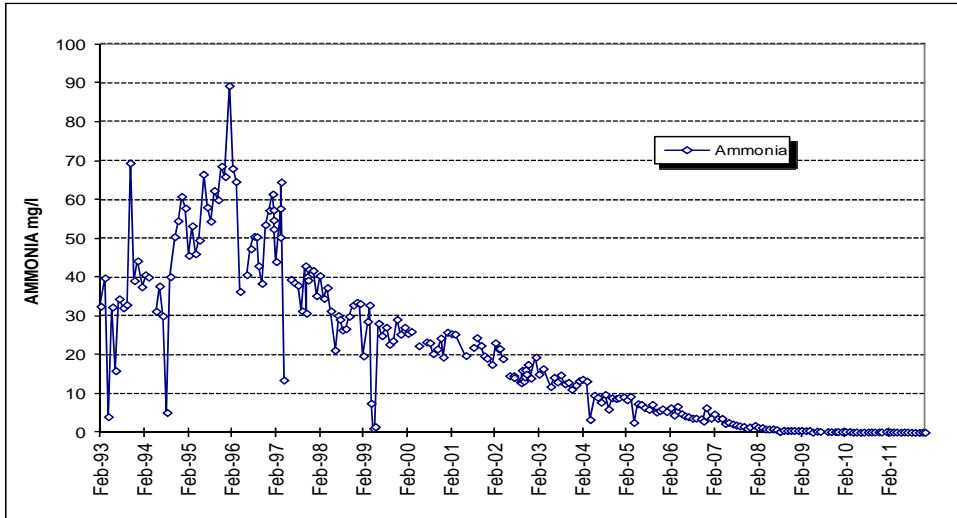
Figure 3. Concentration of ammonium in tailings pond (Aziz and Meints, 2012)

After the mill closed, cyanide (CN) continued to be reduced by natural degradation. By 2003, ten years after closure, natural degradation had decreased cyanide concentrations in the waste cover from 4.5 mg/L to 0.007 mg/L and thiocyanate was below detection (0.5 mg/L). Total cyanide levels in 2009 were below the detection limit (< 0.005 mg/L). Cyanide decomposition increased ammonium (NH₄⁺) concentrations to 90 mg/L in 1996 (Figure 3). Phosphorous fertilization was considered as a means to accelerate NH₄⁺ decomposition but rejected due to concerns about remobilization of treatment sludge and other secondary wastes. Since 1997, NH₄⁺ has steadily decreased and since 2009 has averaged less than 0.3 mg/L.

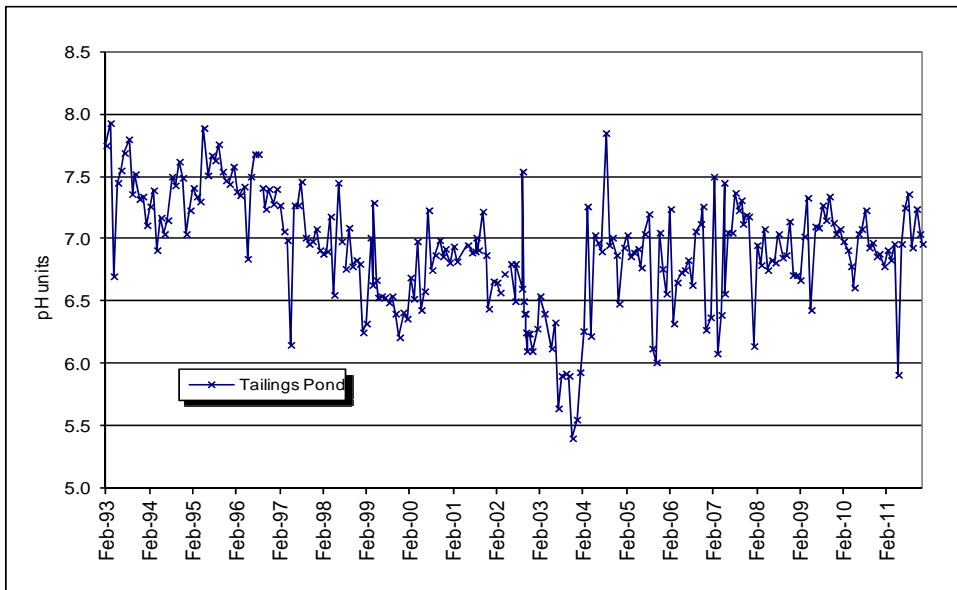
Figure 4. pH of tailings pond (Aziz and Meints, 2012)

At the time the mine closed (1994), the pH of the water cover was 7 to 8 (Figure 4) and there was a large, more than two orders of magnitude decrease in dissolved Cu (Figure 5). In 1997, dissolved Cu was less than 0.01 mg/L.

In 1997, the pH of the impoundment started to decrease (Figure 4) and dissolved Cu and Zn started to rise (Figure 5). By 2000, the pH had decreased to less than 6.5 and dissolved Cu and Zn had increased to 0.2 mg/L. The decline in pH was attributed to depletion of lime added with process water and treatment sludge when the mine was operating and acidity inputs from 866,000 m³/yr of pH 5.5 incident precipitation.

Approximately 51 and 23 tonnes of lime slurry were added to the impoundment from tanker trucks during the second and third quarters in 2000 and 2001 to raise the pH (Table 1). The pH was monitored and lime was added incrementally in small doses to ensure the pH did not get too high and dissolve other contaminants. The amount of lime added was calculated to neutralize

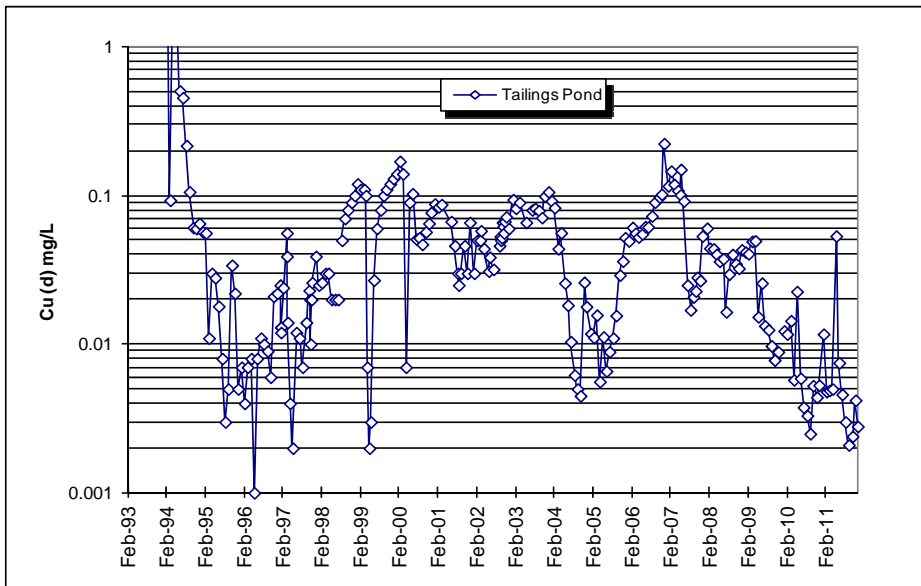
Figure 5. Concentration of copper in tailings pond (Aziz and Meints, 2012)

Peepers, boards containing rows of permeable cells designed to measure concentration gradients of metals in pore water and overlying water cover over short distances at the sediment water interface (Martin et al. 2003), were inserted in the sediment at three locations in the impoundment to locate the source of increasing Cu. The peeper in the southern corner, the location of sludge inputs, fell over (“became dislodged and was not processed for fear of compromised sample integrity”). Based on results from the peeper near to the #1 Dam, it was postulated that the source of Cu and Zn was remobilization of pH sensitive hydroxides [Cu(OH)₂ and Zn(OH)₂] created (precipitated) when ARD from #1 Dam was pumped into and neutralized in the impoundment (Lorax, 1999). Other potential Cu sources were lime treatment sludge and 738 kg/d of CuSO₄ added in the process water.

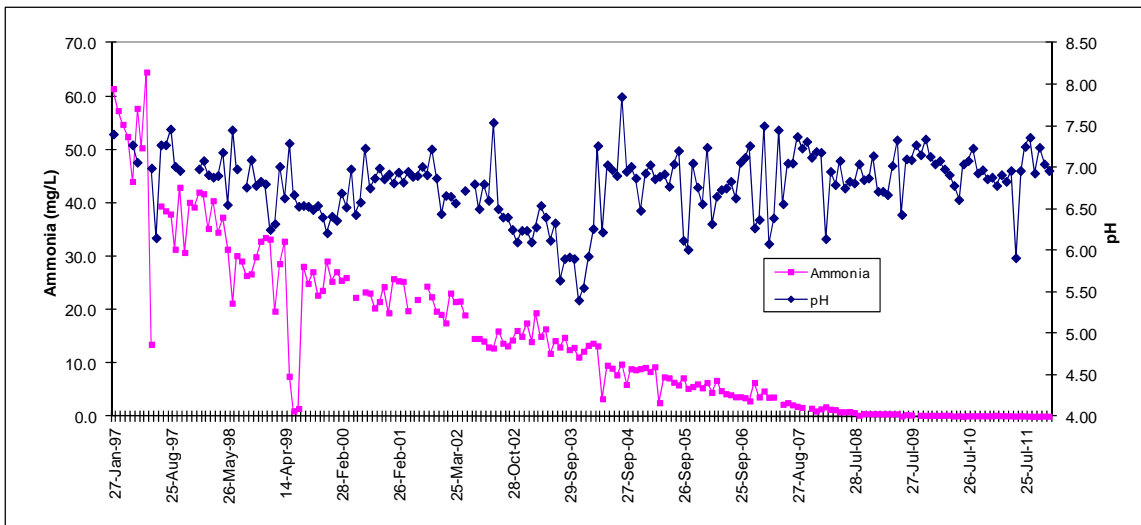
Figure 6. Changes in ammonia and pH over time

The stable pH since 2007 is correlated with the depletion of NH_4^+ and supports the hypothesis that the main source of acid was NH_4^+ oxidation rather than incident precipitation (Figure 6). The low NH_4^+ concentration indicates relatively little acidity will be generated in the future by the nitrification of NH_4^+ . A decline in pH may still result from acidity inputs from the pH 5.5

incident precipitation, but future lime slurry additions are only planned if the pH needs to be raised to suppress Cu solubility. The steady decline in dissolved Cu since 2007 (Figure 5) suggests that the soluble Cu precipitates near the surface of the flooded tailings have been depleted.

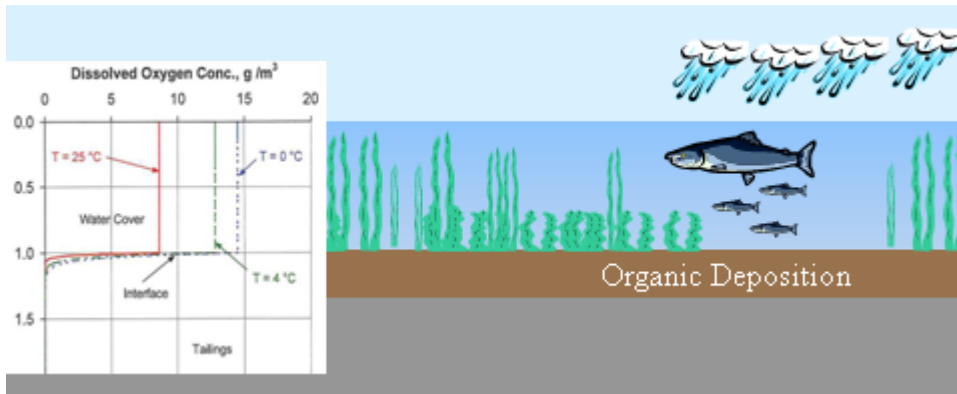
Figure 7. Schematic depiction of the impact of increasing biological activity in the tailings impoundment

Presently the shallow tailings pond contains relatively little aquatic vegetation. Eventually there is likely to be more extensive plant invasion increasing the organic content of the upper layer over the mine wastes (Figure 7). A question regarding the long-term performance of the impoundment is whether accumulation of organics and more reducing conditions in the flooded mine wastes will release trace elements such as arsenic (As) co-precipitated within lime treatment sludge. Released elements may re-precipitate in situ as sulphides or be released into the water cover. The As concentration in the pond of approximately 3 ug/L between 2009 and 2011 was low and within historical levels. If treatment is required in the future, the water would be routed from the tailings pond to the HDS plant.
