MOUNT POLLEY MINE – REMEDIATION UPDATE

BC MEND - 2015

Mount Polley Tailings Dam Breach

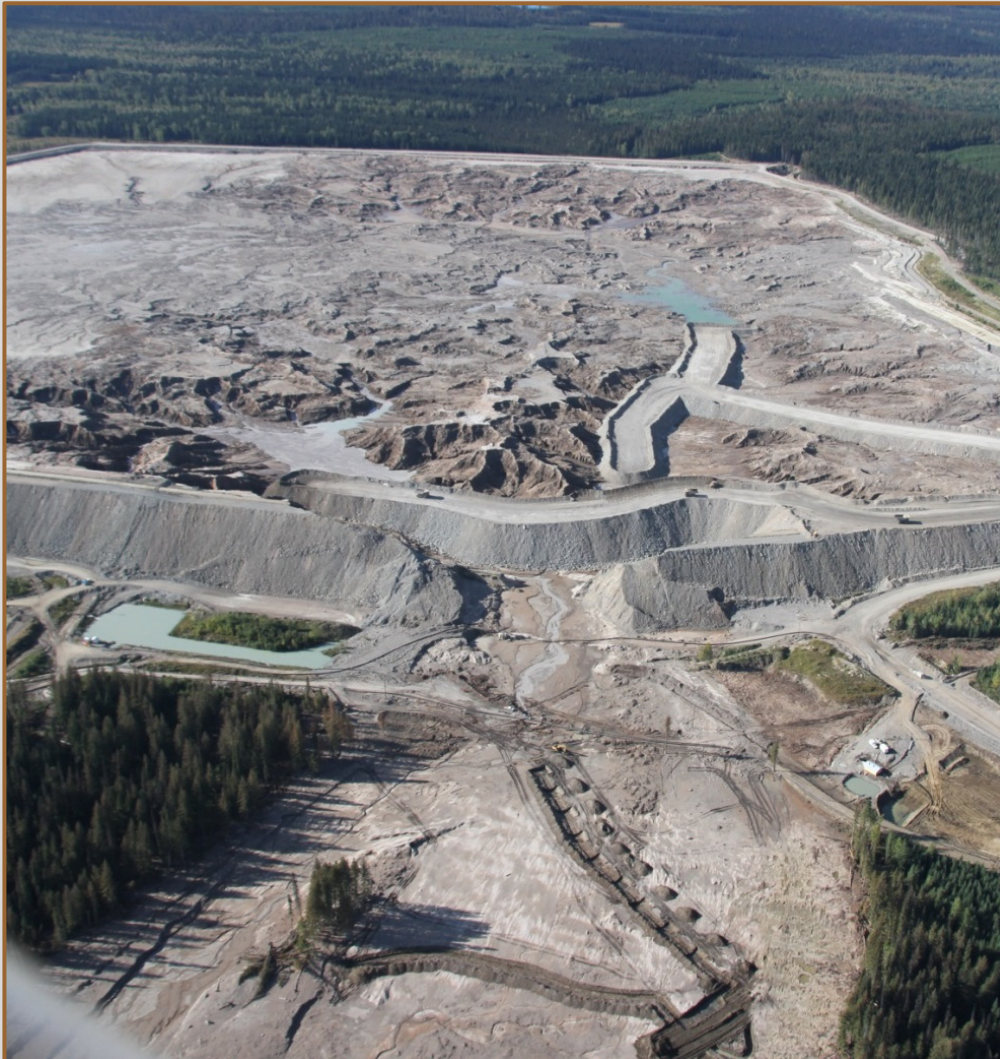
- dam breached early morning Aug 4, 2014
- no injuries or loss of life
- the estimated summary of materials displaced by the breach: 25M m³
- supernatant water: 10.6M m³
- tailings slurry: 13.8M m³
 - tailings solids 7.3M m³;
 - interstitial water 6.5M m³
- construction materials: 0.6M m³
- NB: Hazeltine Creek flow very low in August

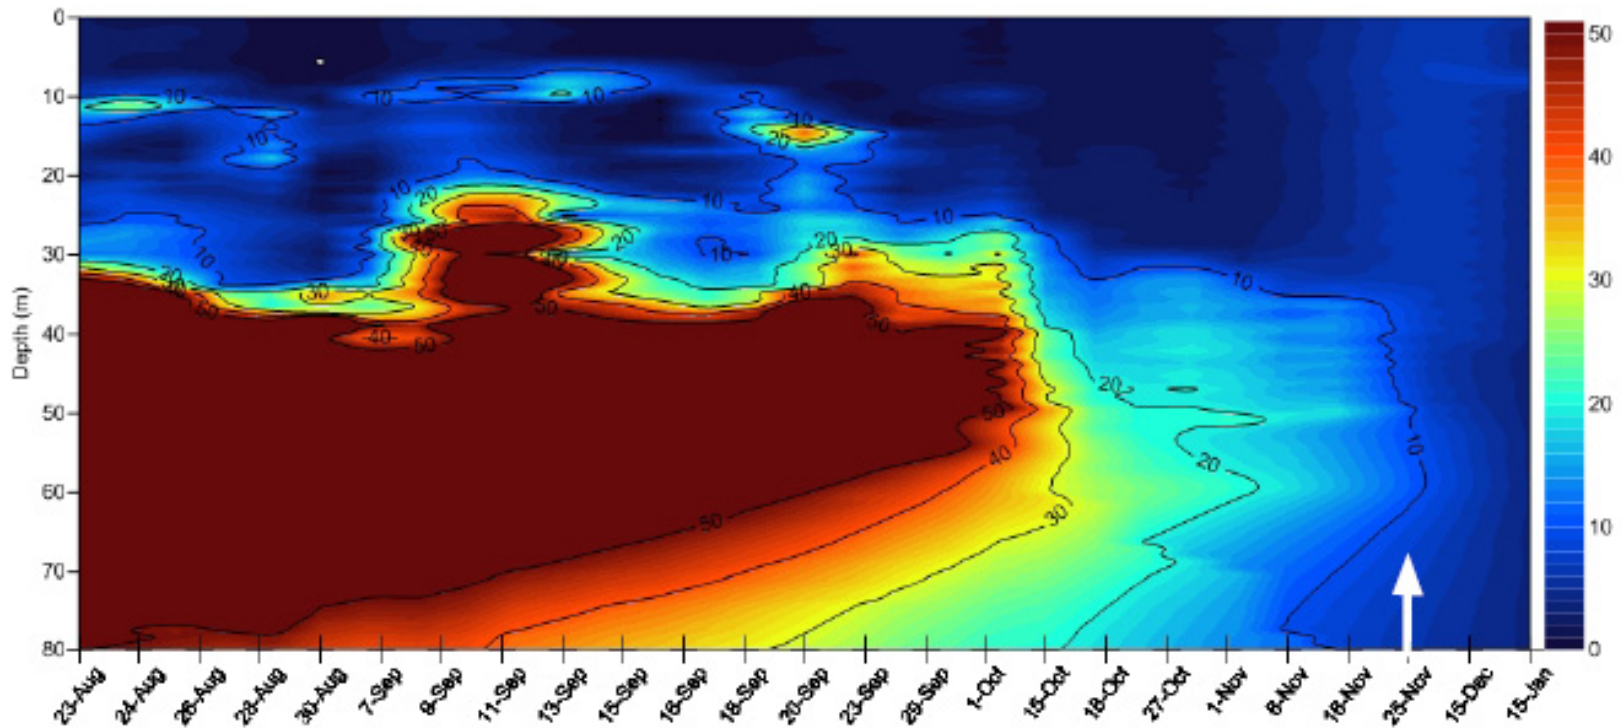
Figure 11: Turbidity measurements of Quesnel Lake water from the surface to the bottom of Quesnel Lake at a station adjacent to the Mouth of Hazeltine Creek, showing the clearing of turbid water that happened over time
