# Evaluating Performance of Cover Design for Remedial Options Analysis of Mine Closure

Cantung Mine Site, NT

Scott Kingston, P.Geo.  
Amy Hudson, Ph.D., CPG, REM

# TP1/2 Existing Cover and Design Basis for TP3/4/5 Cover

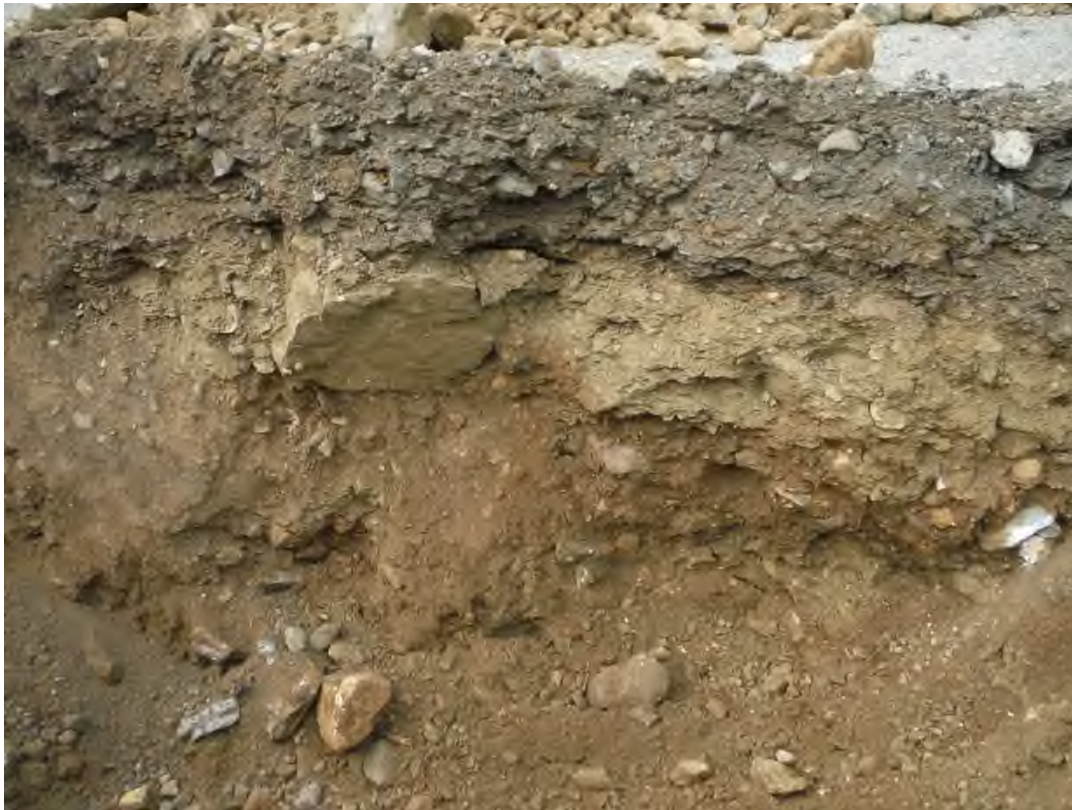
### TP2

- The till cover placed on TP1/2 was typically 1.5 to 3 m thick and consisted dominantly of silicates minerals (quartz, muscovite) and lesser carbonates (calcite and dolomite) with minor feldspars and accessory minerals
- The cover material consistently classifies as non-PAG and has maintained neutral to slightly alkaline pH conditions

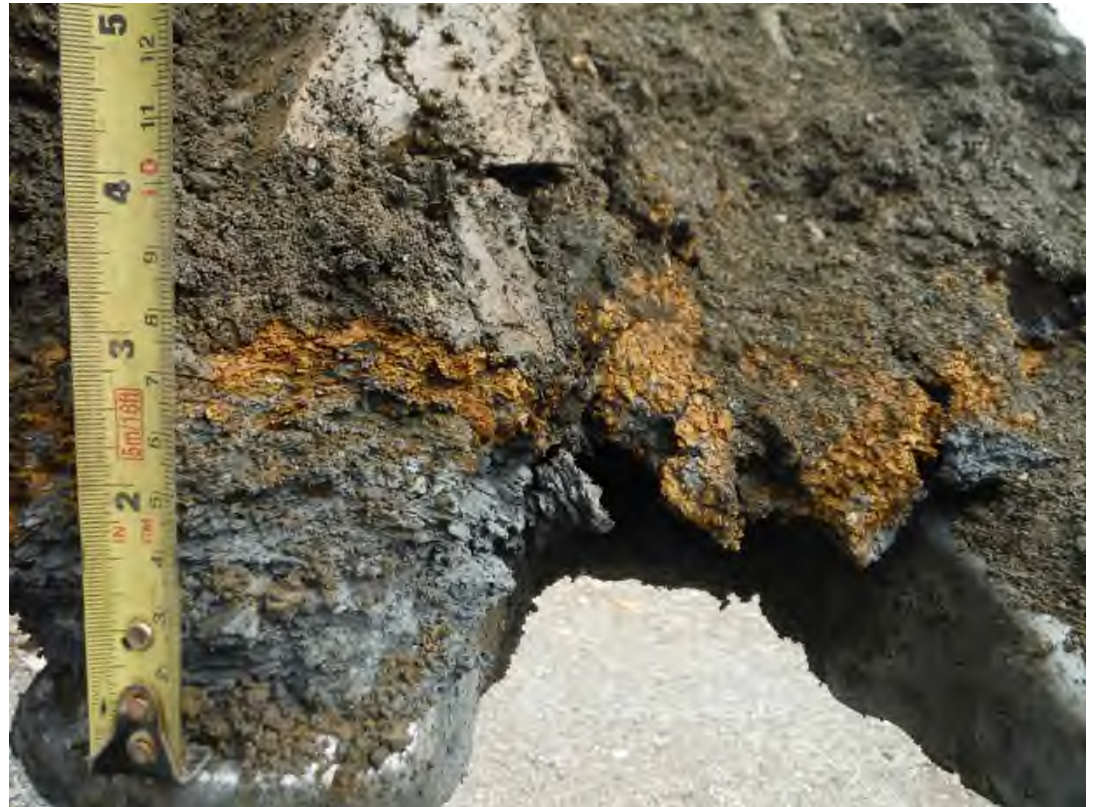
## Tailings Oxidation at Cover-Tailings Interface

- Preliminary oxidation confined to the tailings cover- interface
- In TP1, frozen tailings were observed within 0.10m of tailings-cover contact
- In TP2, partially frozen tailings were within 2m of tailings-cover interface
- Unknown total depth of freezing
- Future investigations to capture full profile

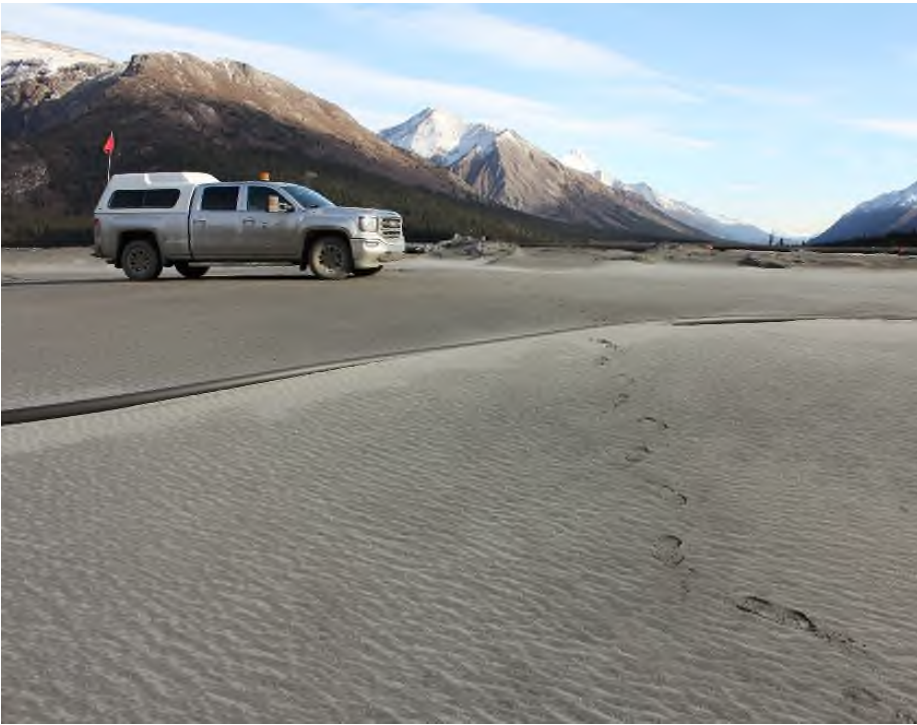
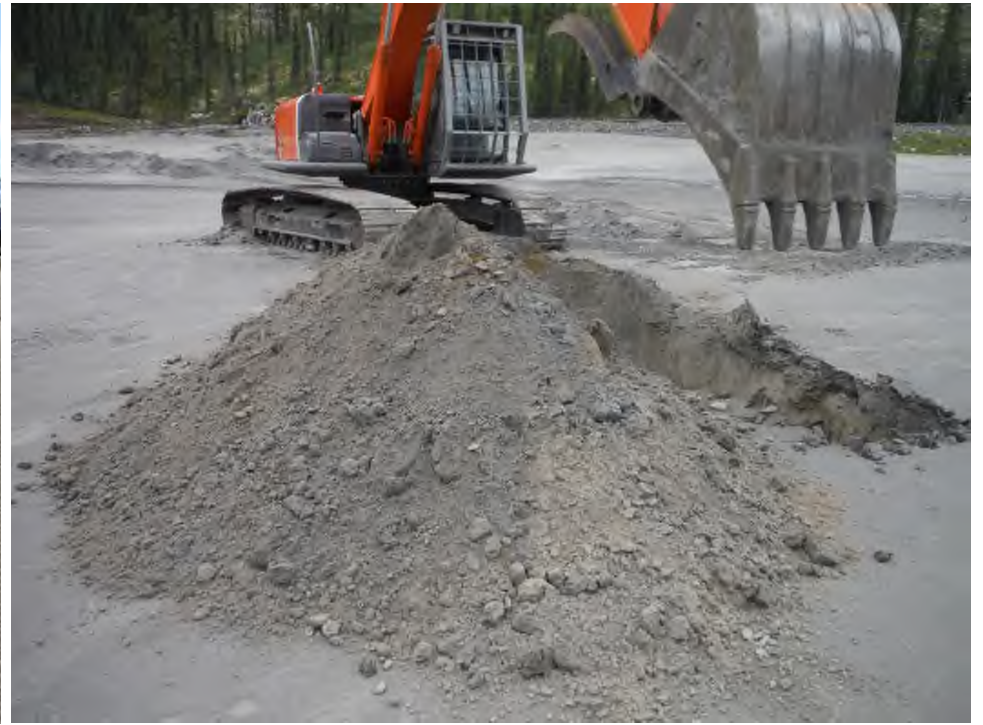
- Testpitting and sampling conducted in July 2018 on all 5 tailings ponds
- Measurement of hydraulic conductivity, in situ moisture content, and visual observations of oxidation front
