B.4. Segregation of ARD Tailings at the Duthie Mine

by Clint Logue, Iain Bruce BGC Engineering Inc.

An Observational Approach to ARD Mitigation

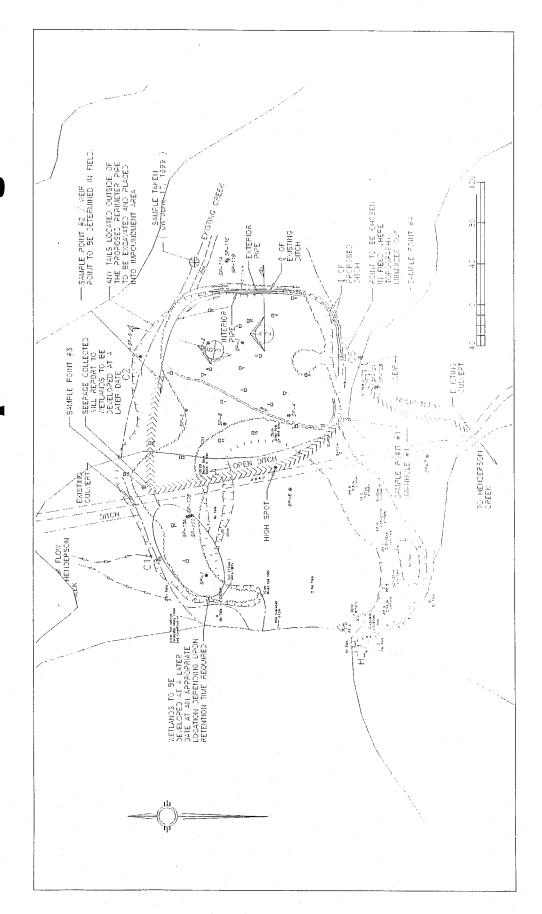
Duthie Mine - Proposed Mitigation

- Diversion Ditch to prevent Seepage from Glacio-Fluvial Sands and Gravels
- Cover to prevent Direct Precipitation

Tailings will stay Saturated Cover to be Designed at a

Later Date

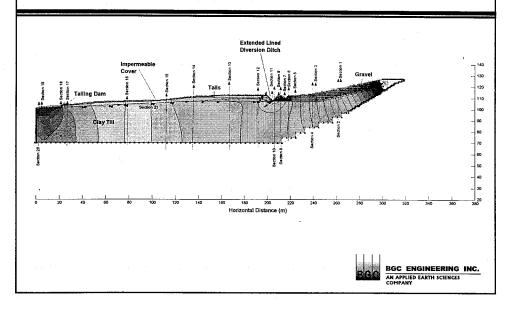
Duthie Mine - Seepage Model Mitigation Implemented - Results

Modeling demonstrated that seepage through the tailings facility can be reduced by 95% by implementing Cover and Diversion Ditch

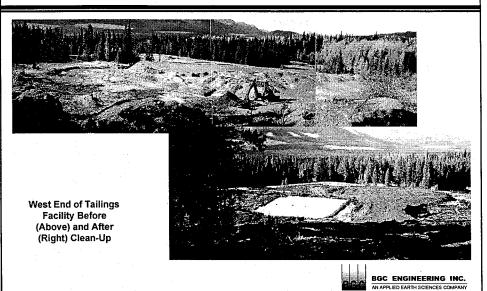
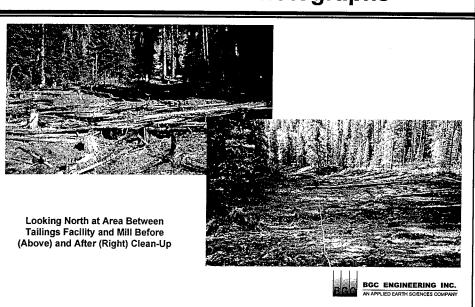
North End of Tailings Facility Before (Above) and After (Right) Clean-Up
