# Mine Drainage Issues at Keno Hills Mine, Yukon

# Keno Hill Mines (formerly UKHM)

# Galkeno 300 Drainage

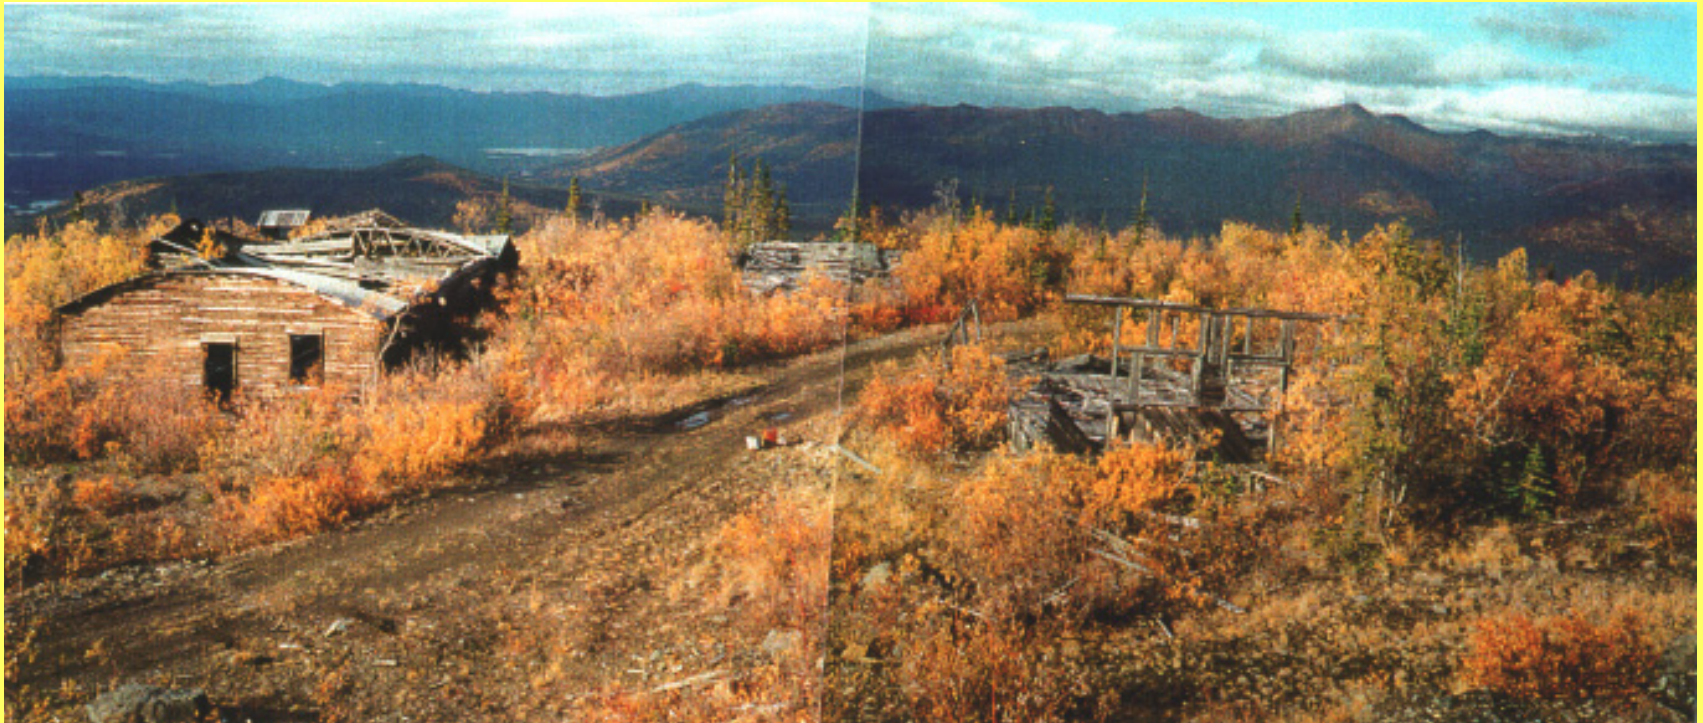
Tailings from the Wernecke mill were discharged down the slope to the small lake in the top of the photo. 250K-400K tonnes

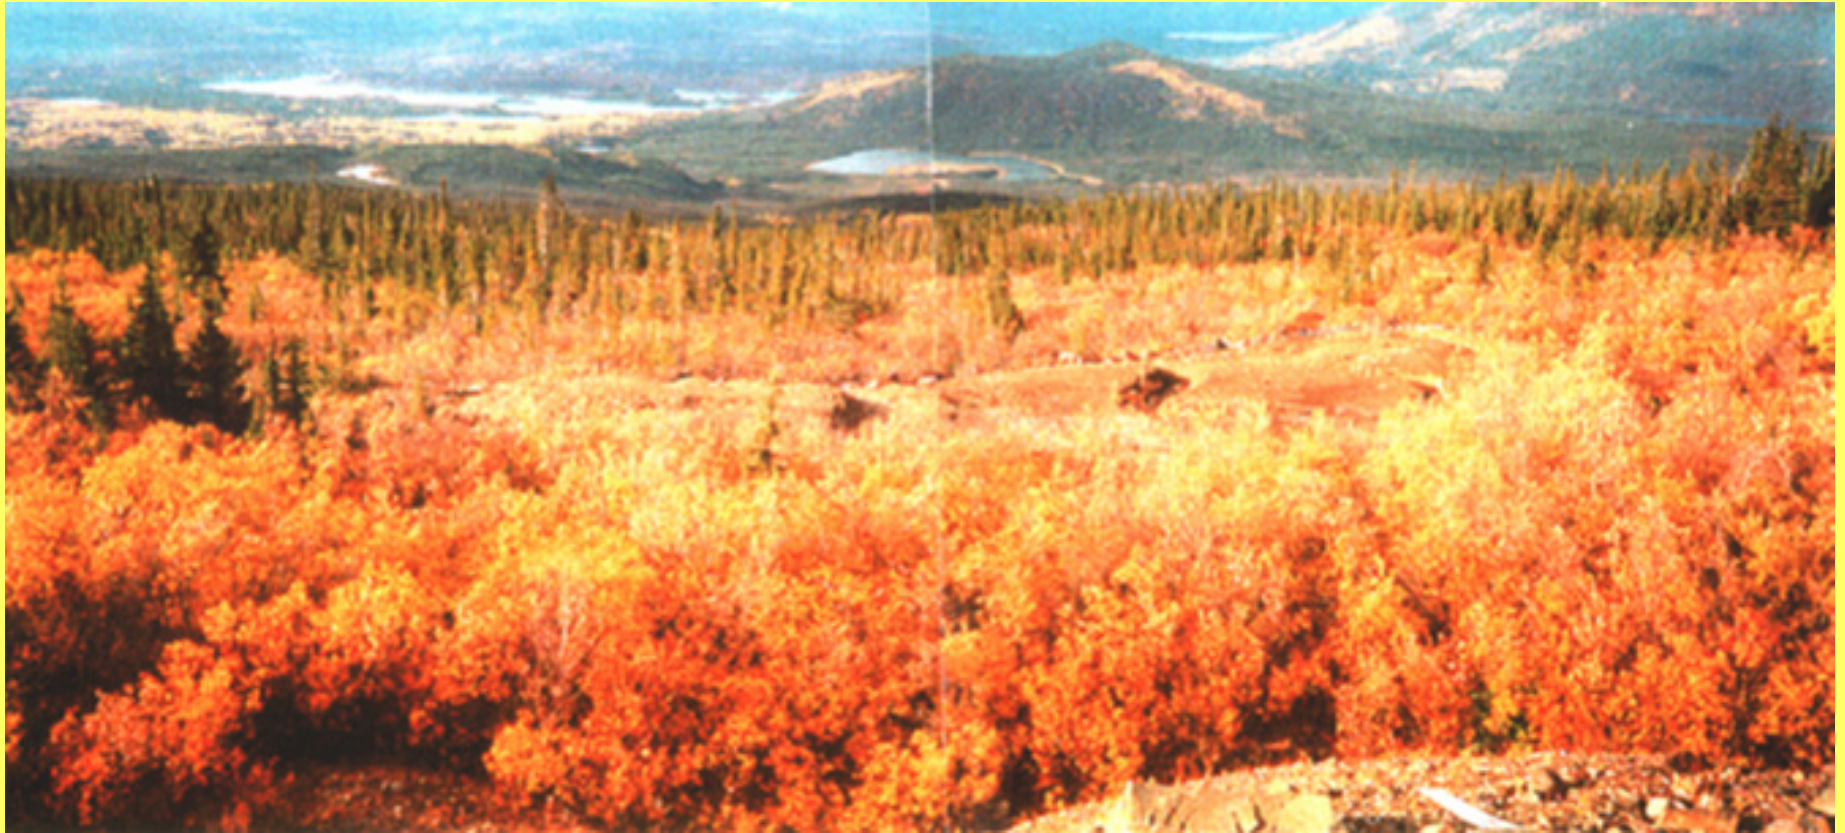
The tailings from 102,000 Tonnes of ore processed at the Mackeno mill were discharged into and beside Cristal Lake

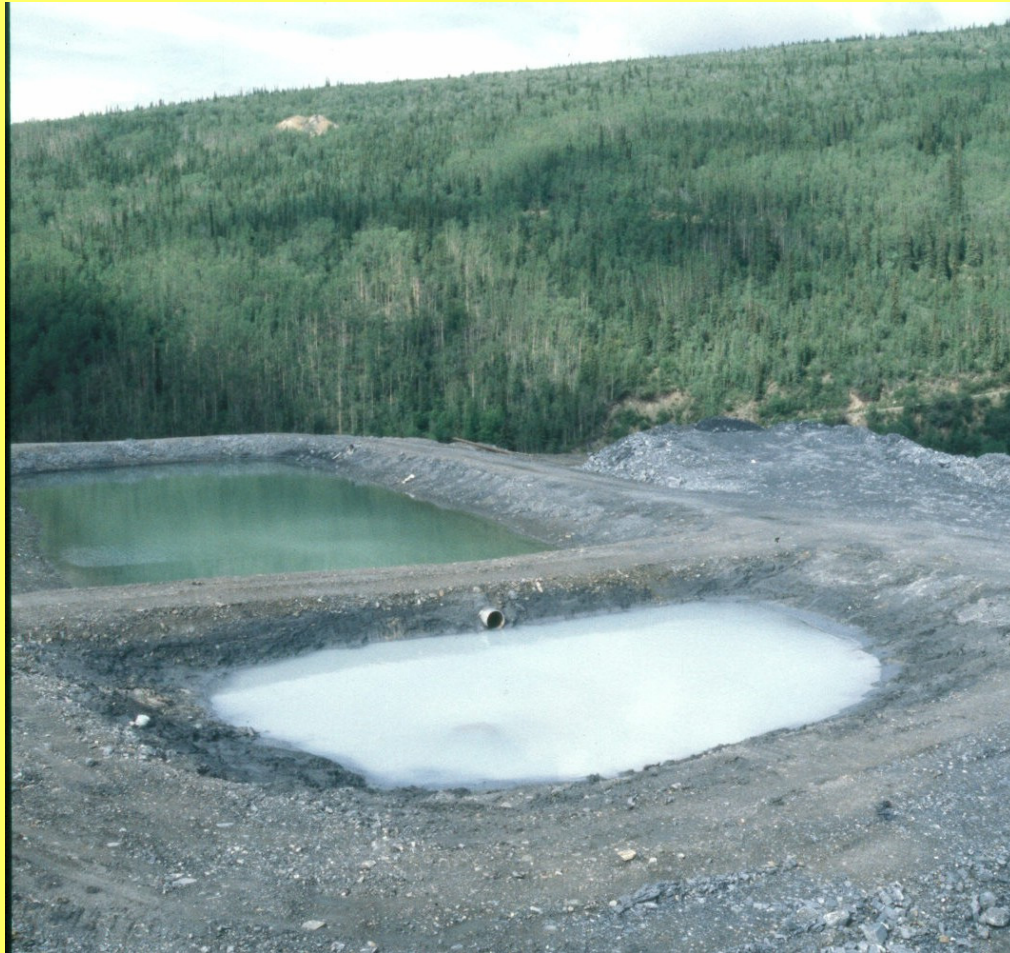
# Bellekeno lime treatment settling ponds

Silver King, Bellekeno, Galkeno 900, lime treated

Flows – 3-10 L/sec

Raw discharge – max. 10ppm zinc

Treated discharge – generally less than 0.5ppm

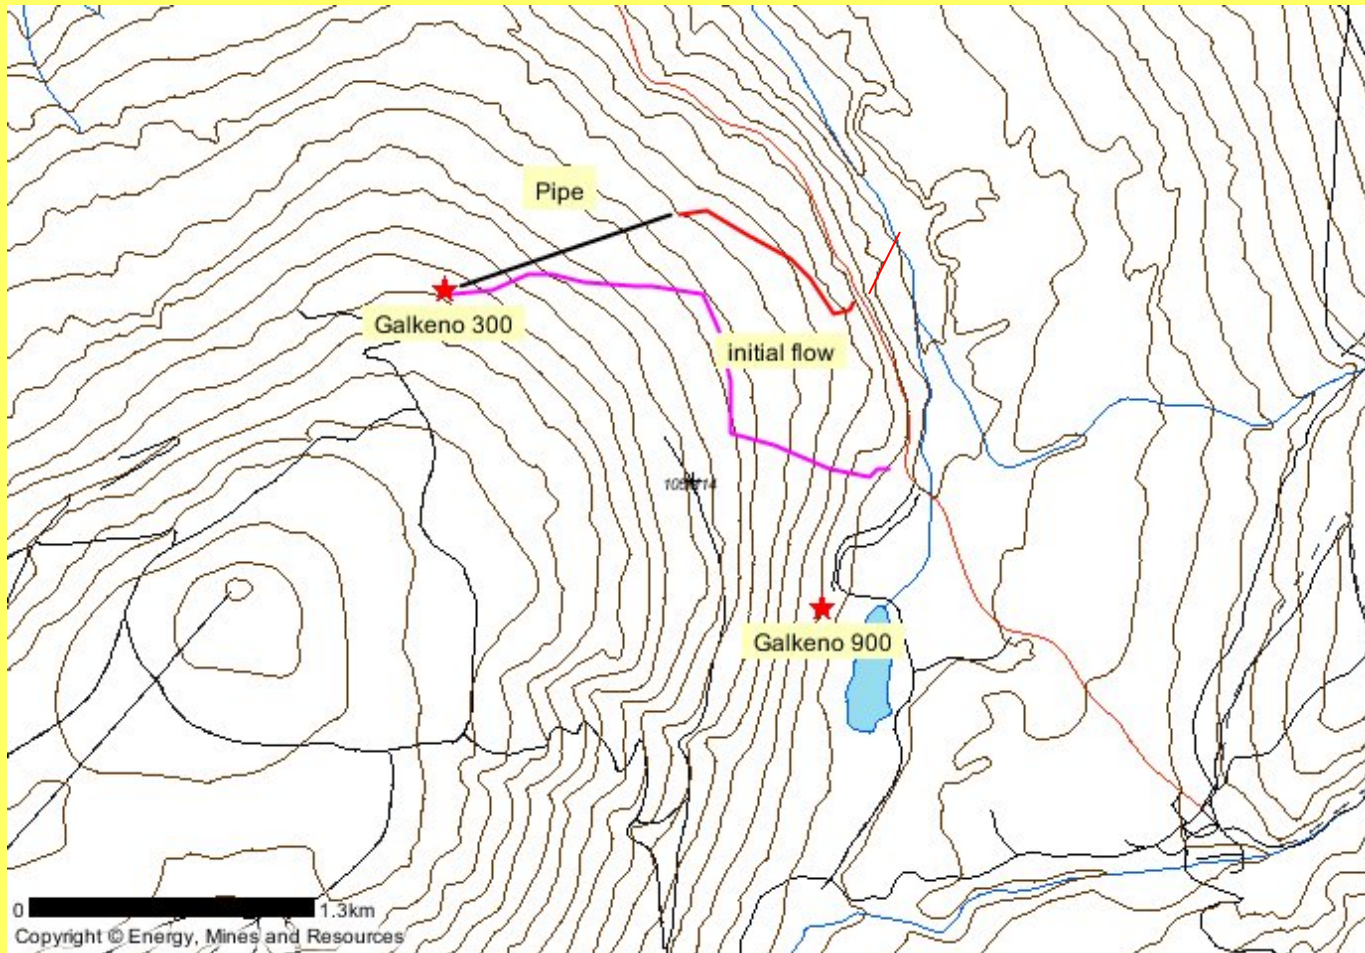
# Galkeno 300 drainage paths

- No significant drainage before 1999
- By 2002 flows from 3 – 20 L/sec, ave. 10 L/sec
- 80 – 140 ppm zinc
- Discharge stream flows intermittently (goes to ground) for ~1 km to road, then to Christal Creek
- Aufeis (glaciation) development at road
- Increased zinc loading downstream
