Poirier Reclamation Performance

Presented at the MEND Maritimes Workshop

Maxine Wiber

Poirier Reclamation Performance Outline

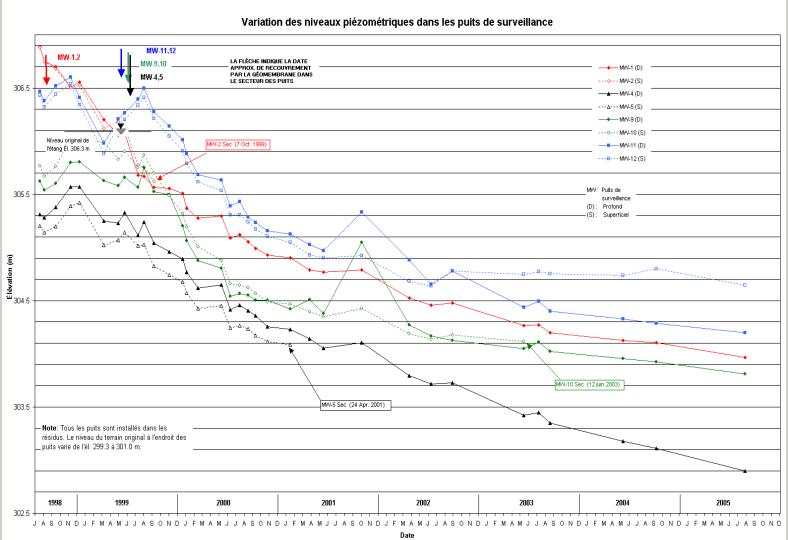
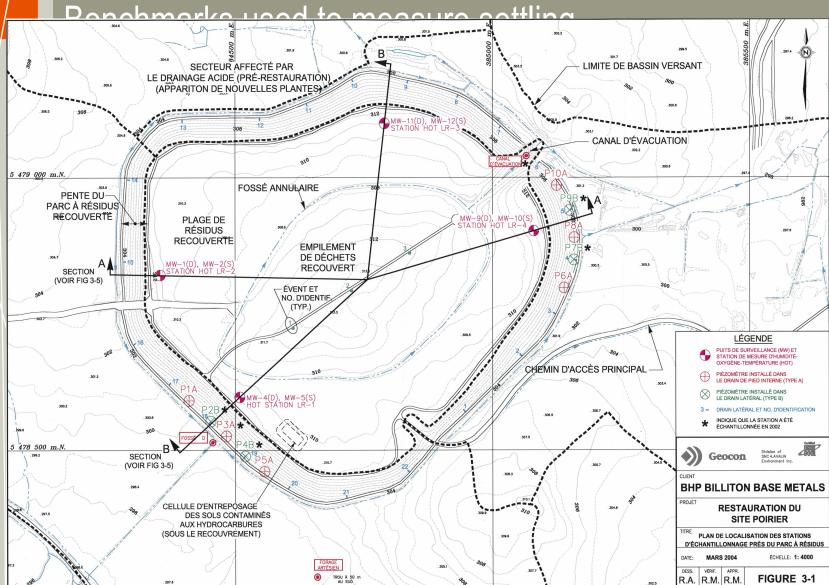
Water Level Decline in Tailings Under the Liner

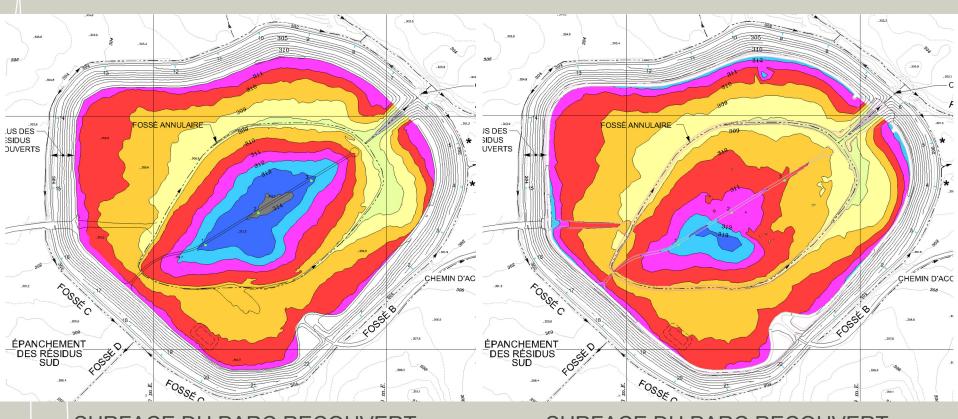
Settling Measurements on the Tailings Pile SNC-Lavalin, 2005

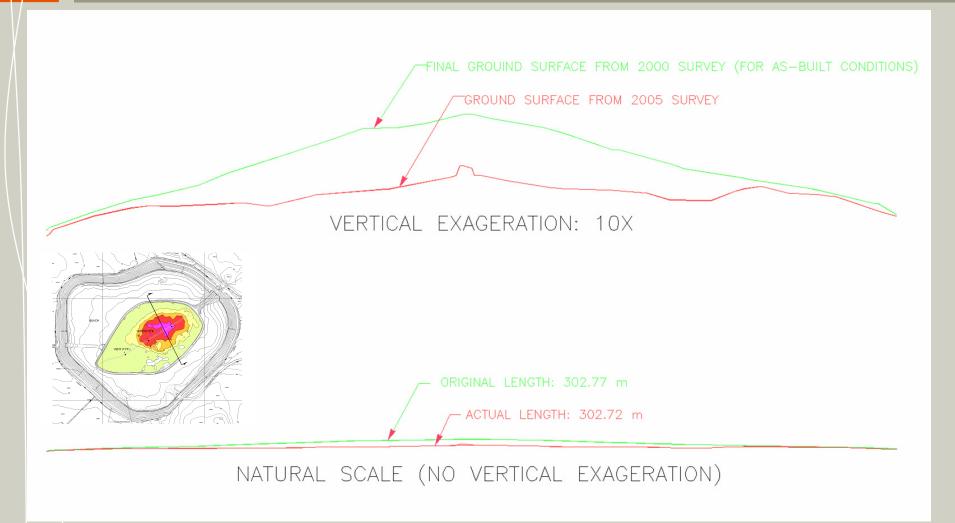
SETTLING MEASUREMENTS AT THE WASTE PILE (SNC Lavalin, 05) ILLUSTRATION OF IMPACT ON THE GEOMEMBRANE

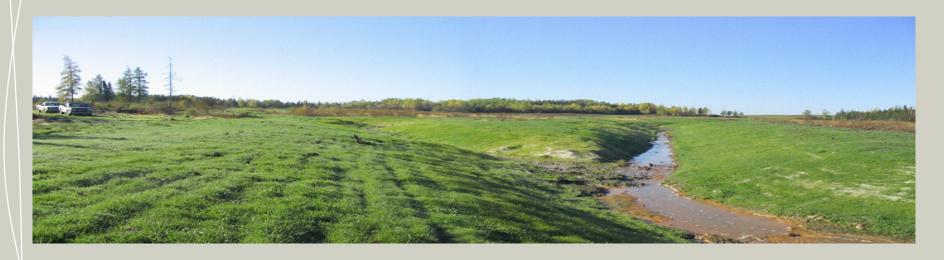
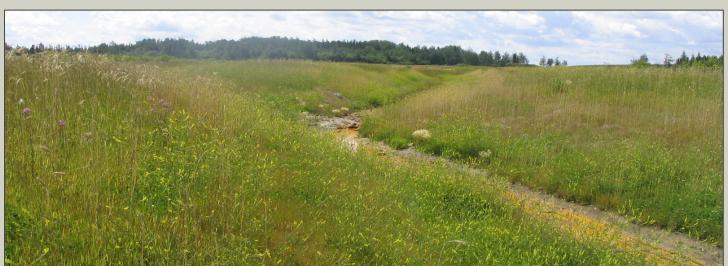
Poirier Remedial works carried out in August 2004: Ditch slope stabilization and seeding at former plant site

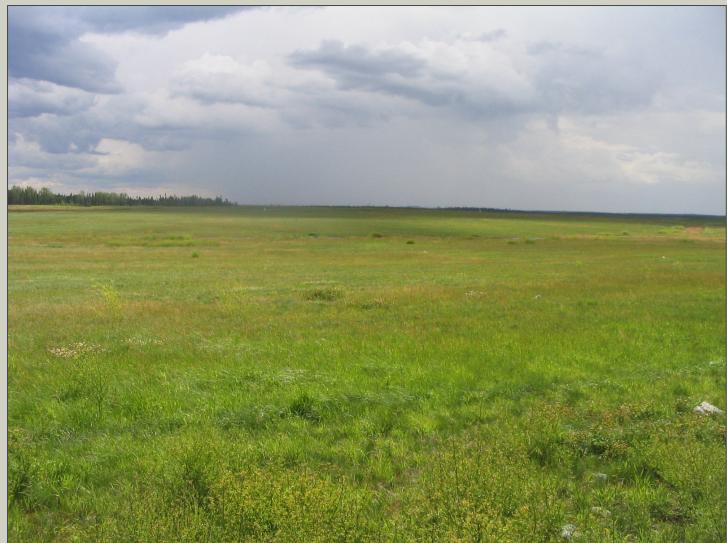
Poirier tailings cover vegetated, looking south 2005

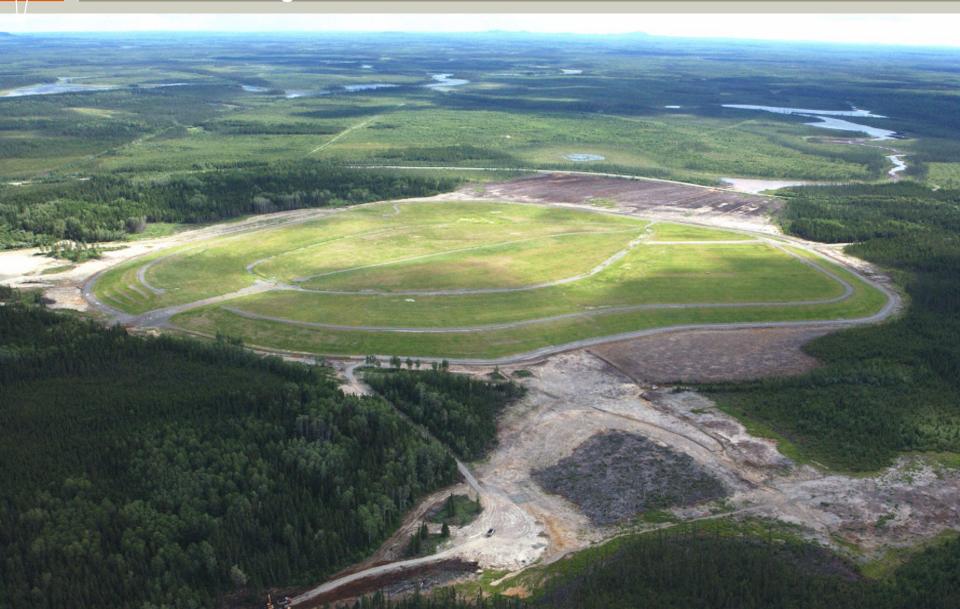
AERIAL VIEW OF THE TAILINGS BASIN AFTER THE REHABILITATION WORKS (2002) Areas remaining to do in 2006

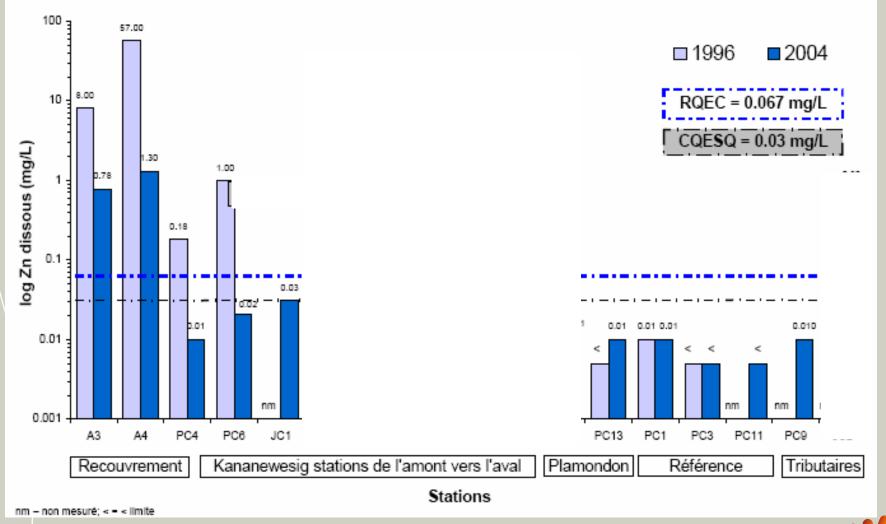
Poirier Aquatic Monitoring Study DISTRIBUTION DU ZINC – R. KANANEWESIG

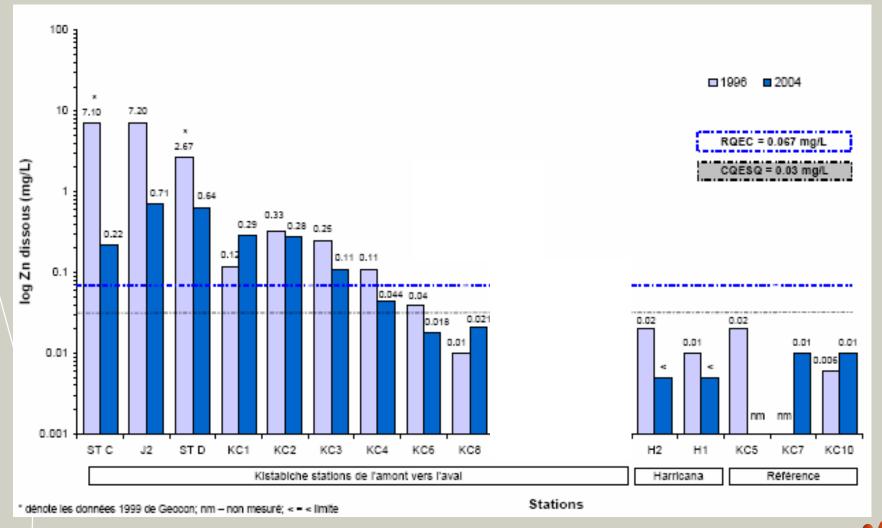
Aquatic Monitoring - Surface Water Quality ZINC in Kistabiche River

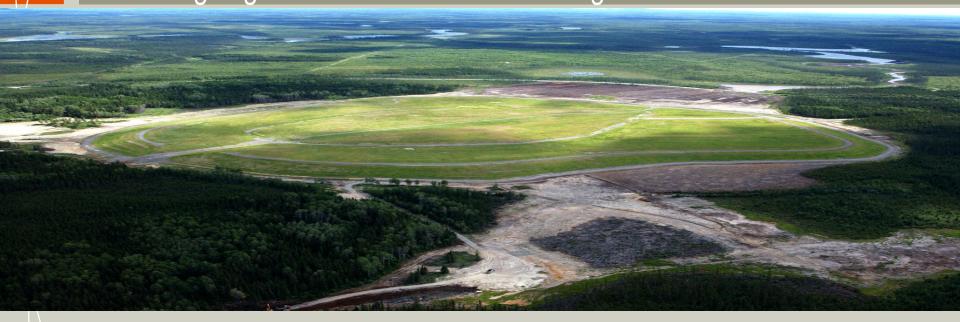
Poirier site in 2002 Next steps in 2006-2010 to complete bare areas and ensure sustaining vegetative cover over lined tailings

Ensure vegetation becomes self-sustaining in all areas
