CREATING AND DELIVERING BETTER SOLUTIONS

Authors: Scott Sylte, P. Eng., EBA Engineering Consultants Ltd.; Lara Reggin, P. Geo., EBA Engineering Consultants Ltd.; Marc Wen, R.P. Bio., Rescan Environmental Services Ltd.

Island Copper Mine Site - Location

South Waste Rock Dump and Lagoon

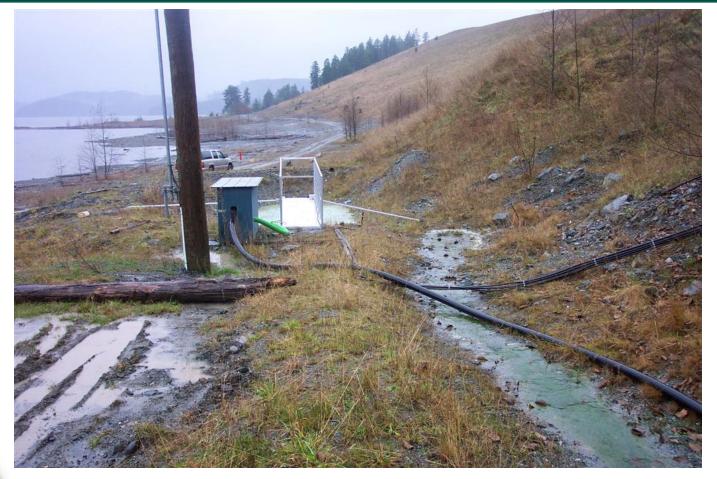
South Dump – Temporary Sump and Pump

Temporary sump and pump system to collect seepage installed in 2001

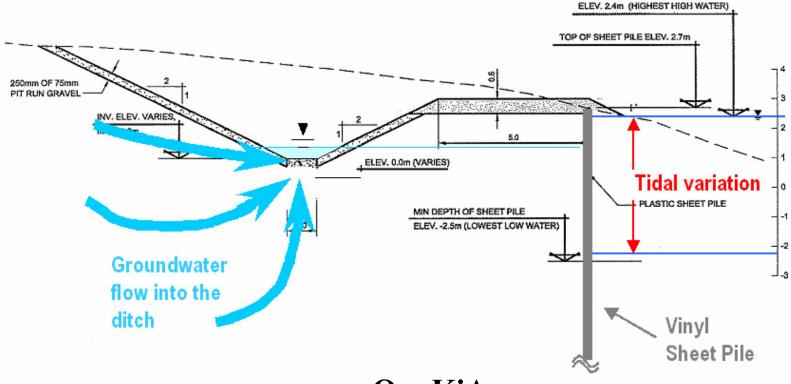
Seepage Collection System - Concept

$\mathbf{Q} = \mathbf{KiA}$

Flow = Permeability x Gradient x Flow Area

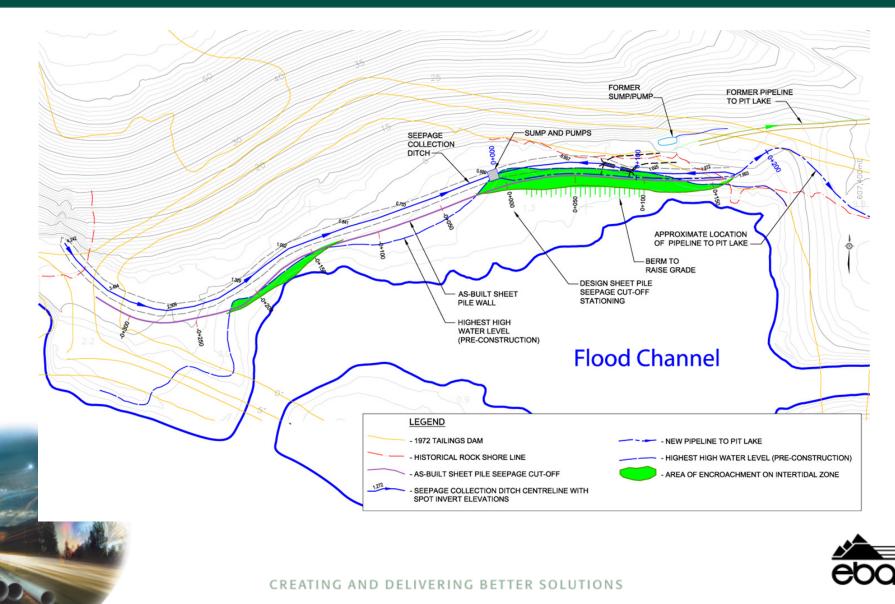
Seepage Collection System Design – Plan View

Location: (As close to high tide line as possible)

- Maximize containment of PAG.
- Minimize excavation volume.
- Minimize geotechnical risk associated with deep excavation at the toe of the South Dump.

Depth: (Cut-off Wall up to 10 m below grade)

- Minimum 1 m into low permeability tailings (up to 6 m below MSL)
- Minimum depth of 2.5 m below MSL (low tide elevation).

Length: (470 m +/-)

• Tie into bedrock at both ends.

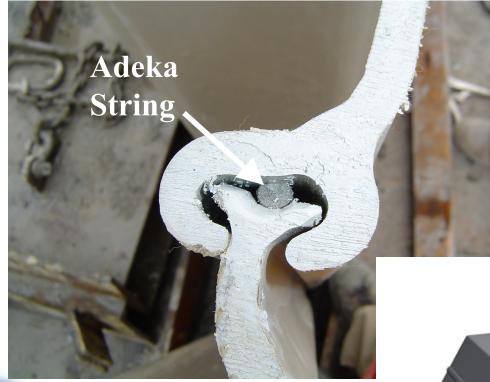
Cut off Wall Construction – Seal Detail

•"C" with Adeka String Driven over "T" (already in place).
