The tailings pond failure at the Aznalcóllar mine, Spain^{1,2}

N. Eriksson
Boliden Environmental Staff, Aznalcóllar, Spain

P. Adamek
Mine Environmental Consultant, Sevilla, Spain

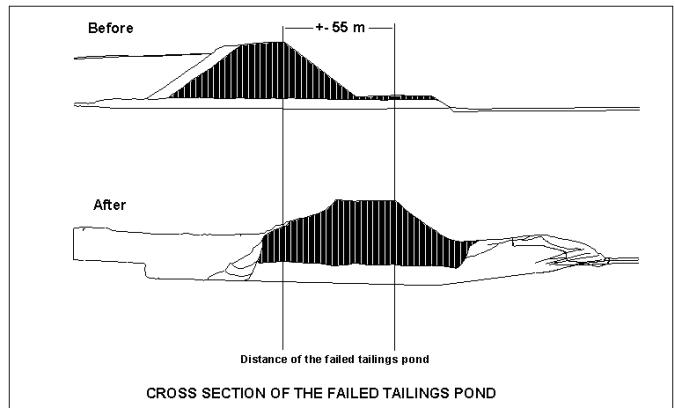
Figure 2. Cross section of the tailings pond.

EPTISA and CEDEX arrived at similar conclusions regarding the cause of the accident. The direct cause of the accident was a fault in the marls 14 m below the ground surface, Figure 2. This fault was the result of surplus pressure in the interstitial water of the clay due to the weight of the dam and the tailings deposit (EPTISA 1998).

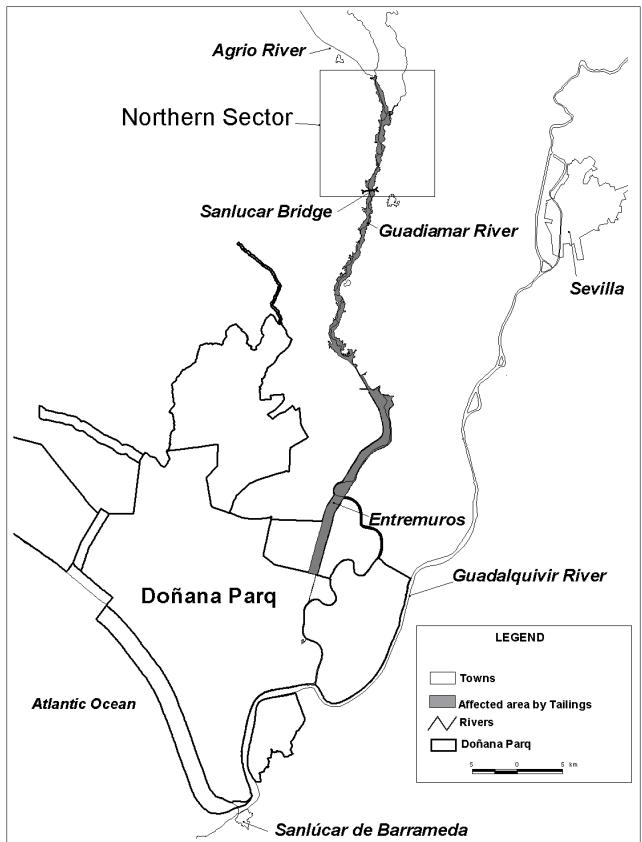
Figure 3. Map of the affected area with reference points and rivers.

The spill flooded the riverbanks along the rivers Los Frailes, Agrio and Guadiamar, from a point located 300 m upstream the tailings pond in the river Los Frailes, down to Entremuros, 40 km south of the mine, Figure 3. In total 4634 ha of land were affected, of which 2600 ha were covered by tailings. When the water had withdrawn the thickness of the deposited tailings ranged between 4 m close to the tailings pond to a few millimetres near Entremuros. The flood wave was contained in the 2000 ha Entremuros area by an emergency containment wall built between the banks. The contaminated water did not reach the Doñana National Park.

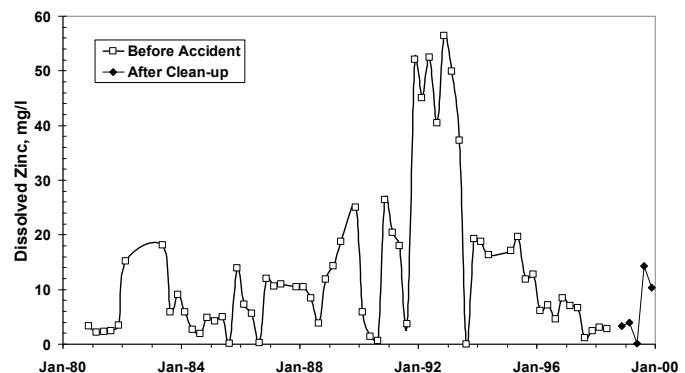
Figure 4 shows the measured Zn concentration at El Guijo from 1980 to 1999, an official flow gauging station 7 km downstream of the tailings pond. In individual samples it was as high as 90 mg/l before the accident, and average quarterly Zn concentrations ranged up to 50 mg/l before 1993. The likely reason for the enhanced concentrations was probably the diffuse drainage of acid waters from the mining area, documented already for the period 1983- 1986 by González et al (1990). The annual Zn load in the river before the accident ranges between 300 and 1200 tonnes/year between 1980 and 1997. Two trends can be noted. Whilst the increasing trend can most likely be attributed to the accumulating amounts of acid-generating sulphuric waste coincident with the advance of the large-scale mining, the decreasing trend is likely to be the result of remedial measures taken by Boliden Apirsa at the site.

Figure 4. Quarterly average zinc concentrations in the Guadiamar river at El Guijo, 7 km downstream the mine, before and after the accident.

Following the clean-up, the Zn concentrations are not higher than before the accident. No concentration peaks have been detected in the river after rainfall events as was feared. In this
