# Comparative Analysis of Defect Leakage Rates at Geomembrane-Lined Cover Systems in the Sydney Coalfield

Public Services and  
Procurement Canada

*BC MEND MLARD Workshop*

*9<sup>th</sup> December 2021*

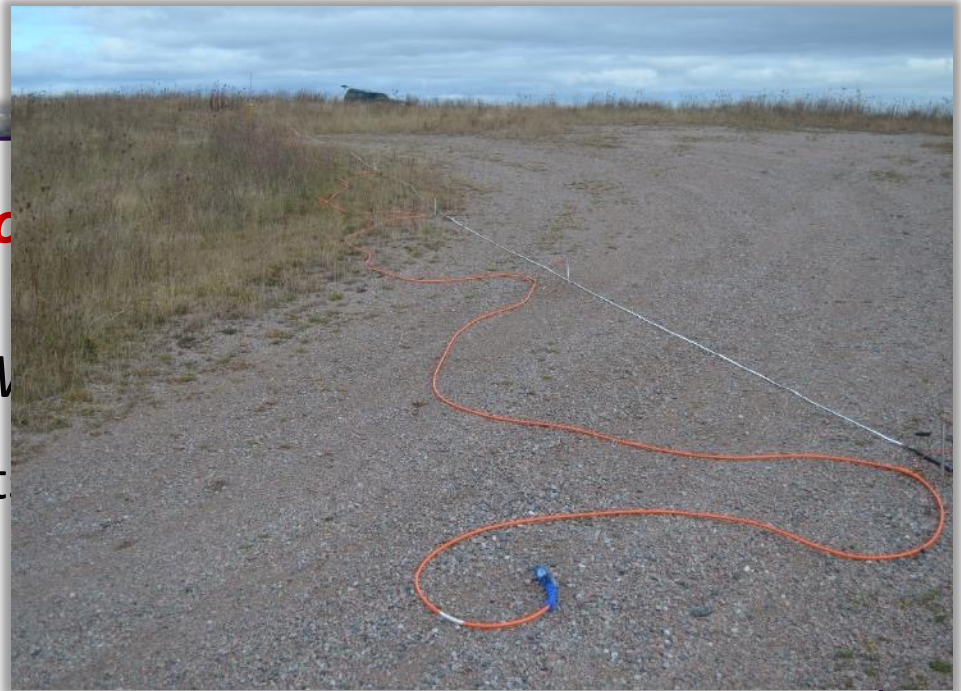
- No electrical isolation existed
- No isolation flap on access

*Total leakage area: 560 cm<sup>2</sup>*

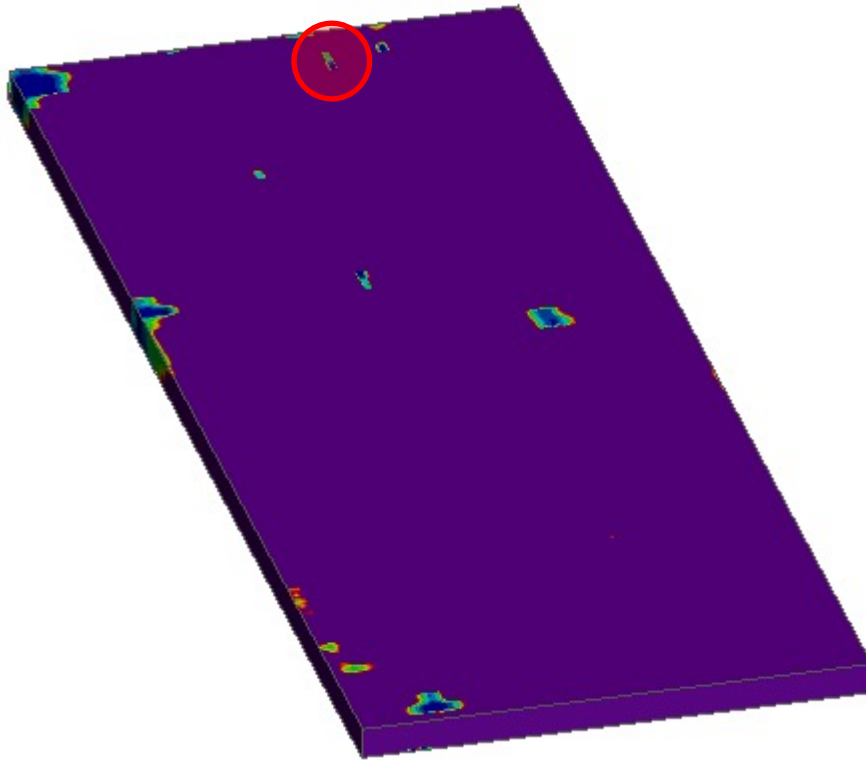
Defect 1 was  $5 \text{ m} * 0.5 \text{ m}$
