Management of the Tailings Storage Facility at the Abandoned Ketzka River Gold Mine in Subarctic Yukon

Dustin K. Rainey, Ph.D., P.Geo.
Assessment and Abandoned Mines
Yukon Government

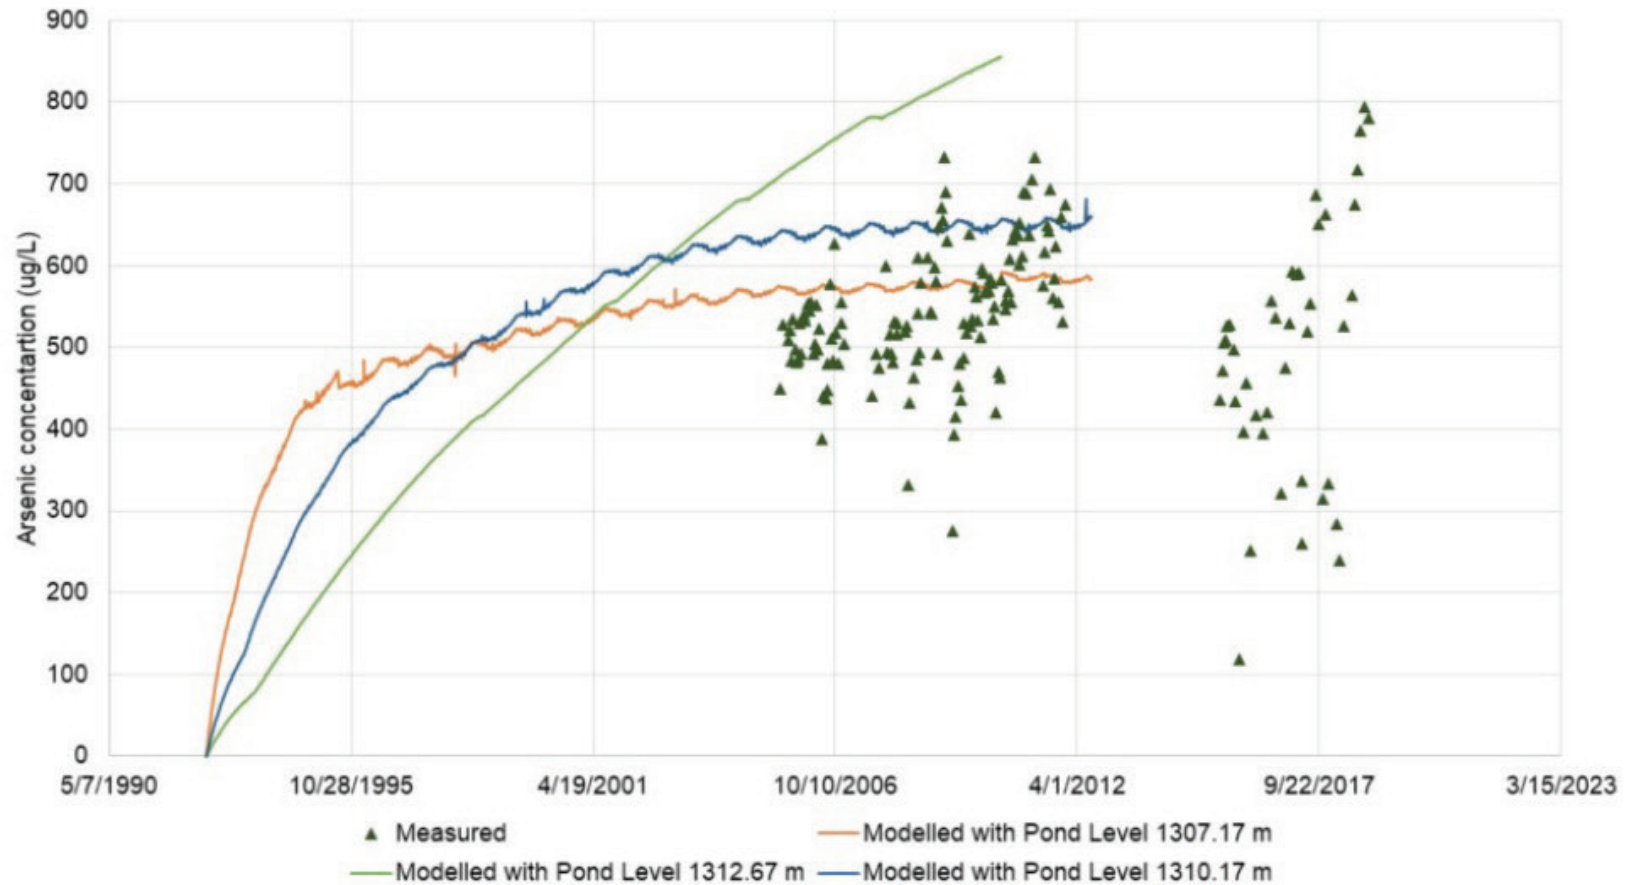
TSF observed and modelled dissolved arsenic concentrations

Studies indicated that the primary input of D-As was by fluctuation of the water levels at the surface of the exposed tailings. Fluctuation of the pond water levels increases dissolution and flushing of arsenic from tailings that were naturally oxidized prior to exploitation by mining. Due to the lack of sulphides in the tailings, restricting air entry into the surface of the tailings does not affect sulphide oxidation. Arsenic leaching is correlated to pond size, where a larger pond contacts a greater proportion of the tailings and can flush larger amounts of arsenic as the pond is seasonally lowered. By maintaining the pond at consistently lower elevations year-over-year, the smaller pond exhibits less fluctuation in water levels, therefore reducing the proportion of the tailings that are regularly flooded then exposed.
