TAILINGS FAILURES AND HOW TO AVOID THEM

Samarco, Fundao, Brazil

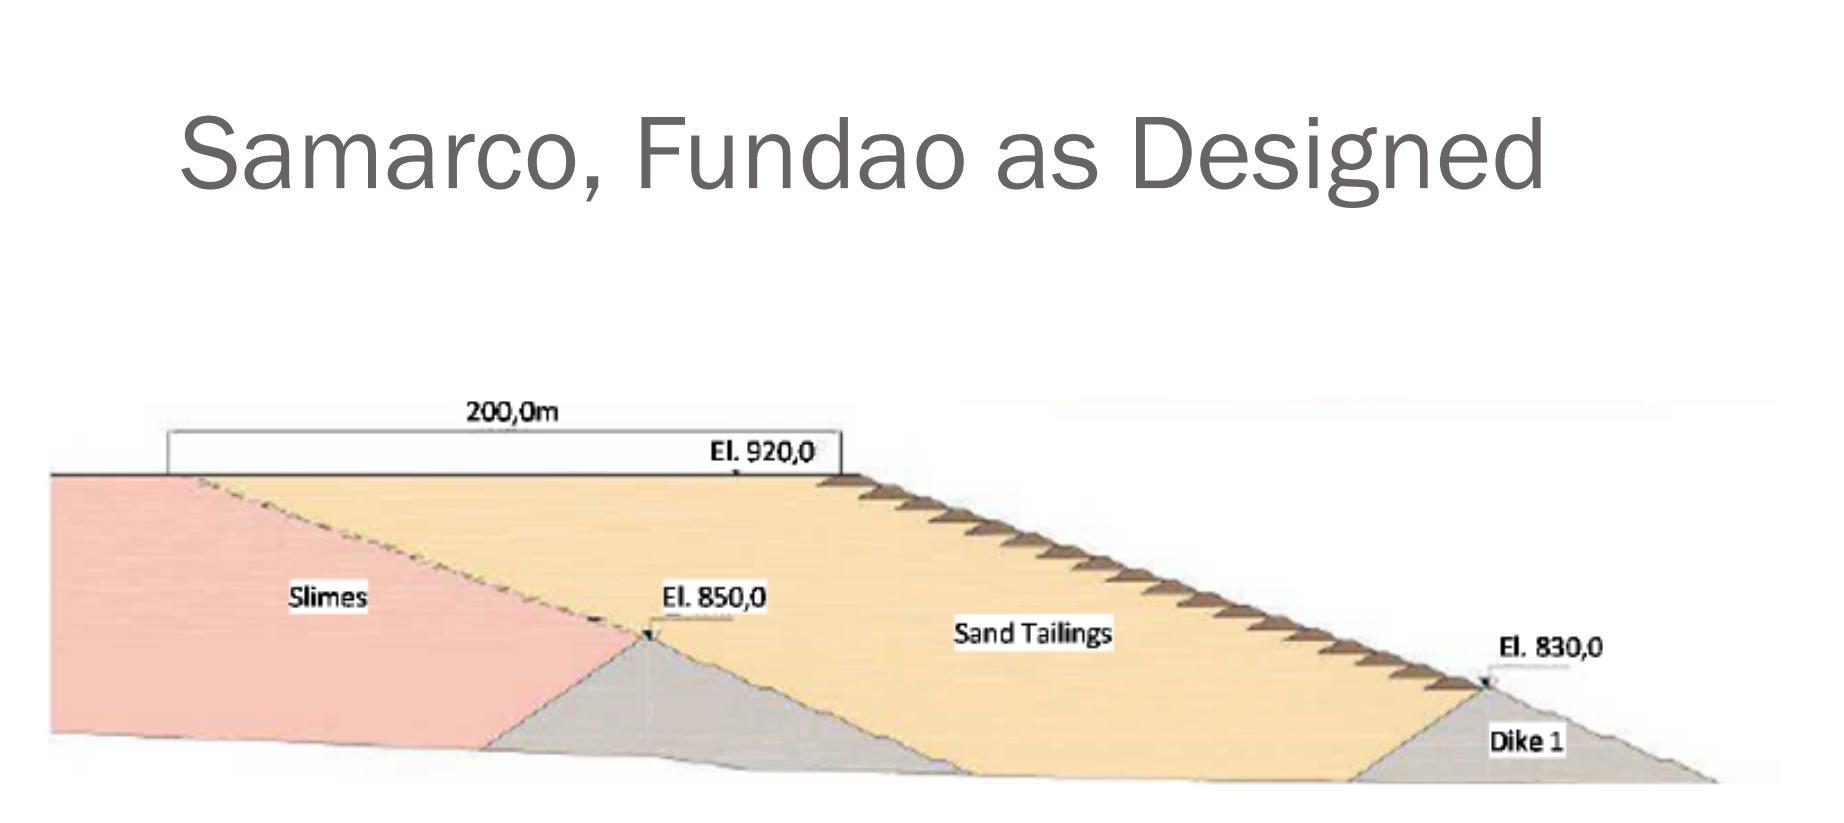
Figure 2-4 Upstream raising of Dike 1 by the "drained stack" concept

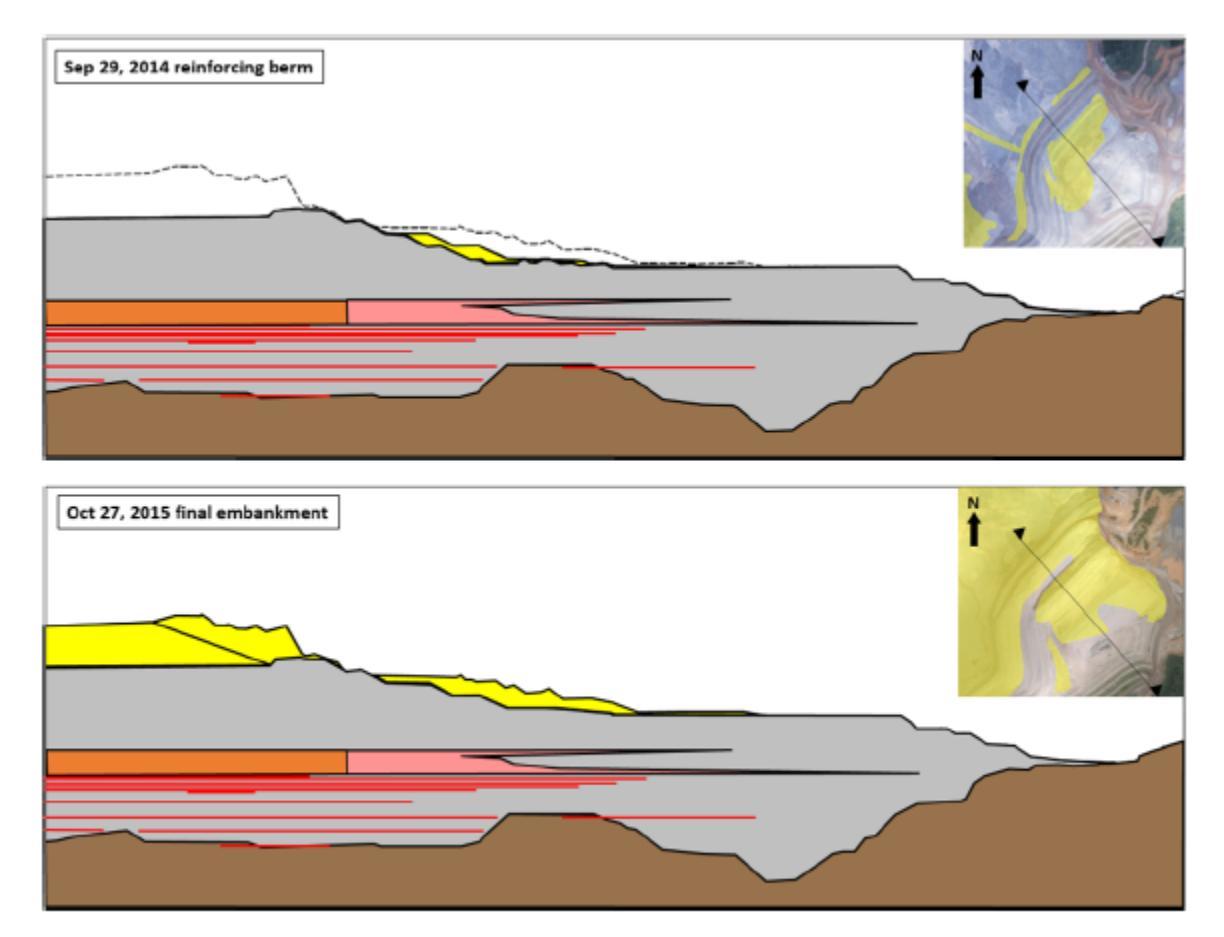
Figure 5-10 Sequential raising of setback embankment over slimes

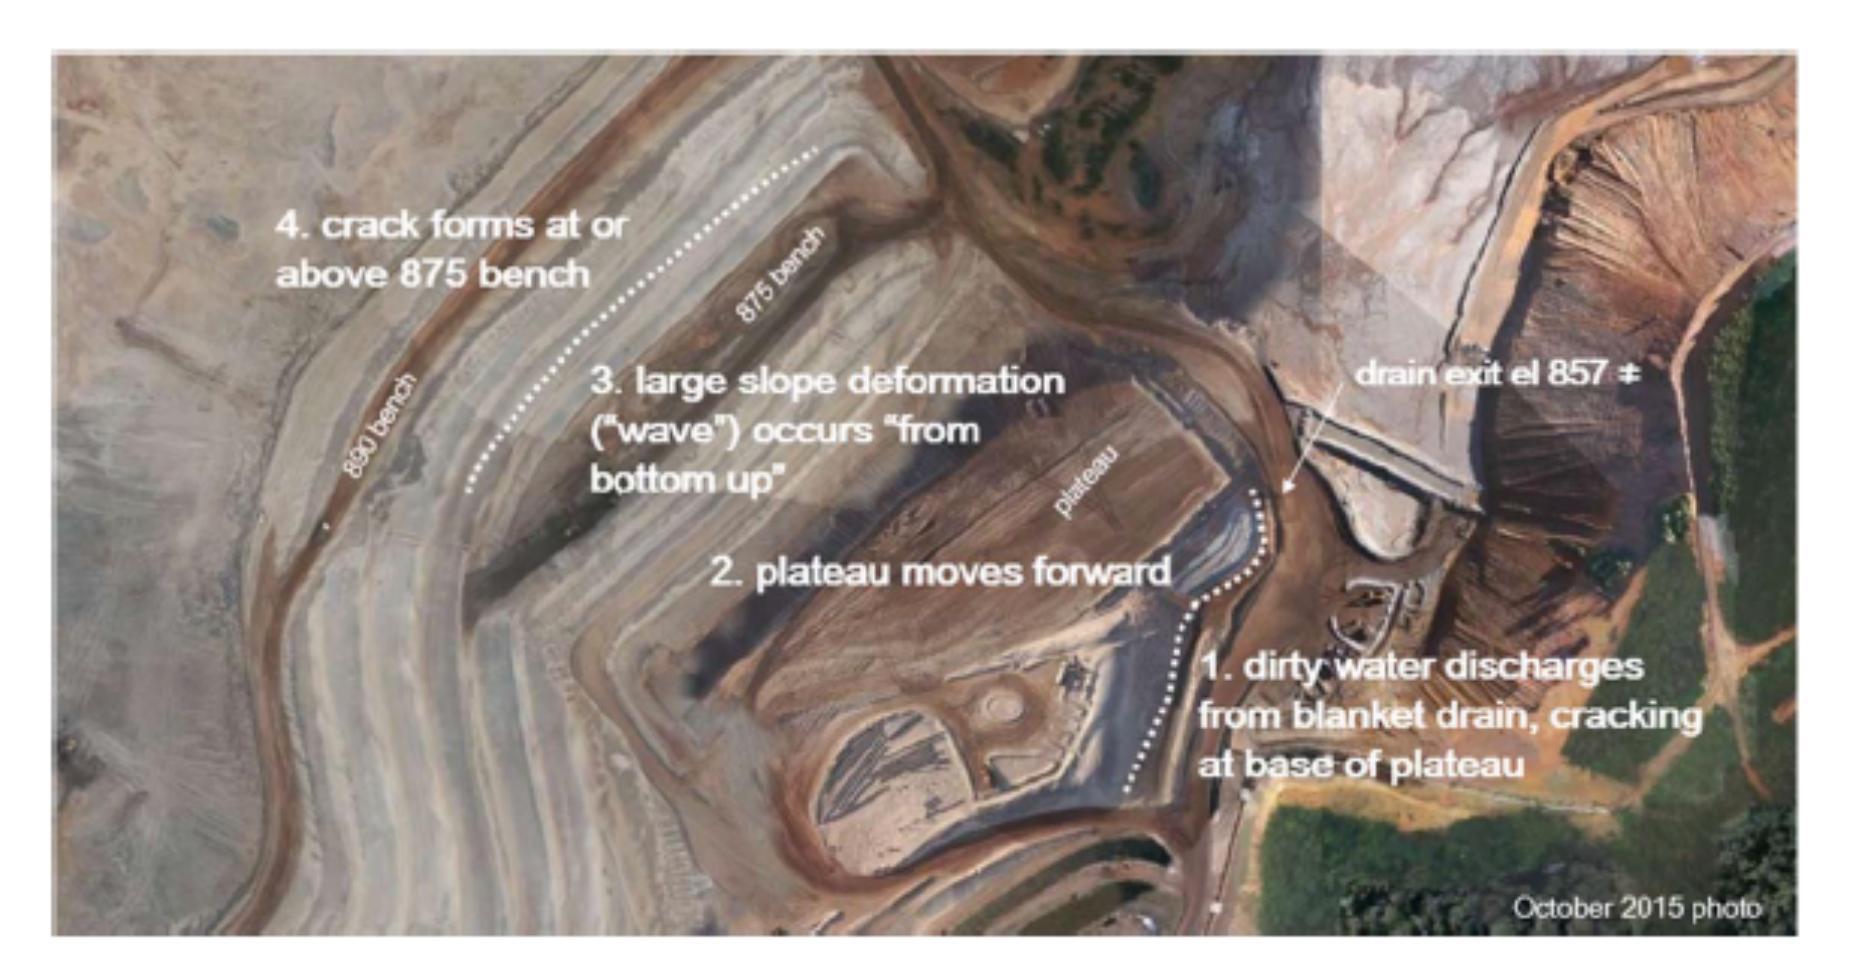
Figure 2-18 Failure initiation sequence

- Blinded drains
- Inadequate replacement drains
- Slimes beneath the slope
- Saturated sands in slope as a result of inadequate drainage
- Sand made even looser as a result of creeptype sliding along slimes
- A tiny earthquake gives the final kick

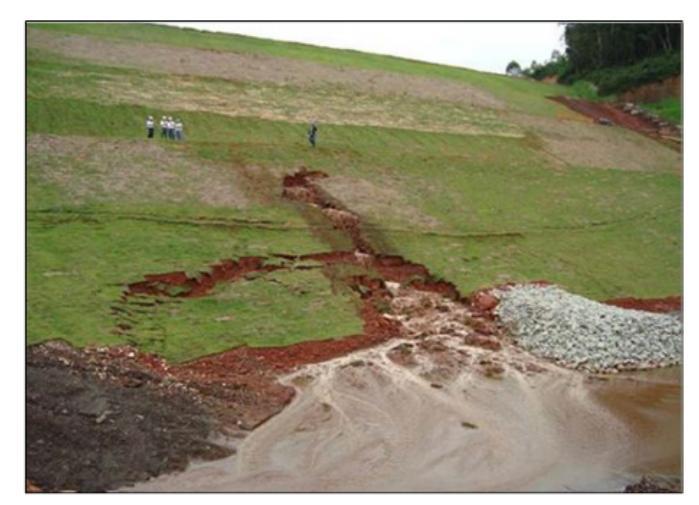
Figure 2-6 Internal erosion effects on downstream slope of Dike 1

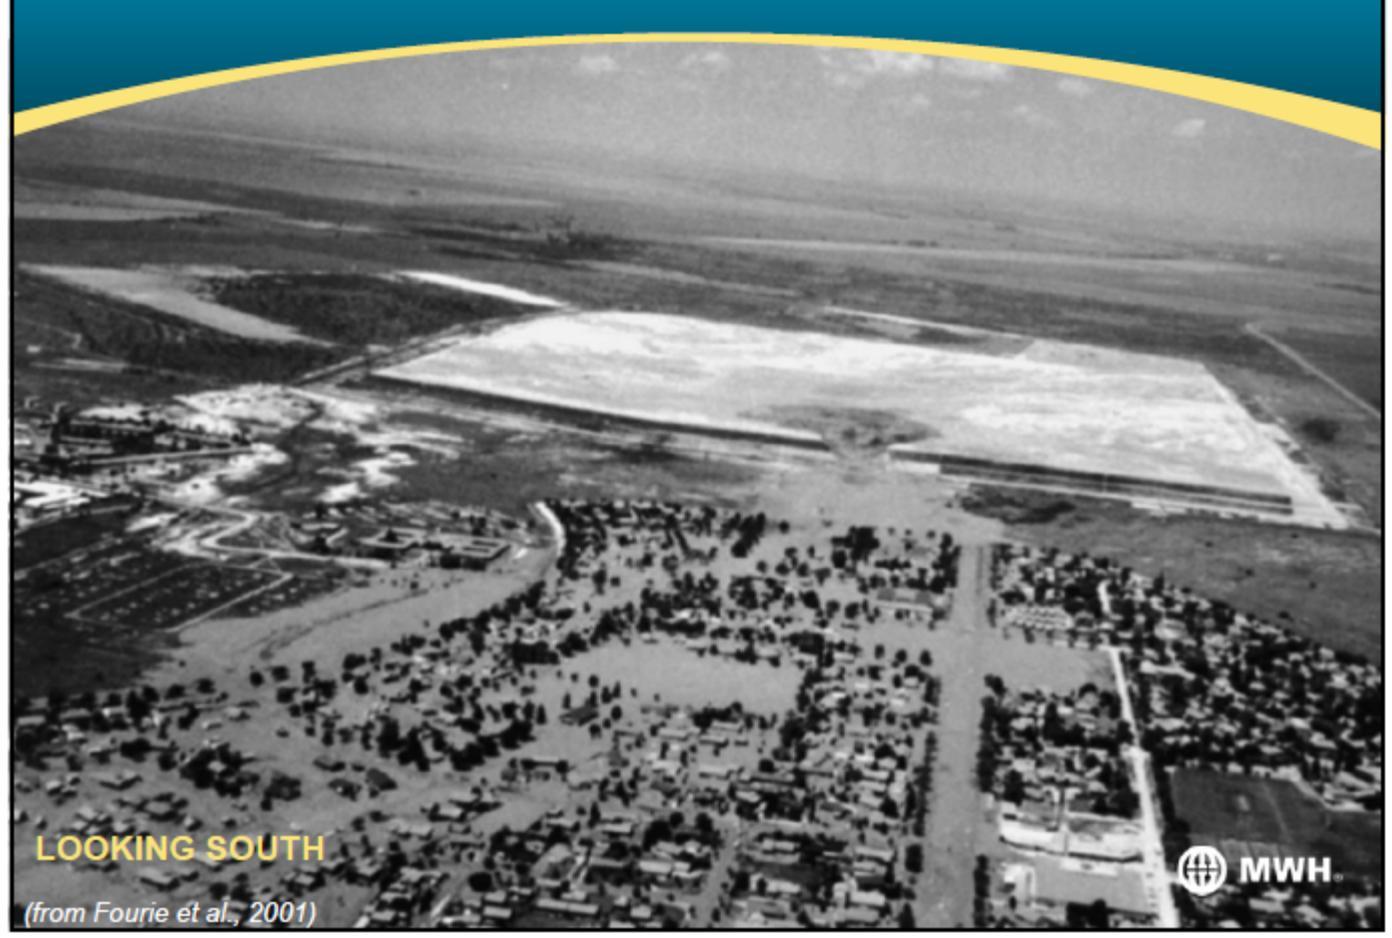
Inundation of Merriespruit Township

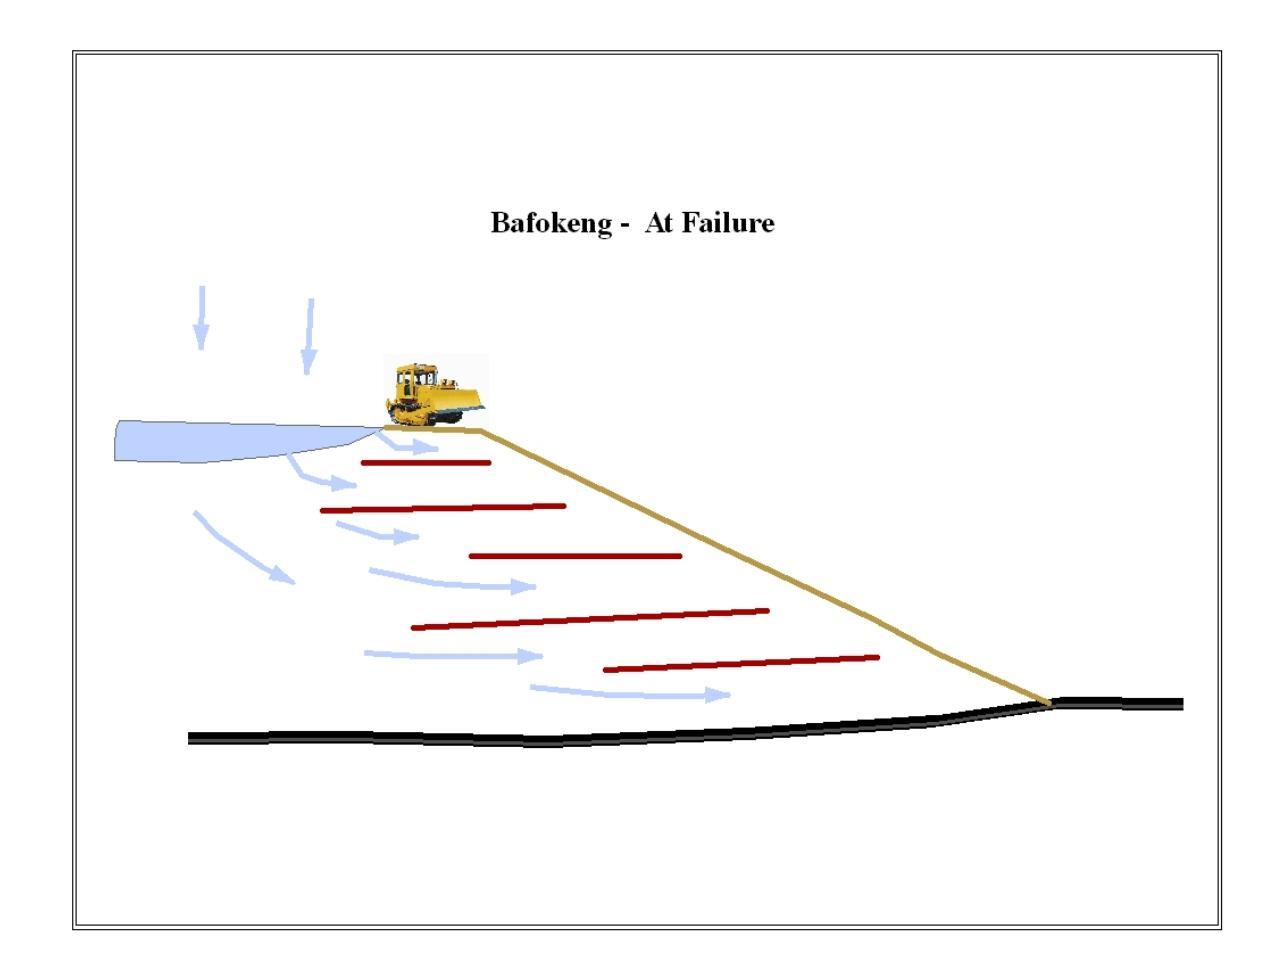
Bafokeng – at Failure

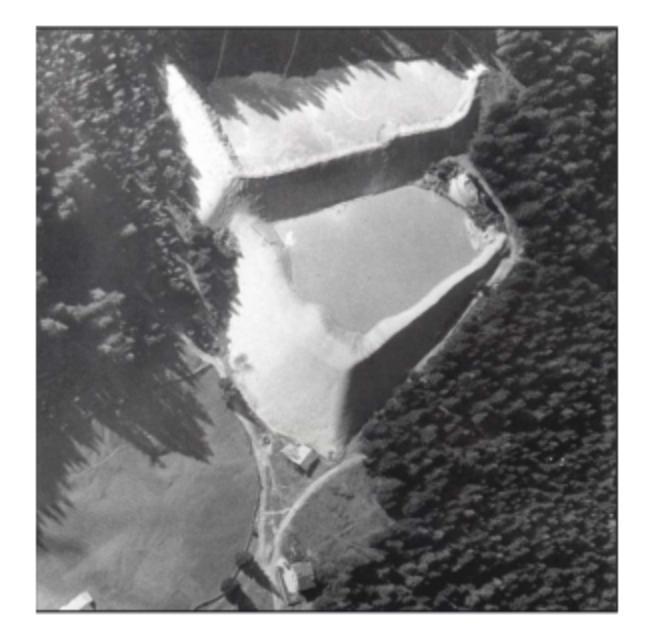
Fig. 5. Aerial view of the basins in October 1973, nearly two years after the construction of upper basin; in this one is in progress the raising of the embankment from the orographic left side (photo Impresa Rossi, Brescia).

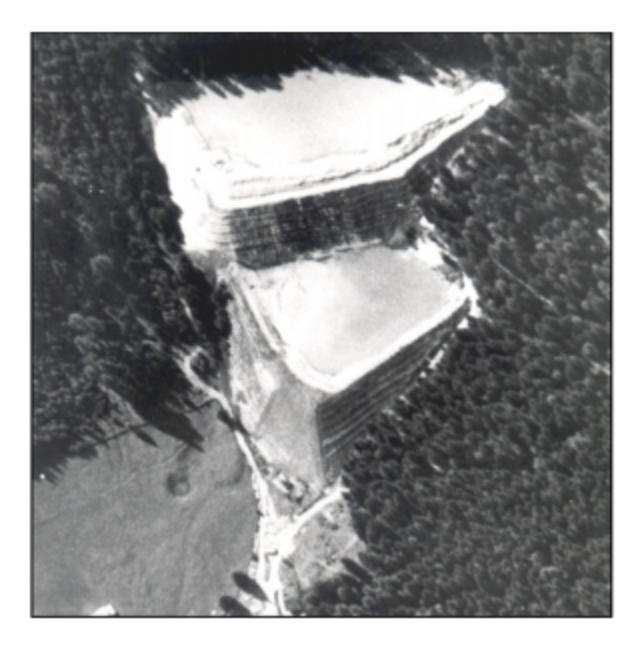
Fig. 6. The decantation basins photographed in September 1978. The geometry of the upper basin seems altered with respect to the previous photo: works to raise the embankment according to the scheme "upstream" are clearly in progress (photo Impresa Rossi, Brescia).
