# **Geochemical Predictions of the Landusky Spent Ore Heap Leach Pads & Implications for Water Management.**

Shannon C. Shaw, & Andrew MacG. Robertson

Robertson GeoConsultants Inc.

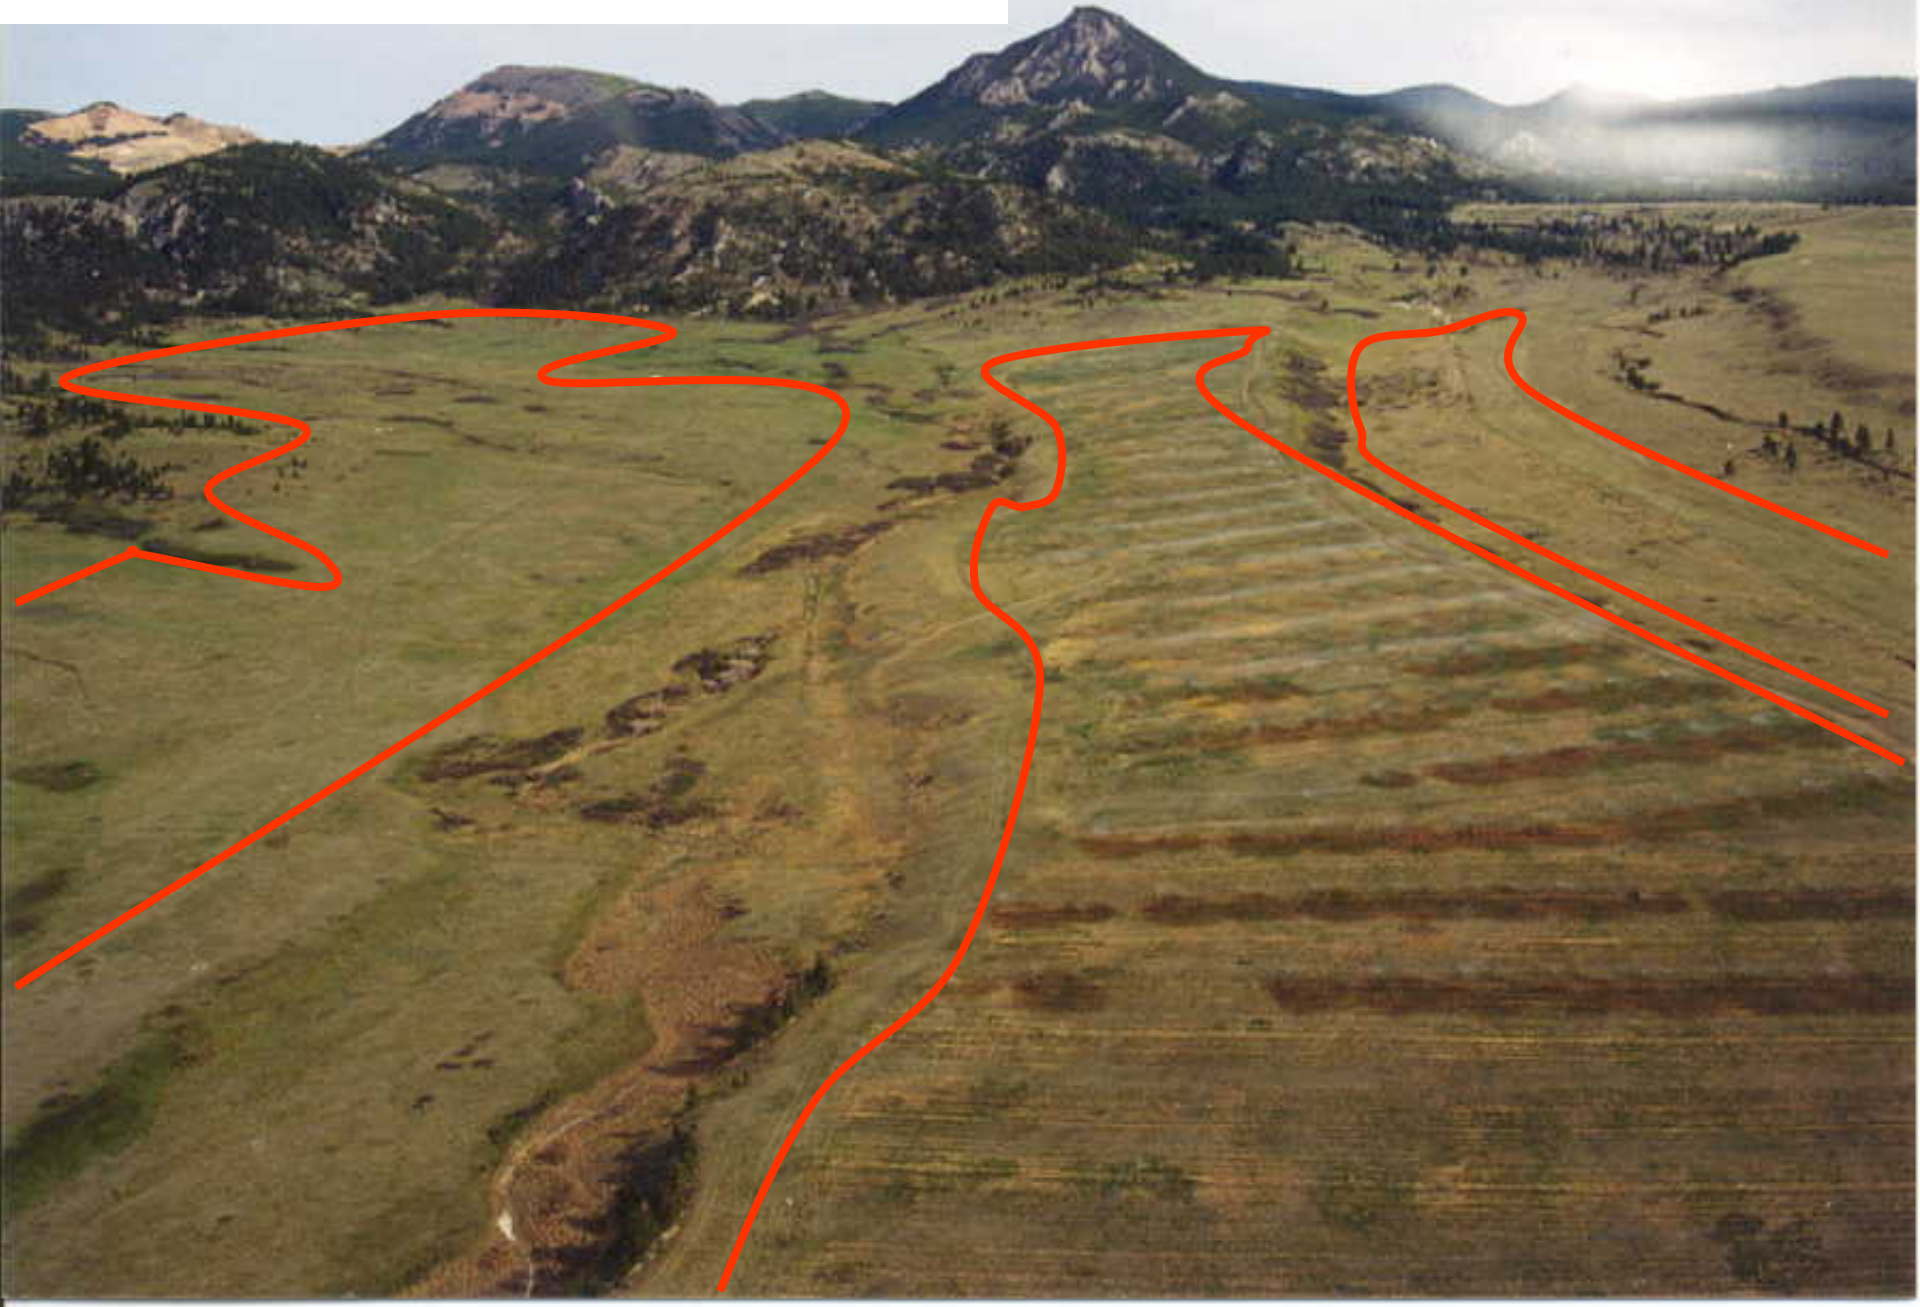
# GOSLIN FLATS LAD AREA

- The LAD relies on the cation exchange in the soils and plant uptake of constituents.
- Solutions are irrigated over the surface to enhance evaporation and minimize surface water discharge.

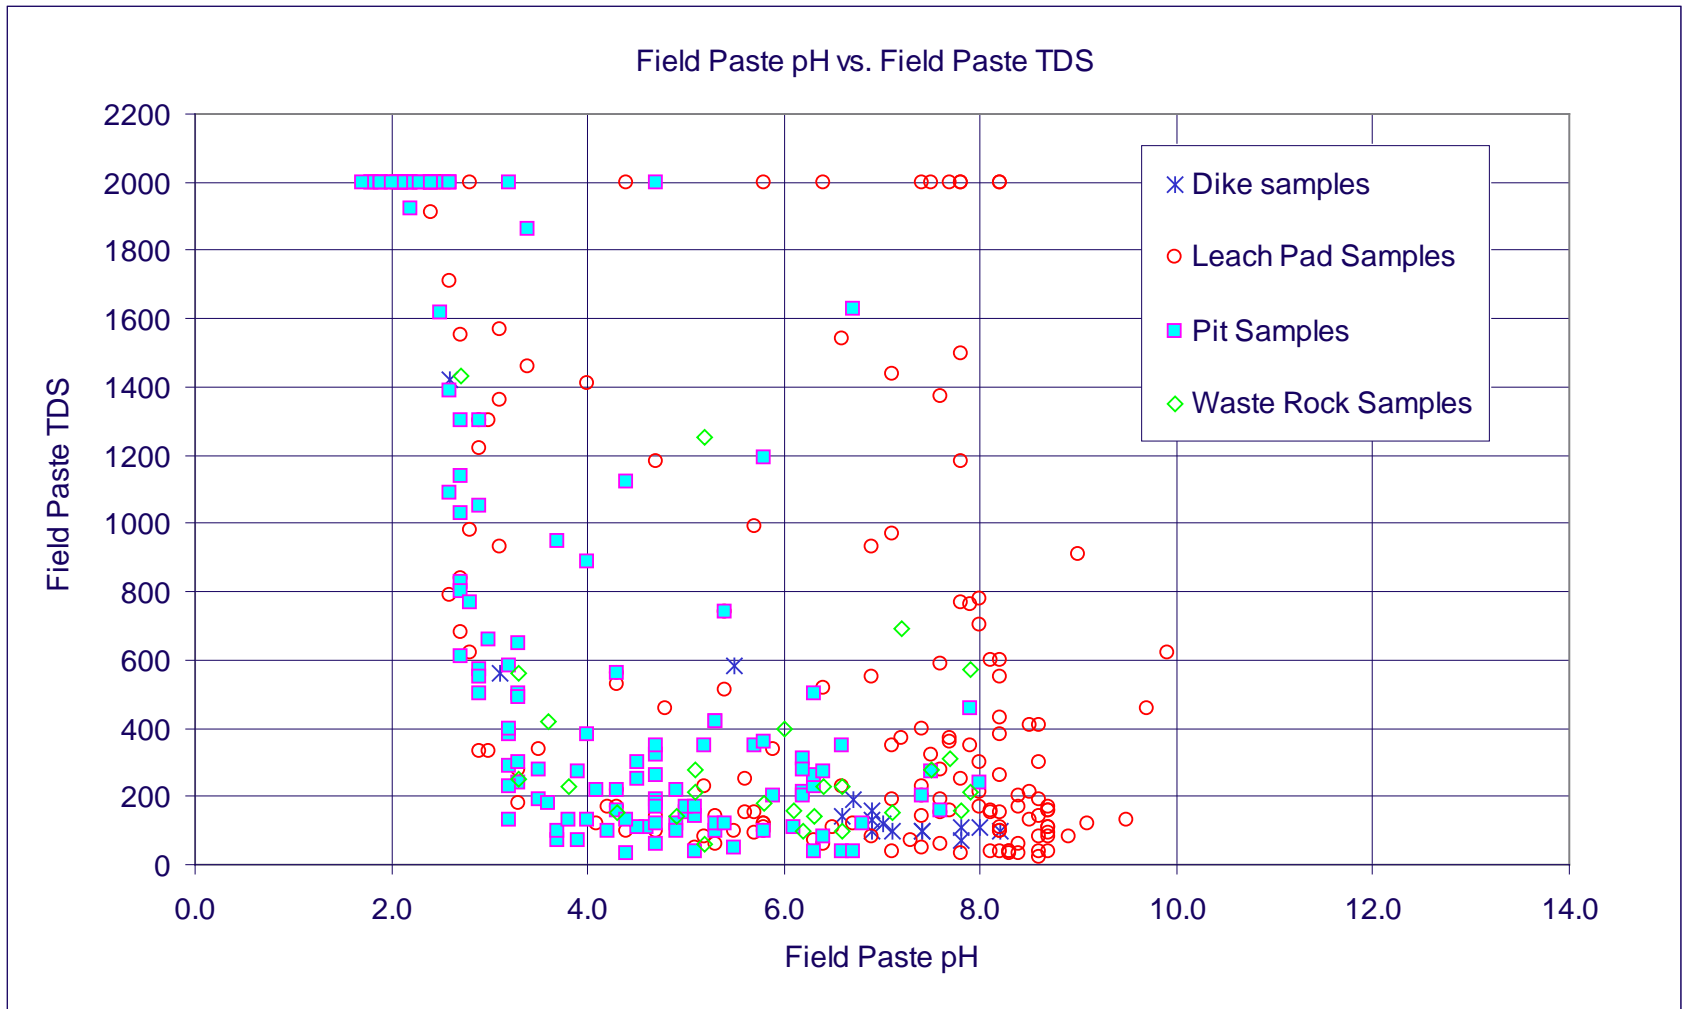
In general, samples with low pH have high TDS values due to the presence of soluble minerals on the grain surfaces. The exception is the leach pad samples for which the added alkalinity (during leaching) is maintaining near neutral pH values and contributing to TDS.

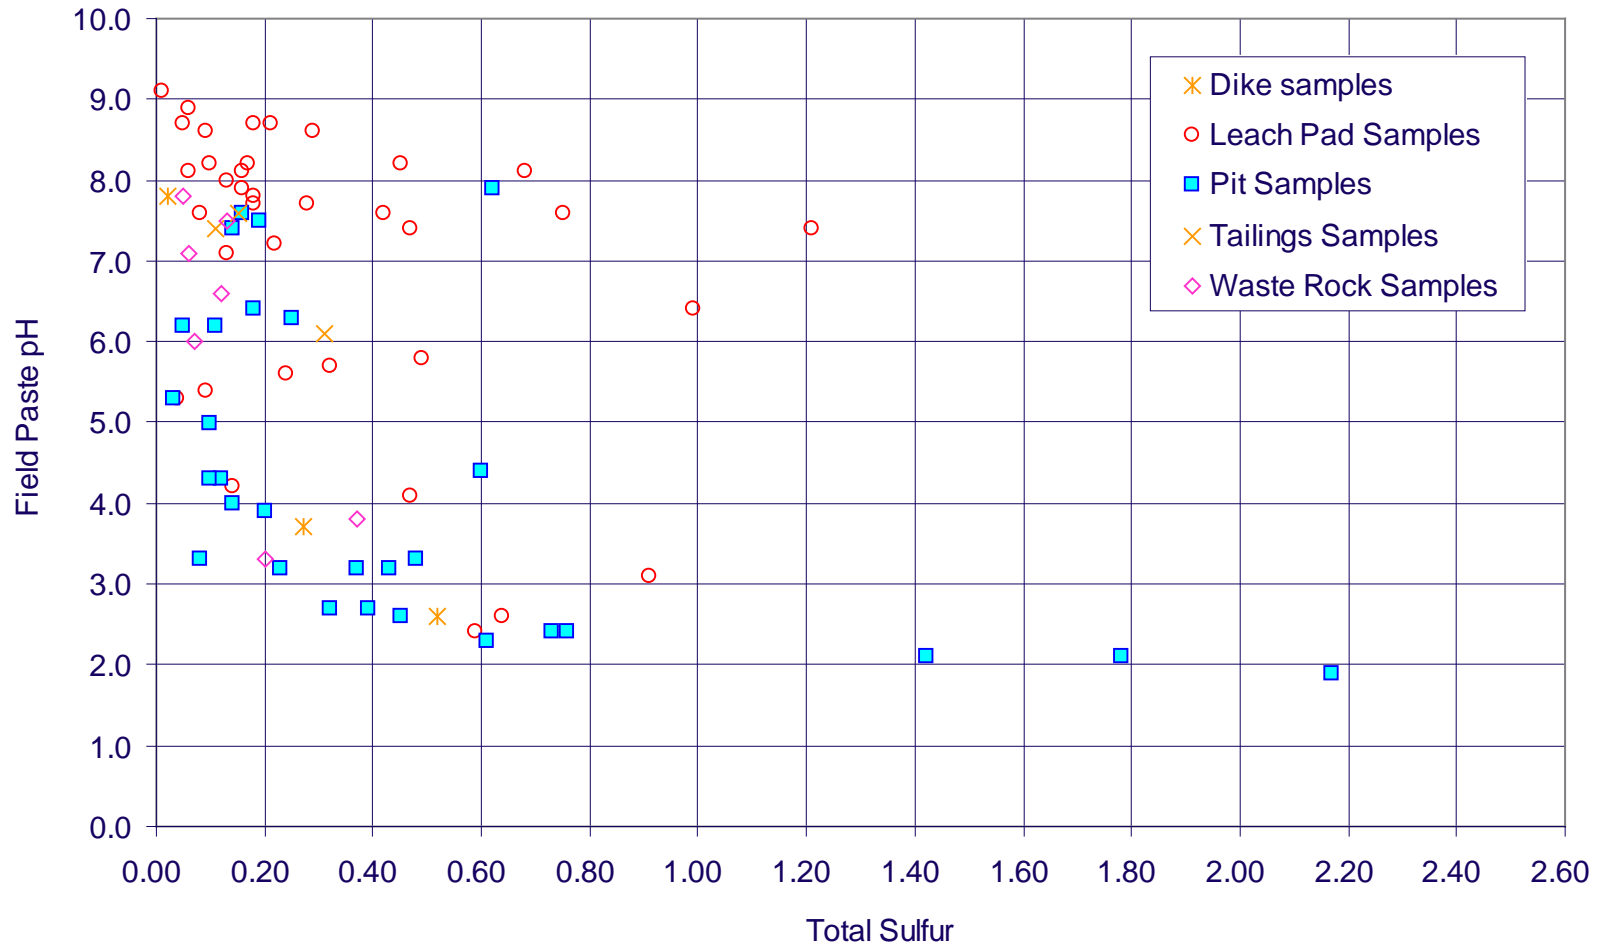
# Modified Acid Base Accounting

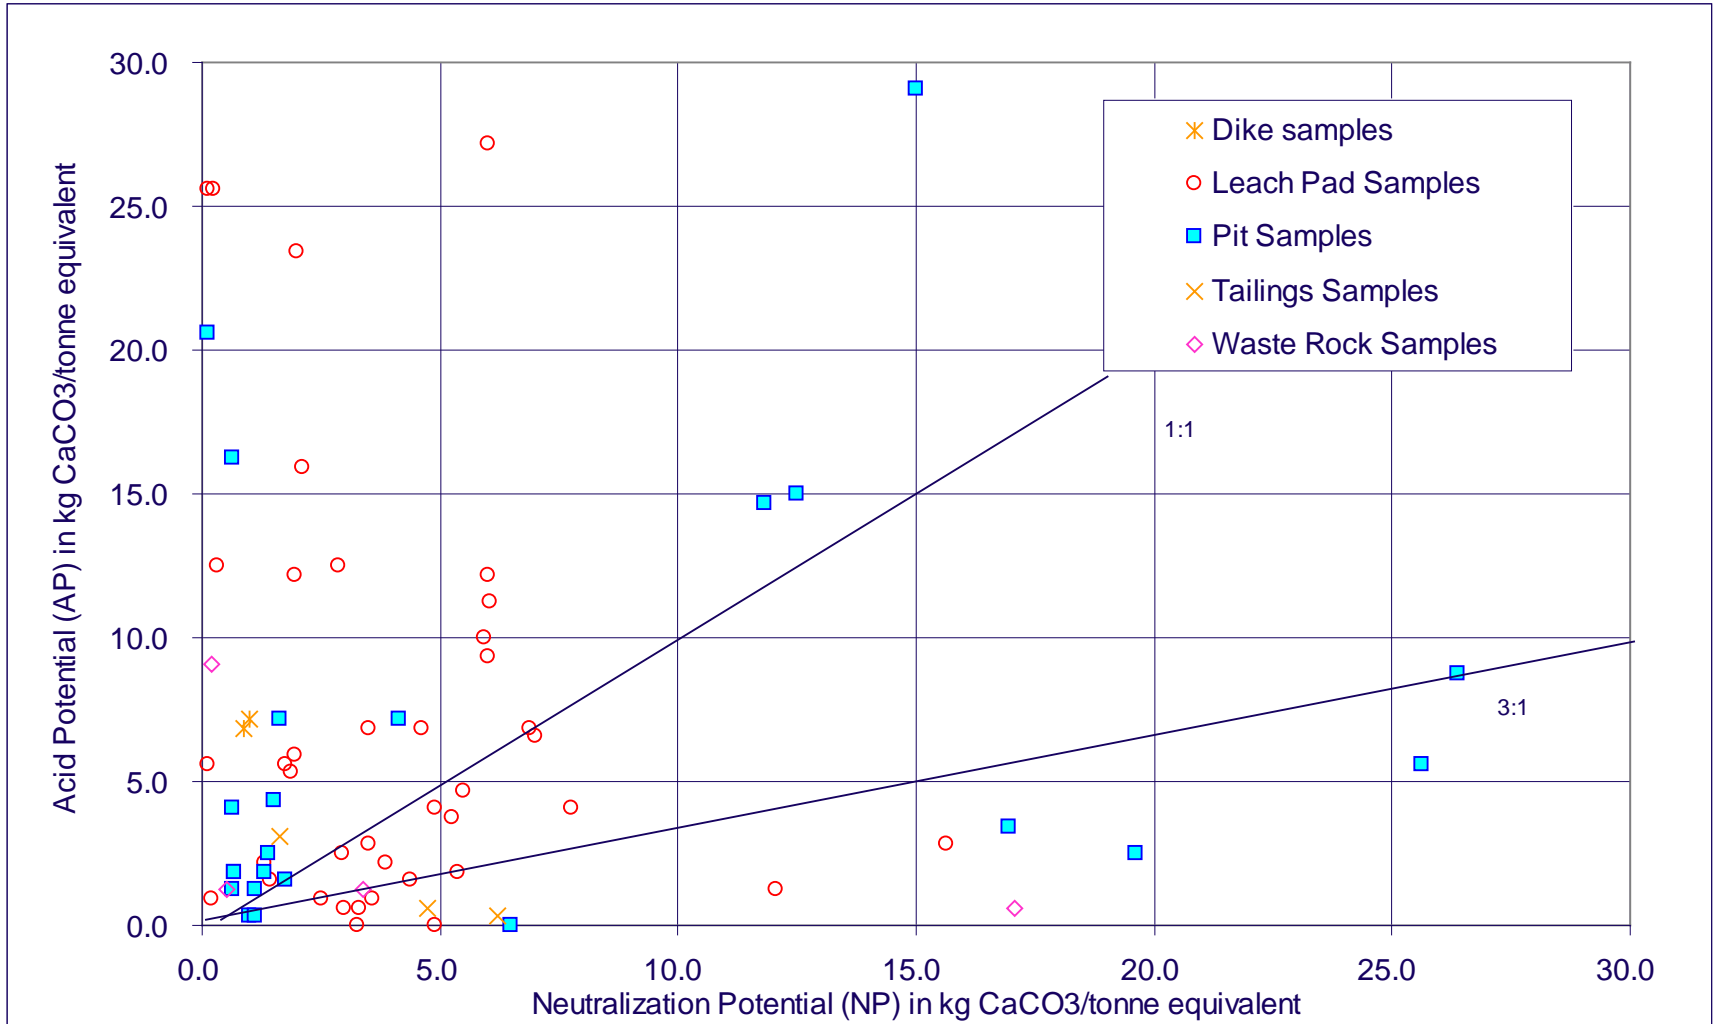
# Modified Acid Base Accounting

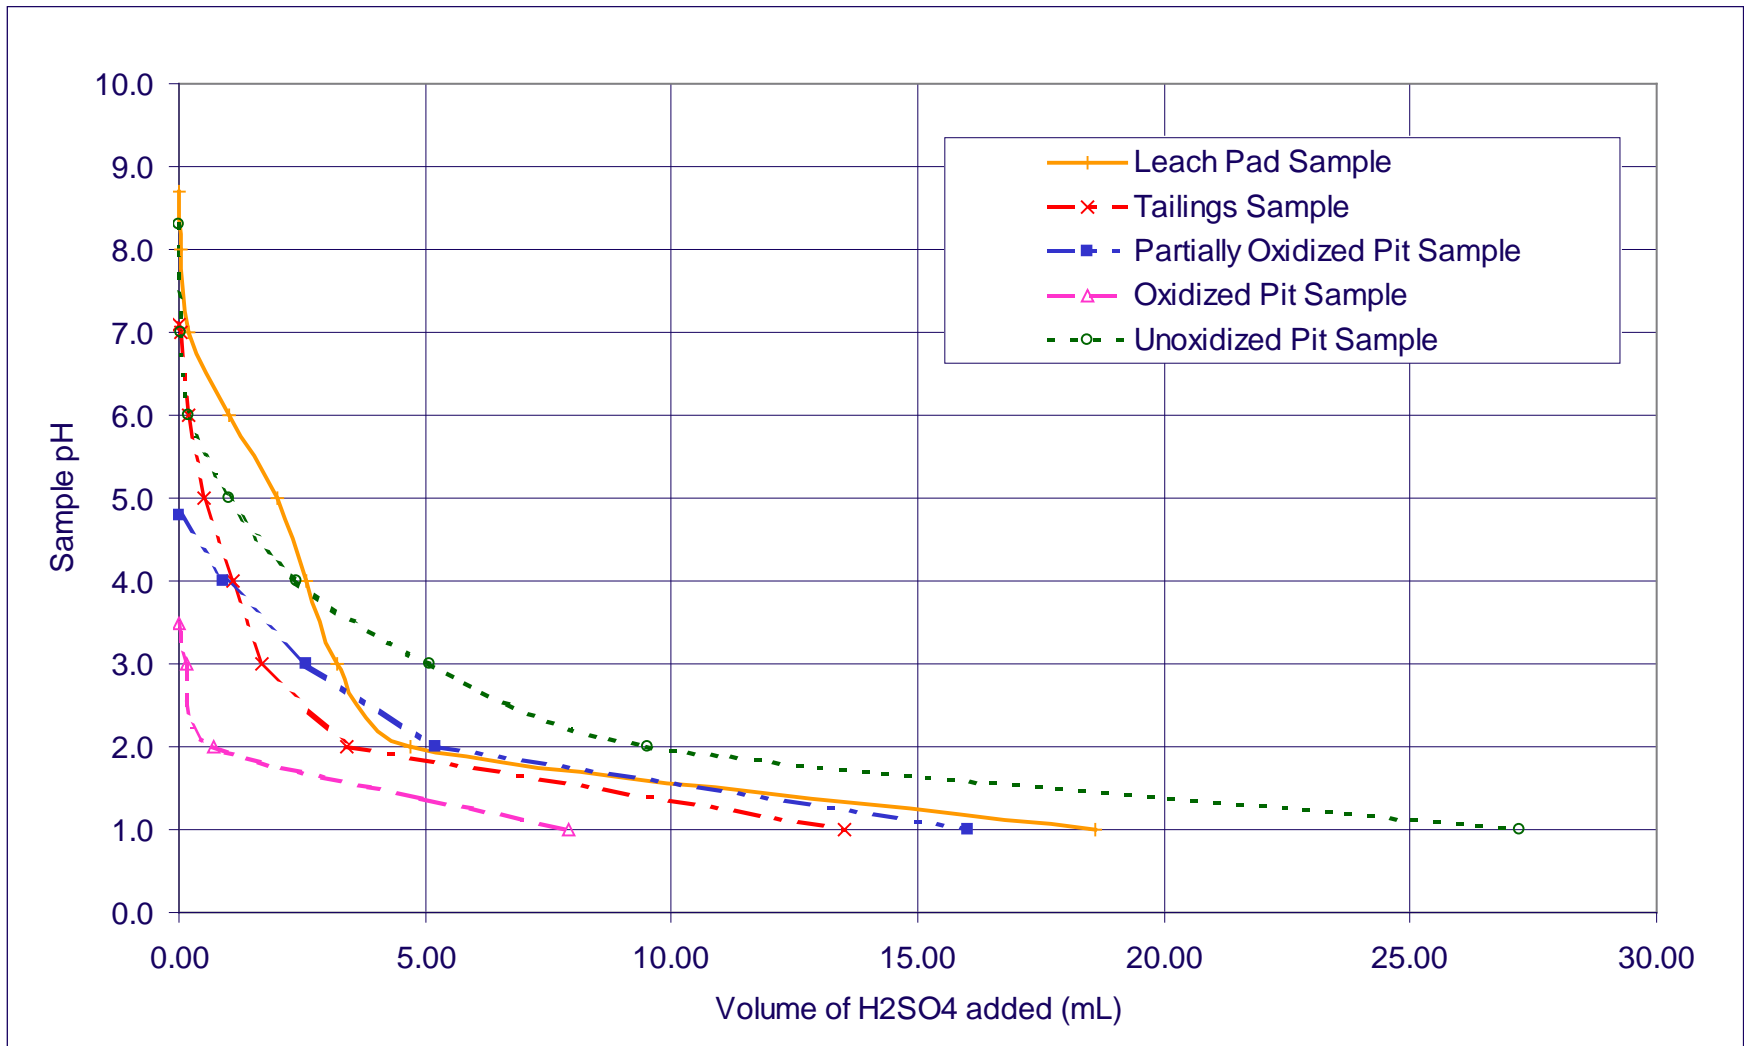
# Forward Acid Titration Tests

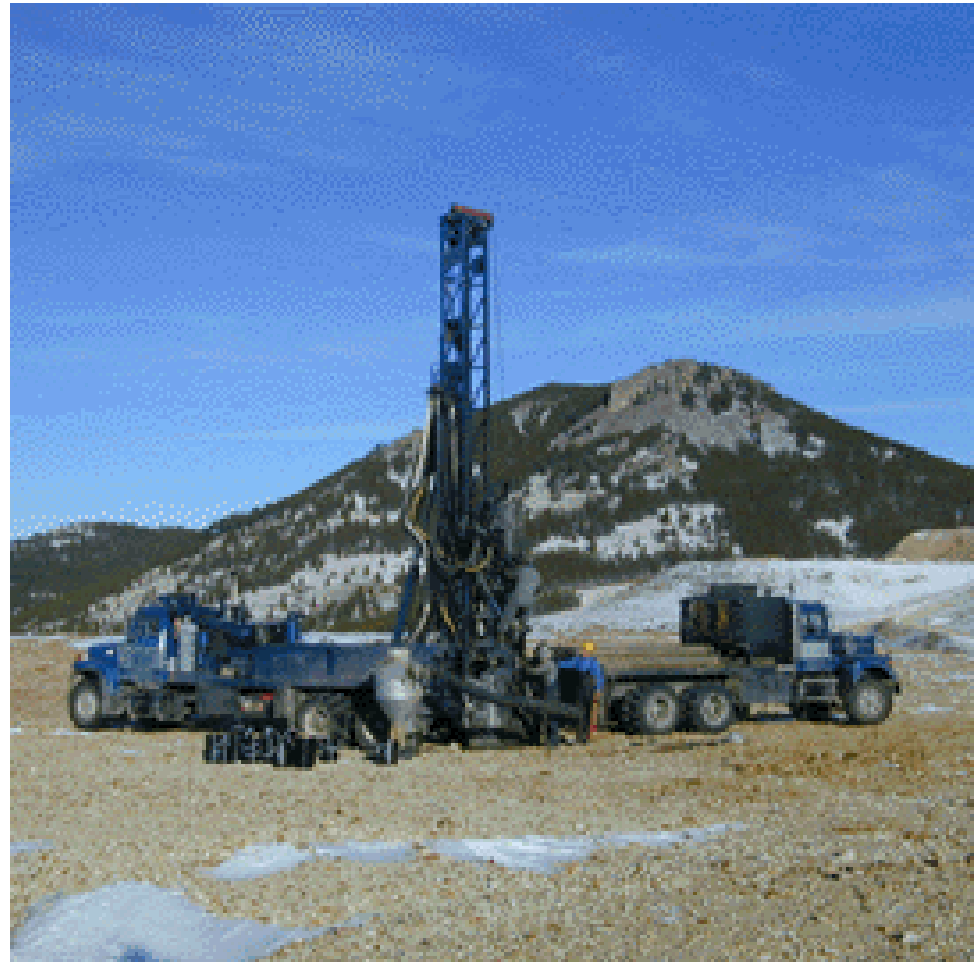
- A Becker hammer-type drill rig was used in order to minimize sample crushing and the geochemical disturbance of the samples

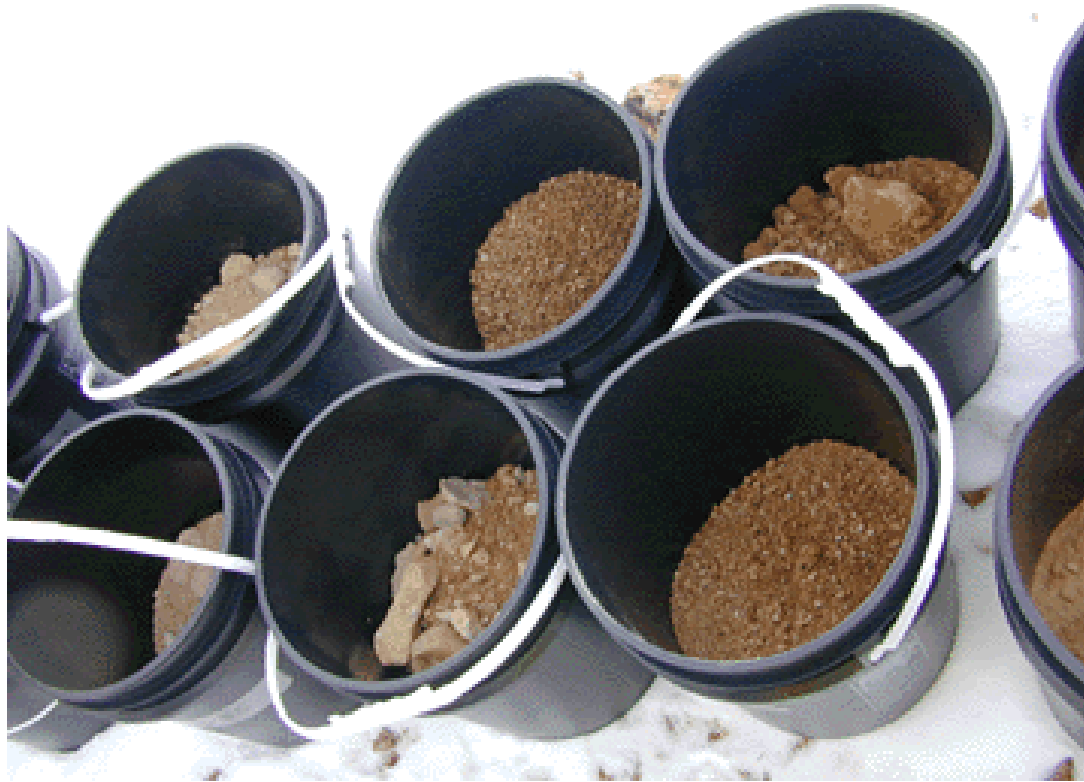
Samples were collected every 10 ft & paste pH and EC measured,  
A sub-set of samples were submitted for laboratory testing

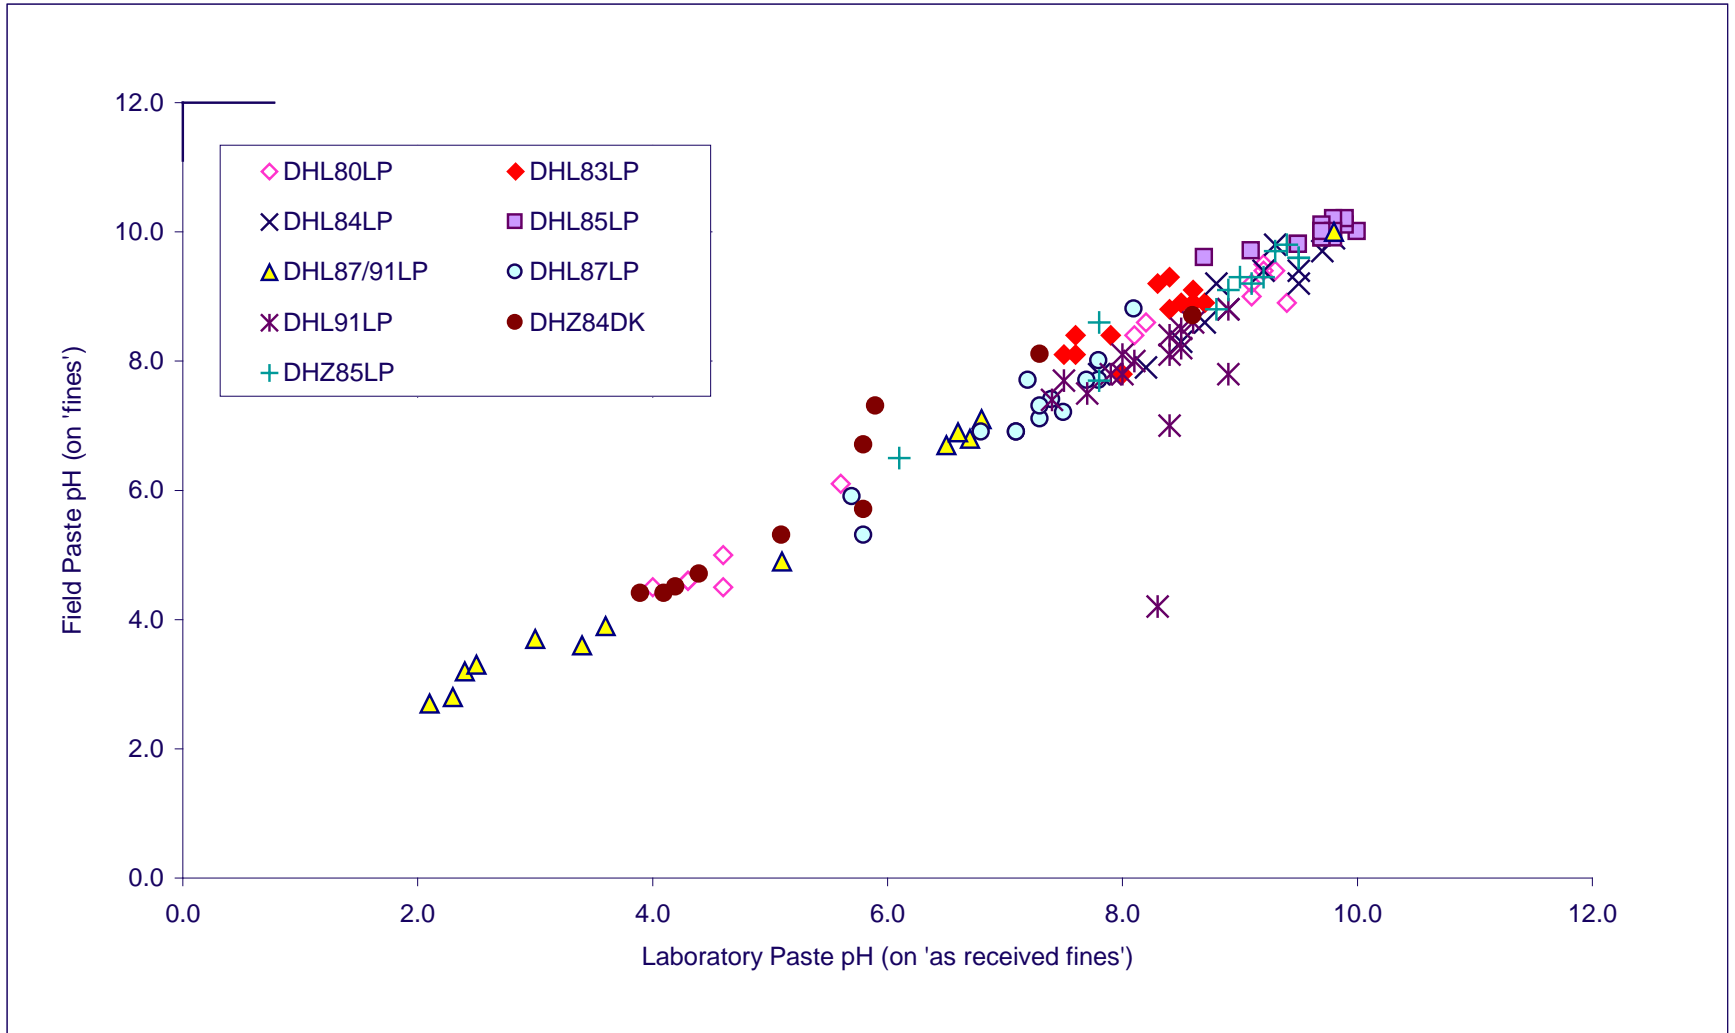
# Paste pH Results

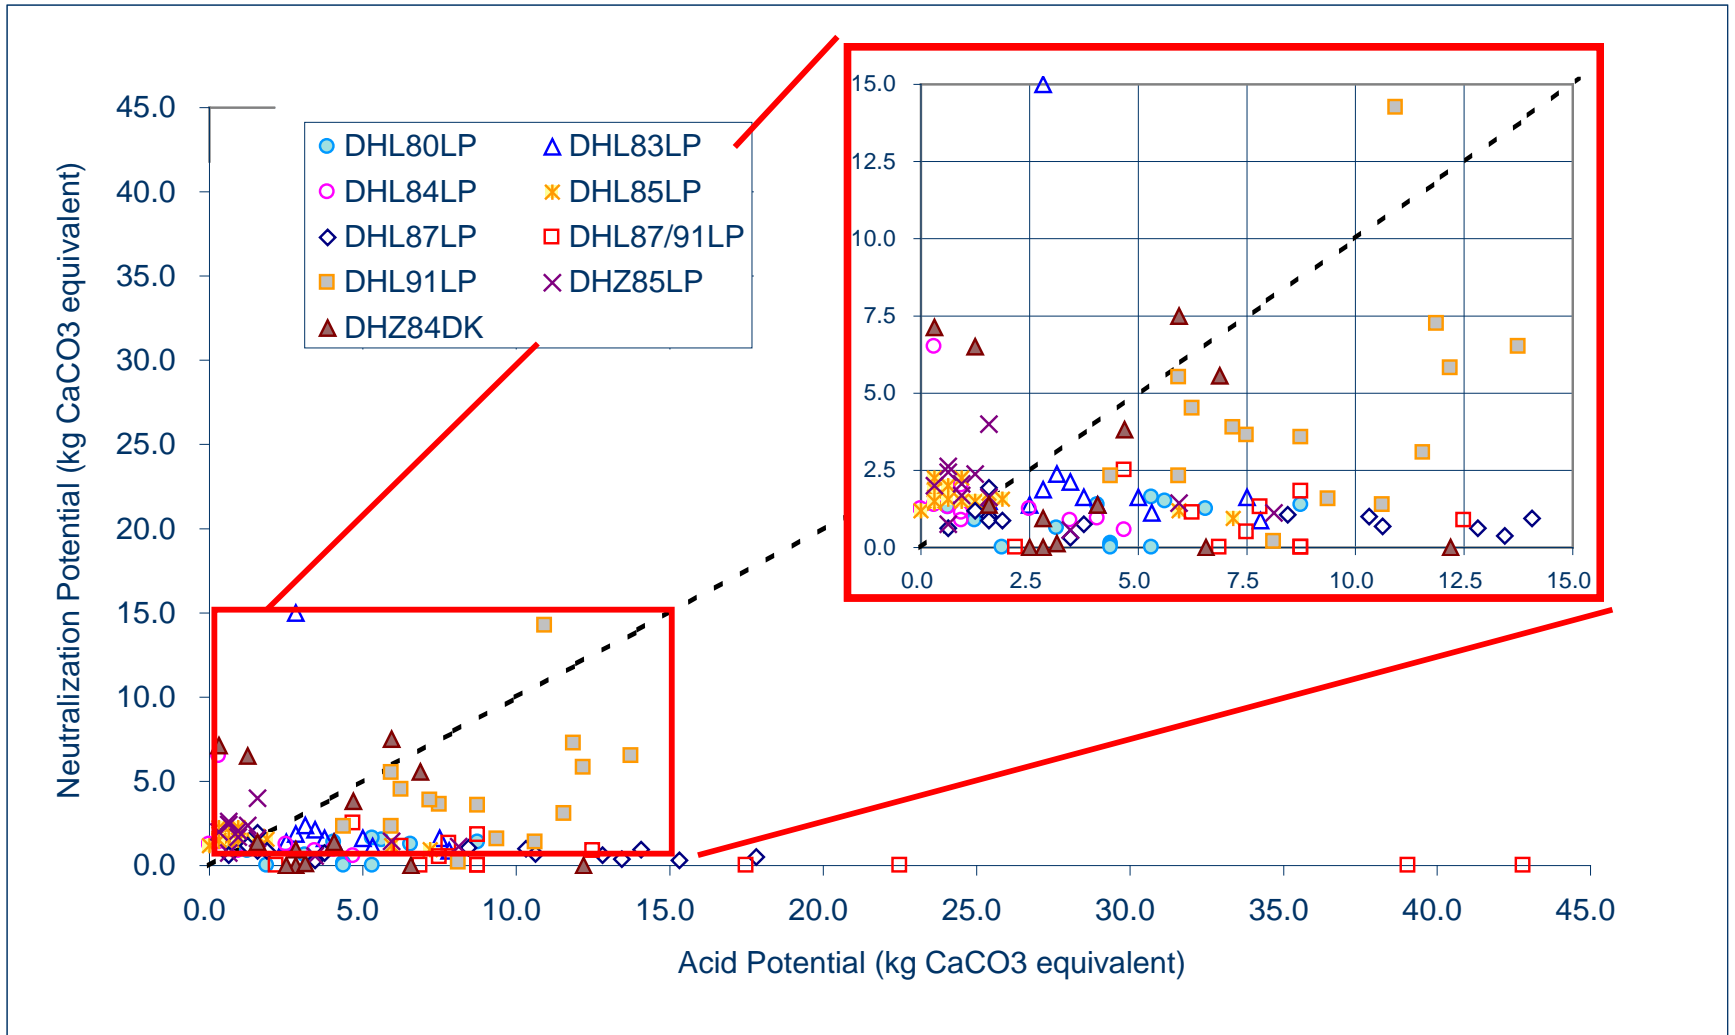
# Modified ABA Results

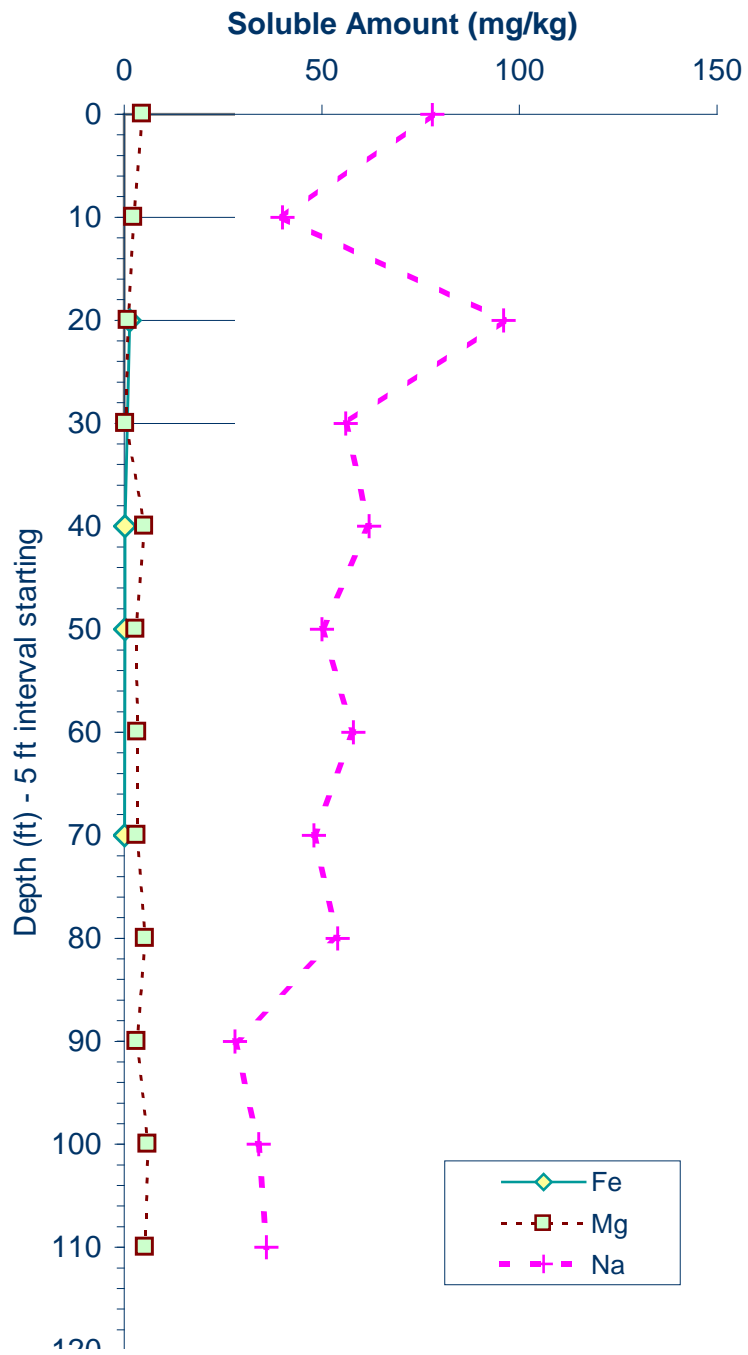
# Geochemical Characteristics With Depth

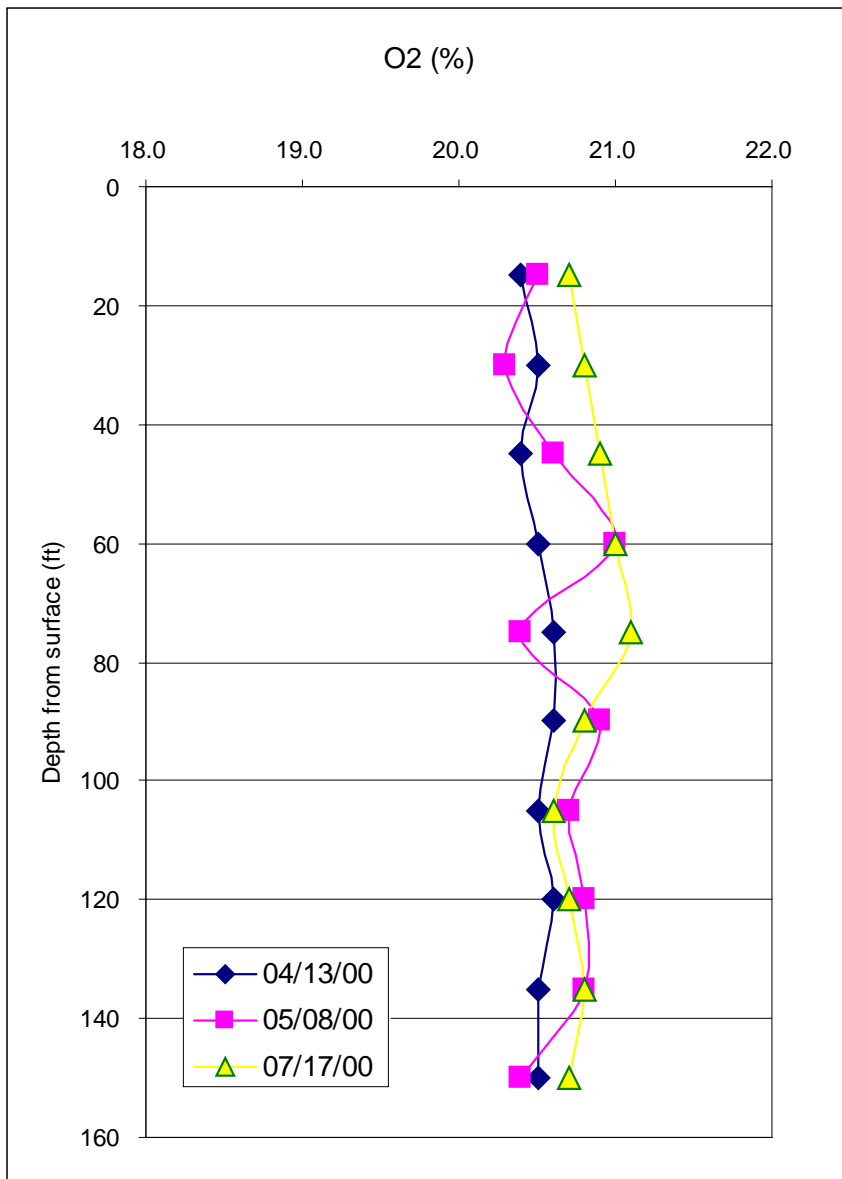
# O<sub>2</sub>, & CO<sub>2</sub> Characteristics With Depth (higher elevation hole)

- Leach pads are nearly fully oxygenated - i.e. O<sub>2</sub> not limited
- Very small build up of CO<sub>2</sub> - indicating either little buffering reactions or continual flush of air through the pad
- Temperatures close to ambient - indicating no substantial build up of heat or continual flush of air through the pad

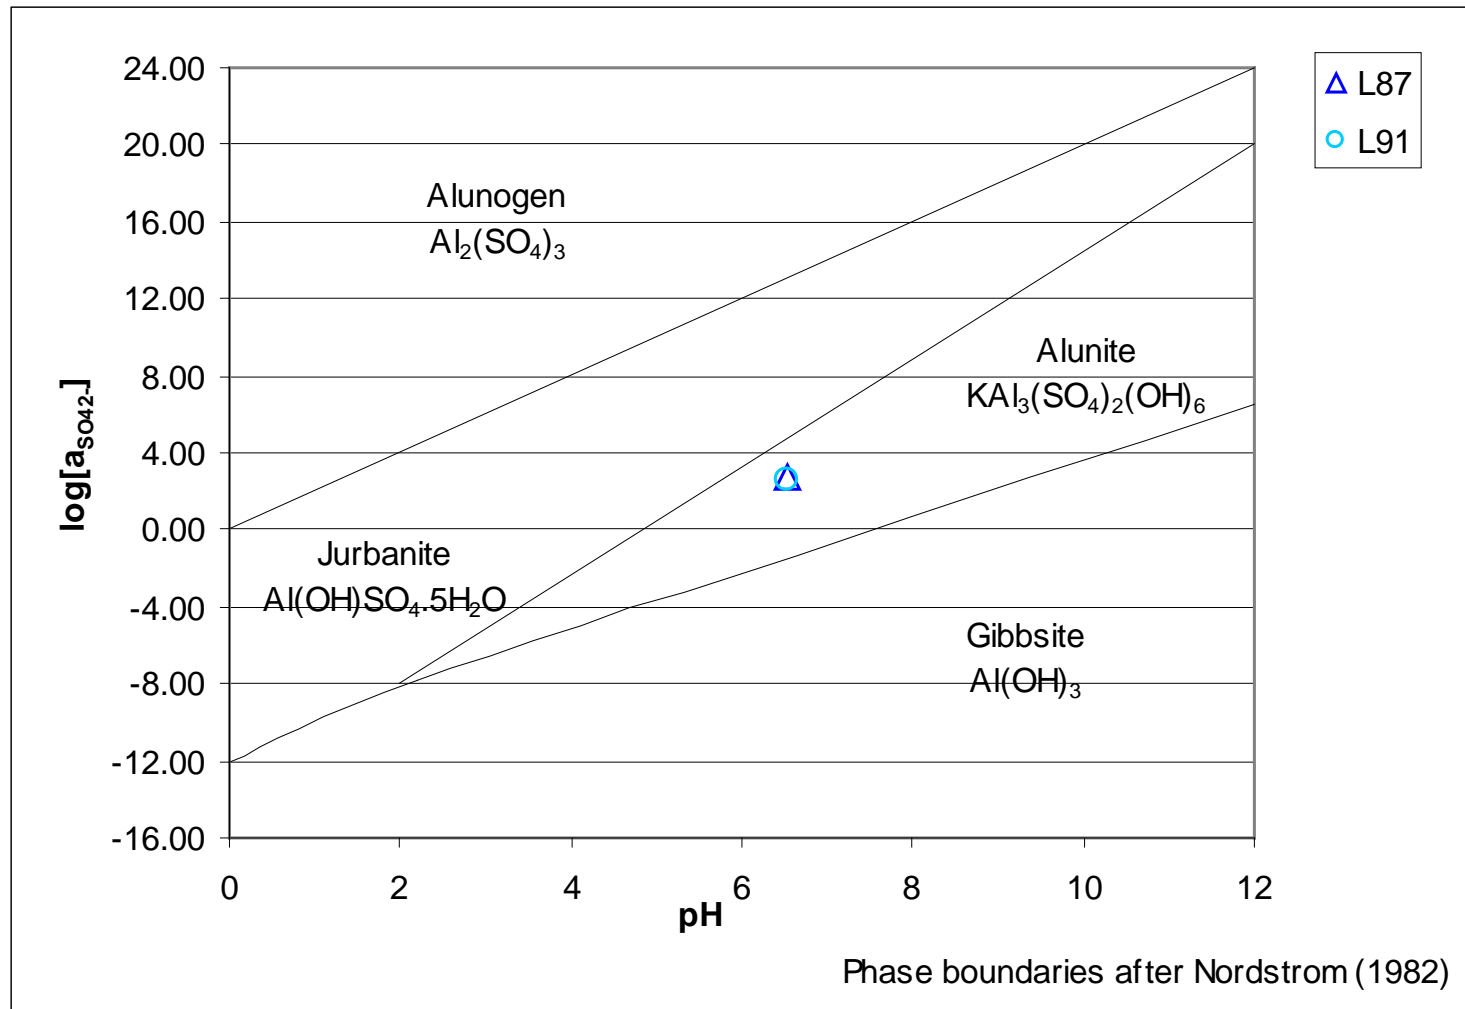
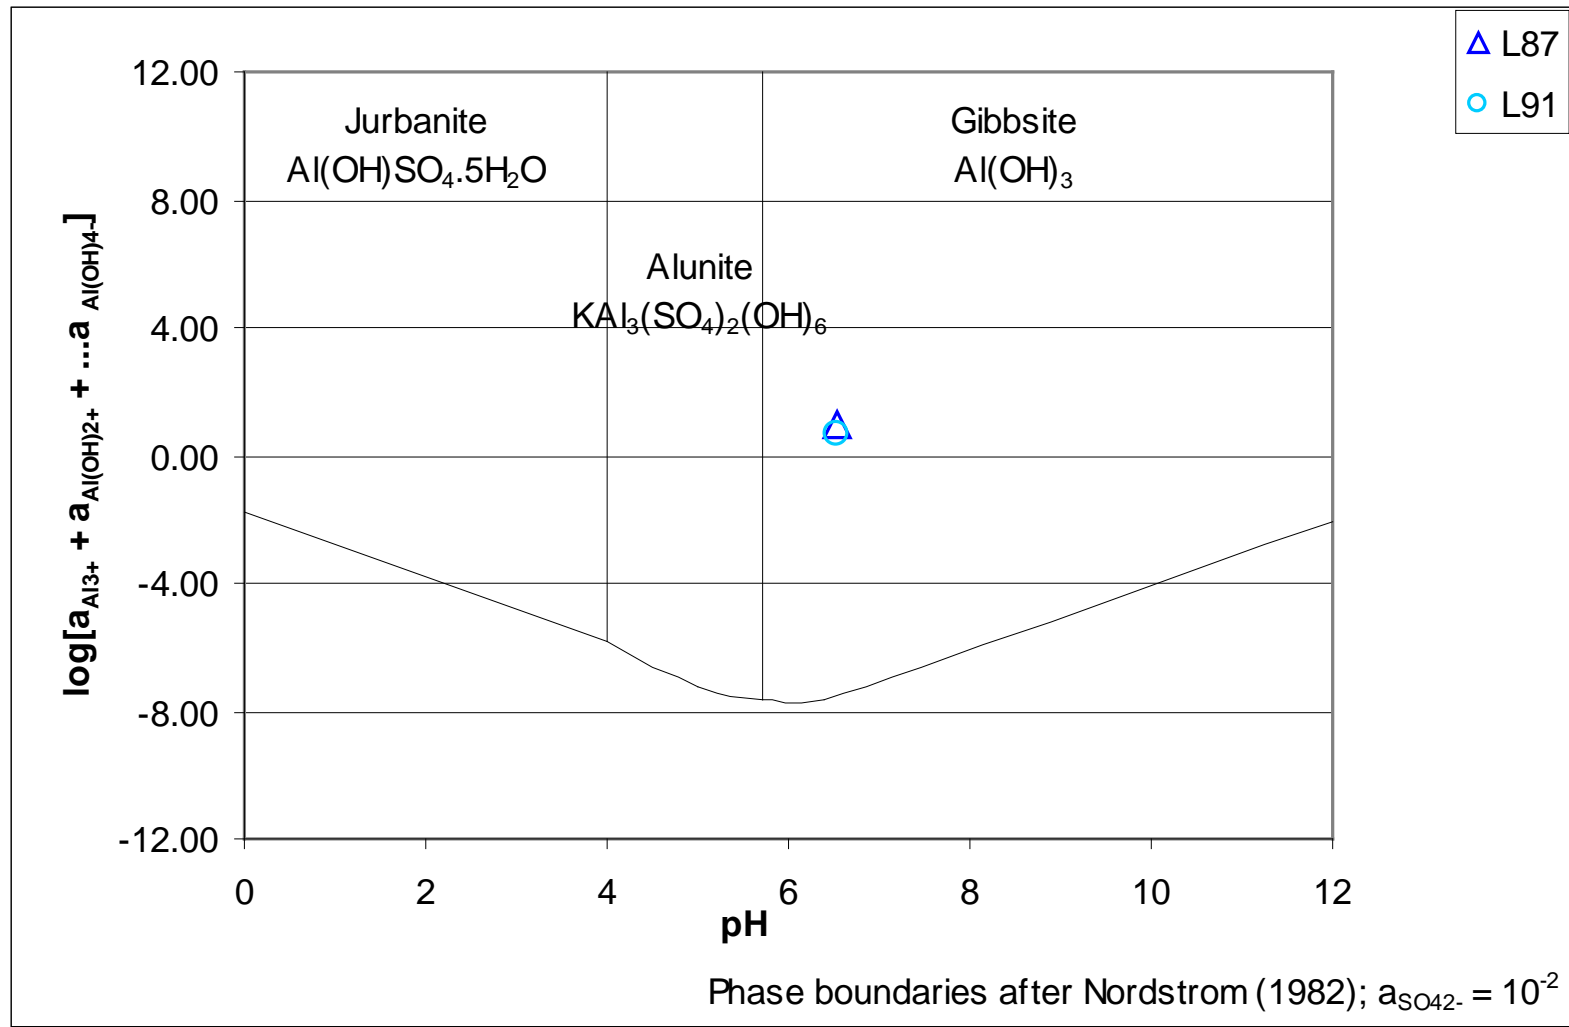
# Trying to define the Al problem

- Pre-treatment prior to LAD is required before Spring 2002
  - Removal of NO<sub>3</sub>, Se & CN
- Applied Biosciences out of Salt Lake were selected
- Technology utilizes reducing bacteria that are relatively temperature tolerant
- Pilot plant studies completed in late 2000
- Full scale plant now commissioned - however...
- Water quality has changed since pilot plant studies
- An aluminum precipitate is now causing problems - must be sorted out before Spring 2002
