Samatosum Division

The Samatosum Tailings Water Cover:
Six Years of Success

Matt Bliss, Brent Hamblin,
Dick Ross, and Craig Ford

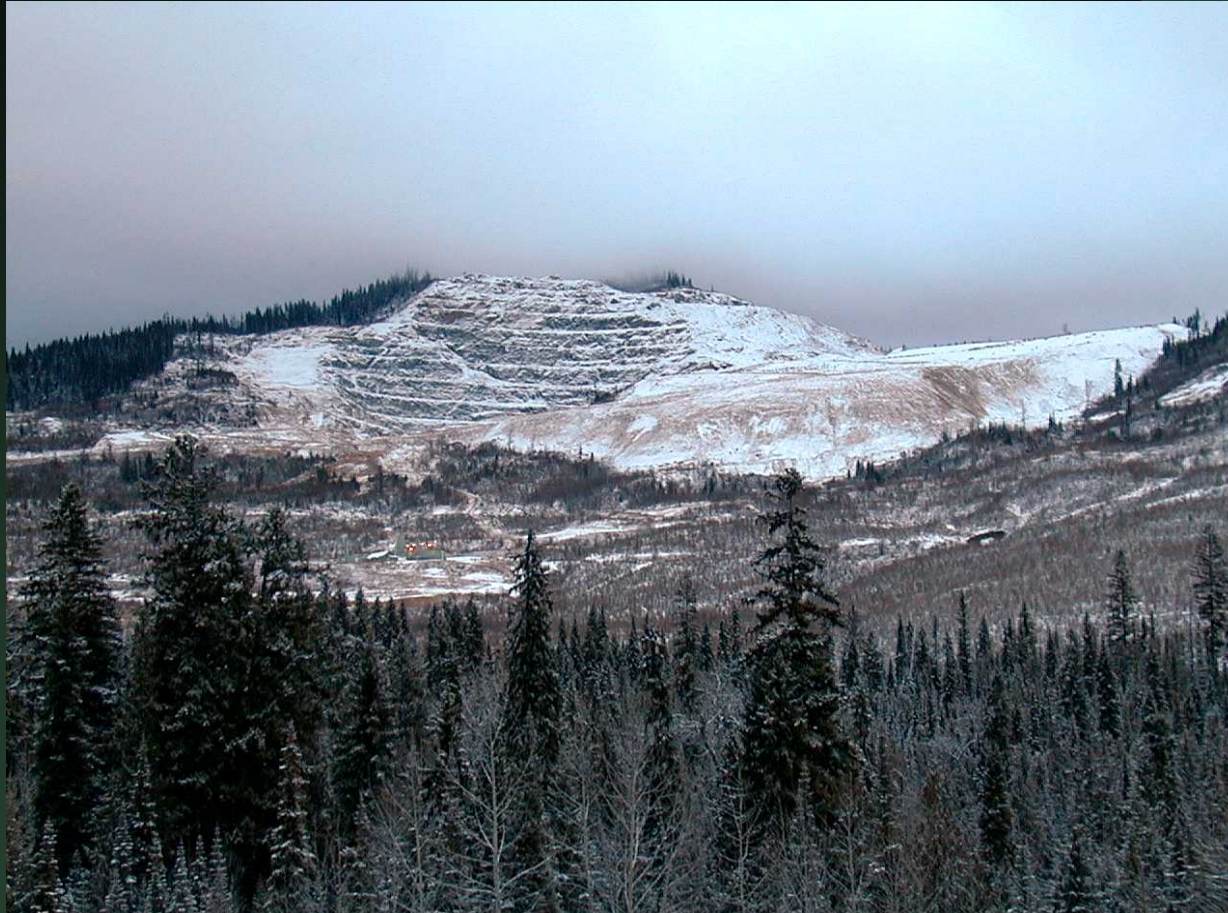
Samatosum Division: Pit, Waste Rock, Plant. Photo looking east

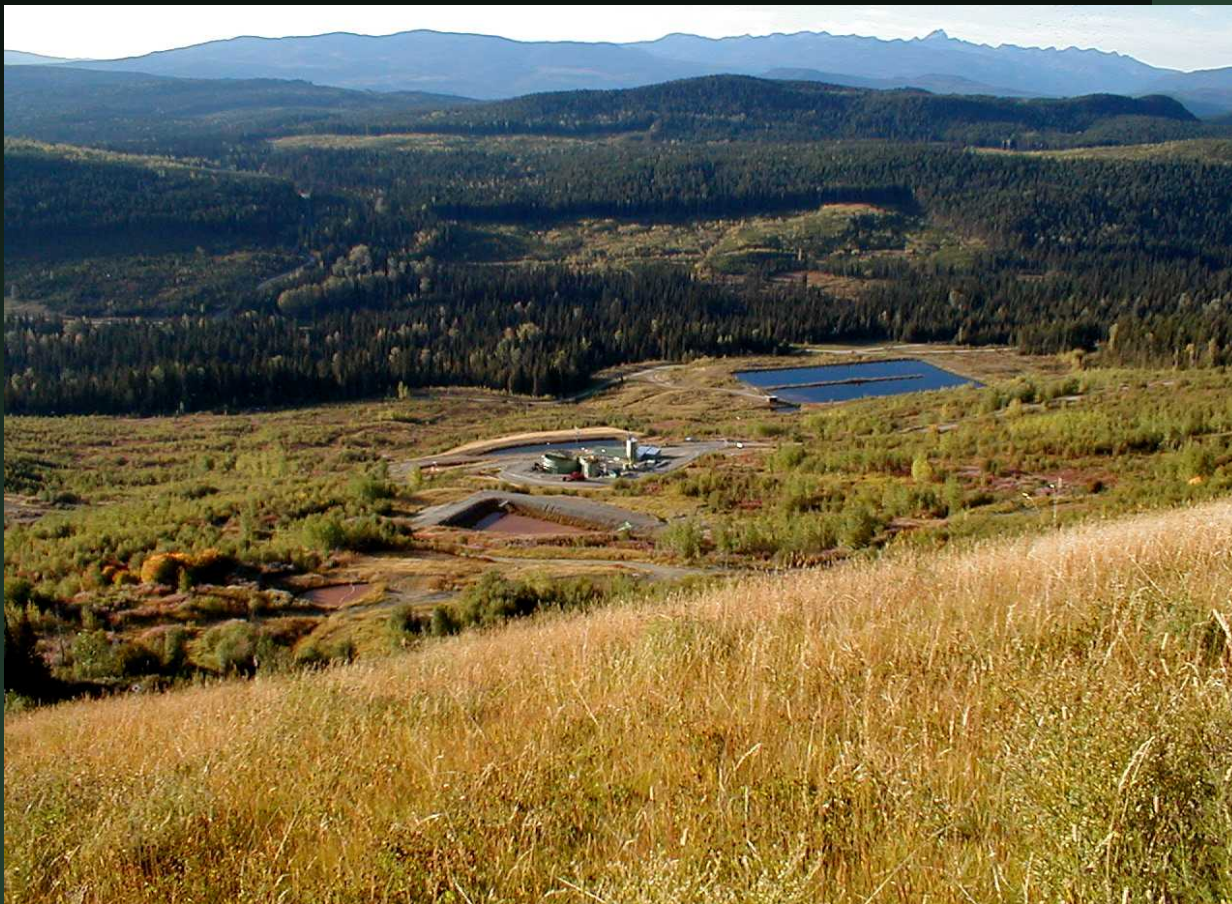
Samatosum Division: Plant, Surge, Sludge and Sed Ponds. Photo looking west.

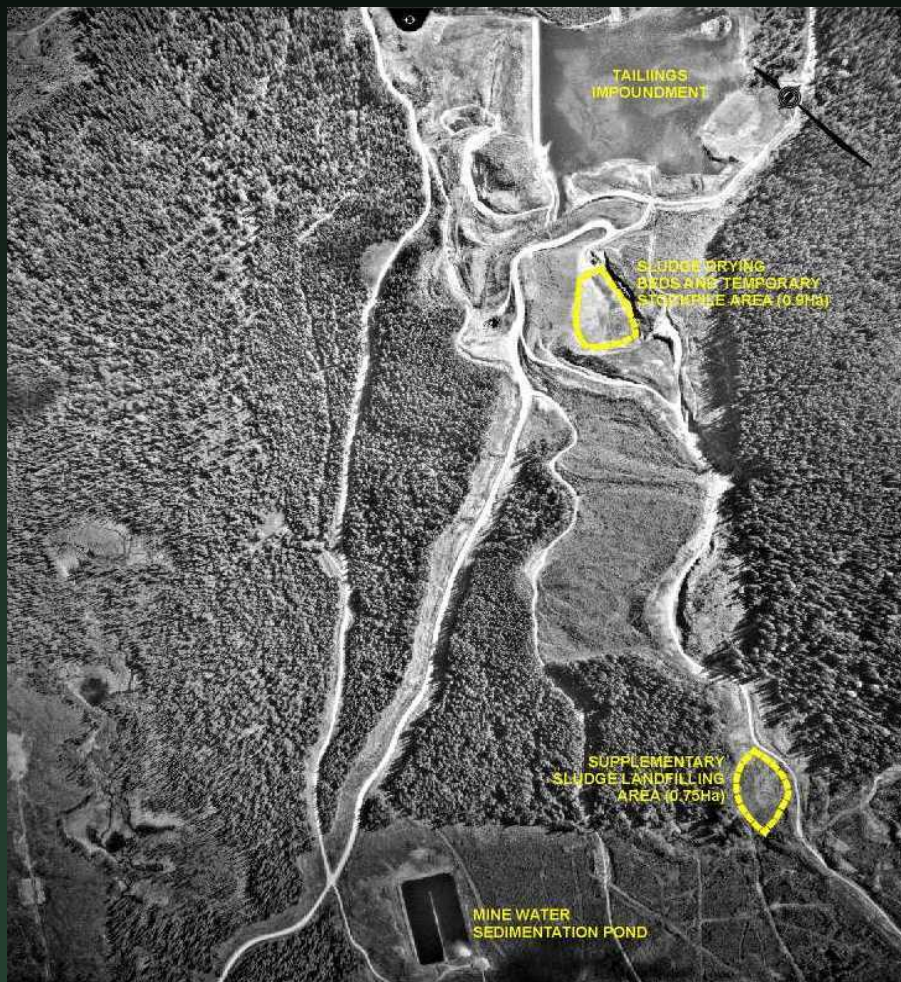
Air Photo of
Sedimentation Pond,
Old Mill Site, Tailings
Pond and Access
Road

~1.5 km x 1.0 km

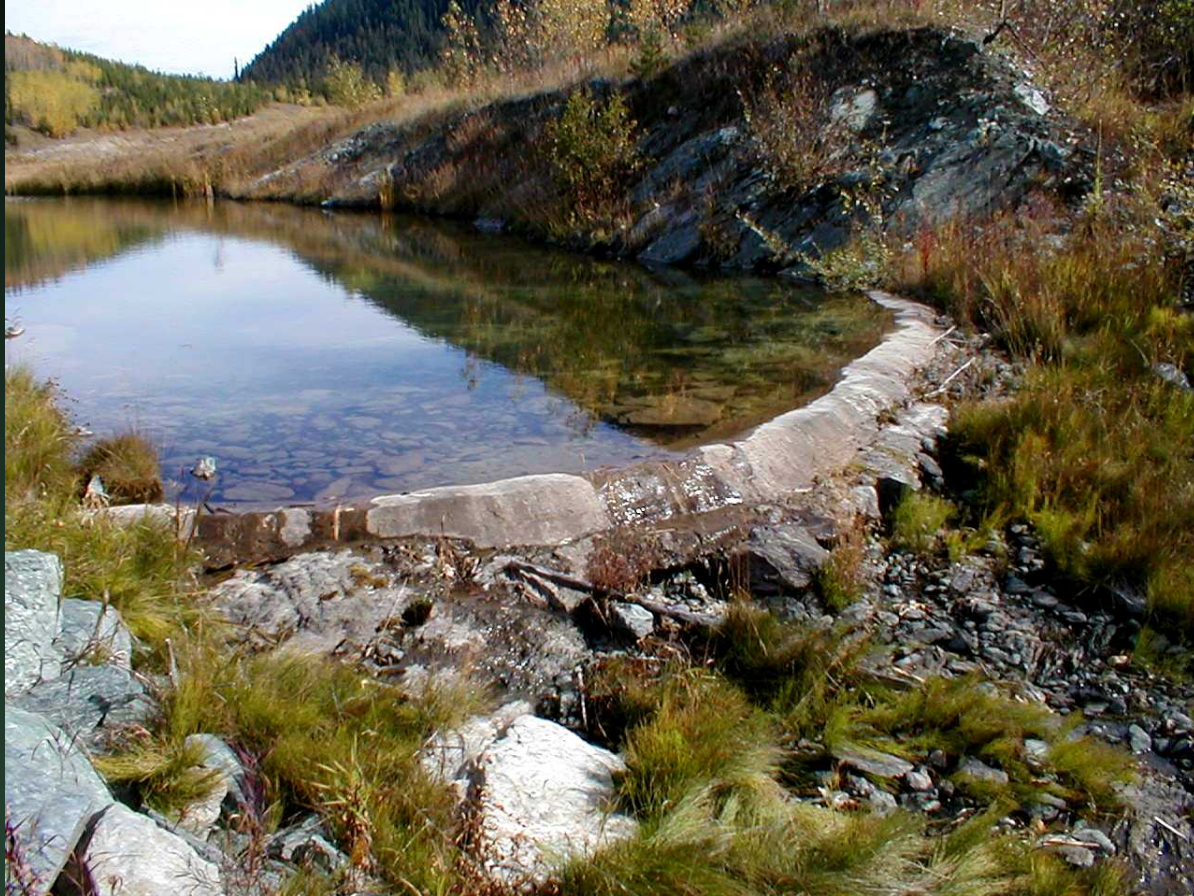
Water Quality - Tailings Pond: Overflow Spillway. Photo looking northeast.

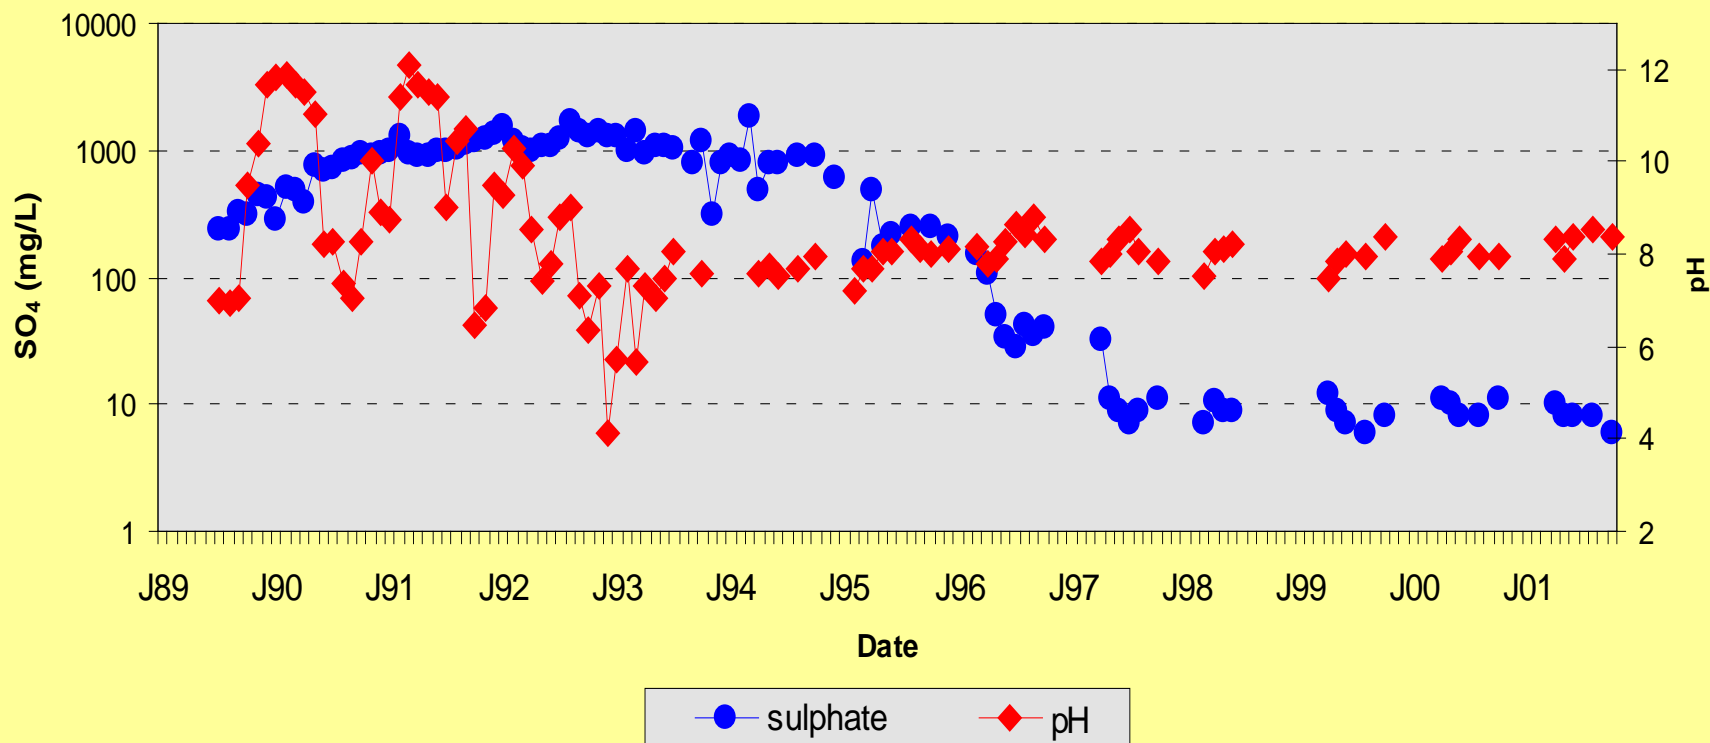
Tailings Pond Surface Water Quality: MOE-10 - Sulphate and pH

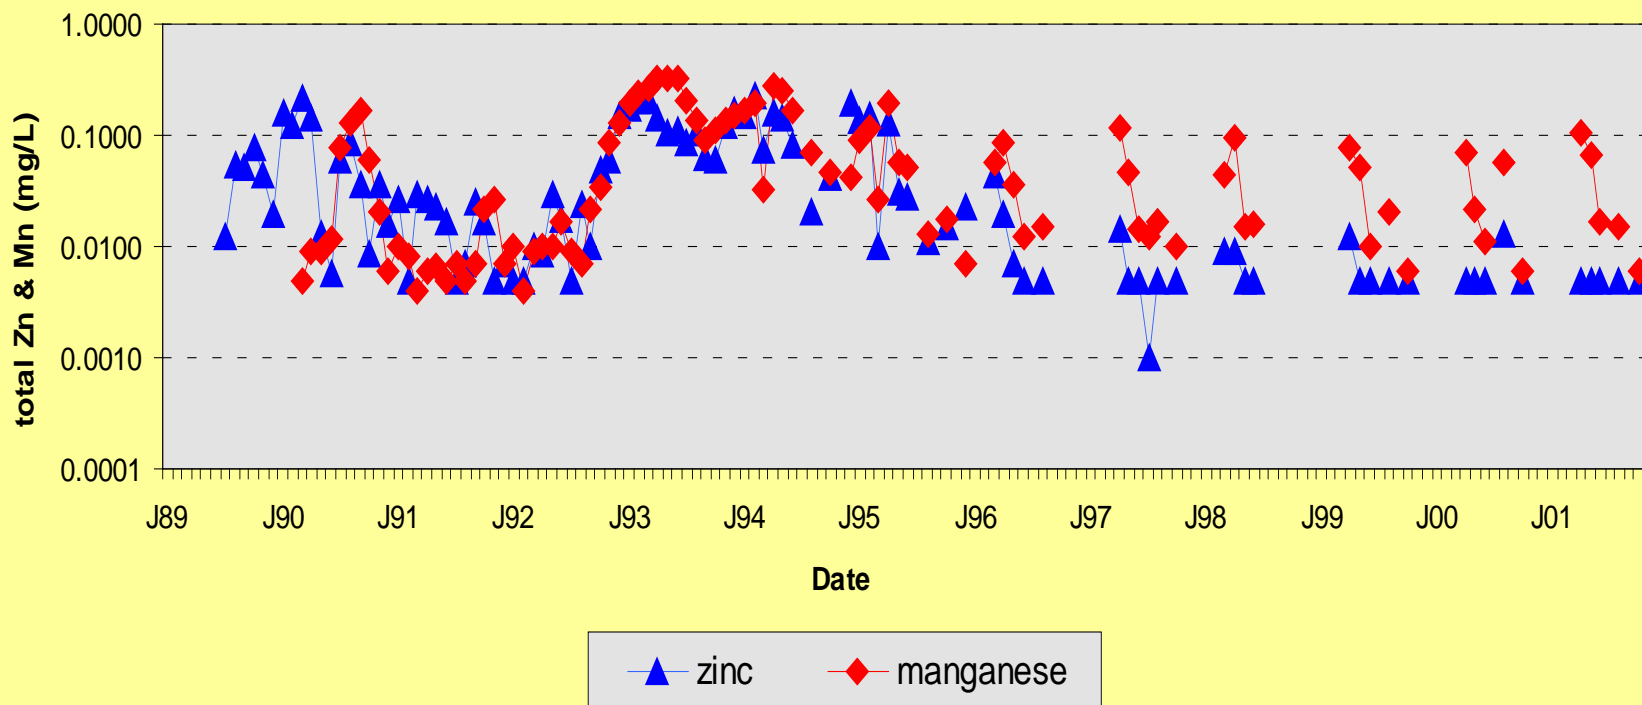
Tailings Pond Surface Water Quality: MOE10 - Zinc and Manganese

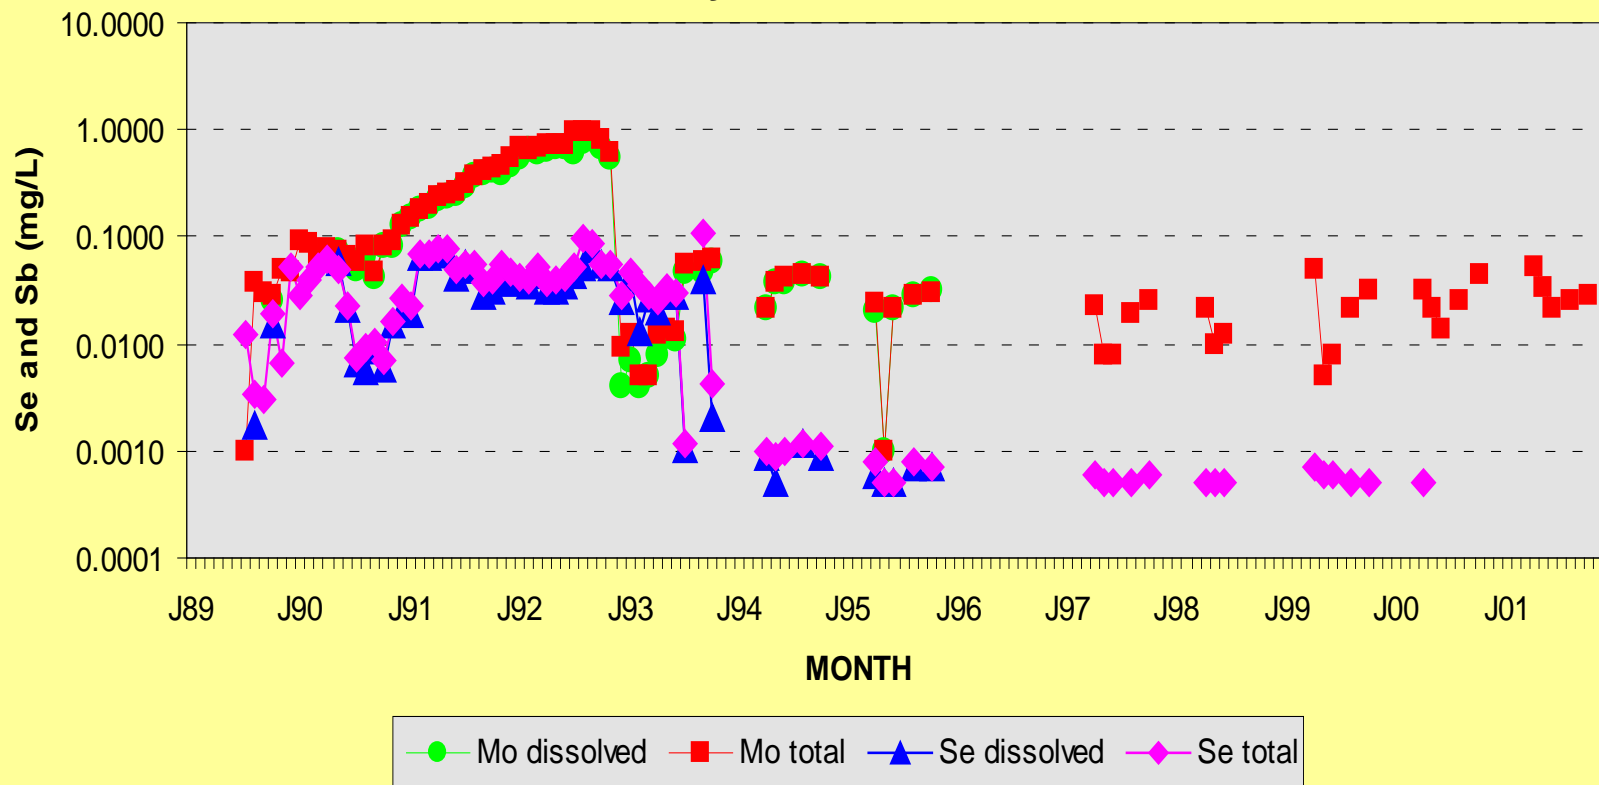
Tailings Pond Water Quality: MOE-10 - Molybdenum and Selenium

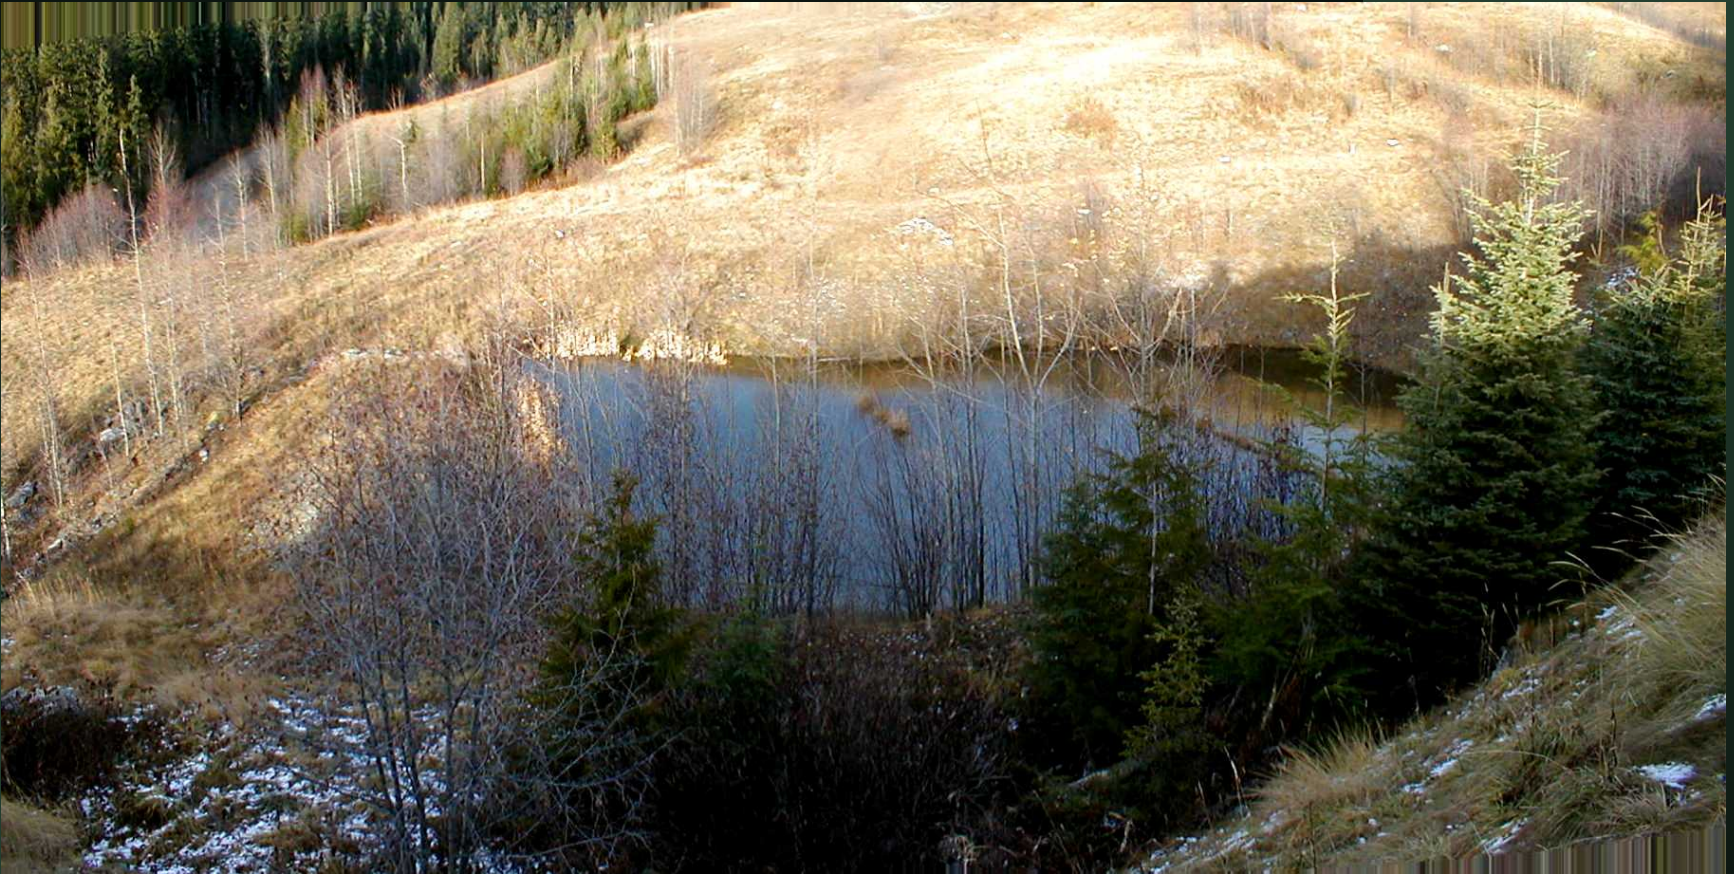
Water Quality - Seepage Pond: Photo looking northwest.

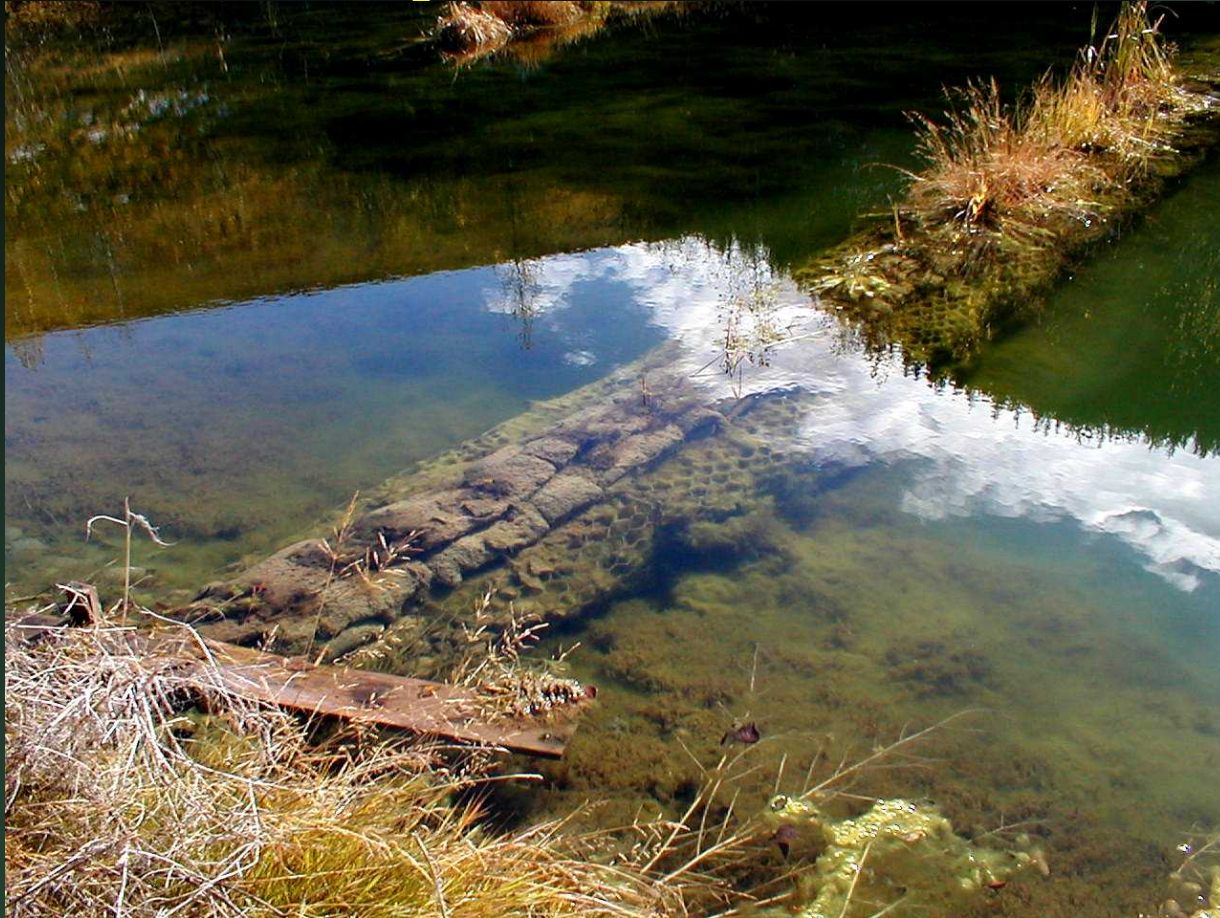
Water Quality - Tailings Seepage Pond: Overflow. Photo looking east.

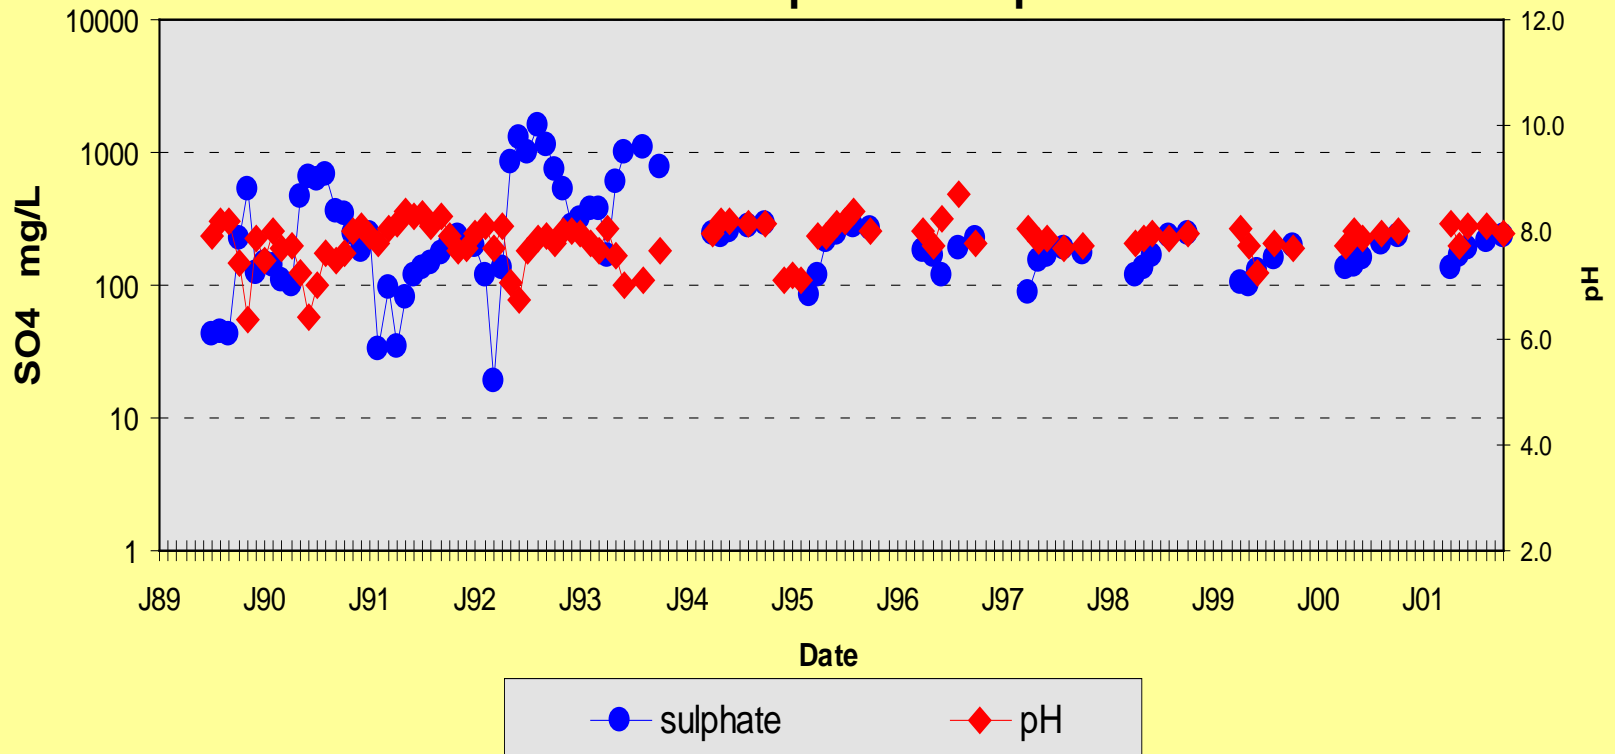
Tailings Seepage Collection Pond Water Quality:
MOE-2 Sulphate and pH

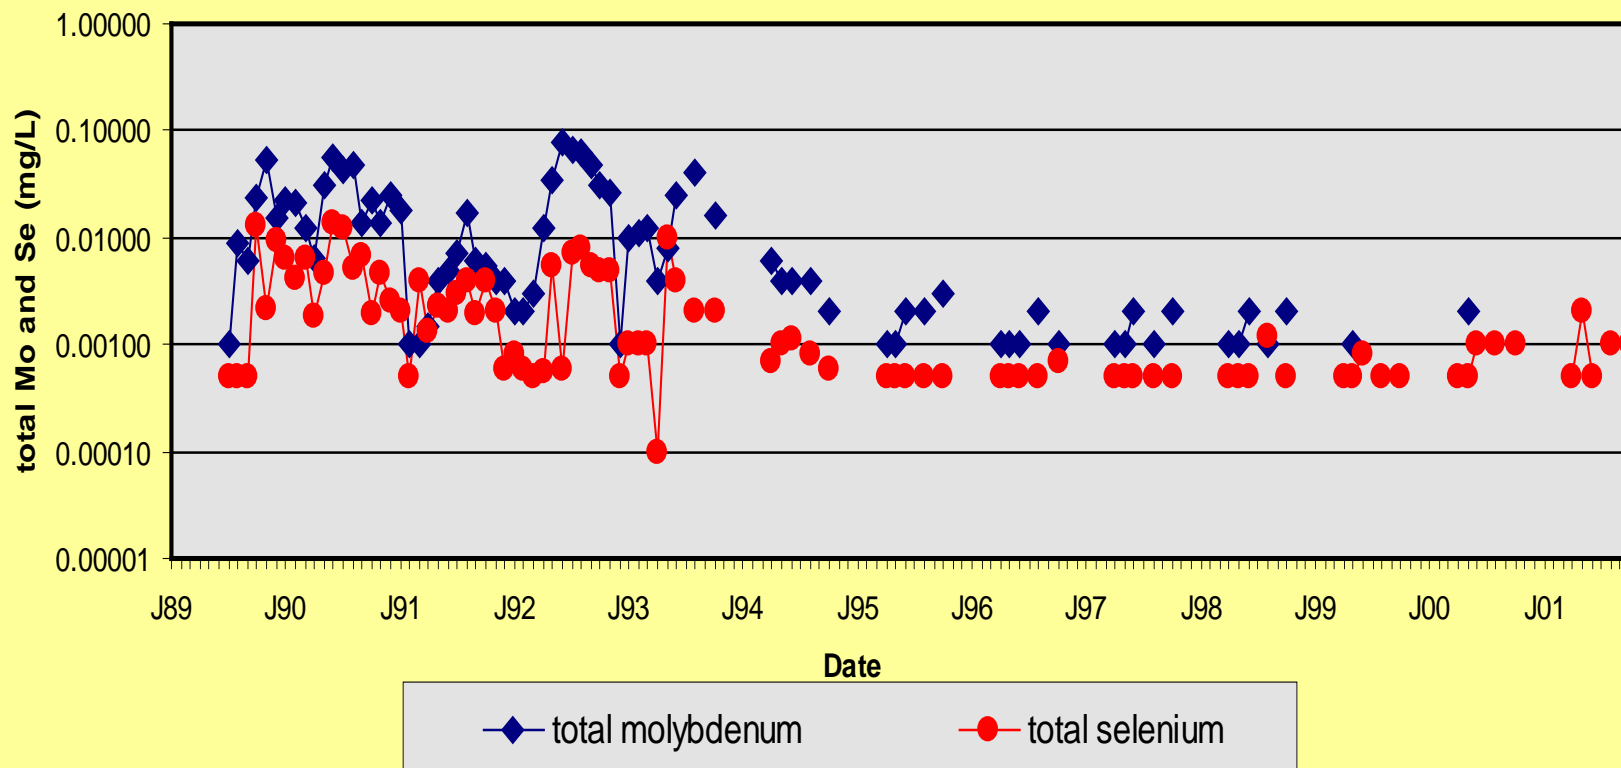
Tailings Seepage Collection Pond Water Quality:
MOE-2 Molybdenum and Selenium
