What Decades of Irregular Monitoring Can Show for Two Mines Sites: Iron Mountain, CA and Questa, NM

*D. Kirk Nordstrom
Boulder, CO*

The Questa Baseline and Pre-Mining Ground-Water Quality Investigation

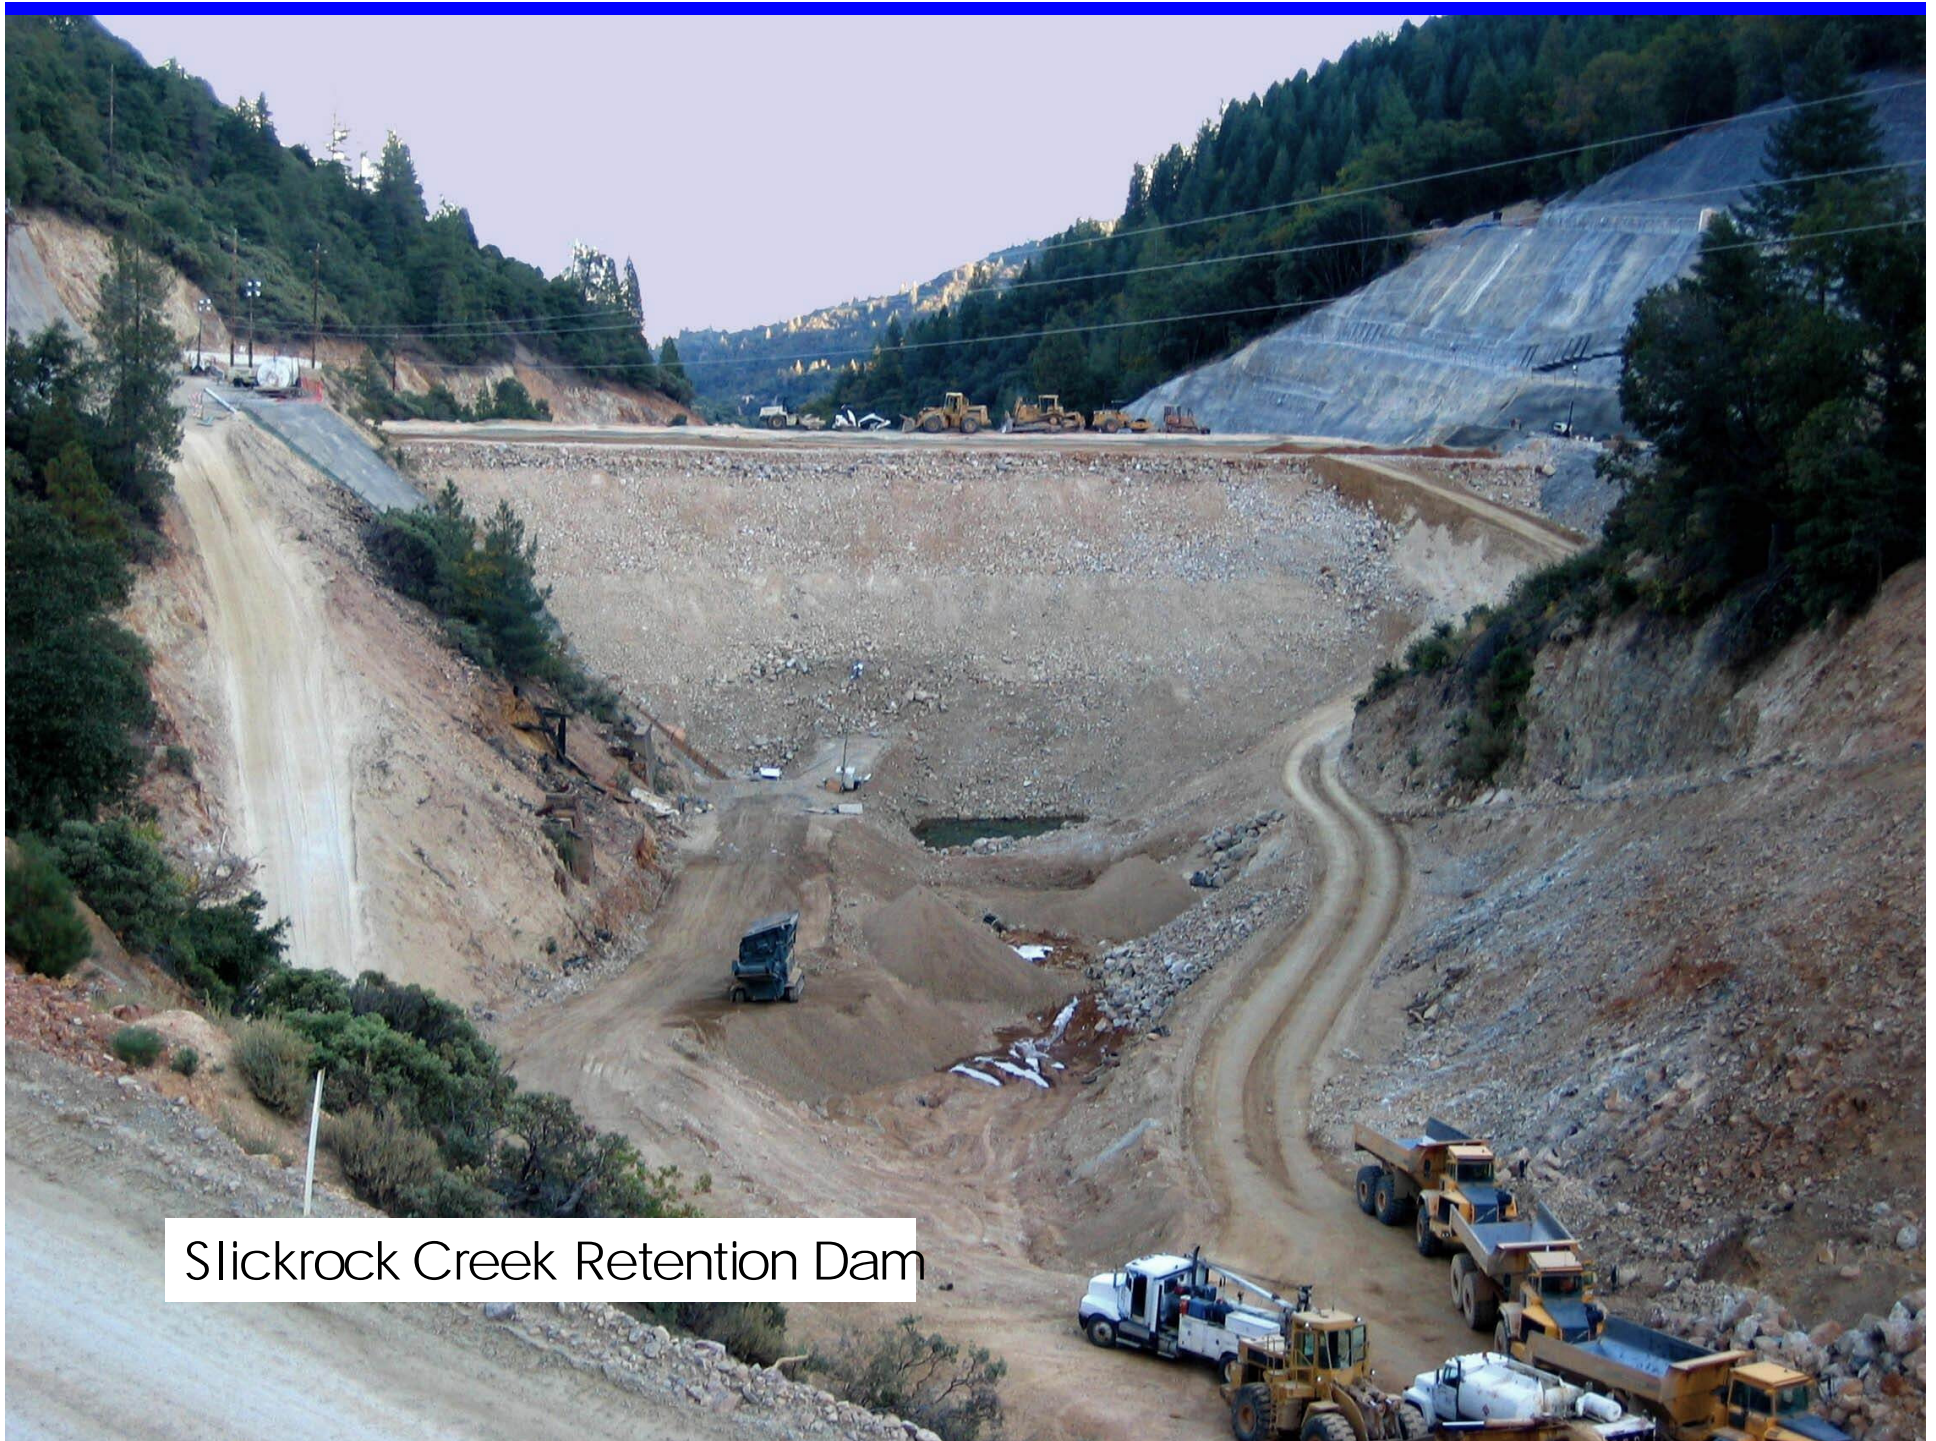
Slickrock Creek Retention Dam

Construction of Slickrock Creek dam to collect last major source of Cu and Zn loads for treatment

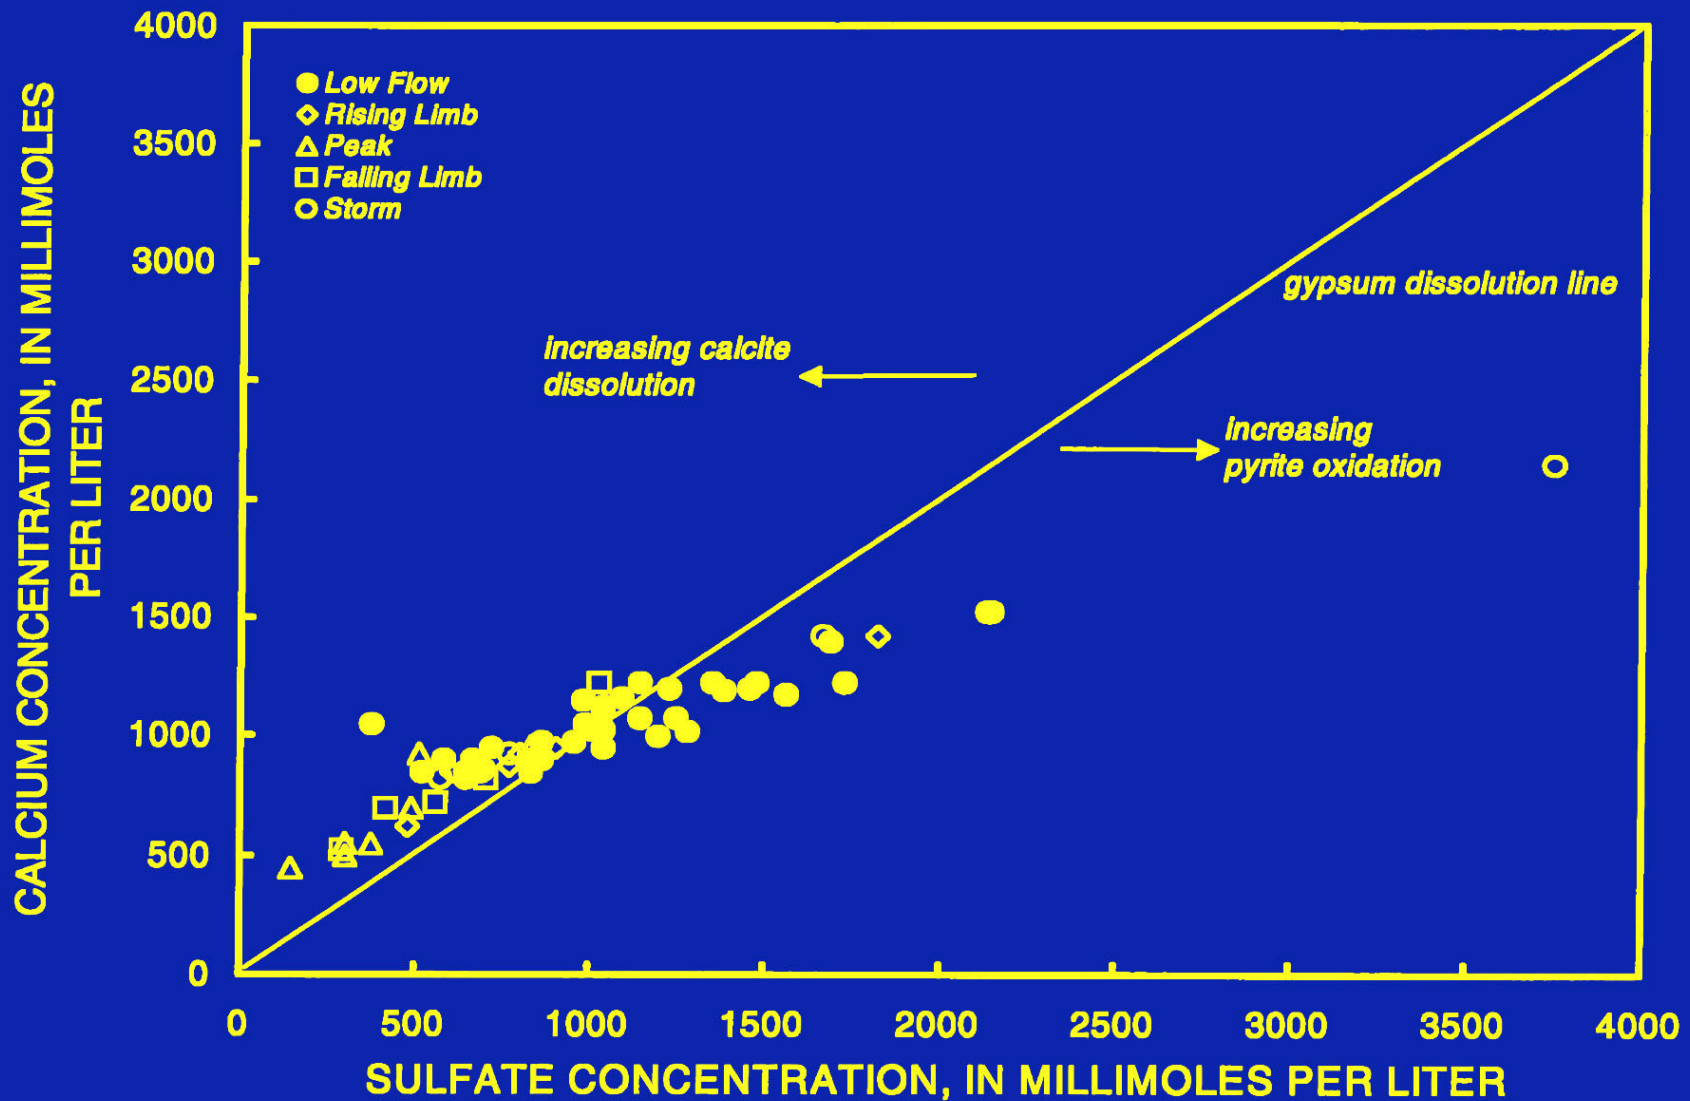
Figure 12. Graph showing calcium concentrations in relation to sulfate concentrations in the Red River at Questa Ranger Station and the gypsum congruent dissolution line.

Gypsum dissolution

calcium up to 600 mg/L

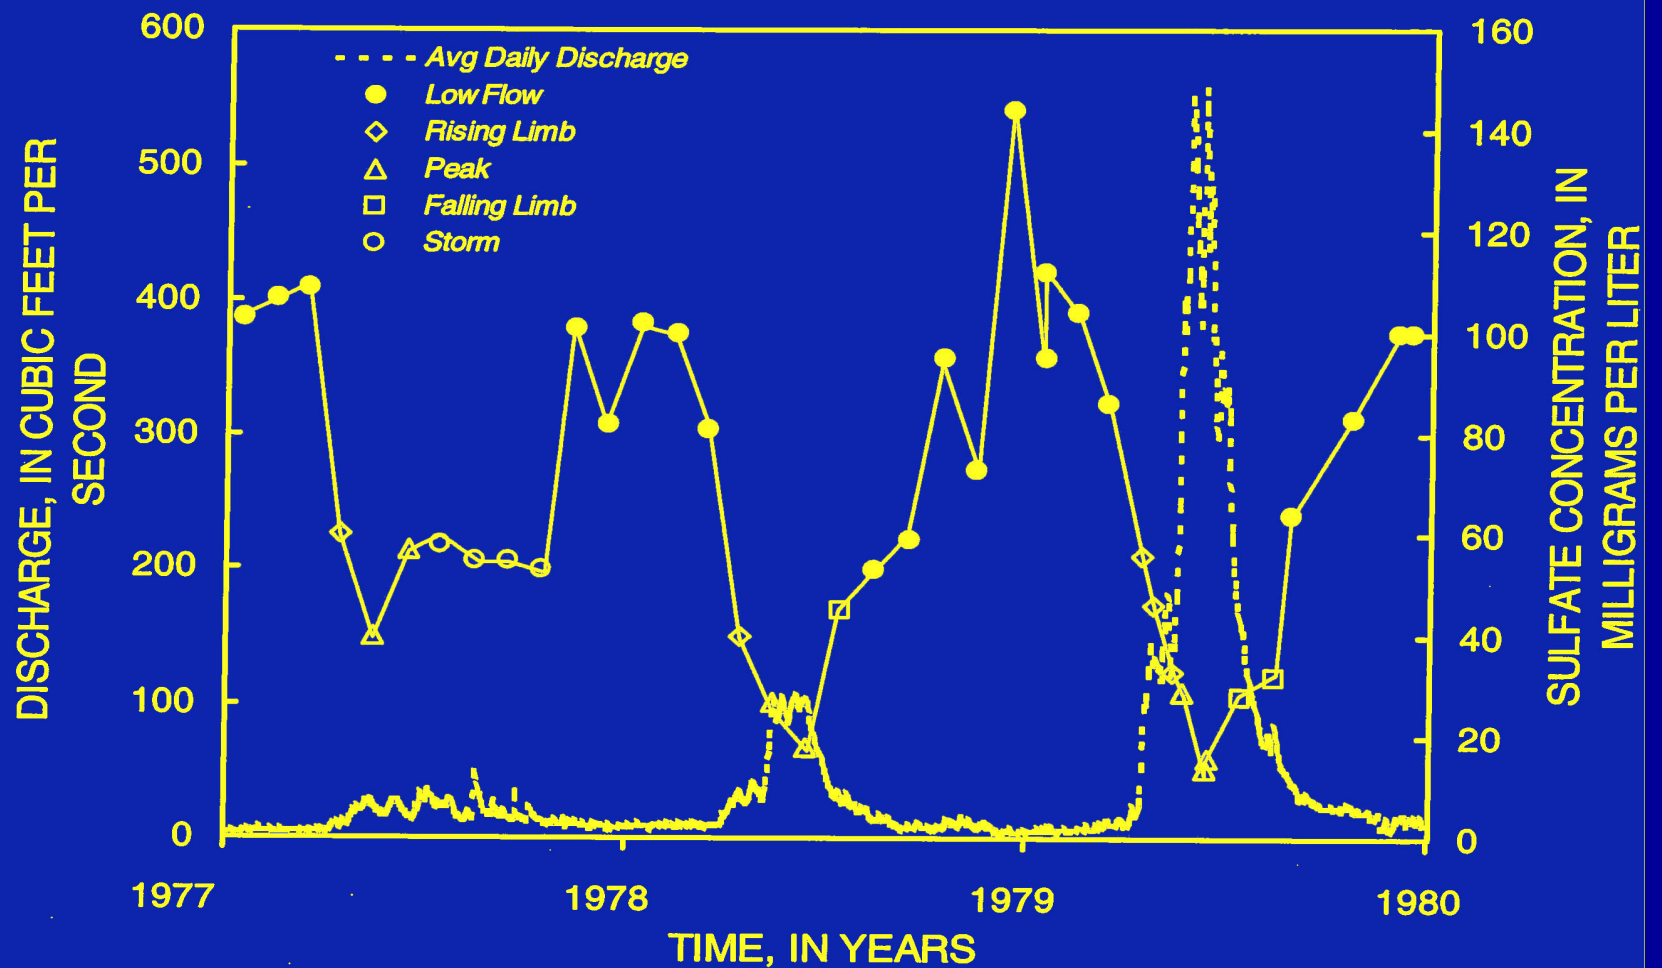
Figure 4. Graph showing sulfate concentrations and average daily discharge in the Red River at the Questa Ranger Station, from January 1977 to December 1979.

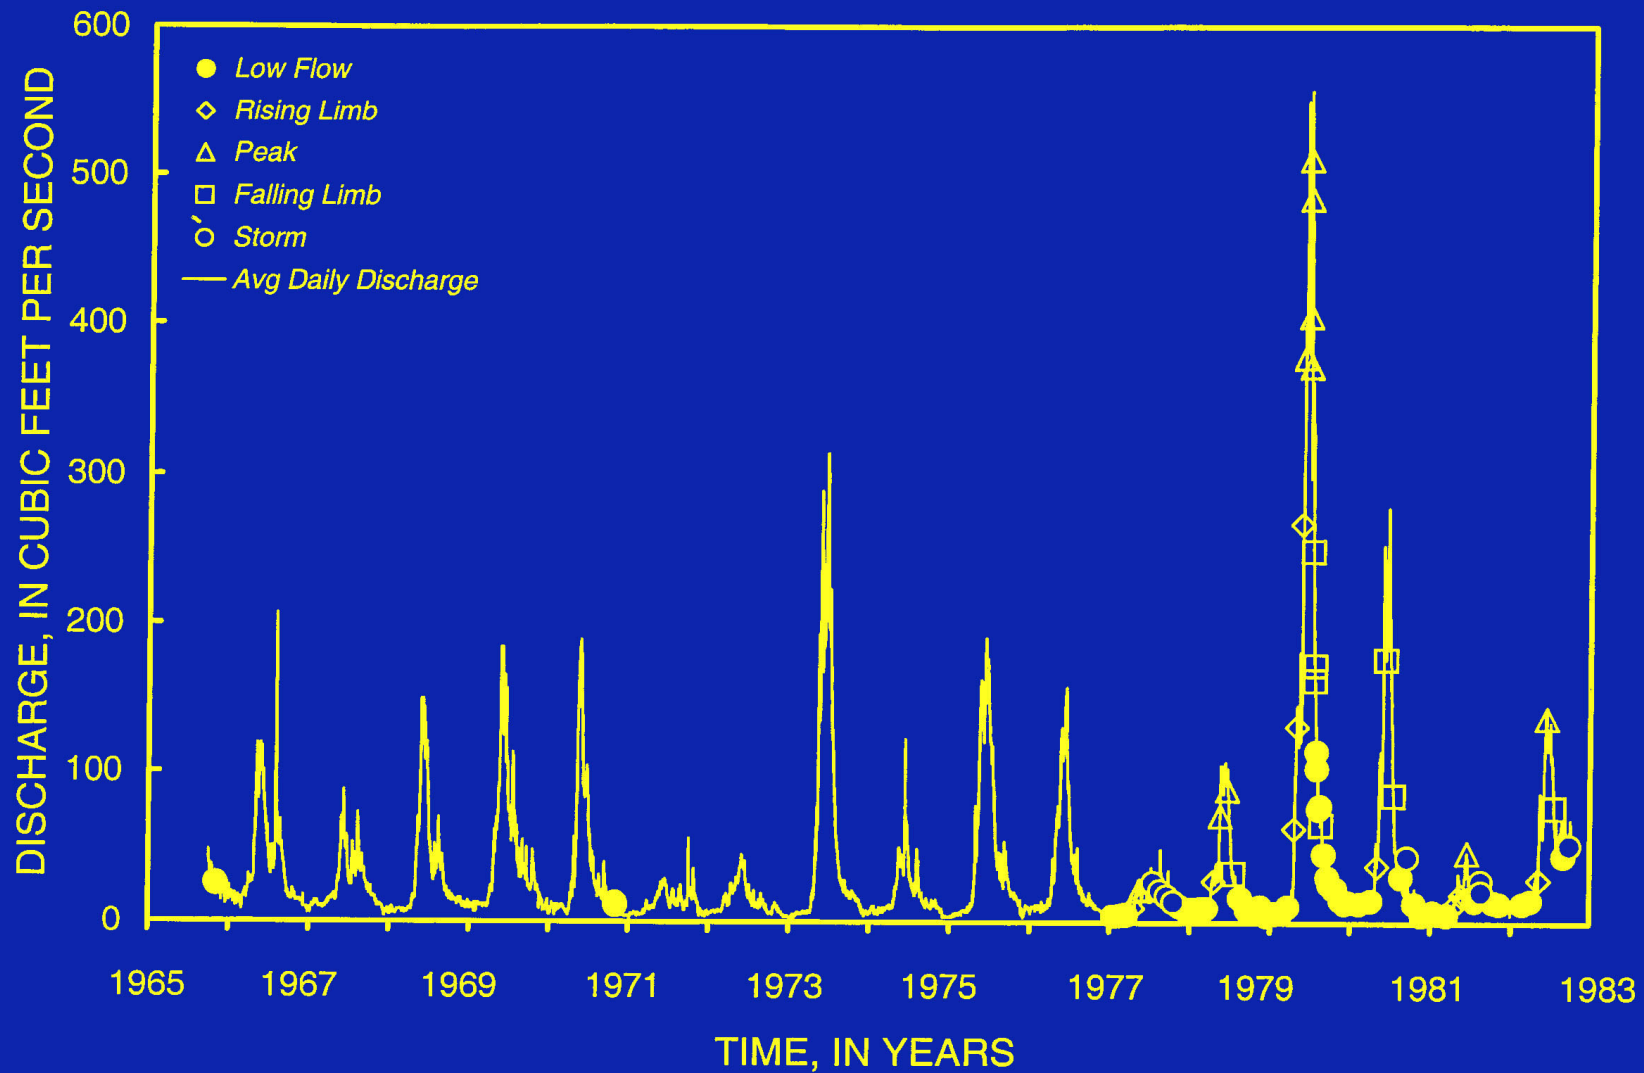
Figure 2. Graph showing average daily discharge and timing of surface water samples collected in the Red River at the Ranger Station in water years 1966 to 1982.

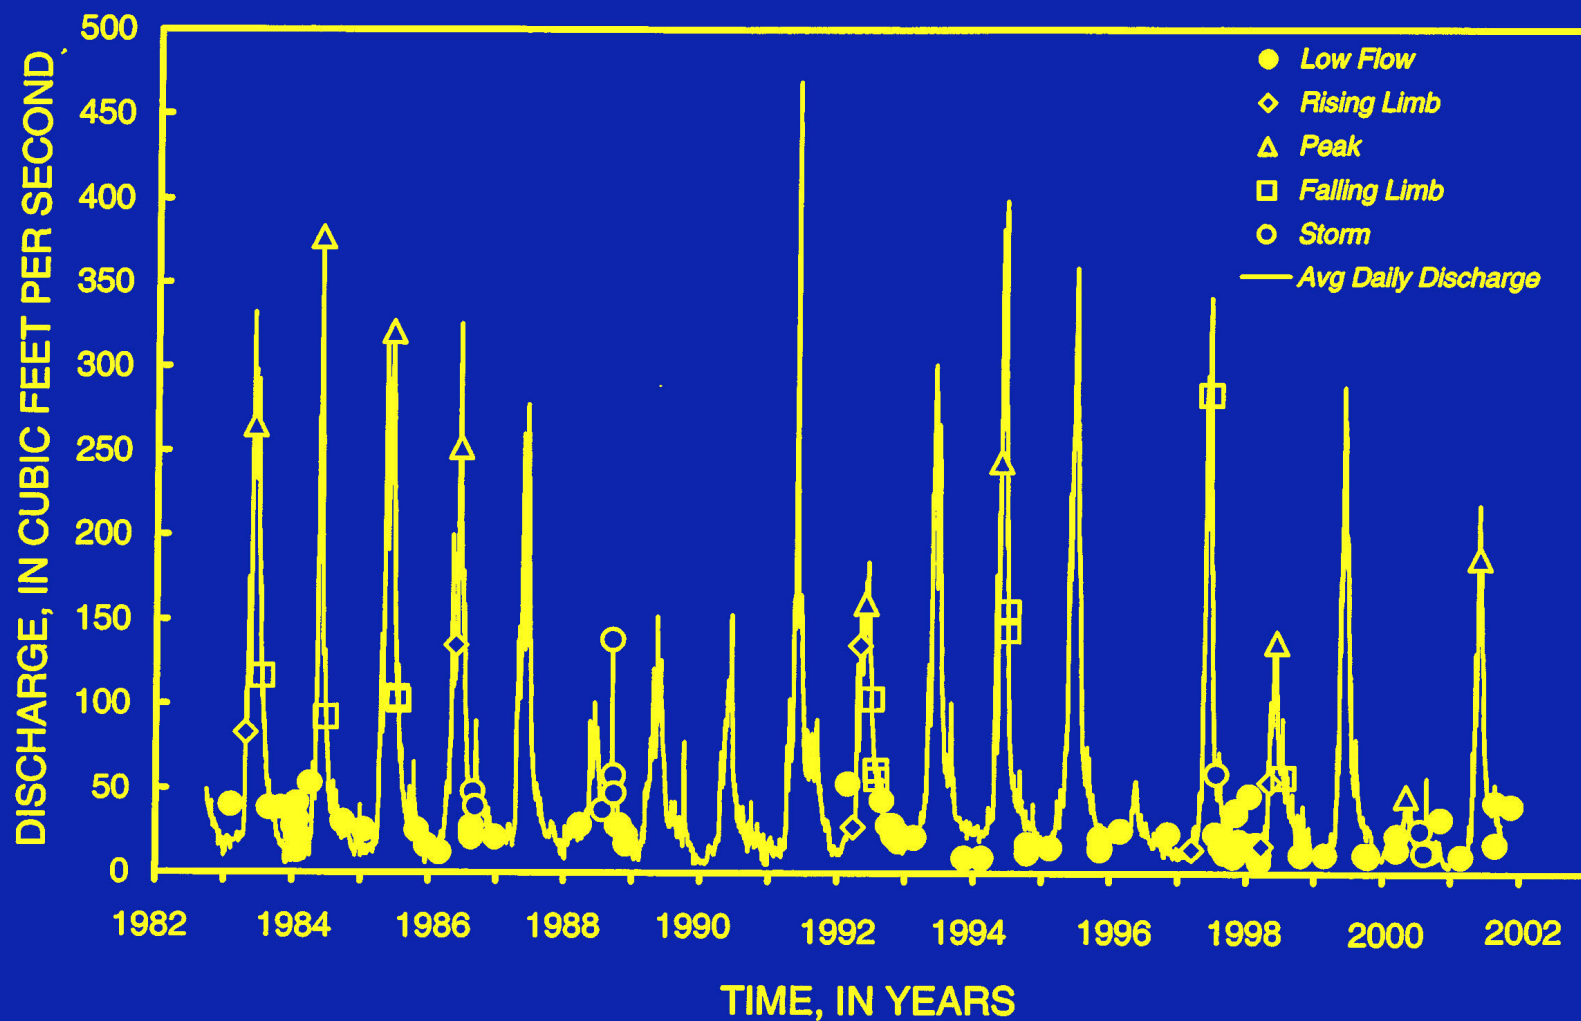
Figure 3. Graph showing average daily discharge and timing of surface water samples collected in the Red River at the Ranger Station in water years 1983 to 2001.

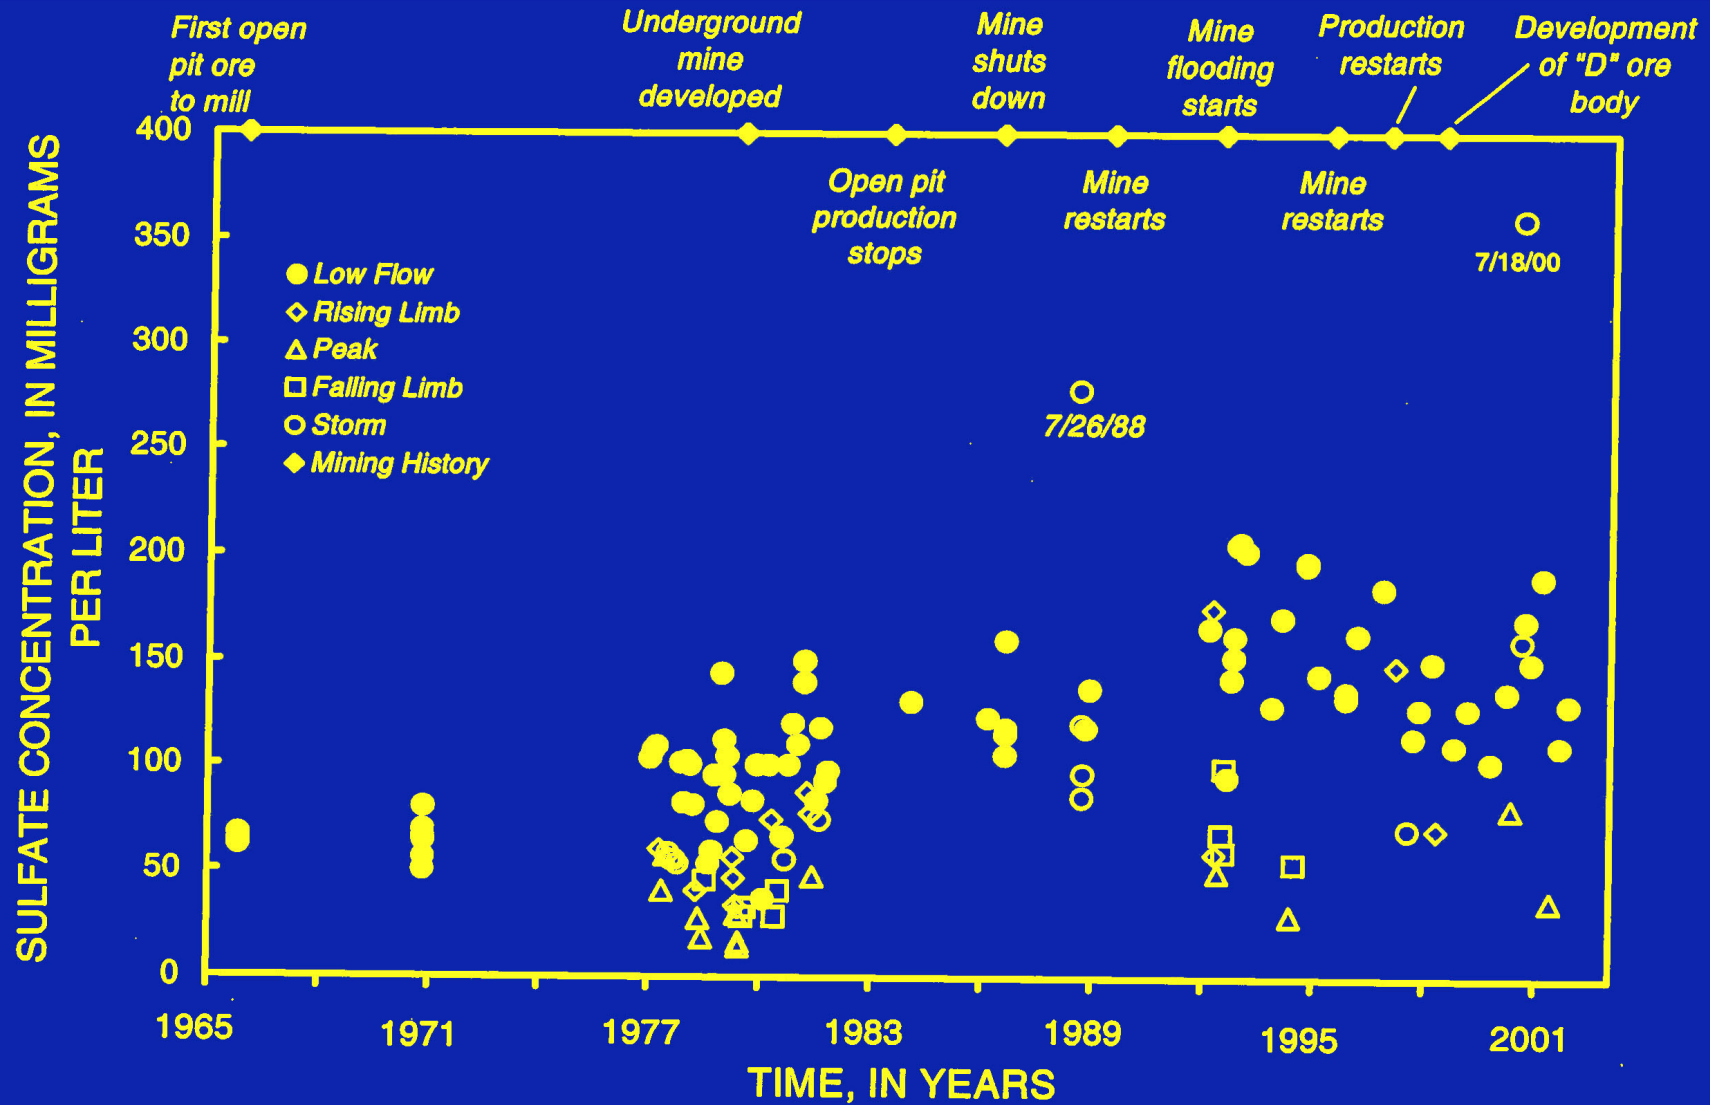
Figure 5. Graph showing sulfate concentrations in the Red River at the Questa Ranger Station from 1966 to 2001, and timing of mining history.
