Permanganate Passivation of Sulfide Rock – Field Trial Results

Presentation at 11th Annual British Columbia ML/ARD
Workshop

Dirk van Zyl, Glenn Miller and Tim Tsukamoto

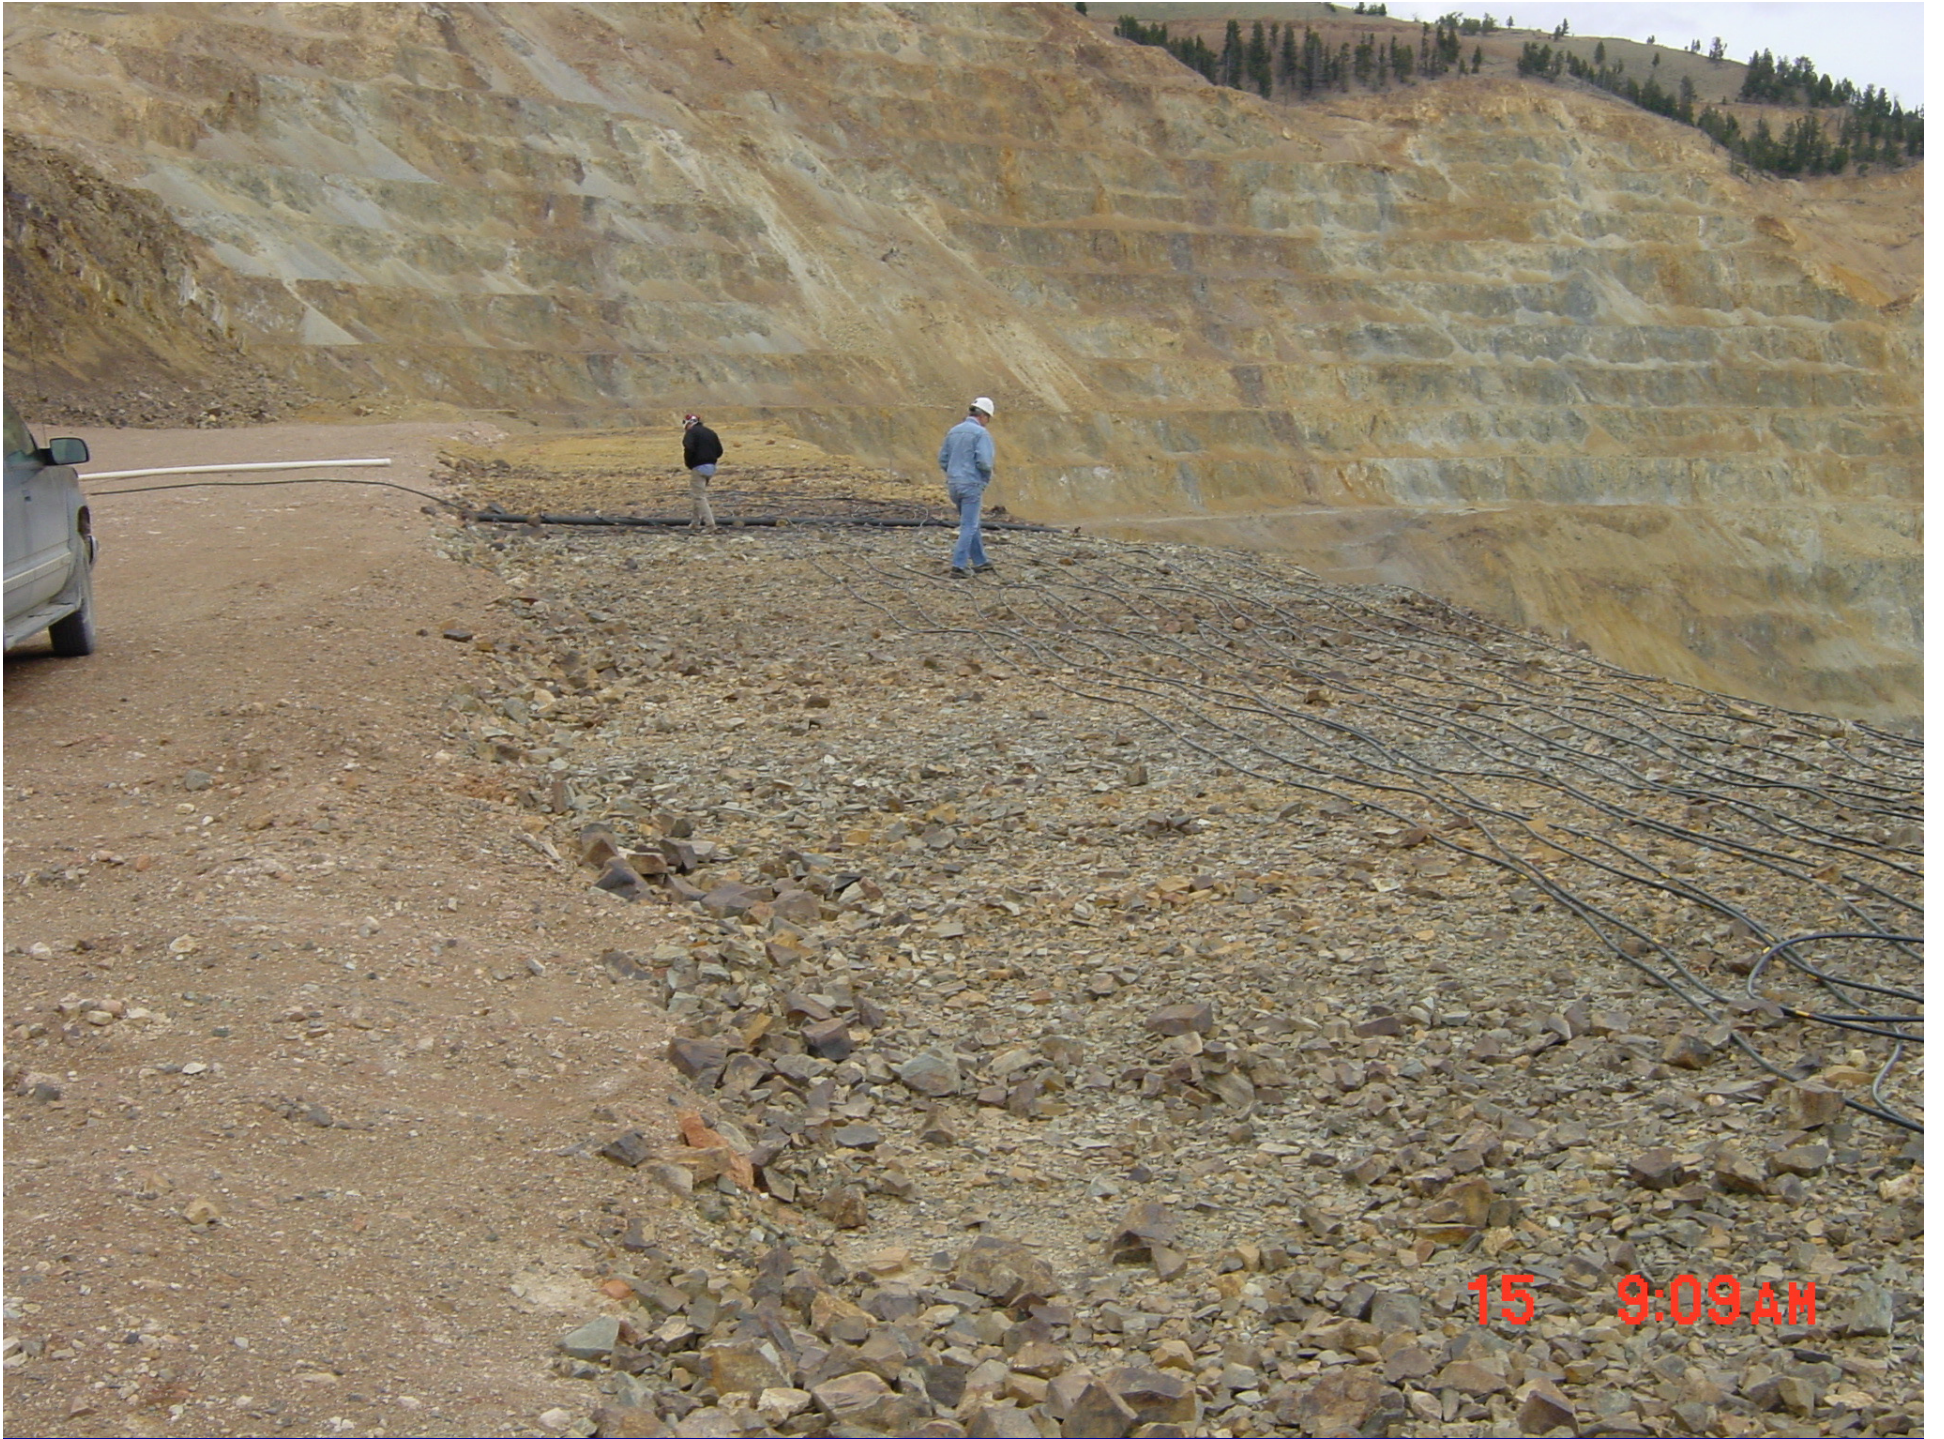
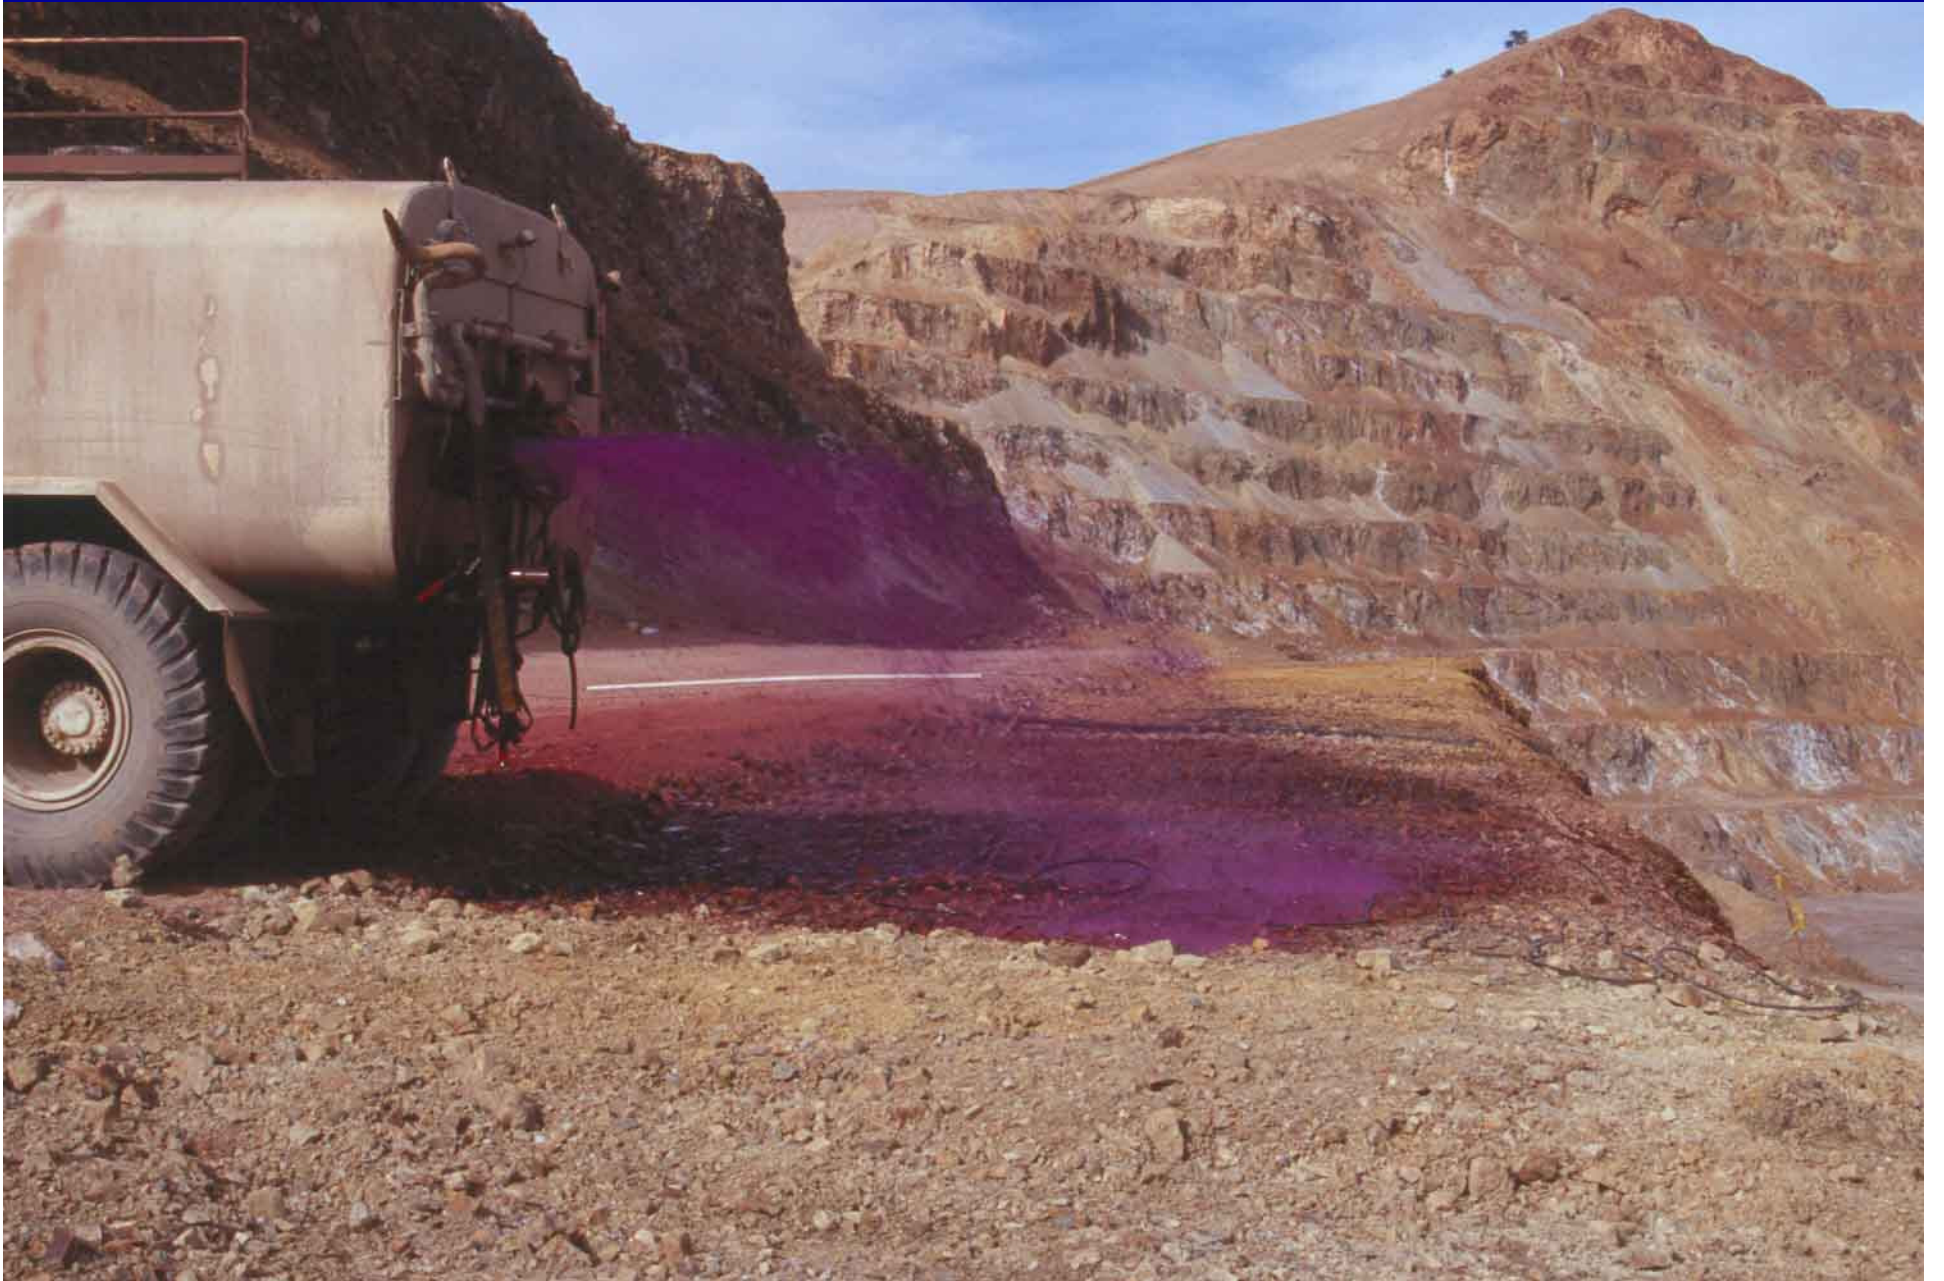
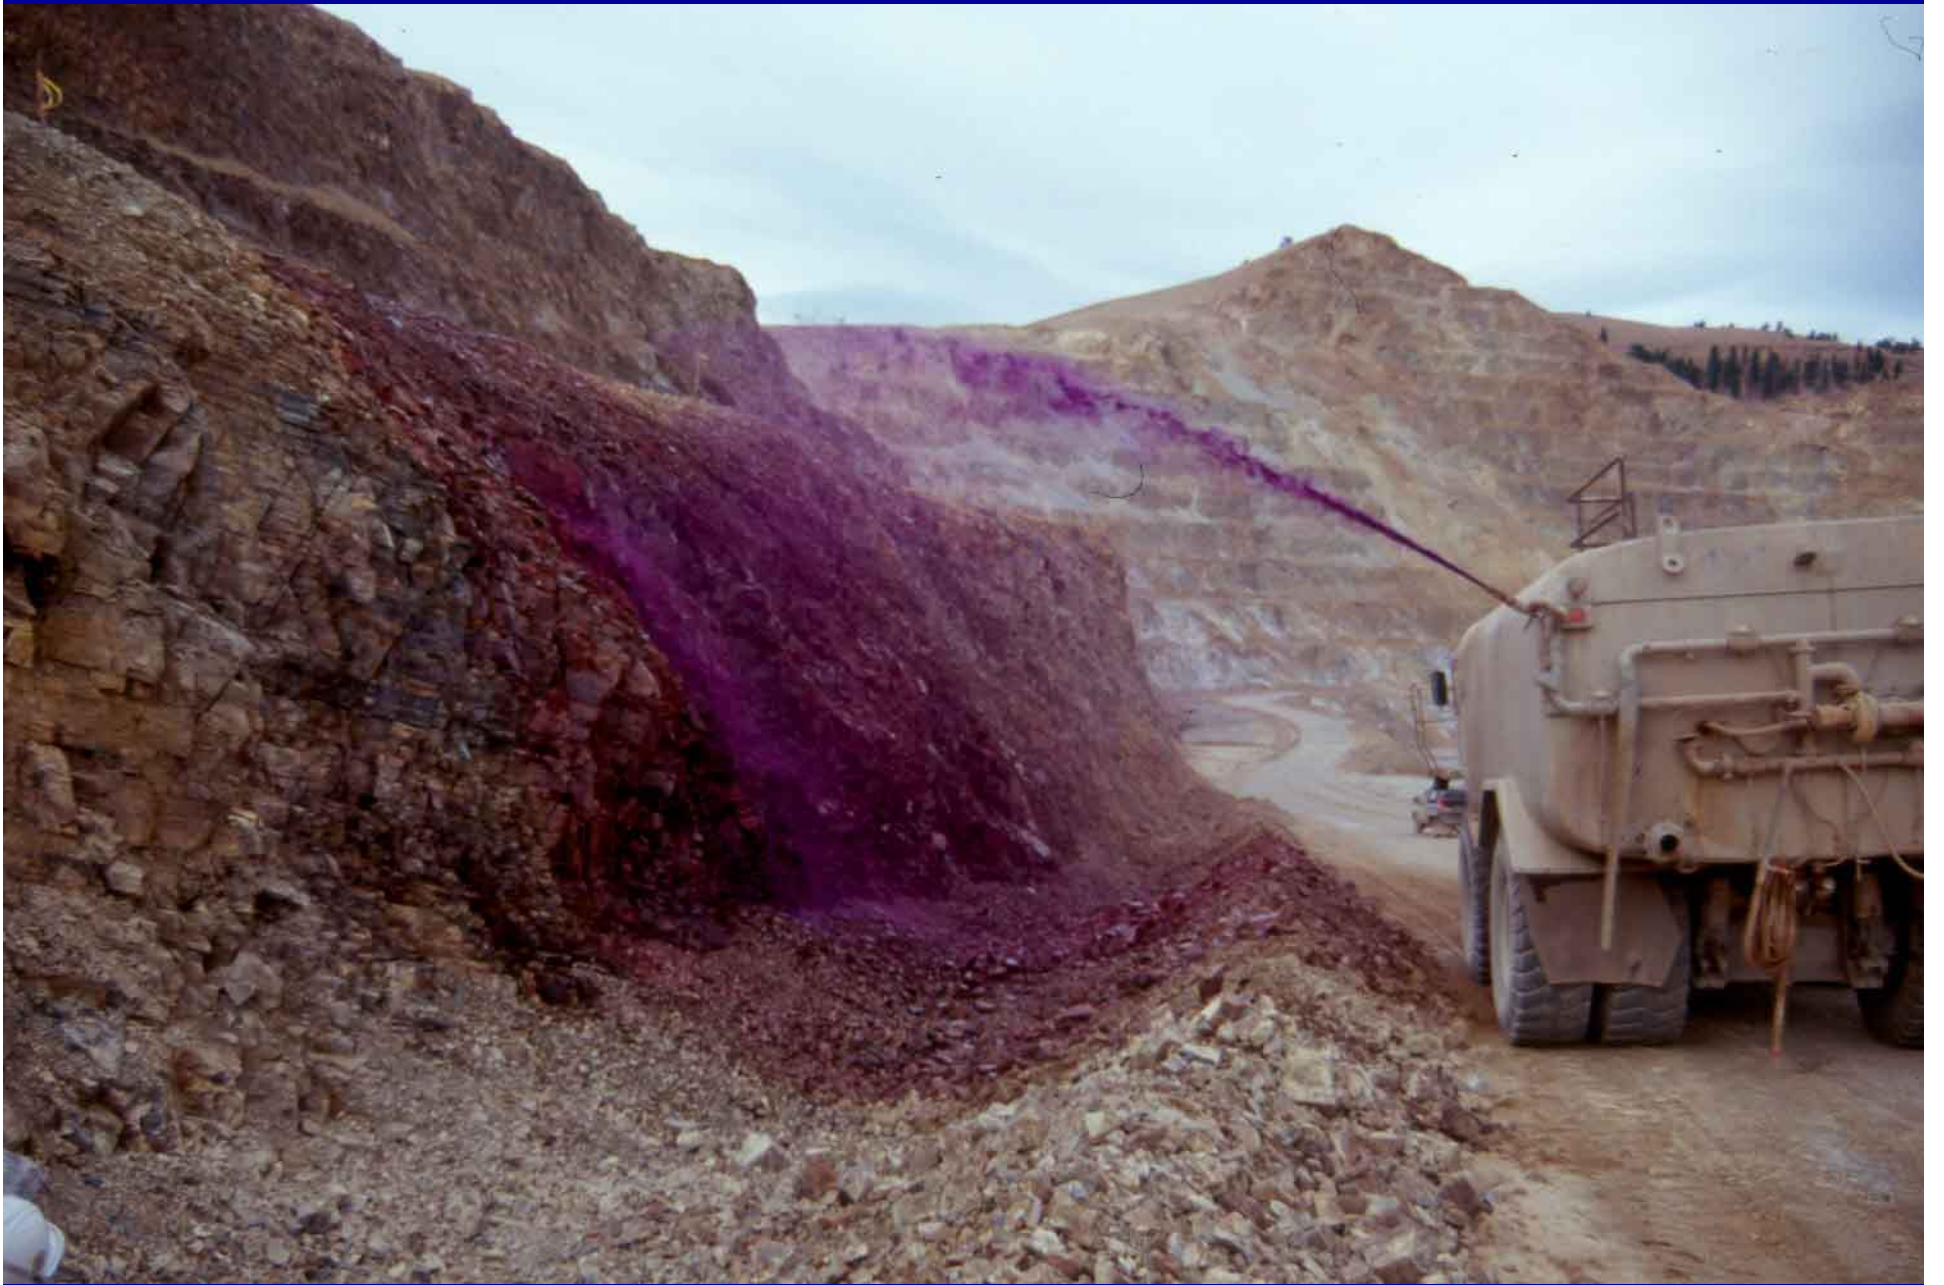
November 2000 (2)

- Approach did not work; solutions flowed downward into fractures and did not exit on face
- Applied solution directly using water truck
- Three sections:
 - No treatment
 - Control – pH and MgO
 - Permanganate

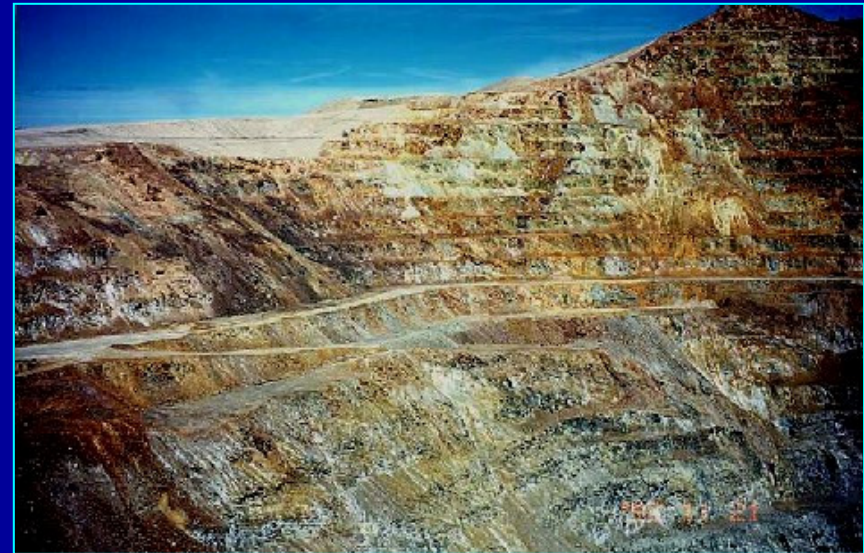
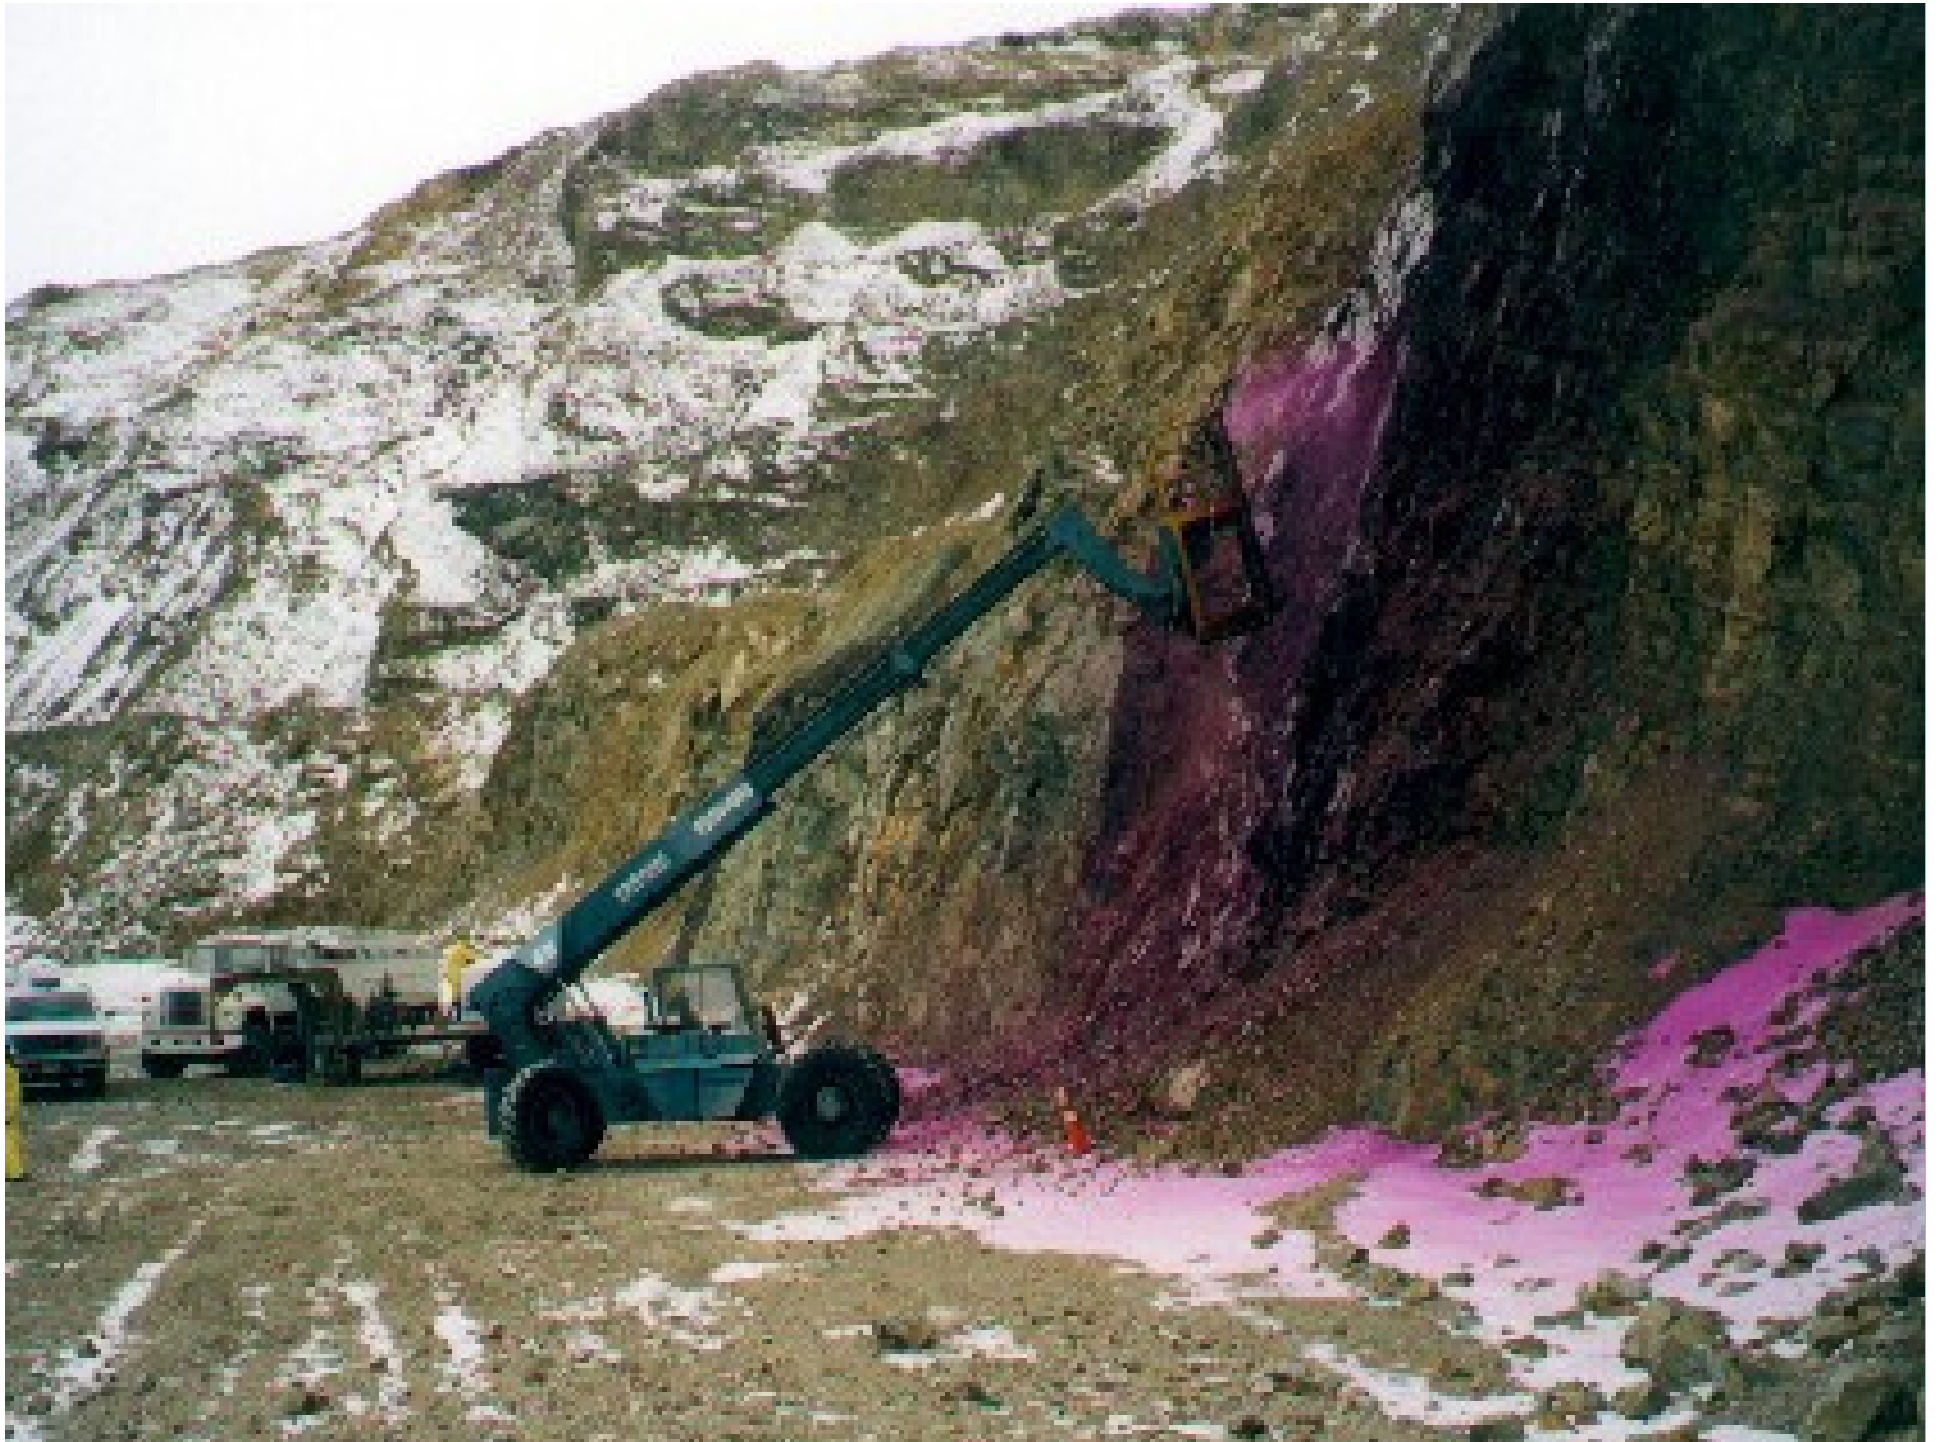
MSE Trials

- Series of tests to compare different treatments:
 - Ecobond™ of MT²
 - Furfuryl alcohol resin sealant (FARS)
 - MgO technology UNR
 - Permanganate passivation
- Technologies applied October to December 2001

*Ref: McCloskey, L., et al (2003)
Evaluation of Technologies to
Prevent Acid Mine Drainage
Generation from Open Pit
Highwalls, 6th ICARD, pp 541 –
547.*

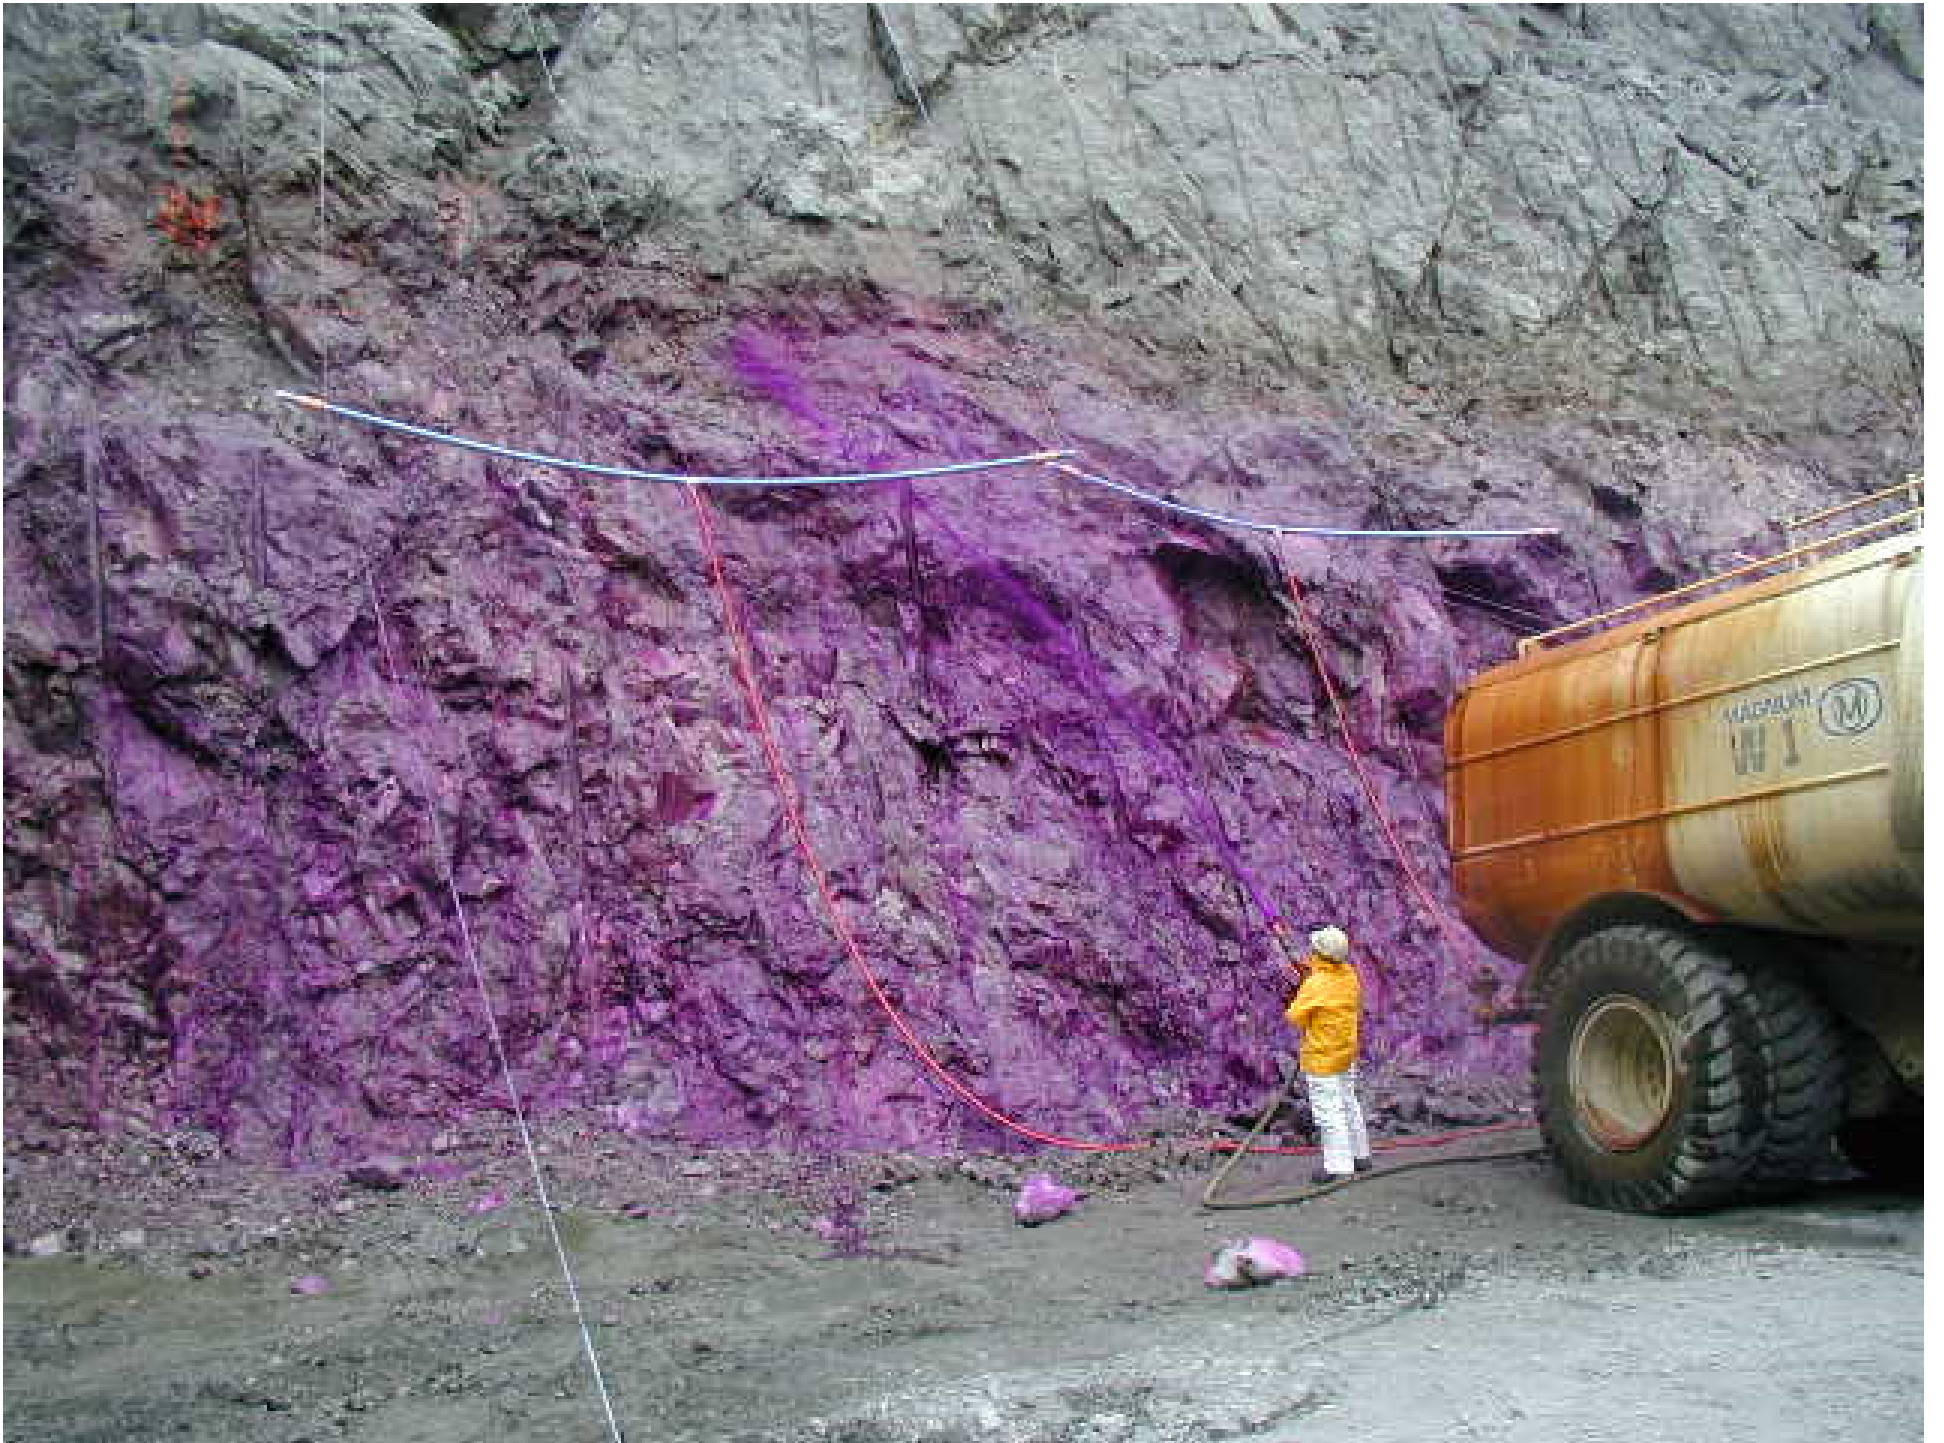
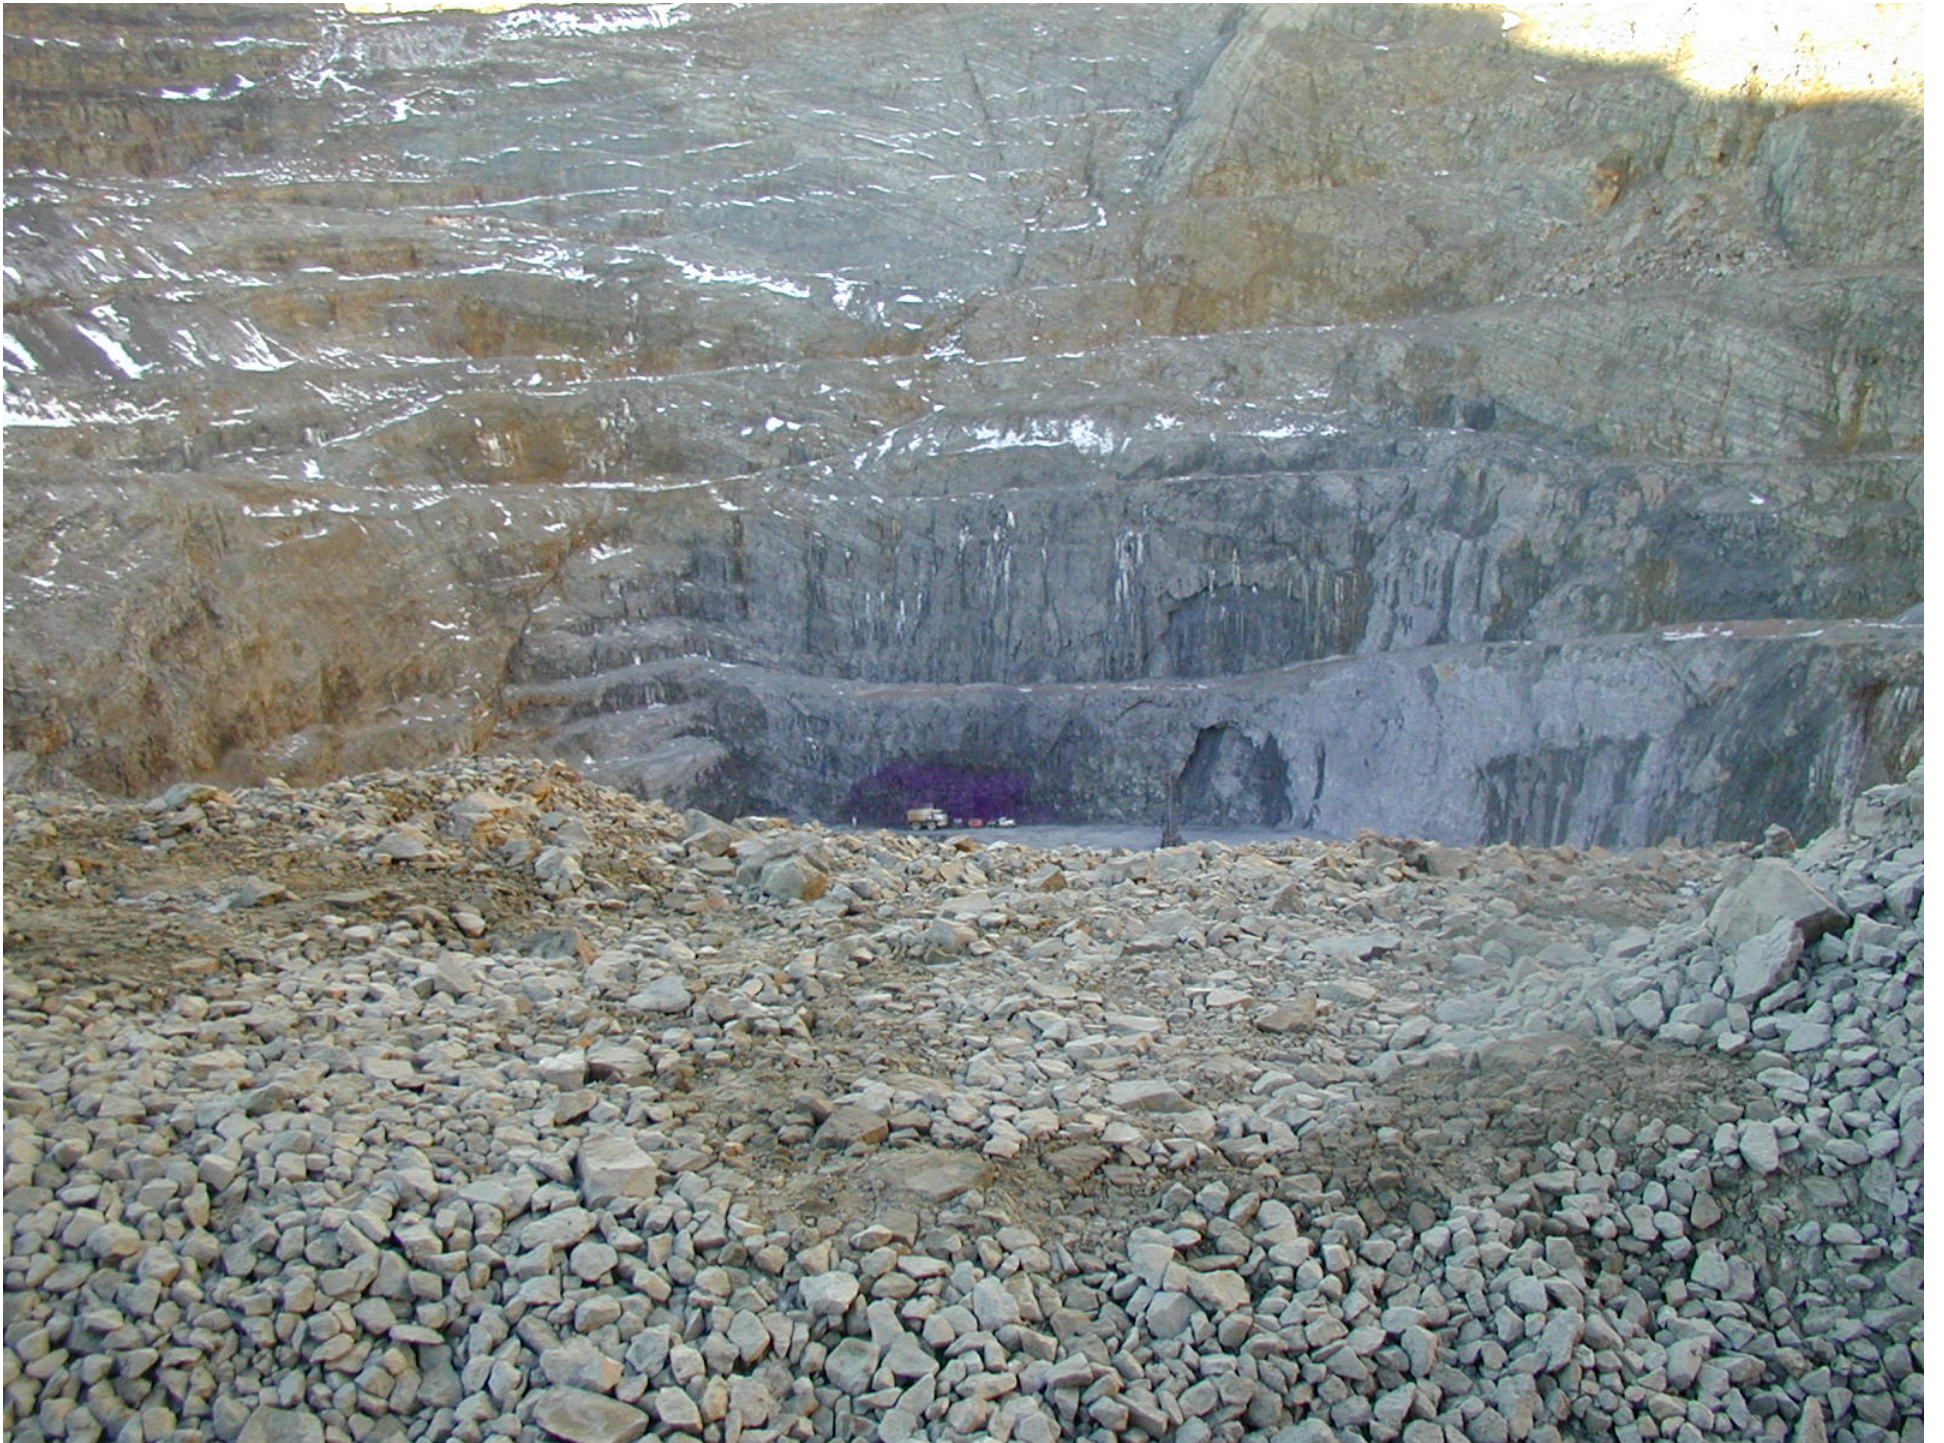
Passivation Process

- Three steps:
 - MgO at pH=10 to rinse wall
 - pH=12 to raise alkalinity
 - Permanganate solution at pH>12 for 3 hours
- Monitoring done from specially marked sections on pit wall between December 2002 and July 2003
- Access became too dangerous after July 2003

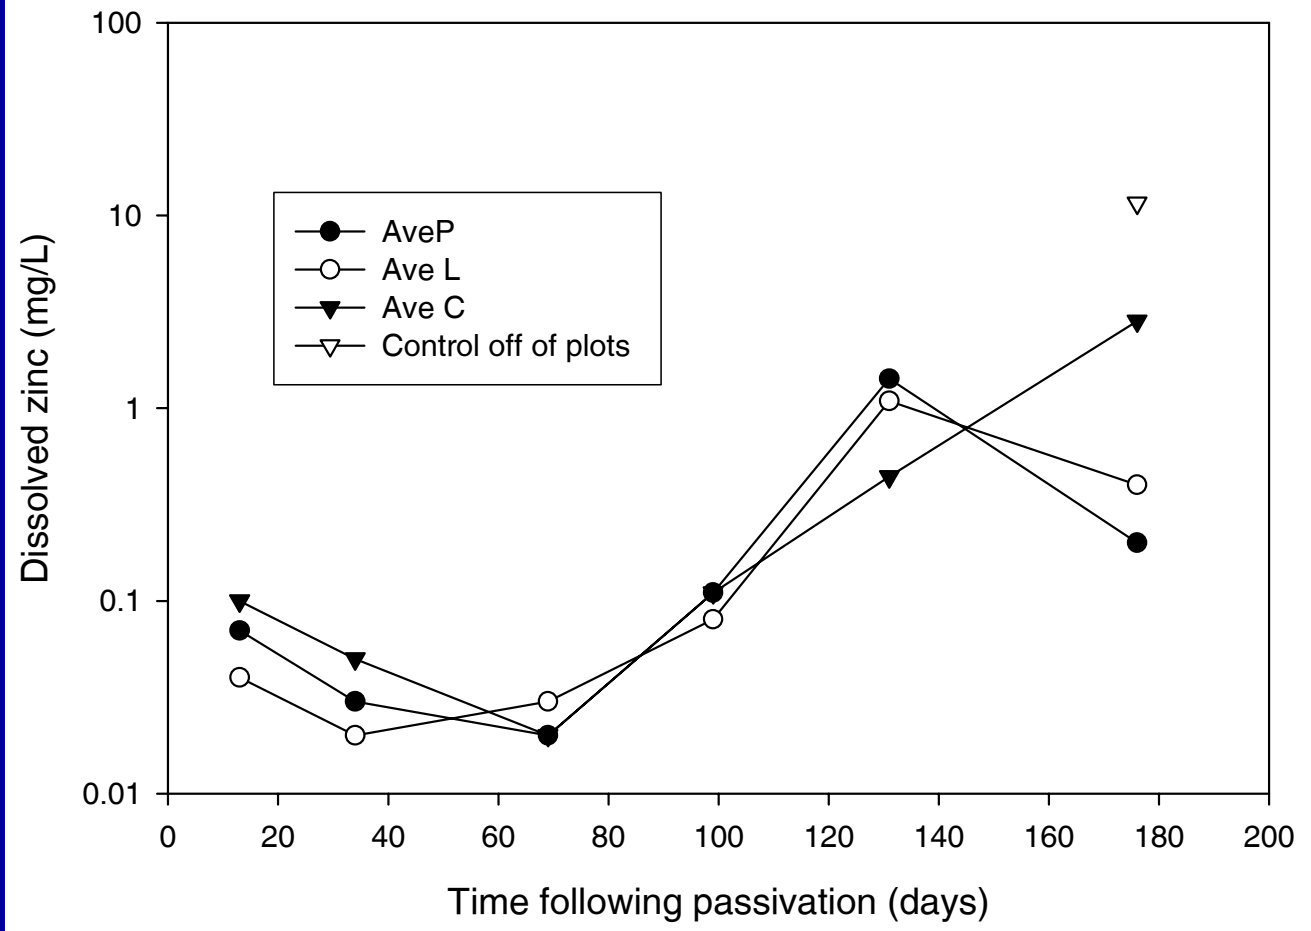
Figure 6. Golden Sunlight Mine Pitwall Passivation Project. Average dissolved zinc concentration plotted vs time for the passivated plots (P), dust control liner plots (L), treatment control plots (C) and final control sample (taken off of sampling plots).

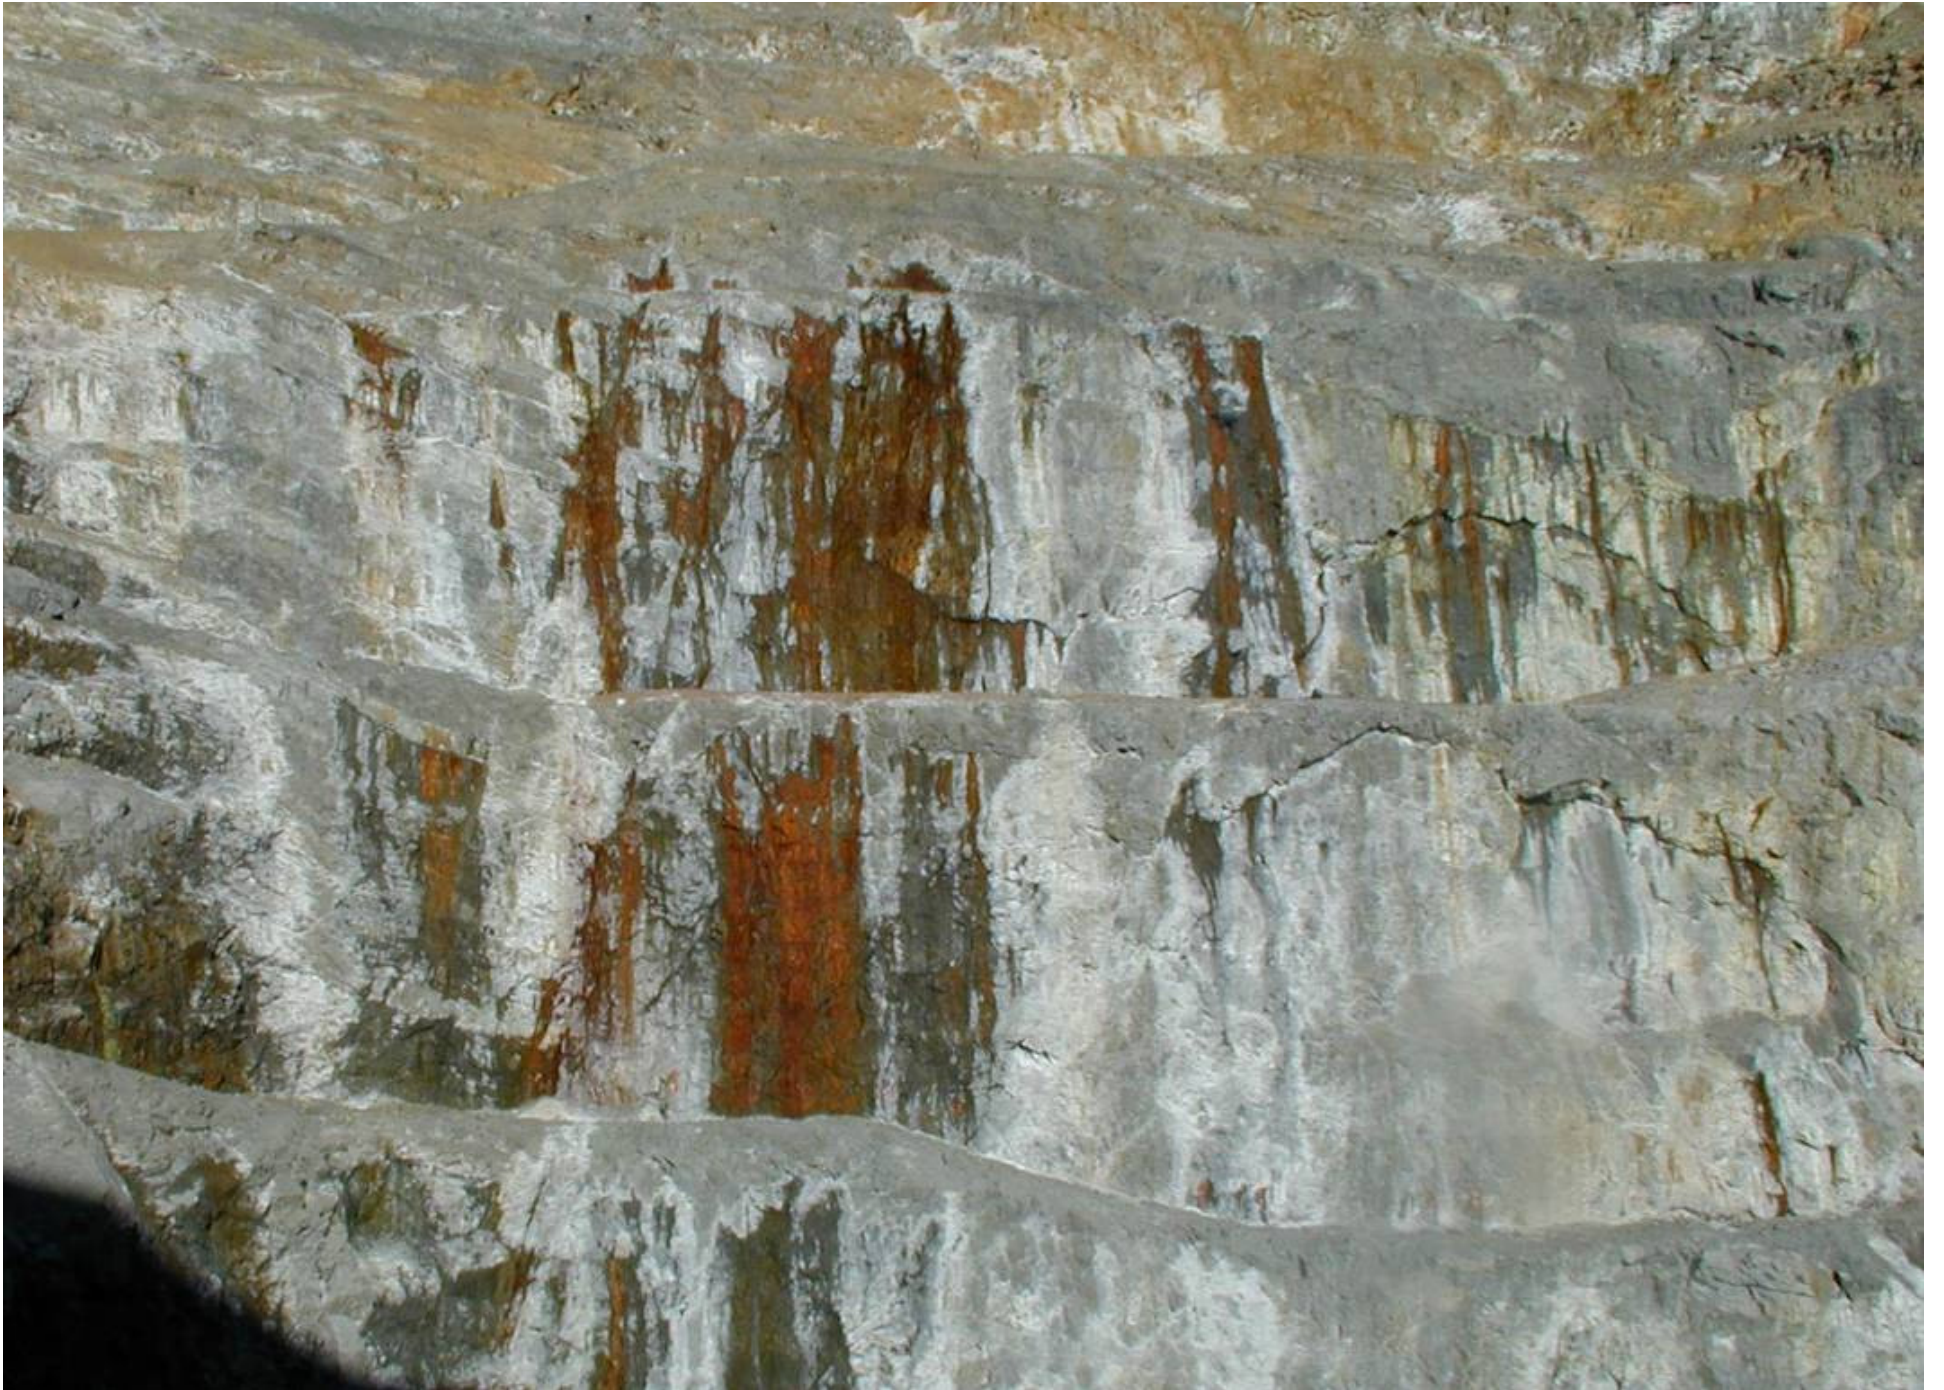
Table 9. Golden Sunlight Mine Pitwall Passivation Project. Average TDS value plotted vs time for the passivated plots (P), dust control liner plots (L), treatment control plots (C) and final control sample (taken off of sampling plots).
