Permanganate Passivation of Sulfide Rock – Field Trial Results

Presentation at 11th Annual British Columbia ML/ARD
Workshop

Dirk van Zyl, Glenn Miller and Tim Tsukamoto

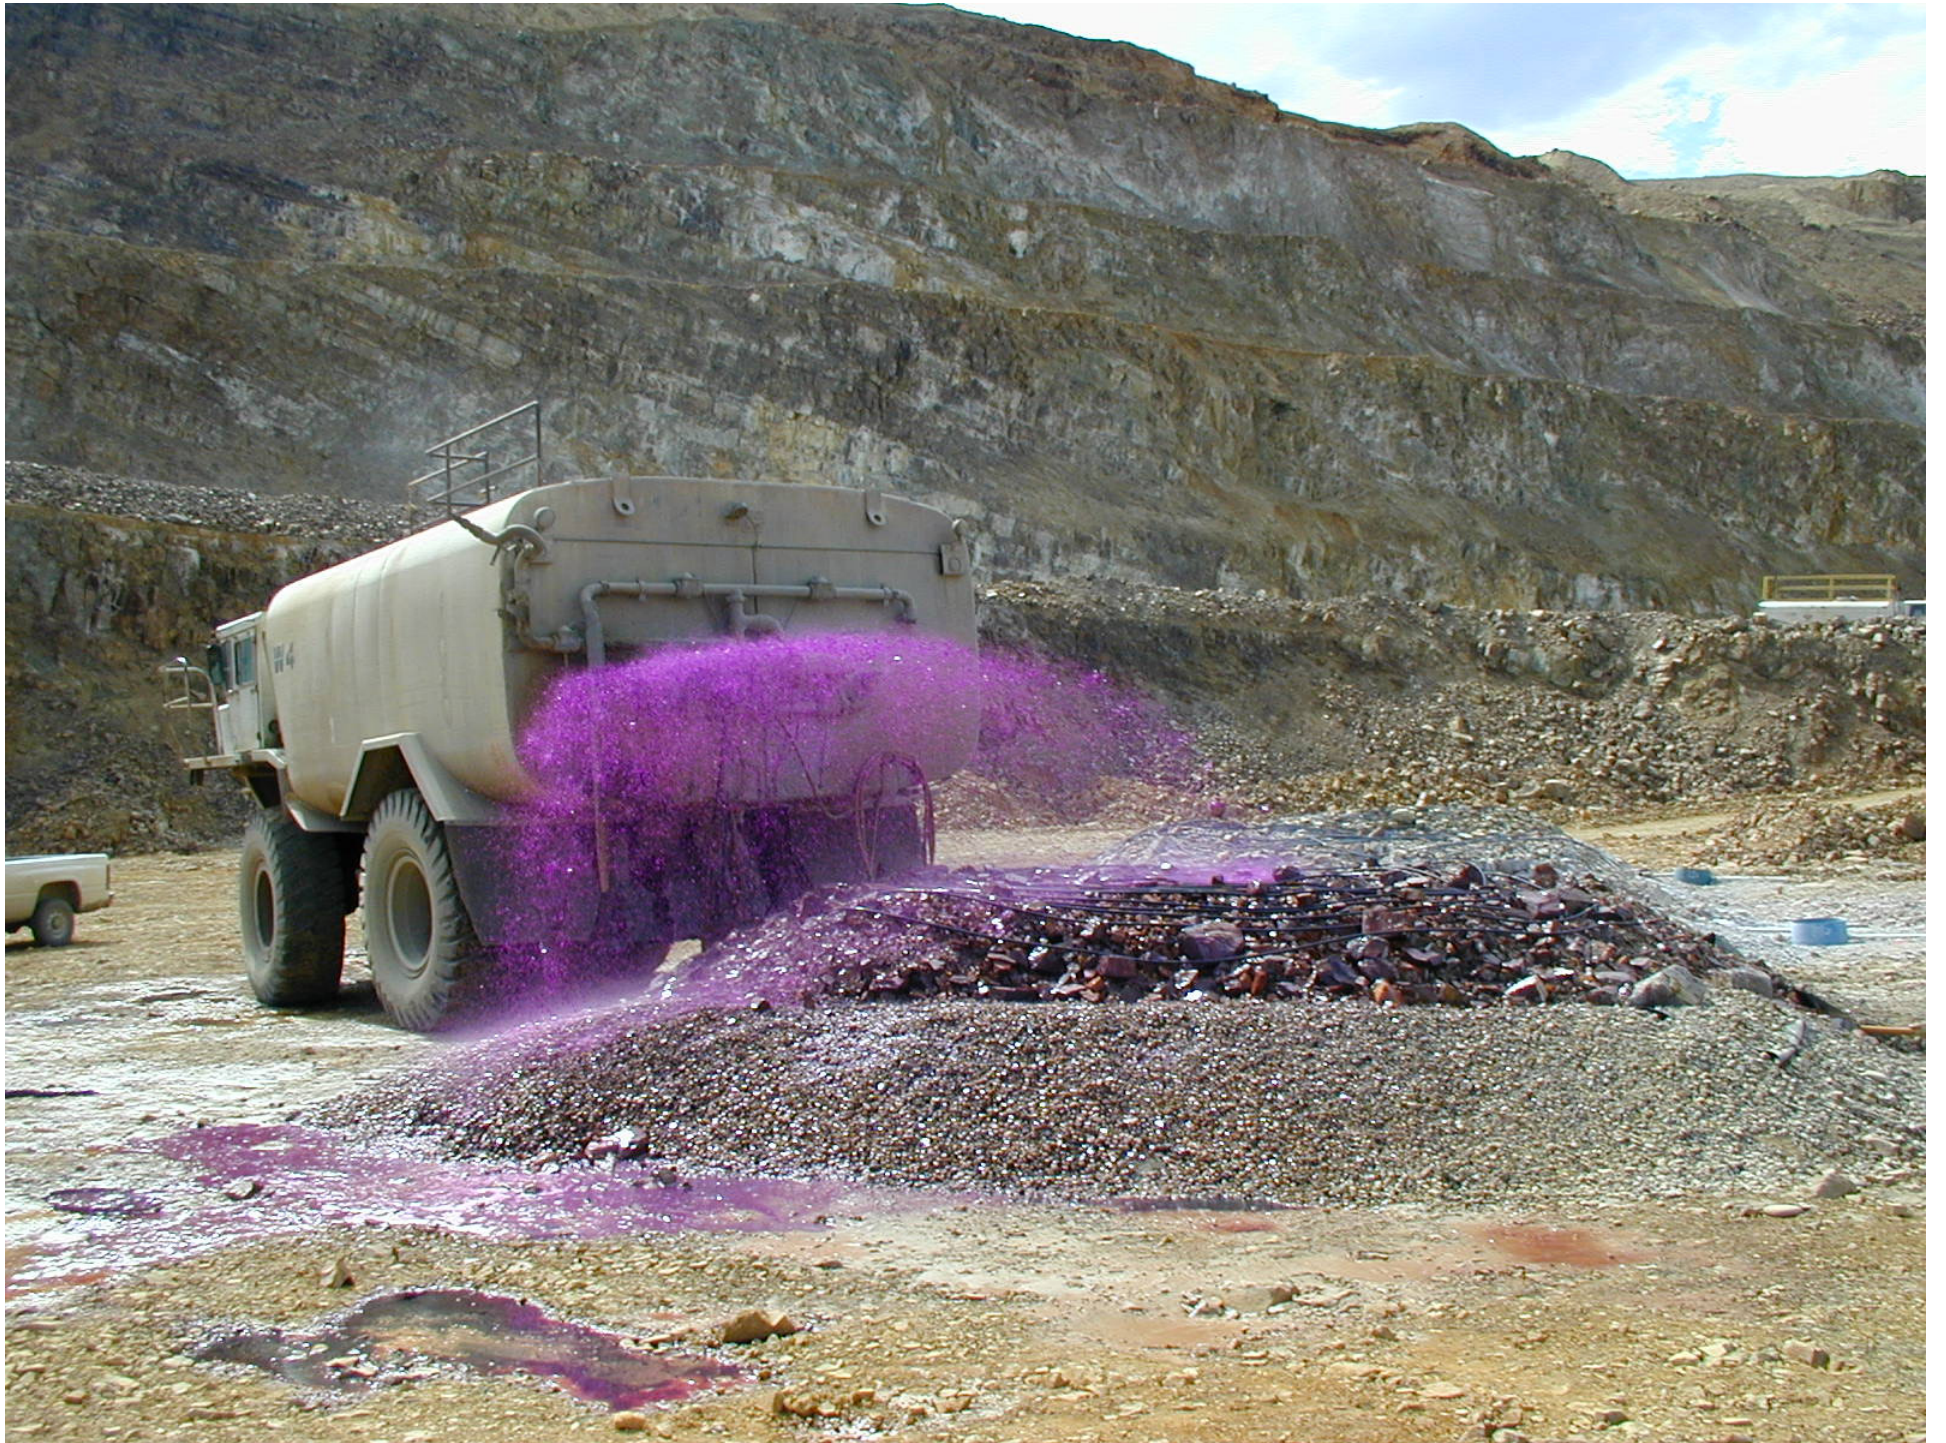
Rubble Piles – Golden Sunlight

- Initial rubble piles placed in November 2000; weathered rock from initial pit wall area
- Second set of rubble piles – fresh material placed in May 2001
- Three piles in each set:
 - No treatment
 - Control: MgO and pH control
 - Permanganate

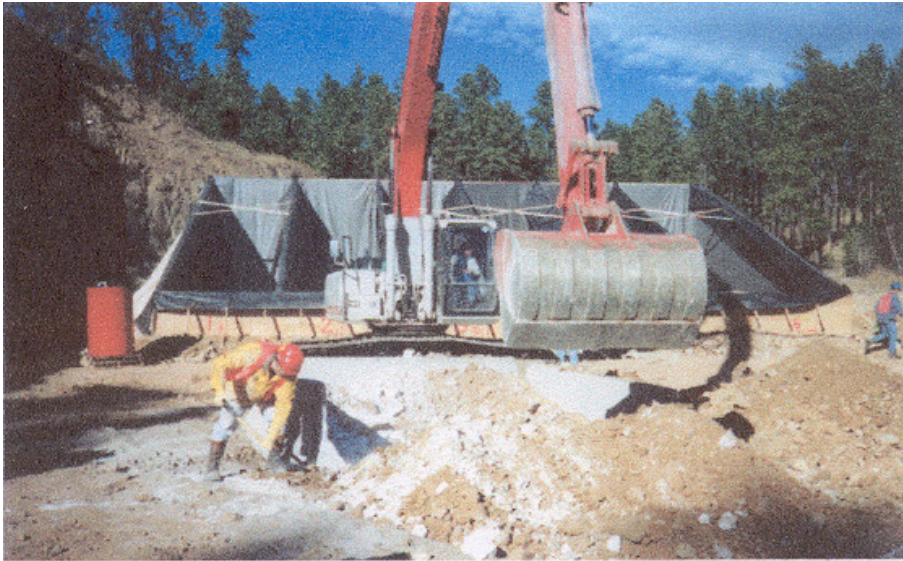
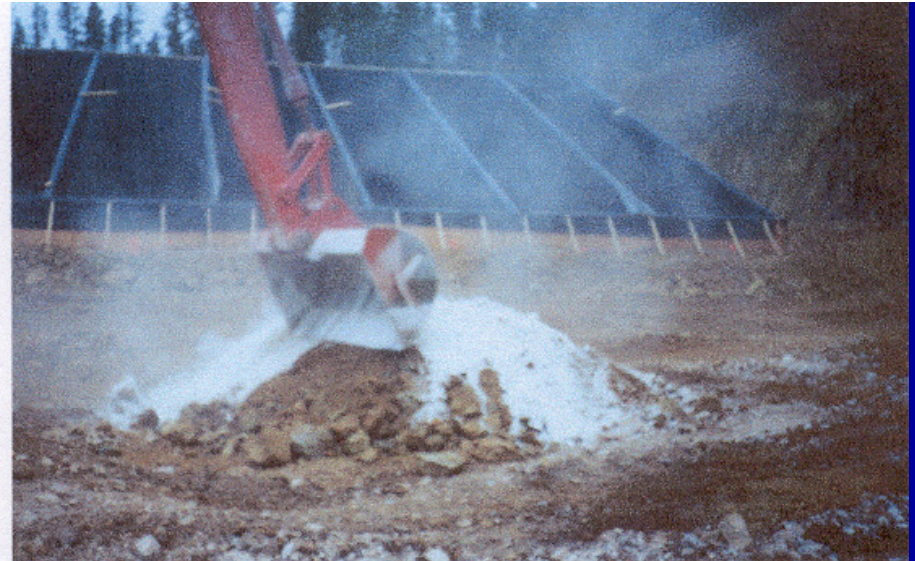
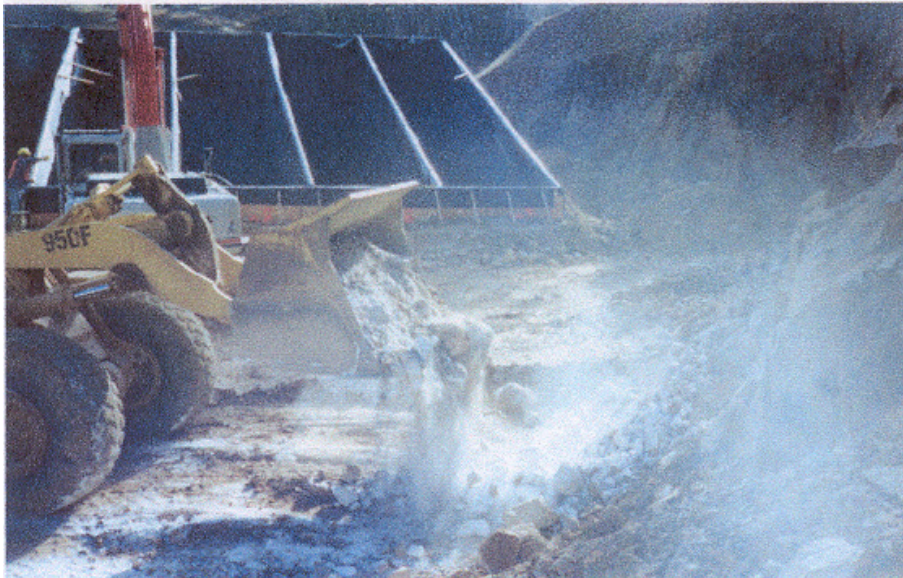
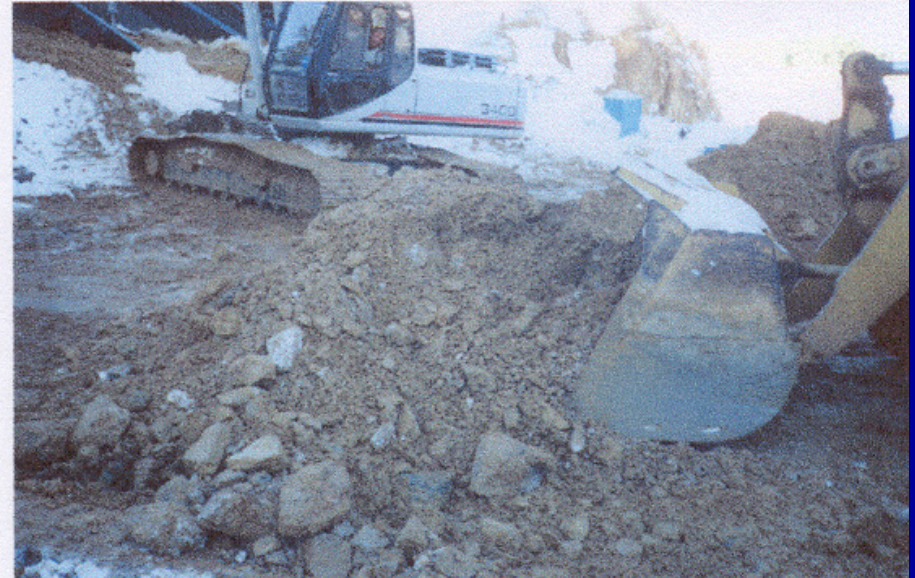
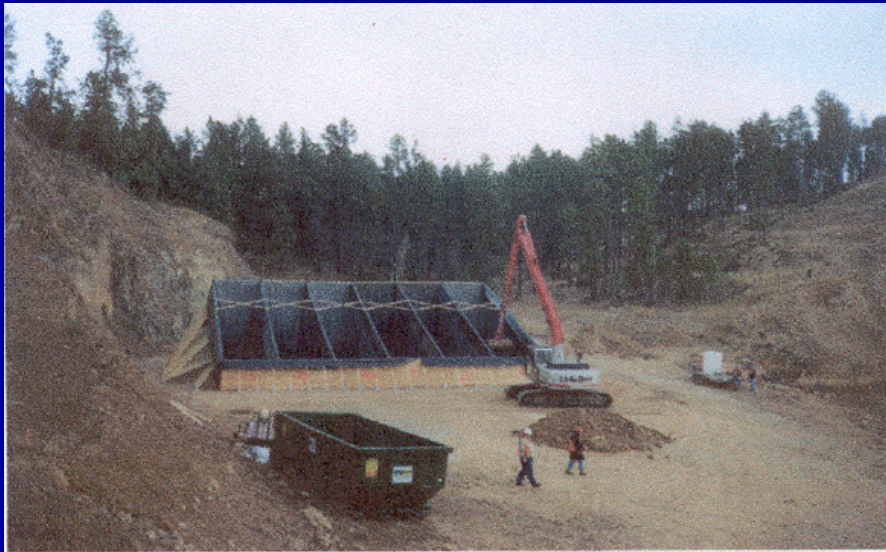
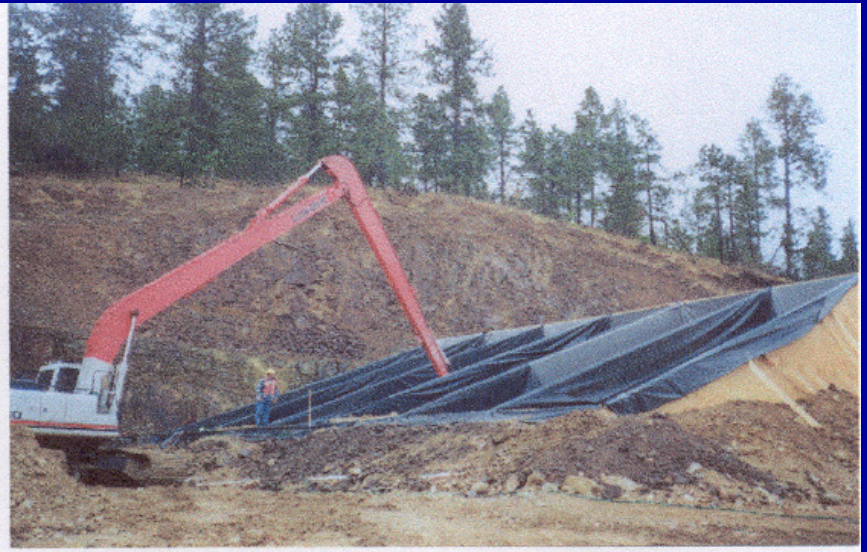
Application and Monitoring

- Mix lime and MgO with rock using a backhoe
- Place in one foot thick lifts
- Spray permanganate solution over the whole area
- Sample and analyze effluent from drain pipe
- Add water to top of cells if not enough precipitation for samples
