# **Long-term Cover Design and Performance Assessment- A Hanford Case Study**

11<sup>th</sup> Annual British Columbia ML/ARD Workshop

Andy Ward

Pacific Northwest National Laboratory Richland, WA

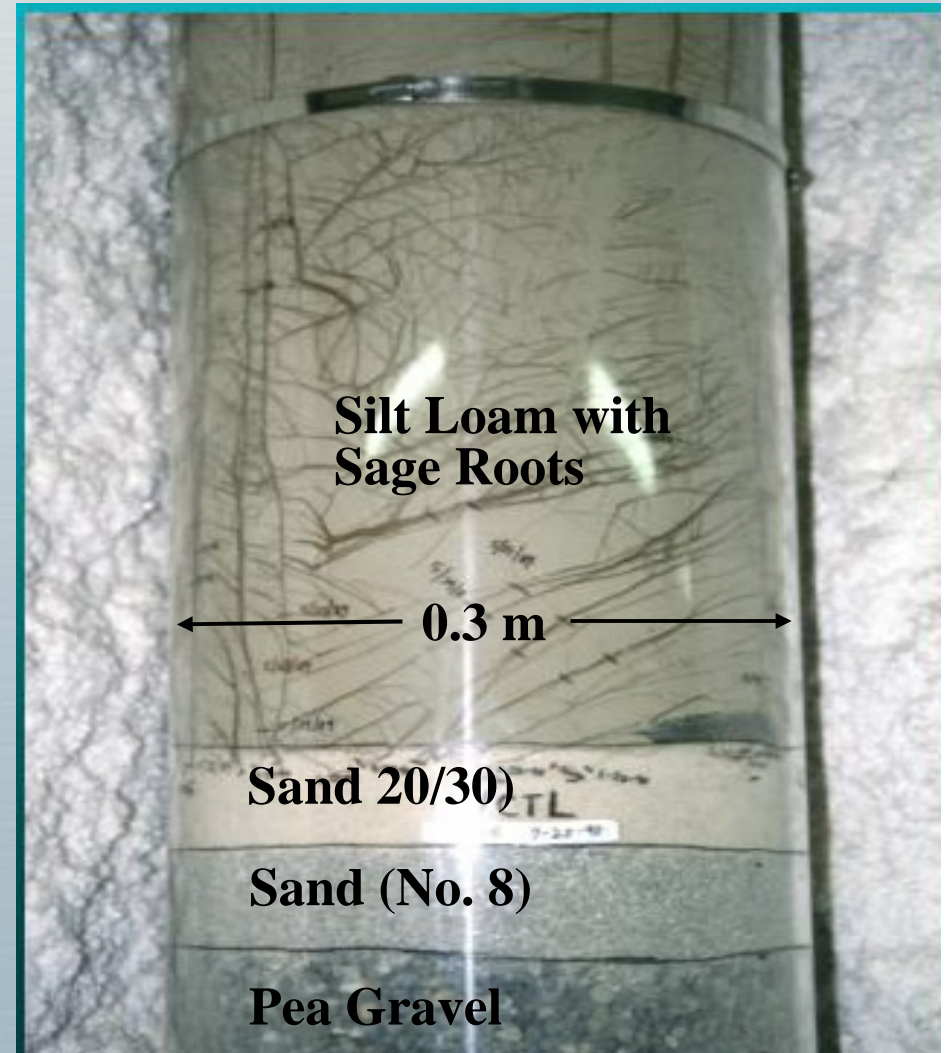
# Vegetated Multilayered with Capillary Break (Lysimeter C6)

- 1.5 m silt loam above capillary break, which is above basalt riprap
- Elevated precipitation
  - 3 yr @ 2x
  - 13 yr @ 3x)
- Result? ***Zero Drainage***

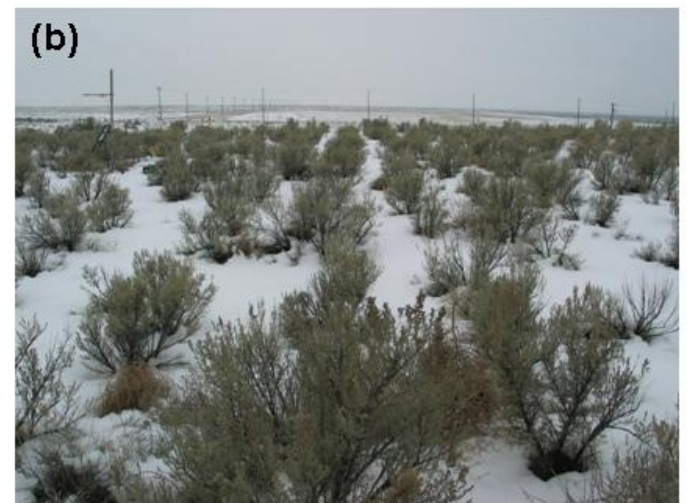
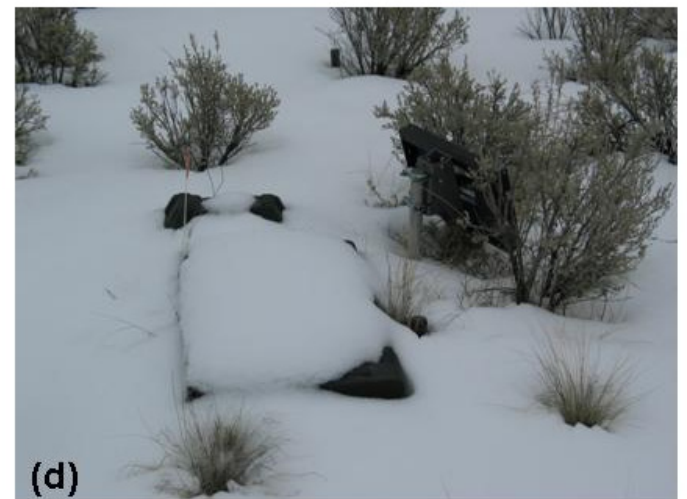
# Water Balance Tests

- 2 precipitation treatments
  - ambient (160 mm/yr)
  - $3 \times$  ambient (480 mm/yr)
  - Simulated 1000-yr storm (68 mm over 8 hr in late March)
- Testing and Monitoring
  - Precipitation
  - Runoff
  - Water Storage
  - Drainage
  - Evapotranspiration
- Over 10 years of data
