**Underwater tailings disposal and
ARD mitigation at the
Inmet - Samatosum Reclamation Site.**

MEND 2011

The two sides to the Samatosum Reclamation Mine Site

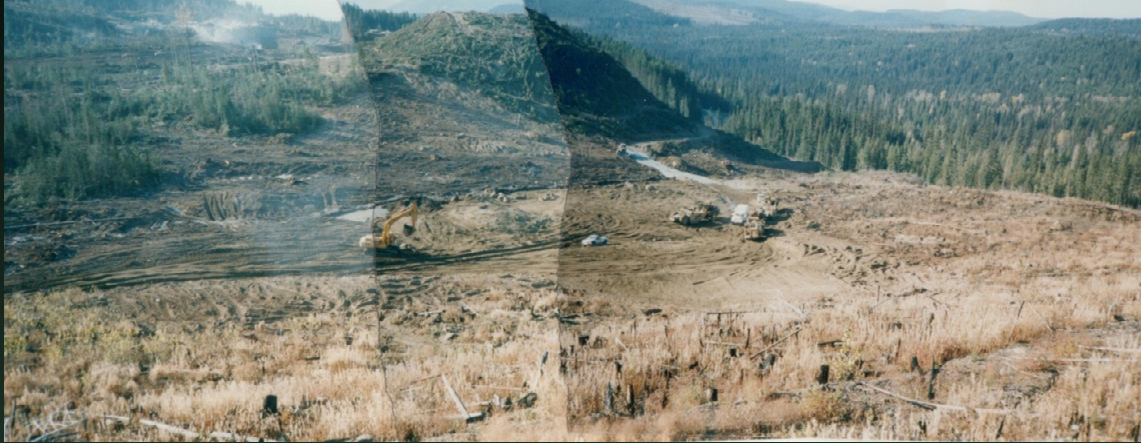
**1988 view across
impoundment,
dam foundation
started**

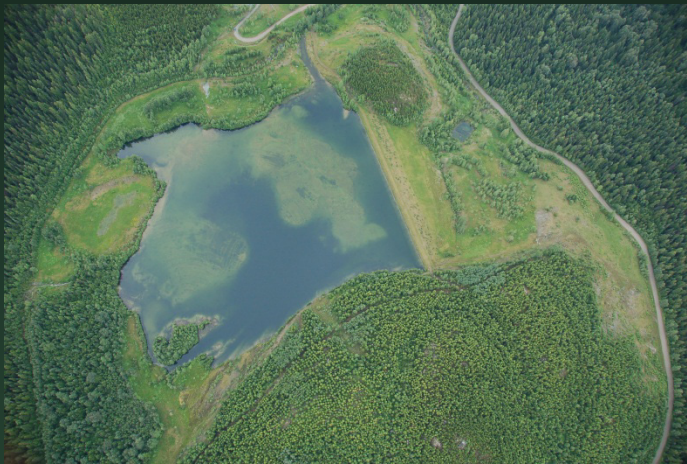
2011 view

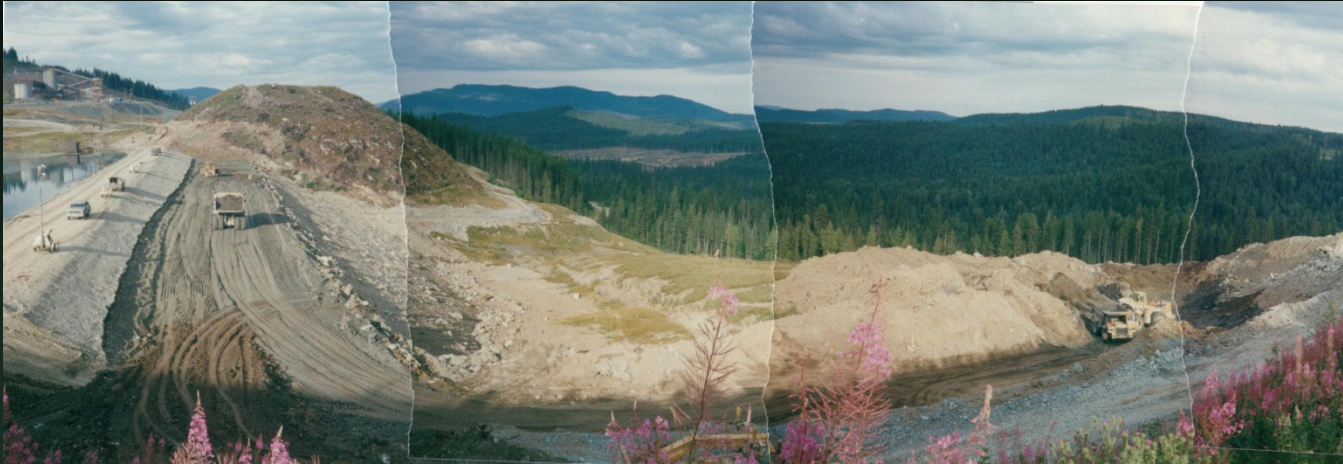
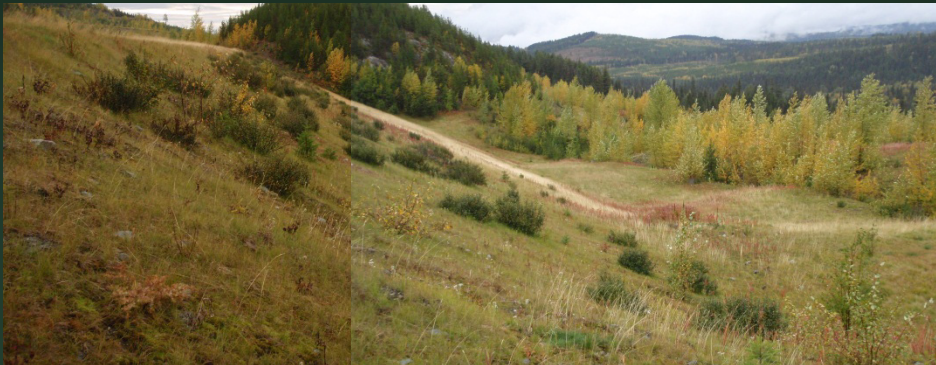
Dam construction and borrow area

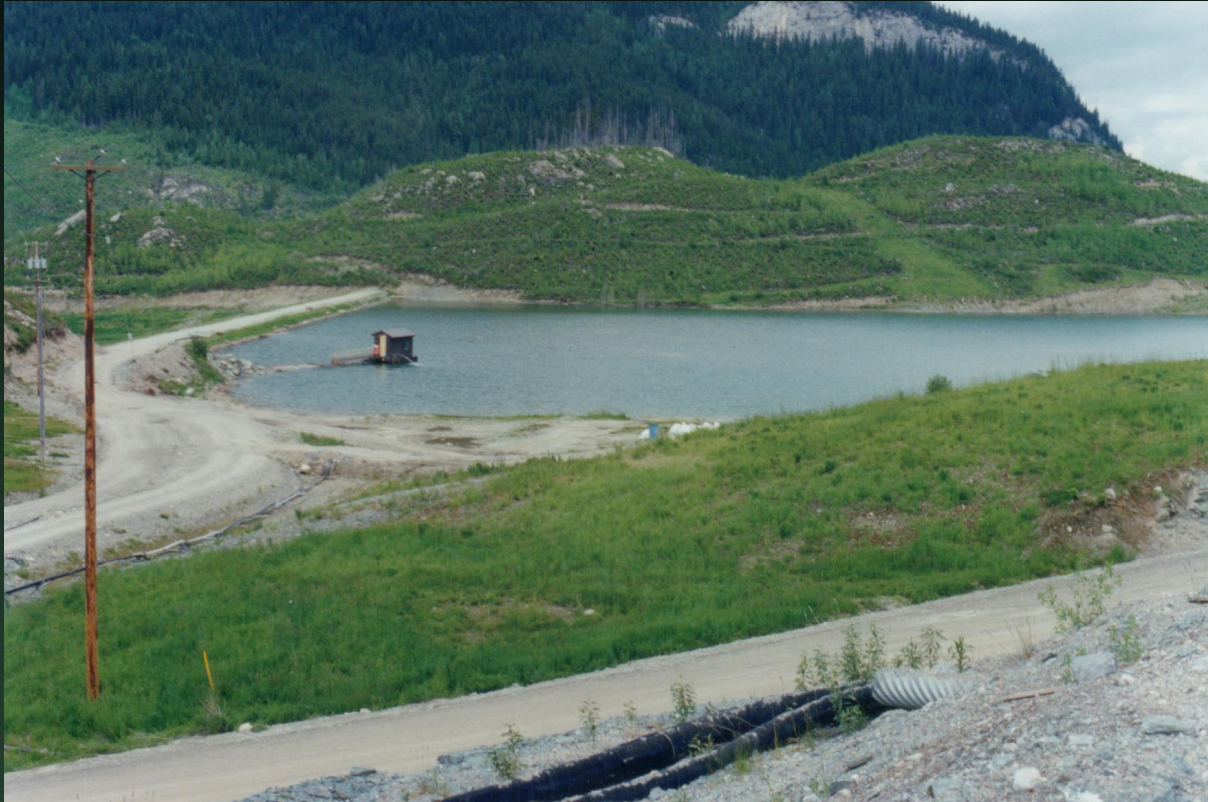
1994 Tailings water being treated before release

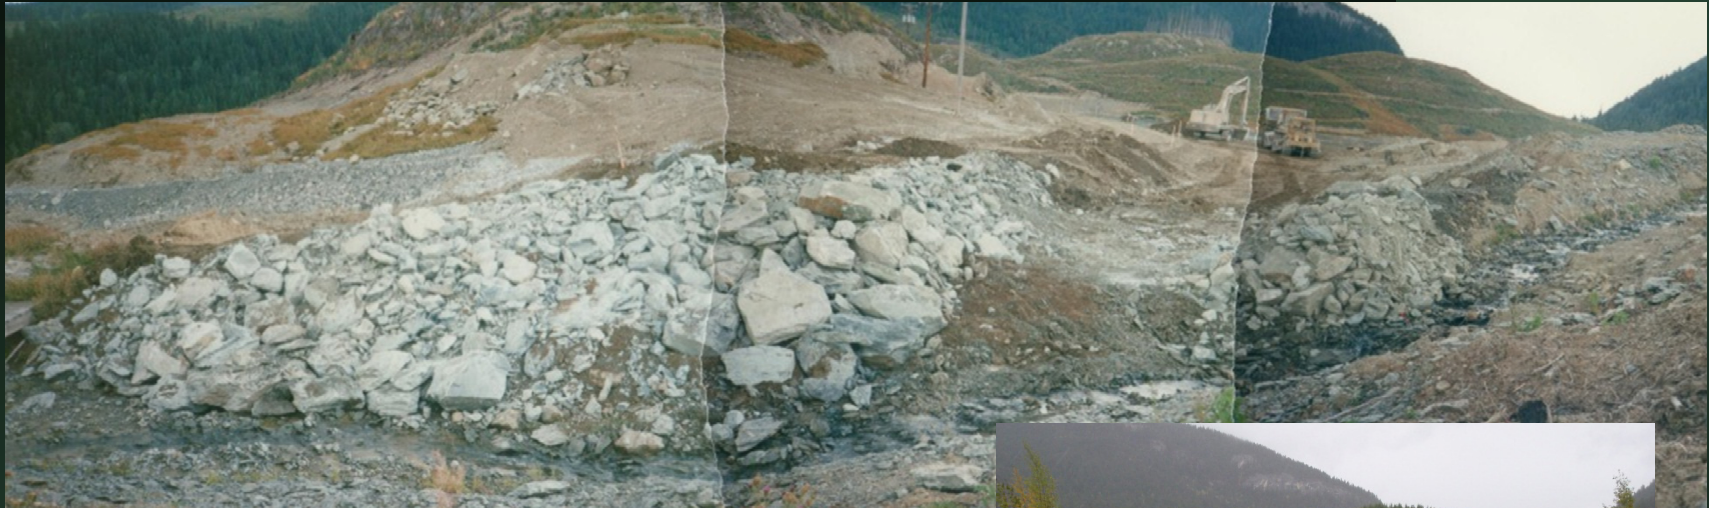
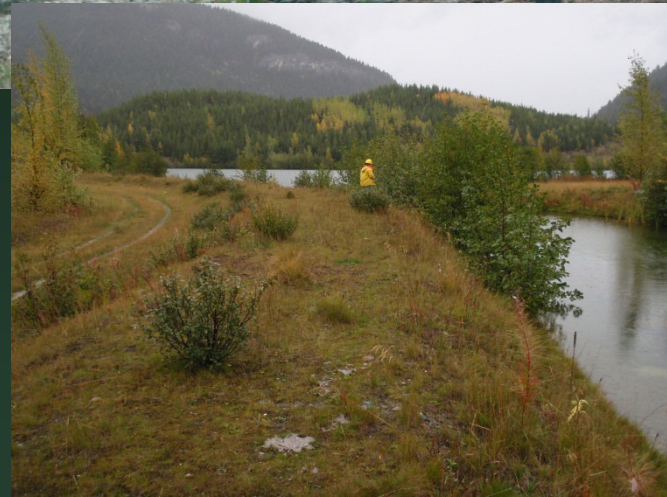
Saddle dyke – decant construction and recent

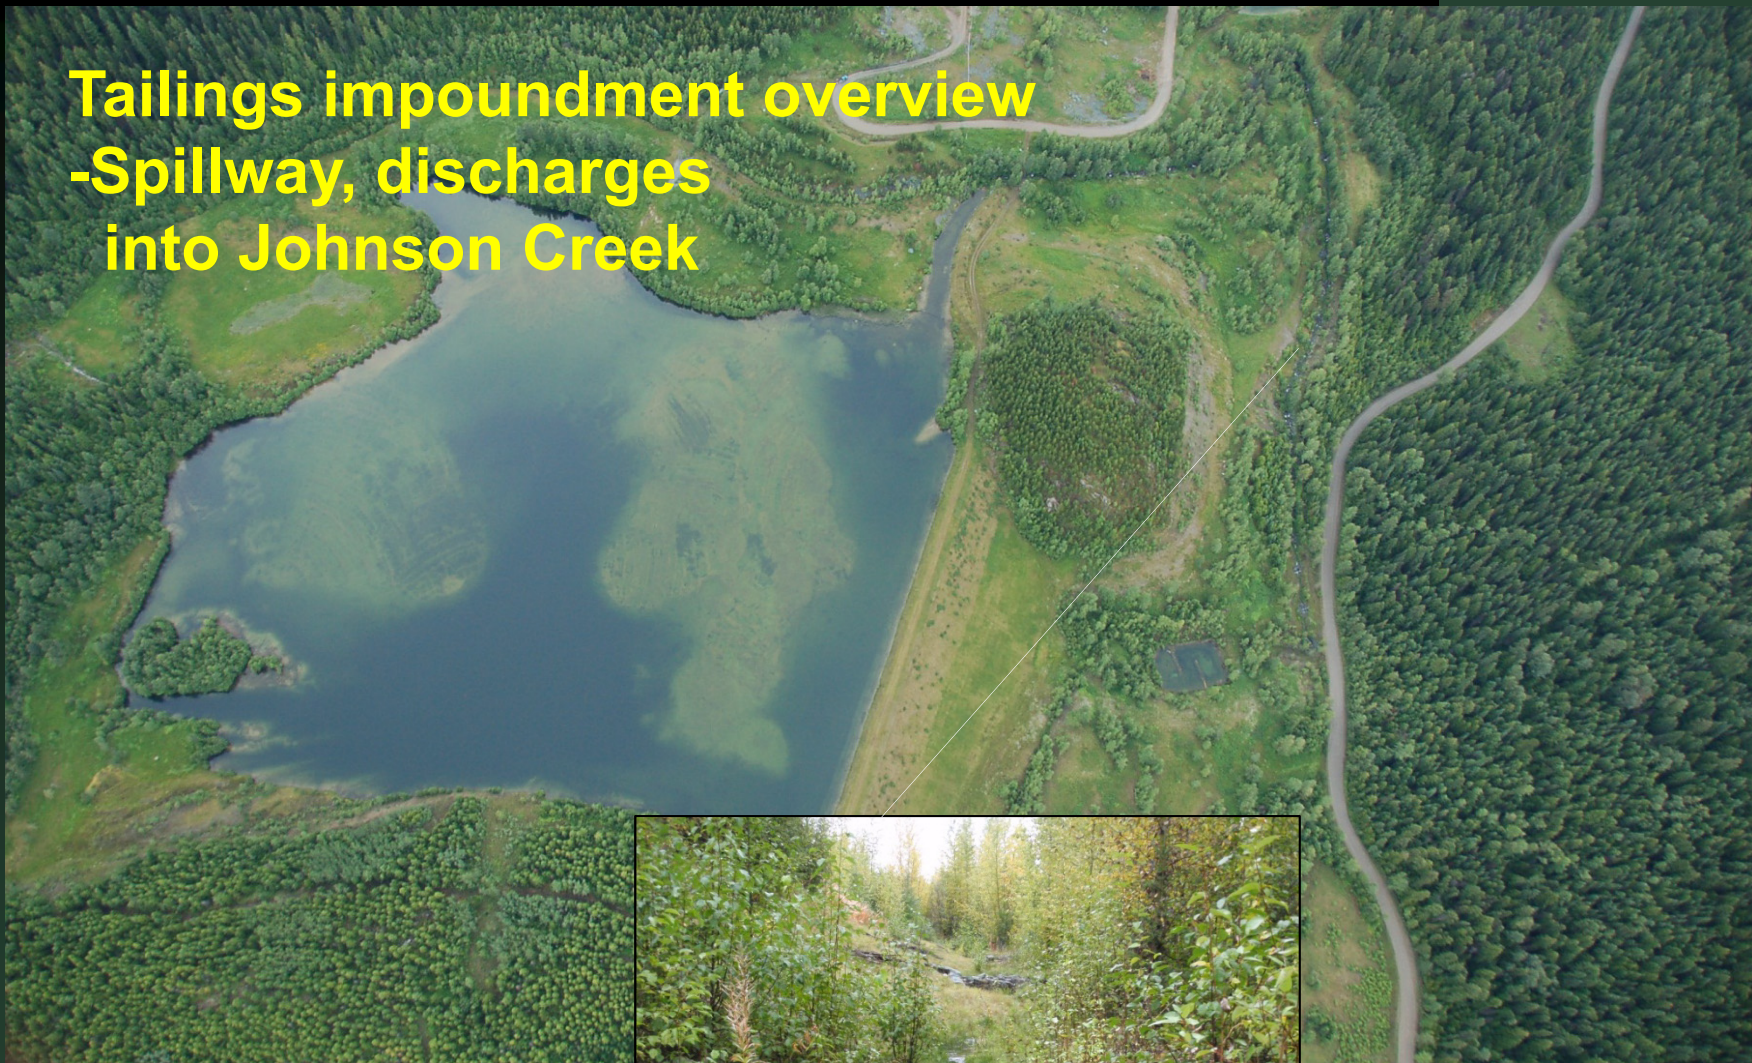
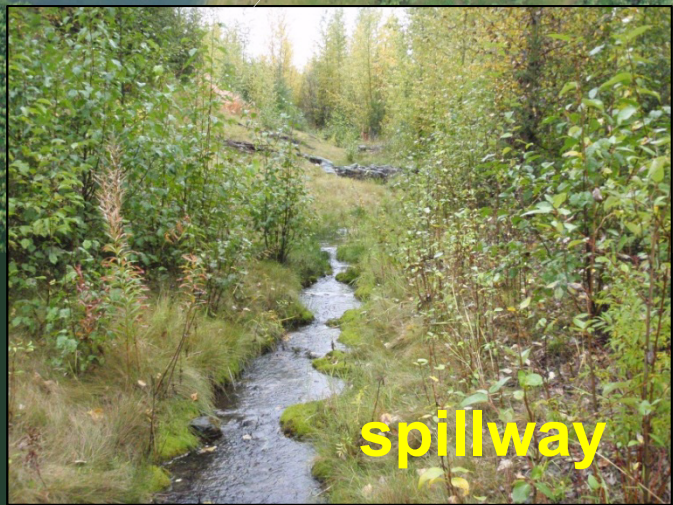
- Spillway, discharges into Johnson Creek

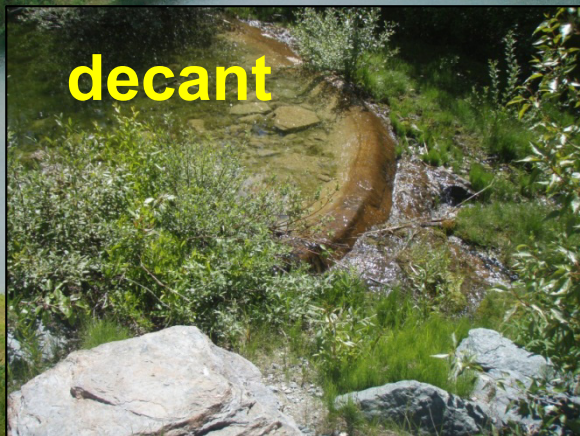
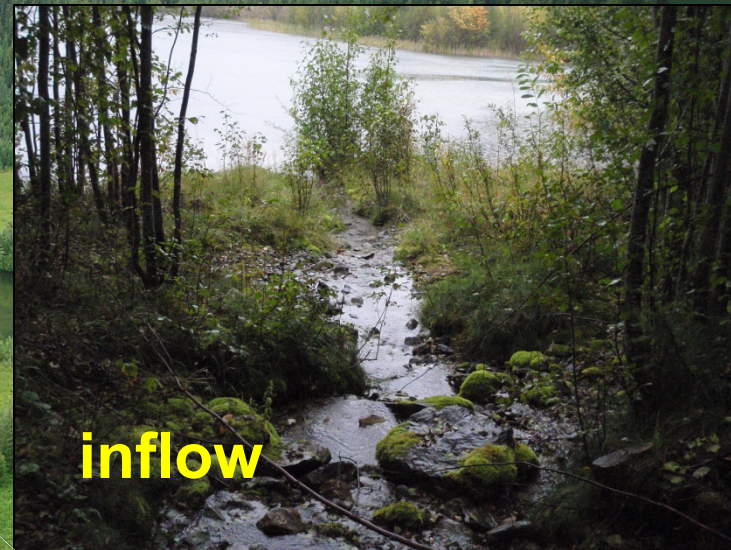
-inflow, decant

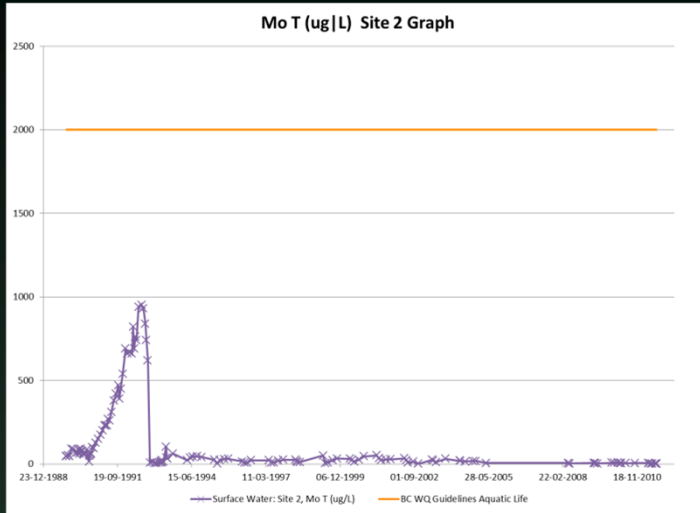
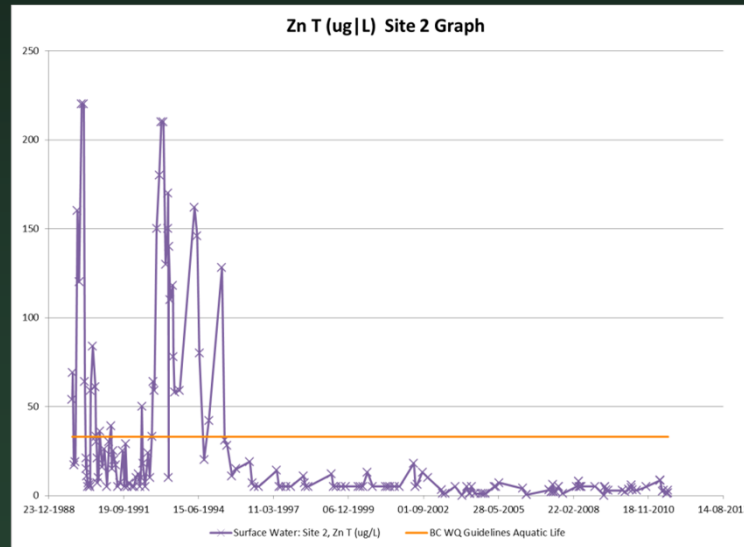
Site 2 - Tailings Decant water quality

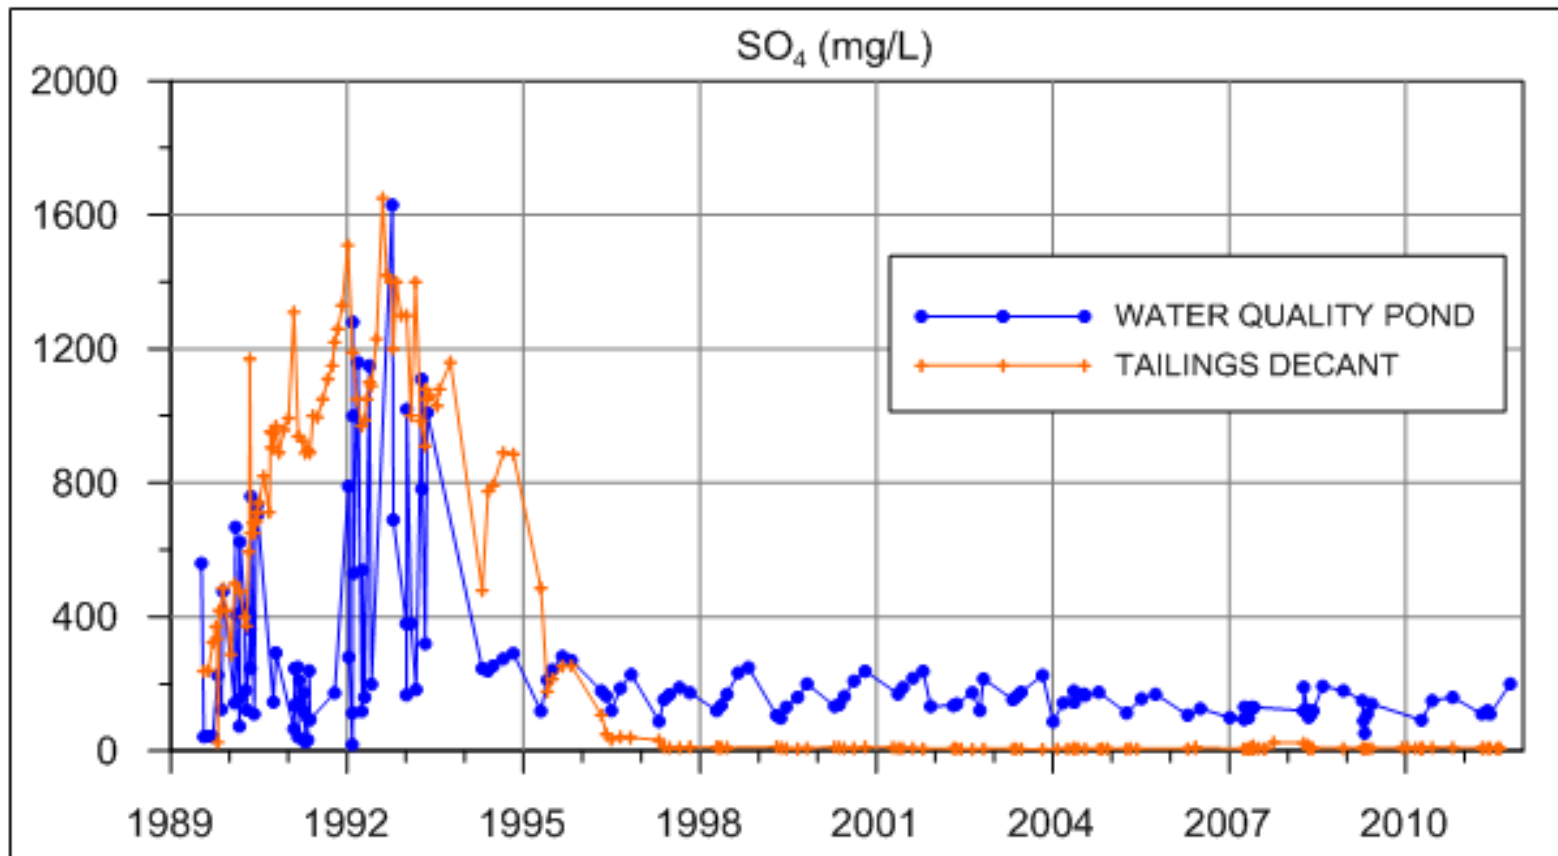
S04 at Site 2-Tailings Decant and WQP

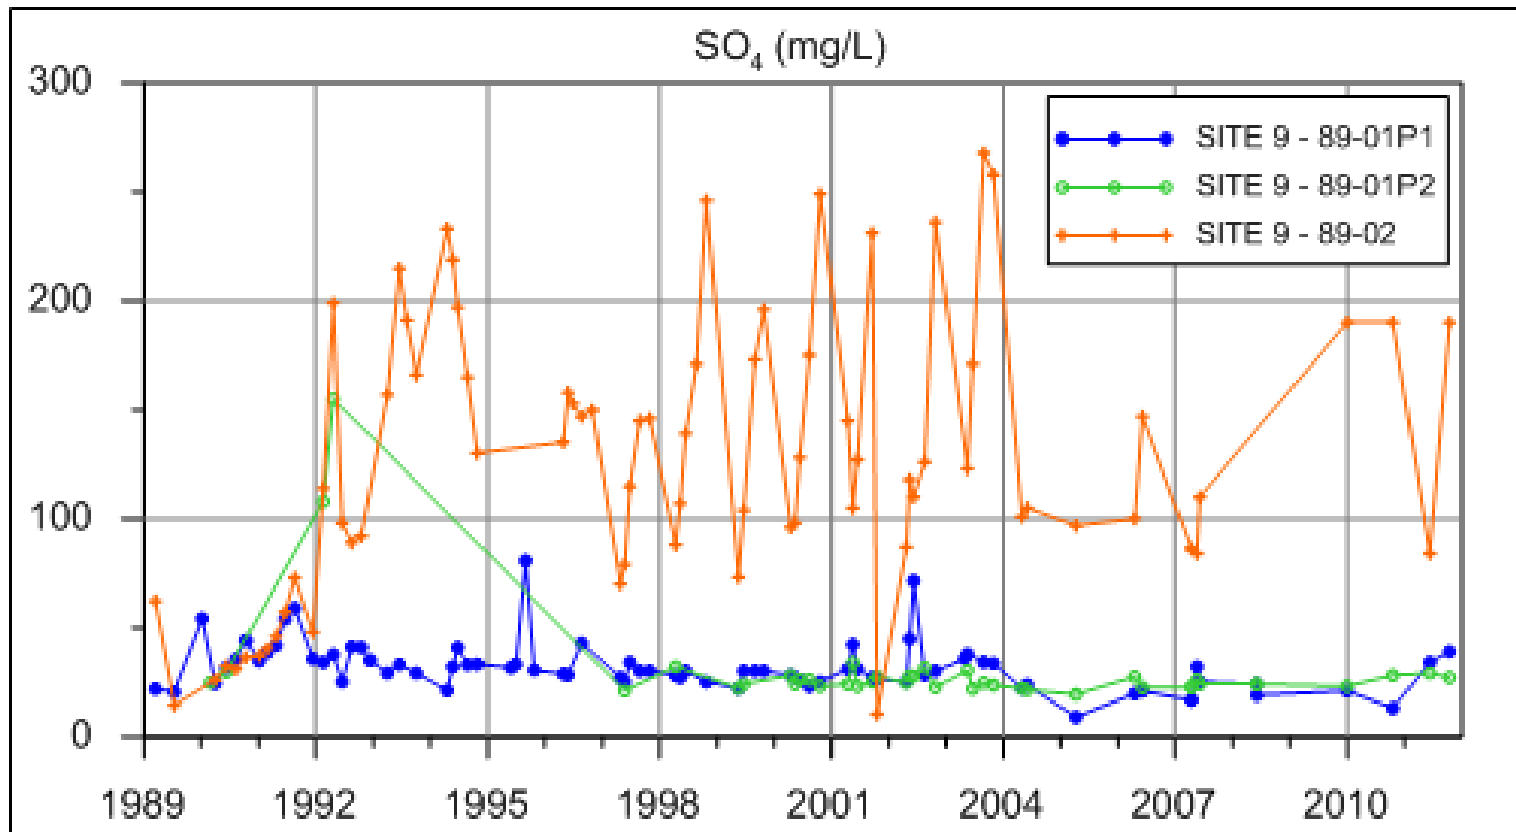
Groundwater wells below tailings impoundment
MEND 2011

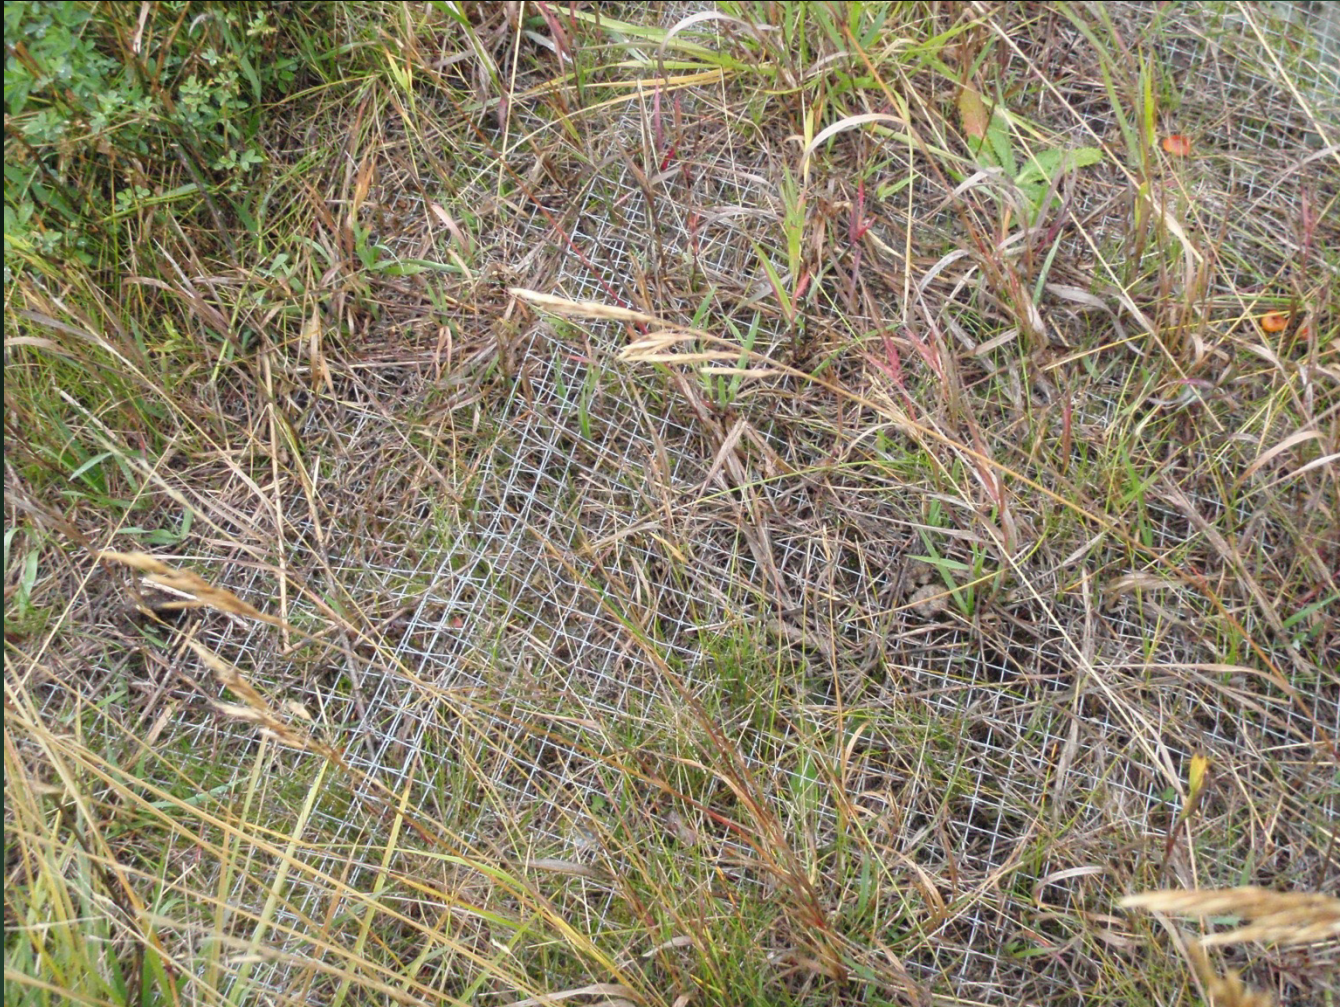
Gopher mesh – $\frac{3}{4}$ by $\frac{3}{4}$ galvanized grid mesh

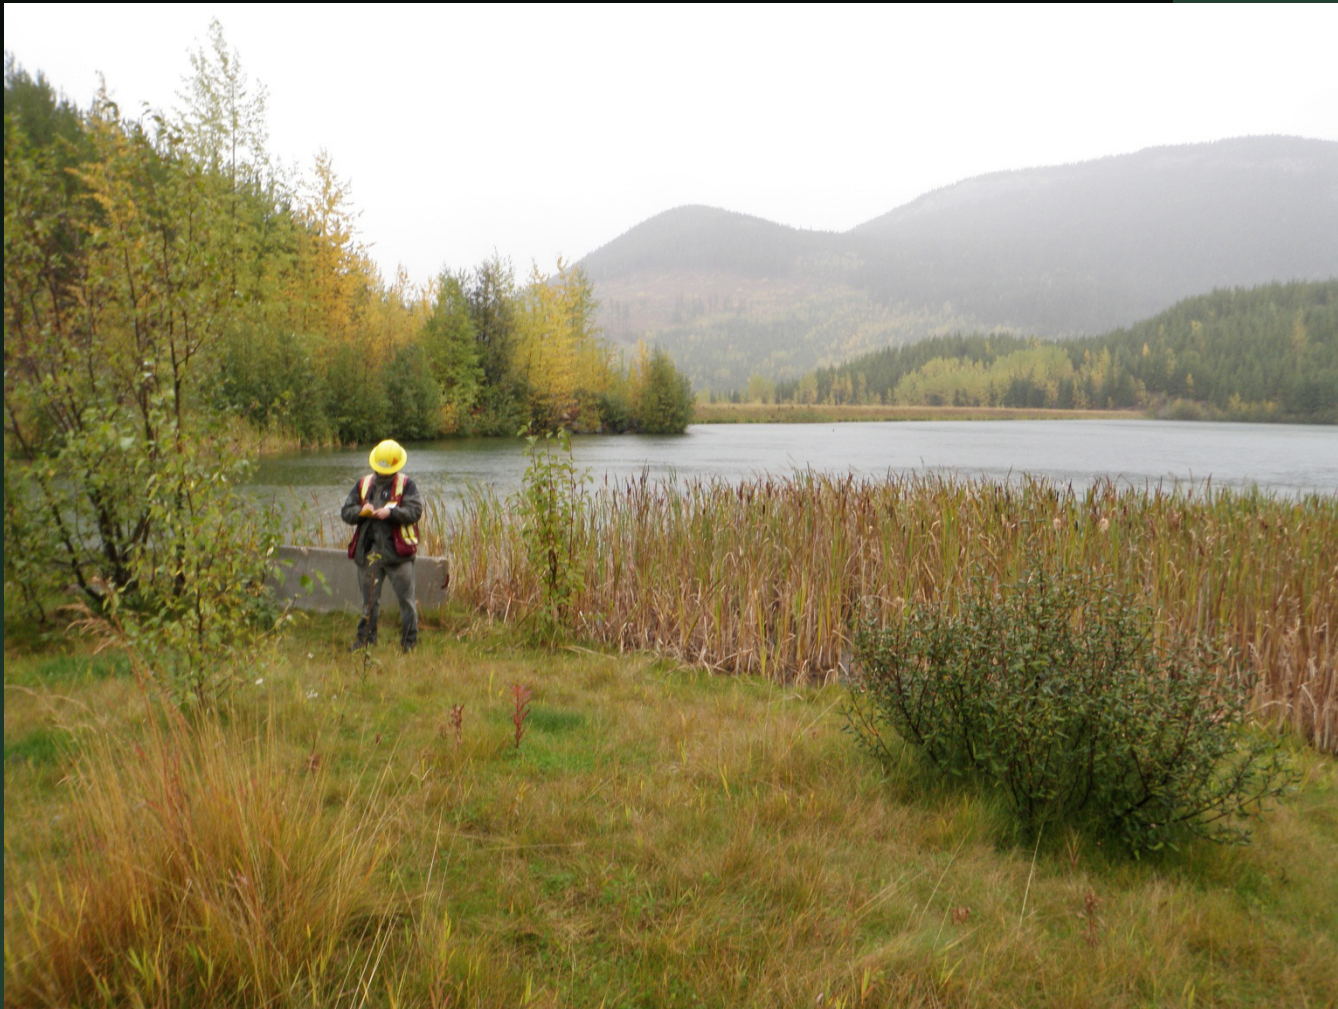
Cattails – transplant program to reduce erosion

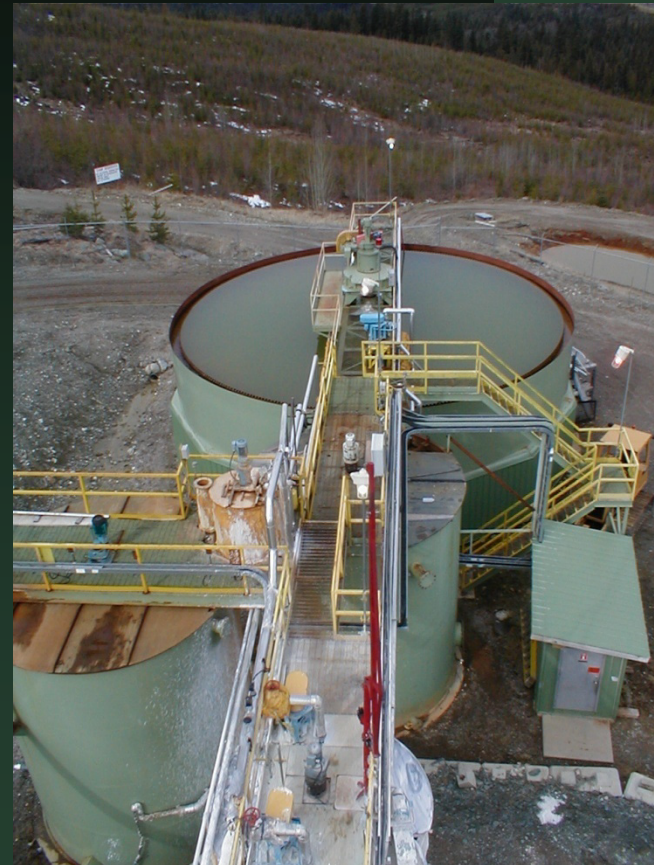
WTP Process overview

- Water travels from the pit and surge pond through pipelines and enters the plant through the manifold house. (aka Doghouse)
- From the Doghouse the water enters the reactor where the treatment starts. A mix of oxygen, lime and recycled sludge is added and stirred with mixers.
- It is during this period that the pH (can be low if acidity is present) is raised to 9.60 Any metals are precipitated onto tiny recycled sludge nuclei. These little starter kernels (mostly iron) keep collecting metals and keep getting larger and heavier.

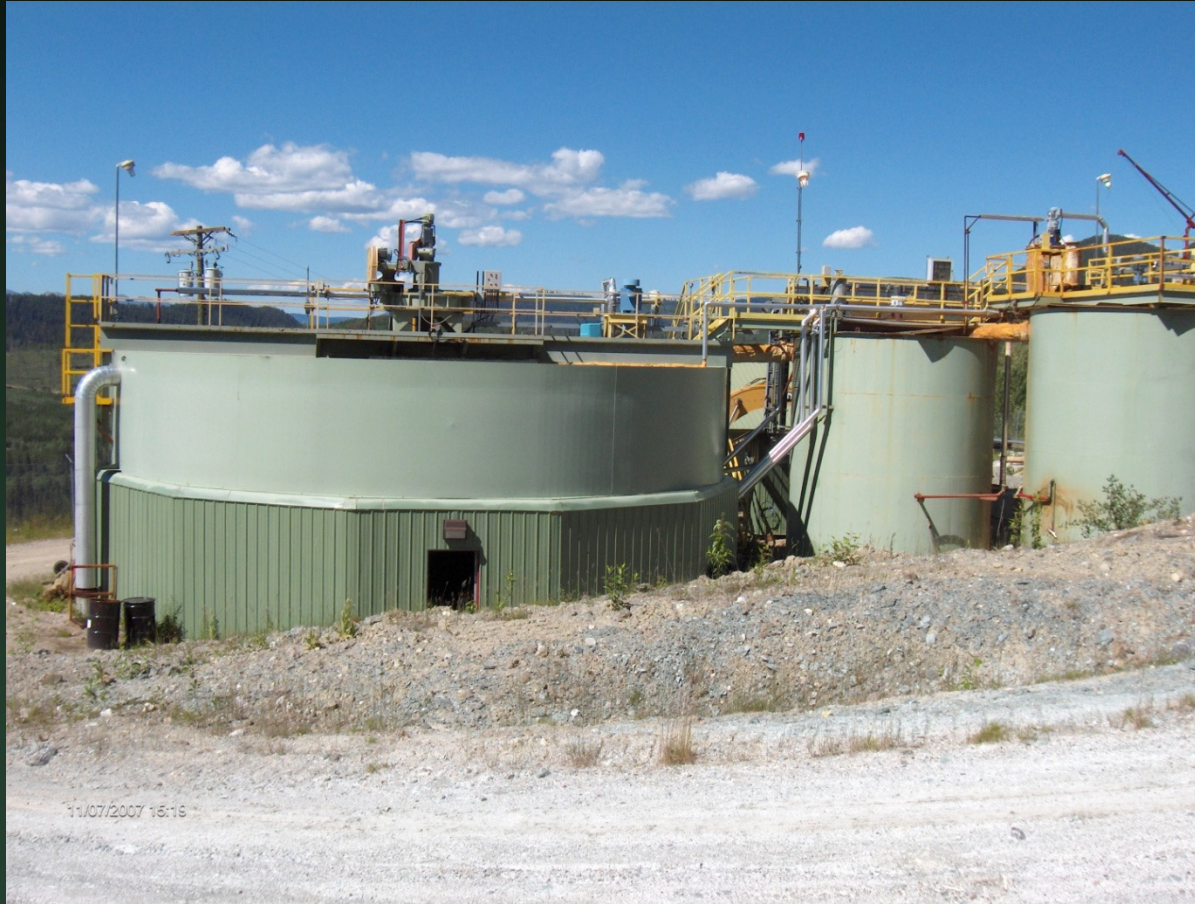
Water treatment plant tanks

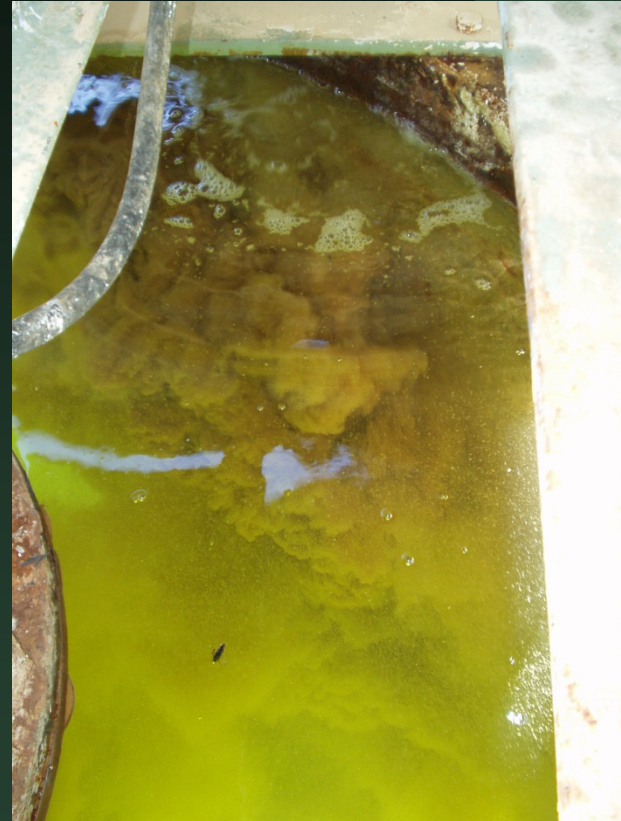
WTP Process overview

- At the pipe entrance to the clarifier a polymer called flocculent is added (sticky elastic band).
- In the center well of the clarifier the stuck together sludge nuclei are separated from the water.

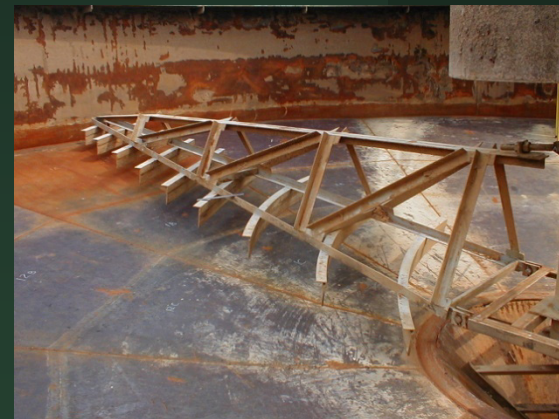
WTP Process overview

- The top of the tank is clean water and the bottom is settled out sludge. The Rakes continually pull the sludge into the center where some of it is pumped back into the reactor to start the process all over again.
- The Plant is a HIGH DENSITY SLUDGE operation. (20%-30% solids) We upgraded from a Low Density operation in 1998. (3%-5%)

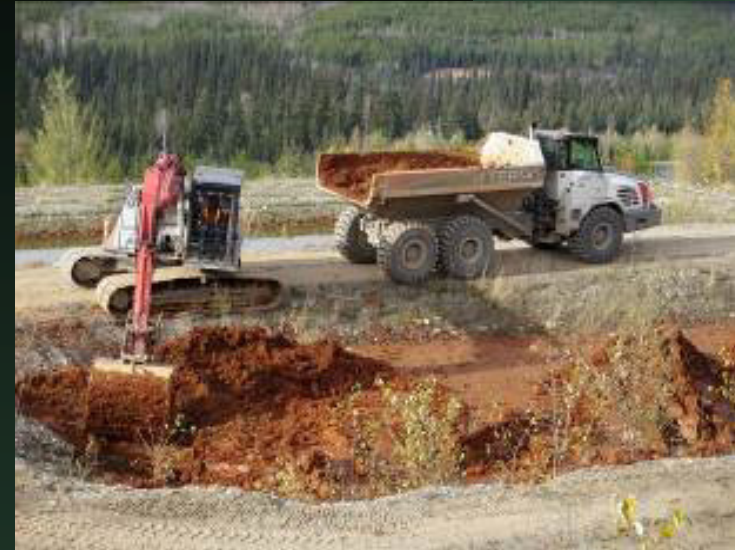
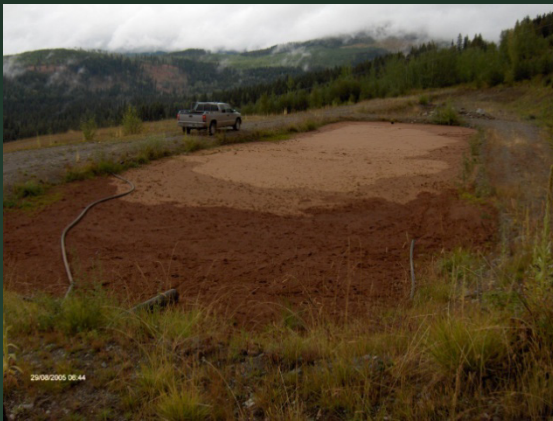
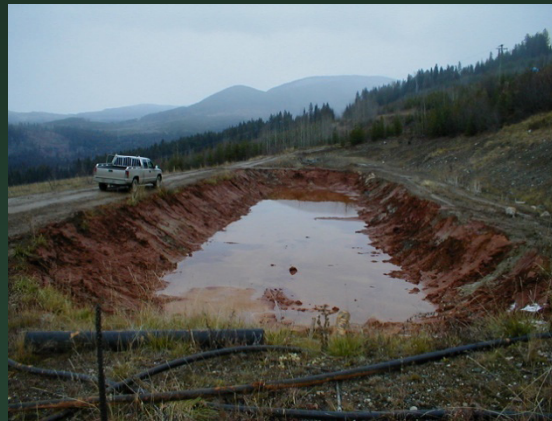
Sludge management

- The improved high density sludge now takes four to six years to fill one pond versus one year before plant optimization.

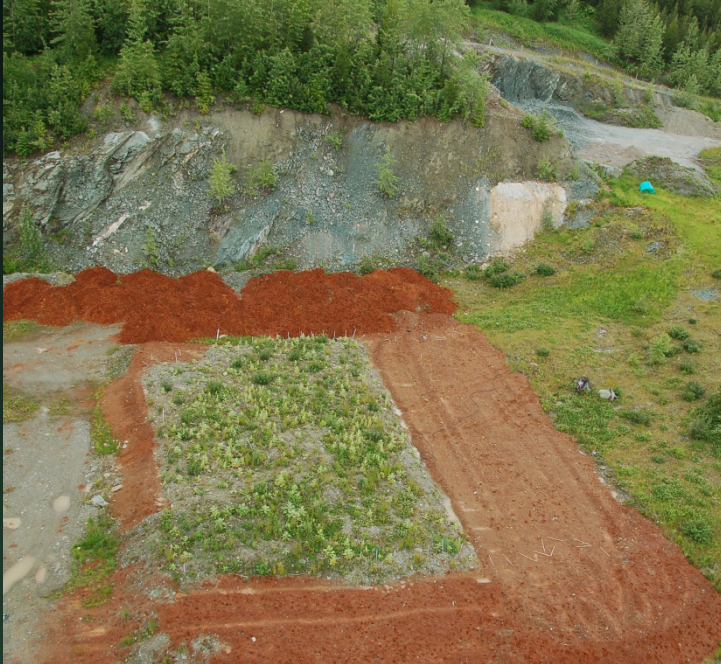
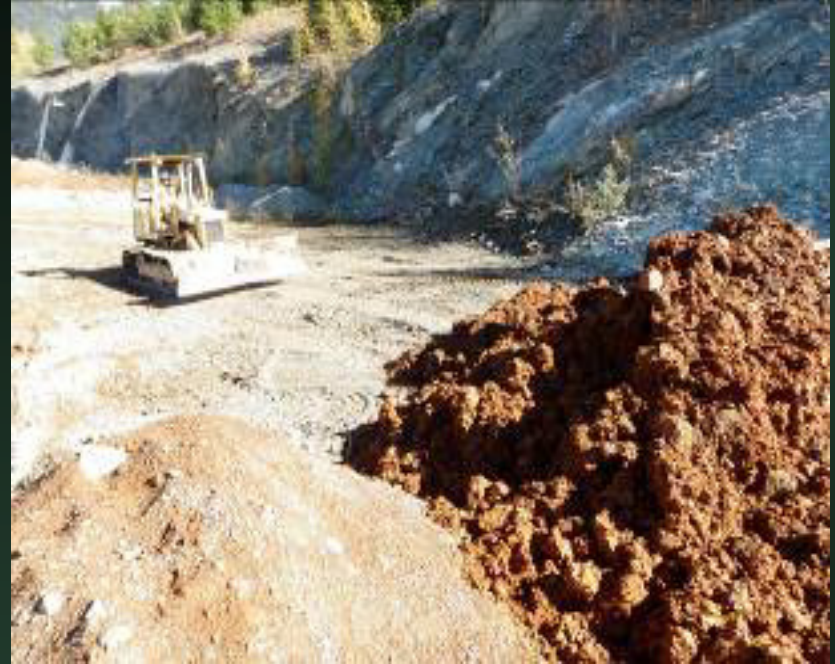
Sludge management – test plots, sludge piles
