Unexpected Events at Closed ARD Sites

BC MEND Conference- Vancouver
December 2013

Glencore Zinc Canada Closed Sites

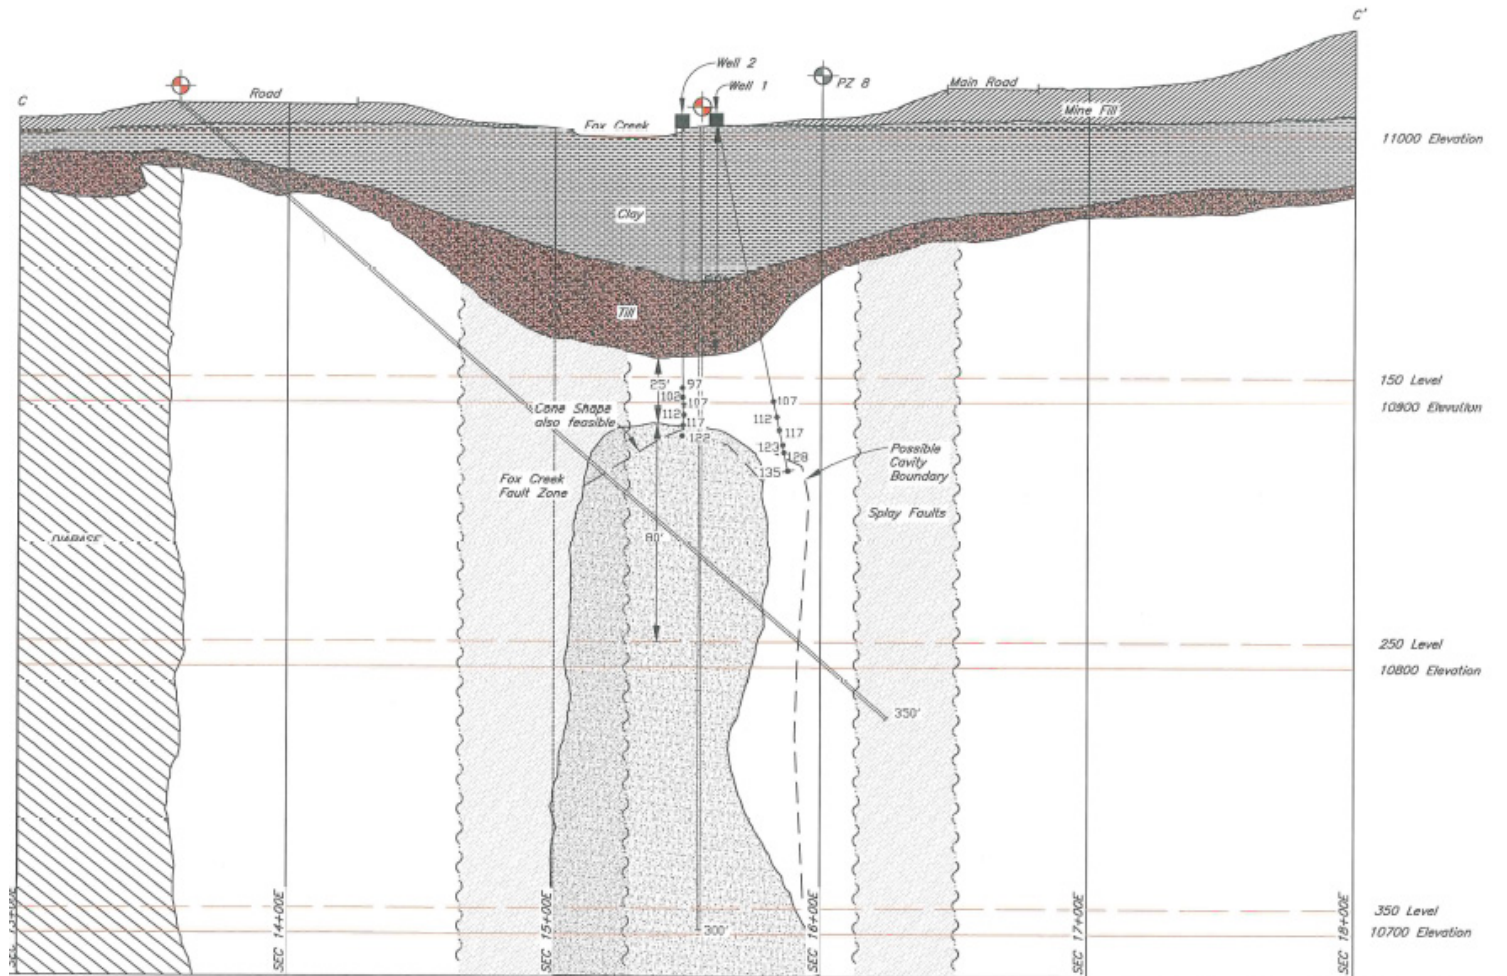
Section View of Geco Mine

- Crown pillar was to be mined in early 1990's
- Series of chimney caves occurred prior to mining resulted in collapse of much of the crown pillar in 1994
- Emergency remediation program started in January 1994 to pump backfill into the stope
- CMS performed after filling indicated fill was near top of cave zone

- Annual site risk assessment in 2004 indicated that stability of crown pillar should be investigated
- Desktop study indicated that crown pillar would fail if backfill (tech foam) failed
- Holes drilled into crown pillar in 2006 found a void in the backfill large enough to eventually cause failure and a 6 m thick crown pillar with low RQD numbers

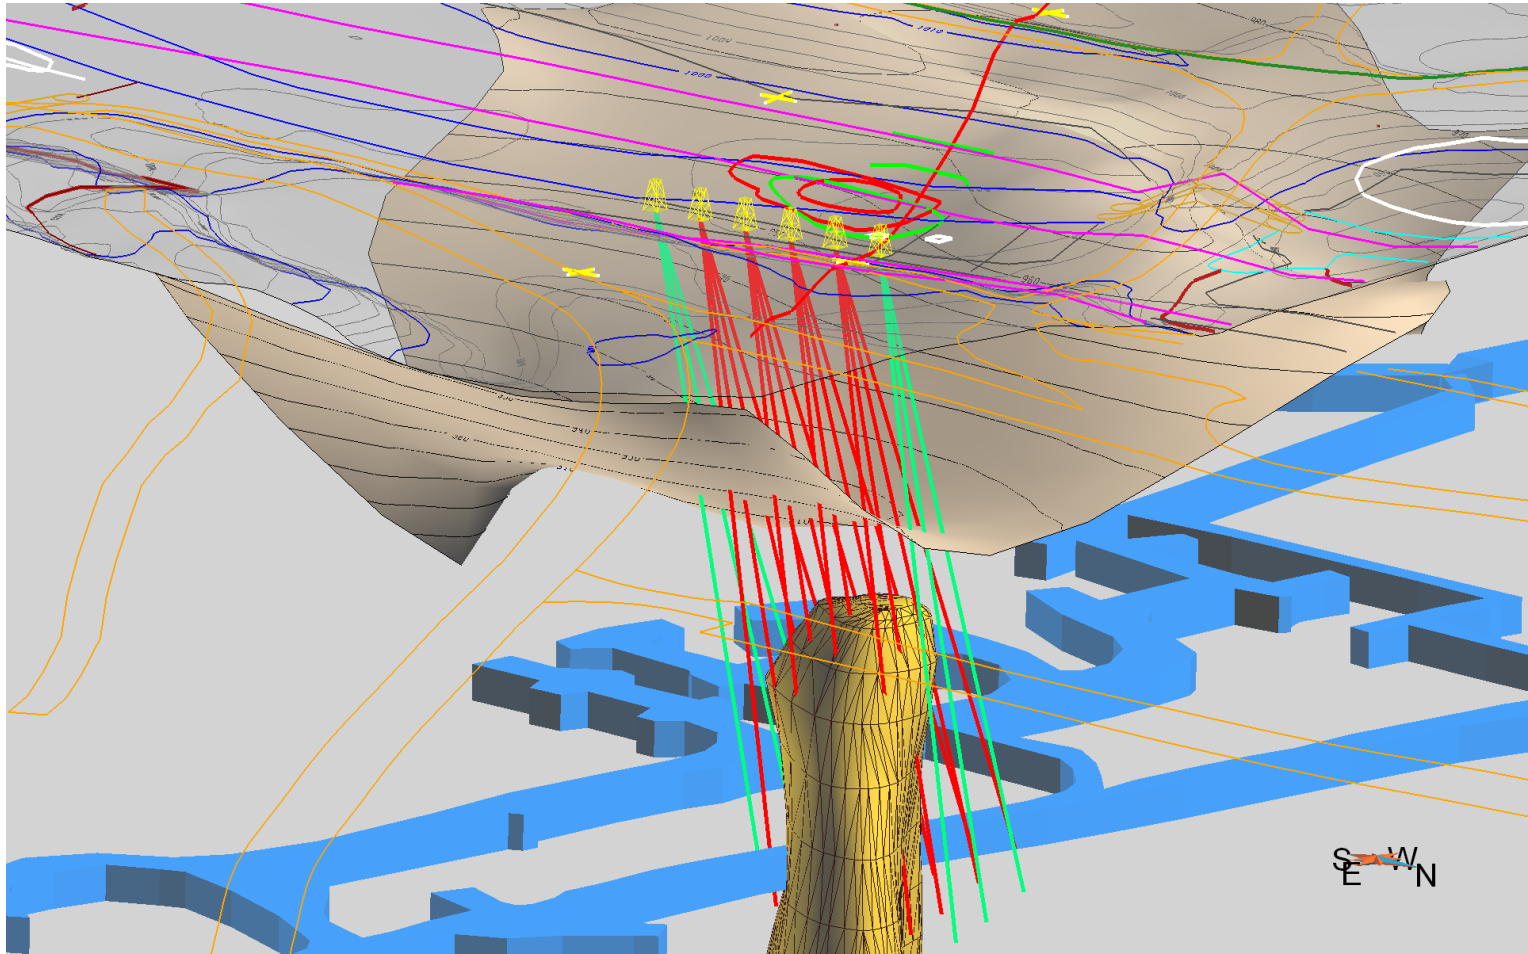
Drill Program to Define Void

- Drill a series of holes to define extent and size of void, crown pillar now 4 m thick
- Enlarge selected holes for introduction of backfill
- Stockpile of minus 2 inch material on site
- Batching plant on site to mix gravel with 4% cement to back fill void

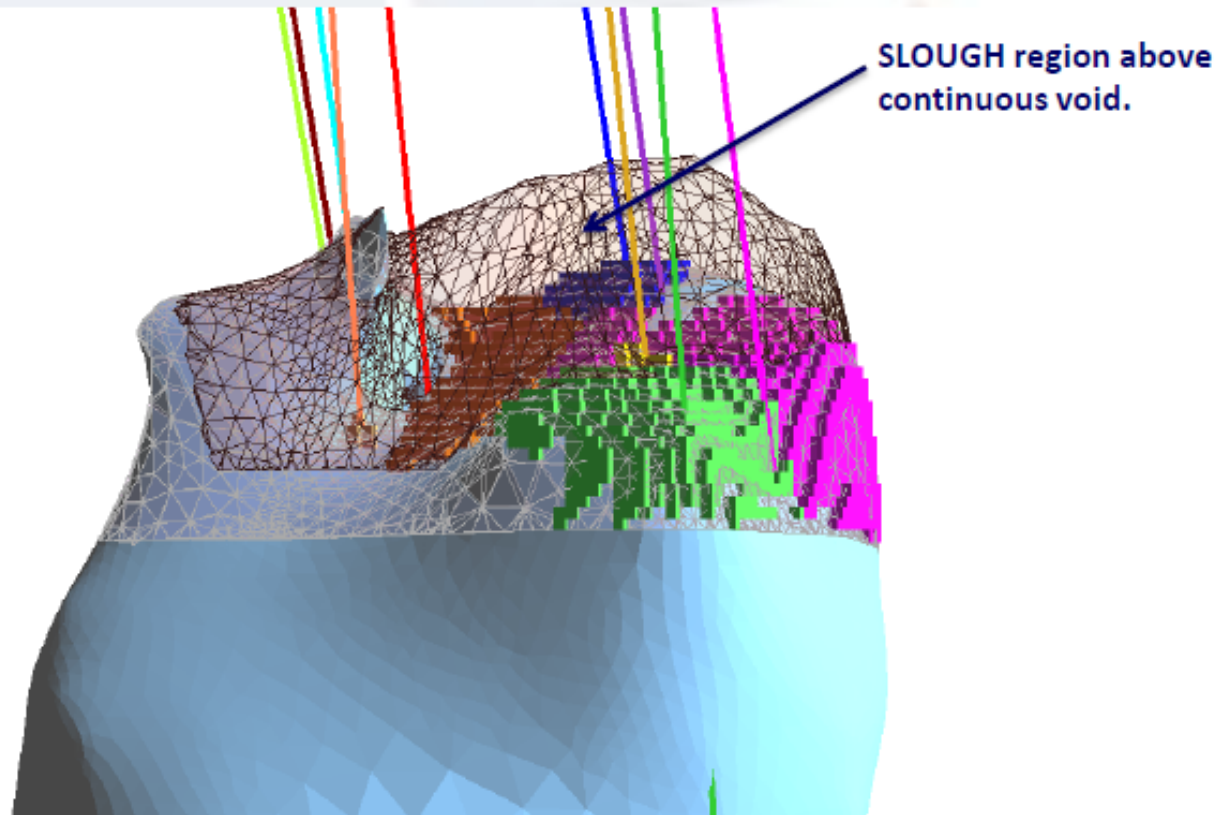
Filled Void

Looking Southwest
