Rum Jungle

Investigation of Future Rehabilitation Requirements

Northern Territory

Department of Mines and Energy

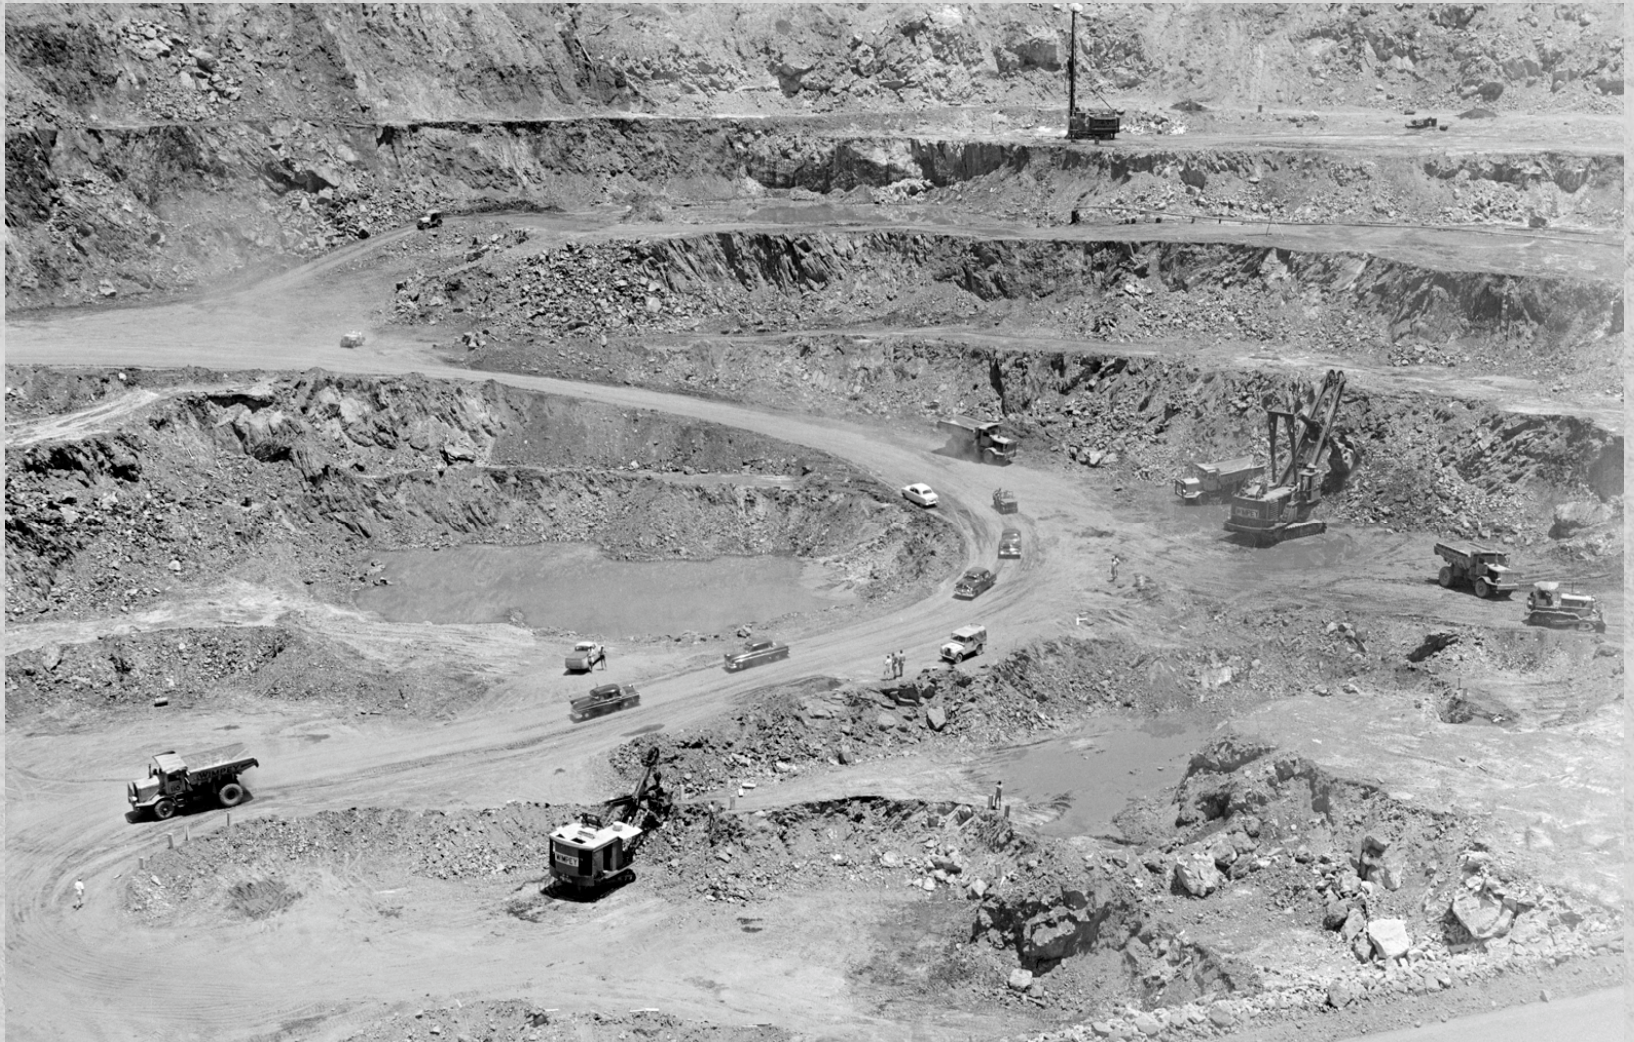
Mining – 1954 to 1971

- Most mining completed by 1963
- 3,530 tonnes of U_3O_8 produced
- 20,222 tonnes of Copper concentrate produced
- Processed stockpiled ore until shutdown in 1971

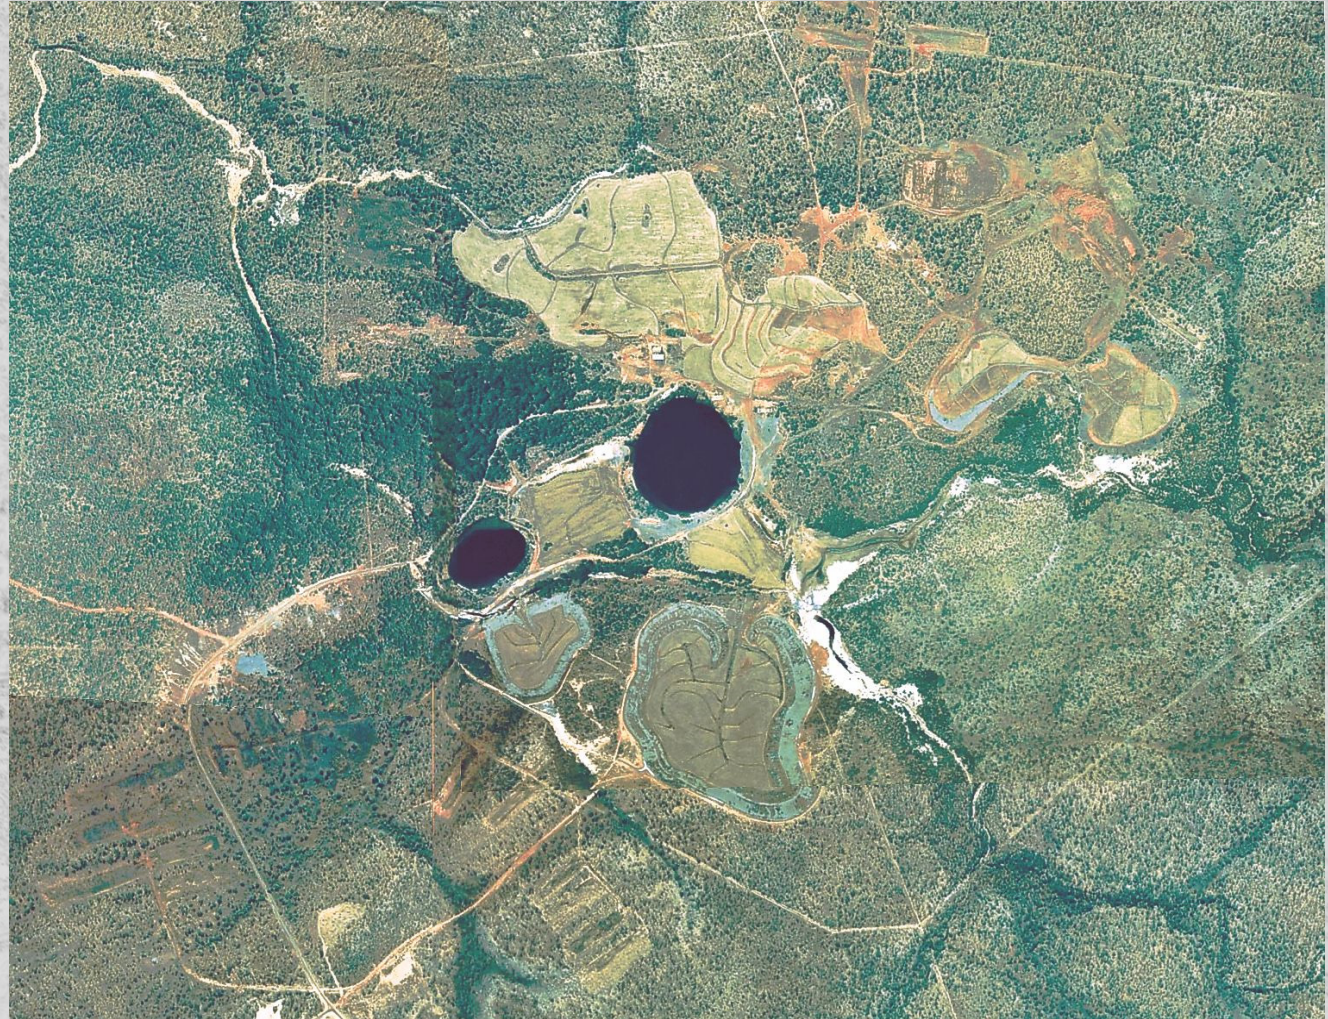
- Reclaimed tailings & heap leach material
- Reshaped and covered WRD's
- Treated water in the flooded pits

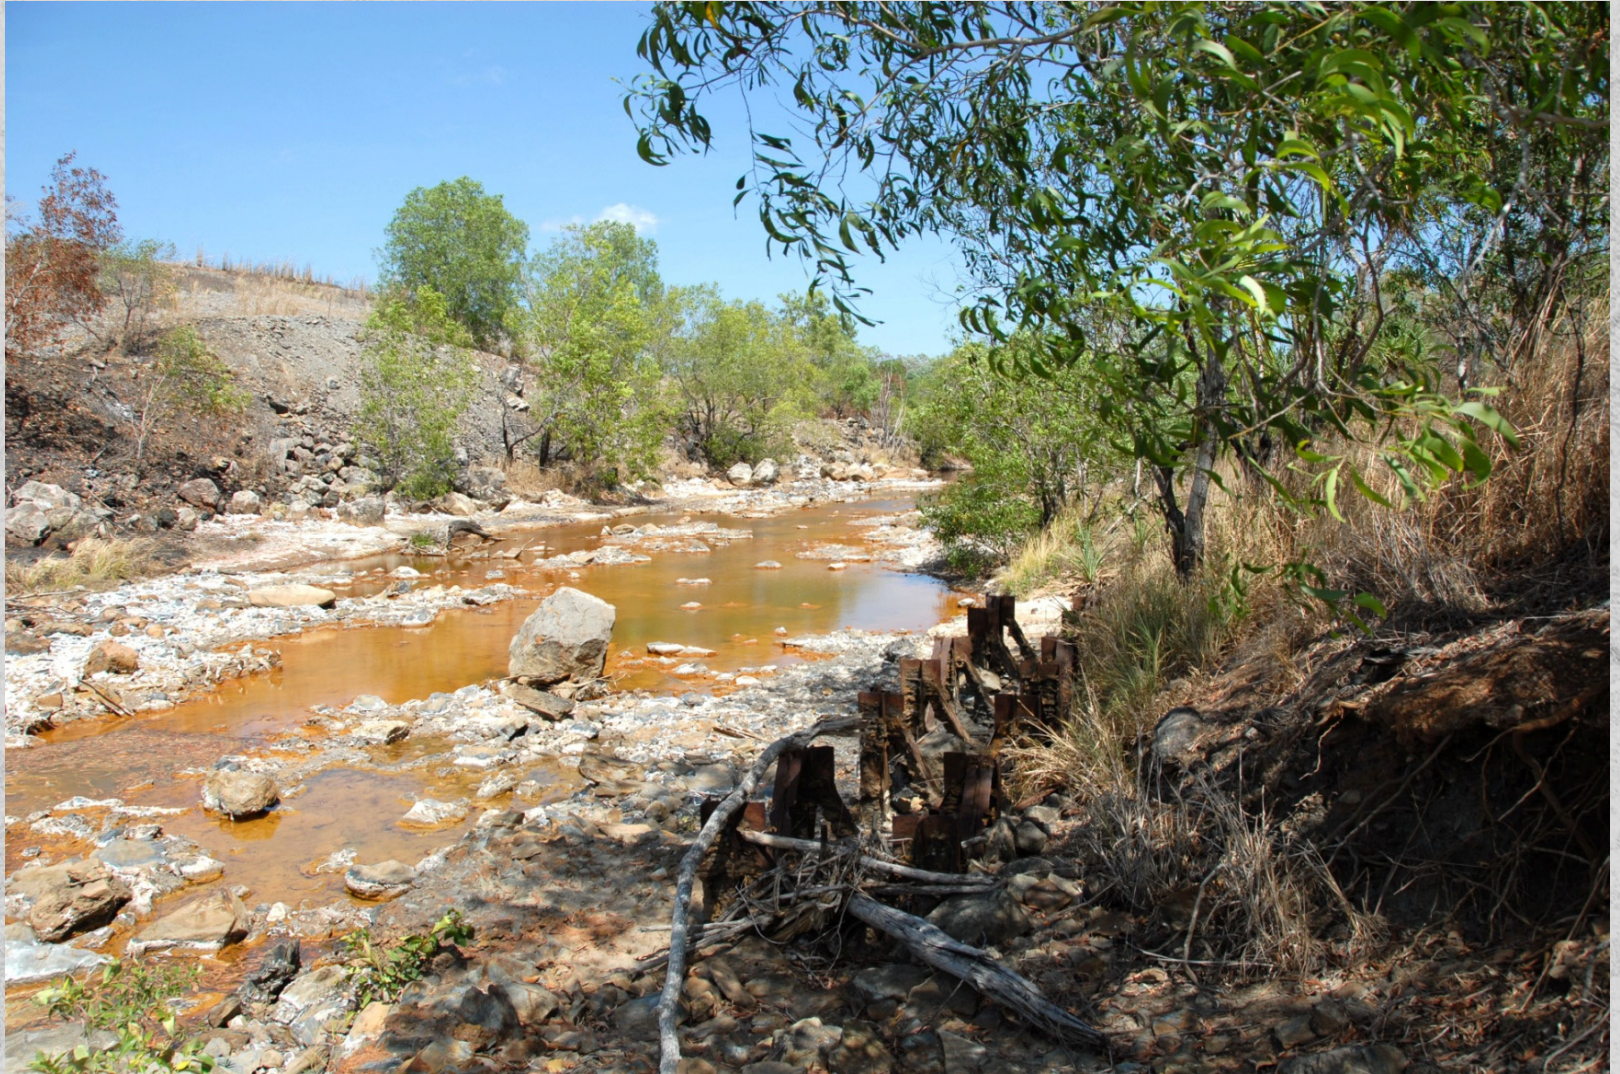
The Site 2013

- Post Rehabilitation
 - Water quality in the East Branch of the Finniss River improved
 - Does not meet current leading practice standards for mine closure
- Continuing impacts from Acid and metalliferous drainage (AMD)

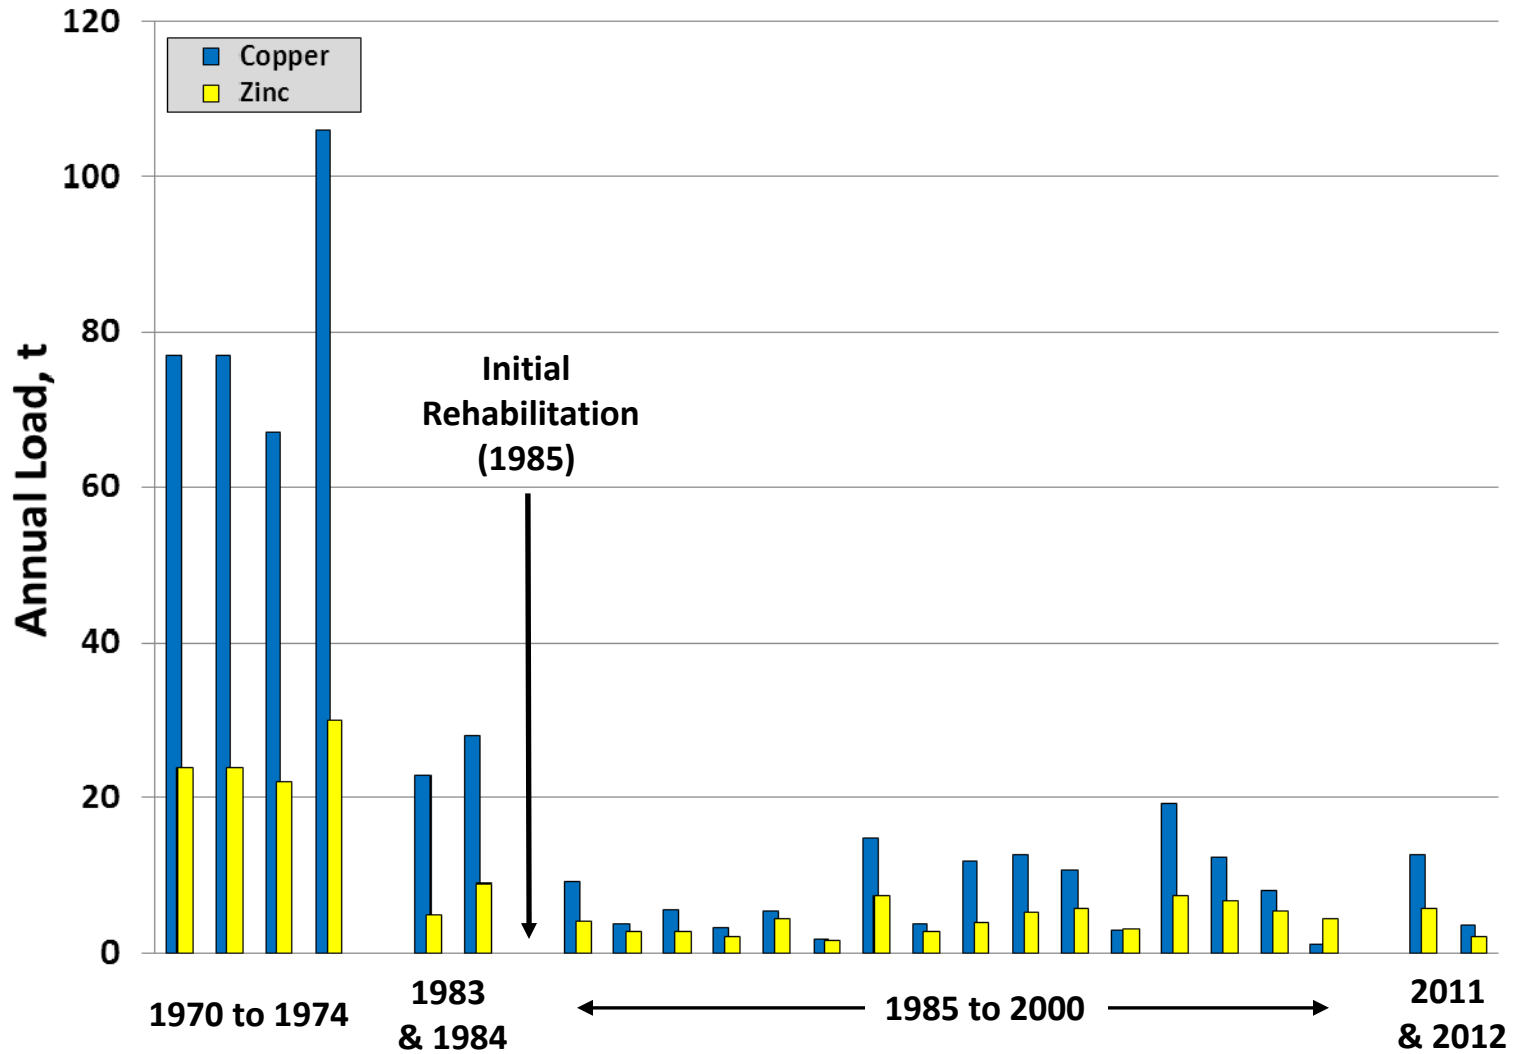
Seepage loads in the East Branch of the Finnis River

- Analysed data monitoring data on and downstream of the site
- Annual load of SO₄ in the East Branch for 2010/2011 was about 3,400 tonnes
- Annual loads of dissolved metals range from 5 tonnes for Cu & Ni to 24 tonnes for Mn

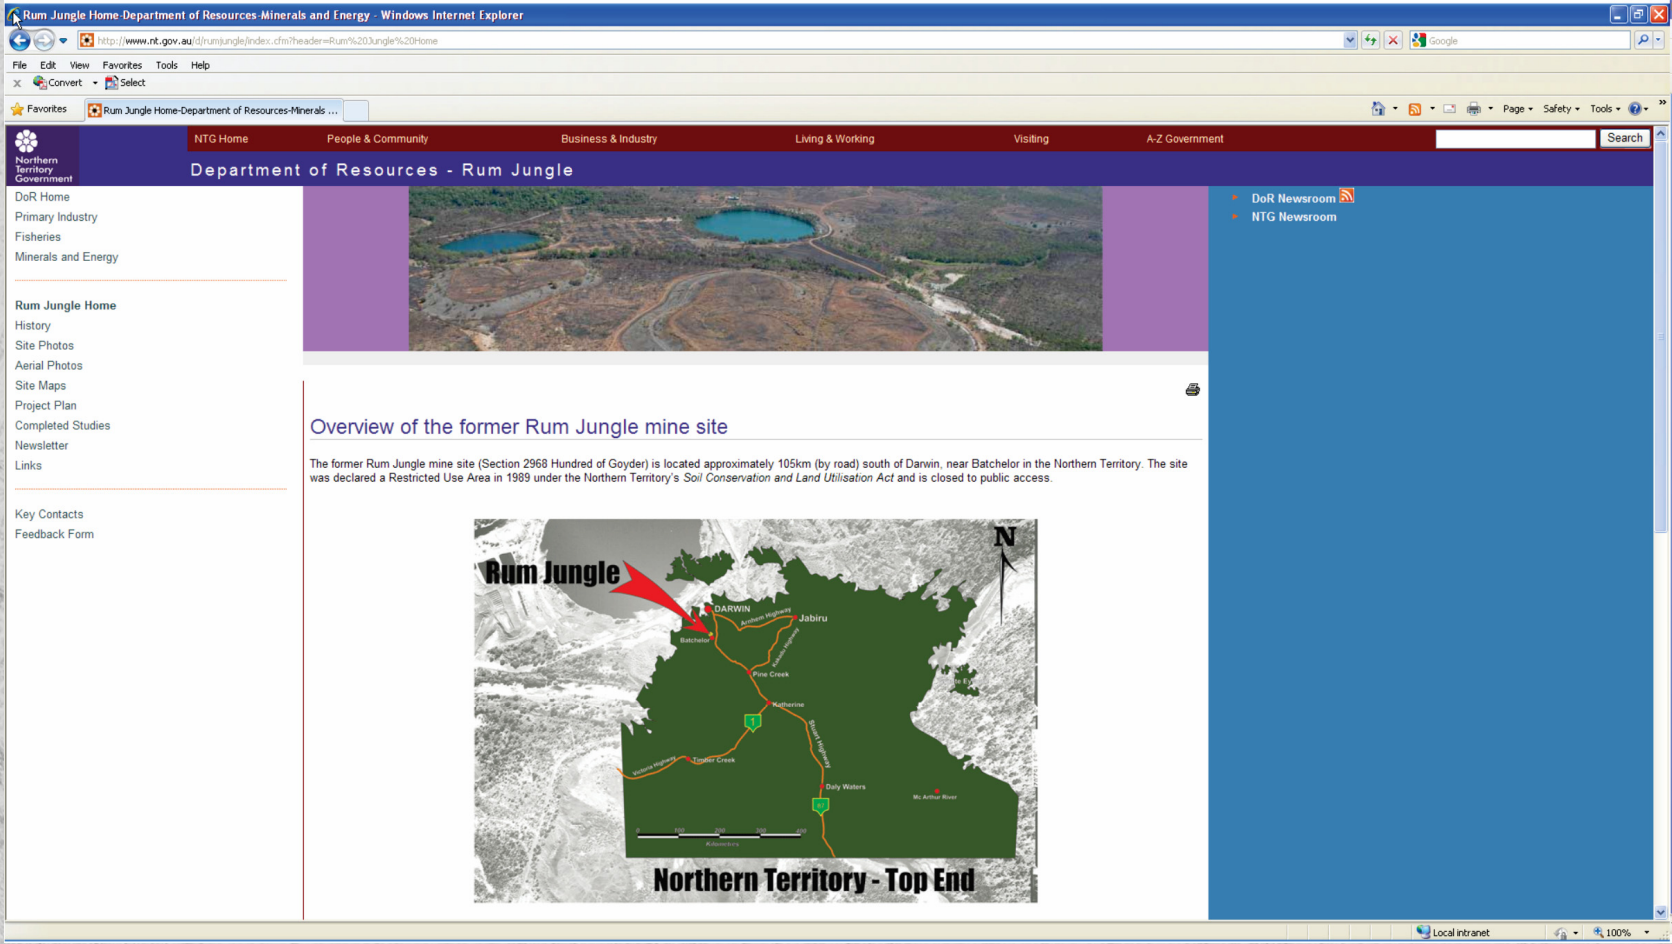
The screenshot shows a Windows Internet Explorer browser window displaying the website <http://www.rumjungle.nt.gov.au>. The browser's address bar shows the URL. The website's navigation menu includes links for NTG Home, People & Community, Business & Industry, Living & Working, Visiting, and A-Z Government. The main content area features a large aerial photograph of the Rum Jungle mine site, showing several large circular water bodies and surrounding terrain. Below the photo is the heading "Overview of the former Rum Jungle mine site" and a paragraph of text: "The former Rum Jungle mine site (Section 2968 Hundred of Goyder) is located approximately 105km (by road) south of Darwin, near Batchelor in the Northern Territory. The site was declared a Restricted Use Area in 1989 under the Northern Territory's Soil Conservation and Land Utilisation Act and is closed to public access." Below the text is a map of the Northern Territory titled "Northern Territory - Top End" showing major roads and locations. A red arrow points to the location of Rum Jungle near Darwin. The map includes labels for Darwin, Jabiru, Pine Creek, Ruffalo, Daly Waters, and Mt. Arthur. A scale bar and a north arrow are also present. The browser's status bar at the bottom shows "Local intranet" and "100%".

- Web-GIS
 - Accessible by the public from **www.rumjungle.nt.gov.au**
- Historic and current aerial imagery, cadastre, photos, contours, data from investigations commissioned (e.g. waste rock characterisation, soil contamination)
- Conceptual rehabilitation plan
