22nd BC MEND Metal Leaching and Acid Rock Drainage Workshop

Performance of Cover Systems With Geosynthetic Barrier Layers

Presentation Discussion Points

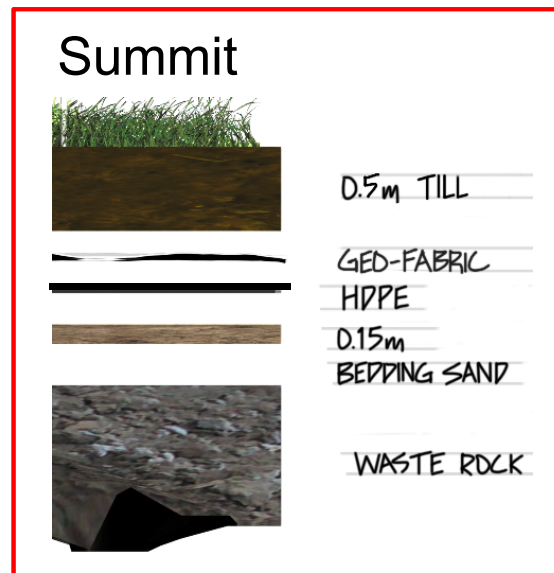
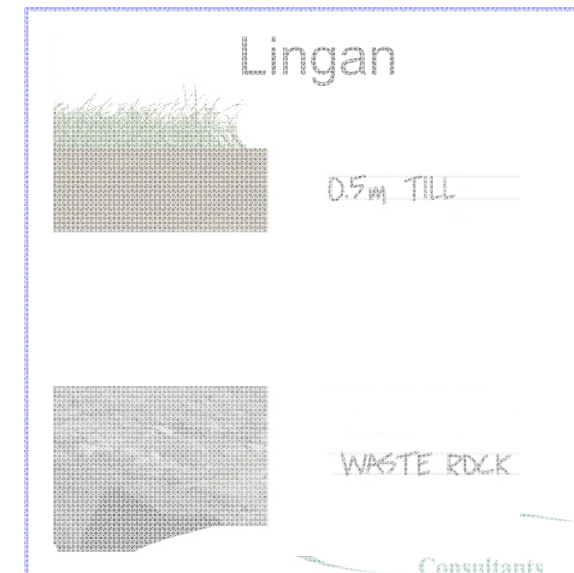
Water Balance

- Surface runoff and interflow ~67% for the geomembrane cover systems
- NP offsets proportional runoff volume
- NP
 - Lingan ~29%
 - **Summit ~5%**
 - **VJ <0.1%**
 - **Franklin <0.1%**

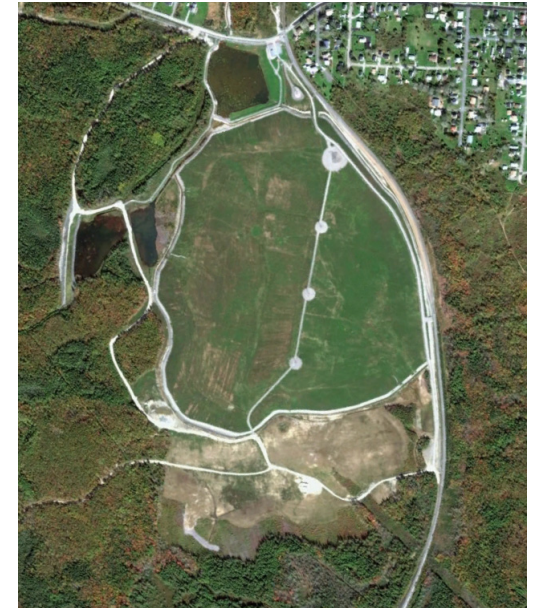
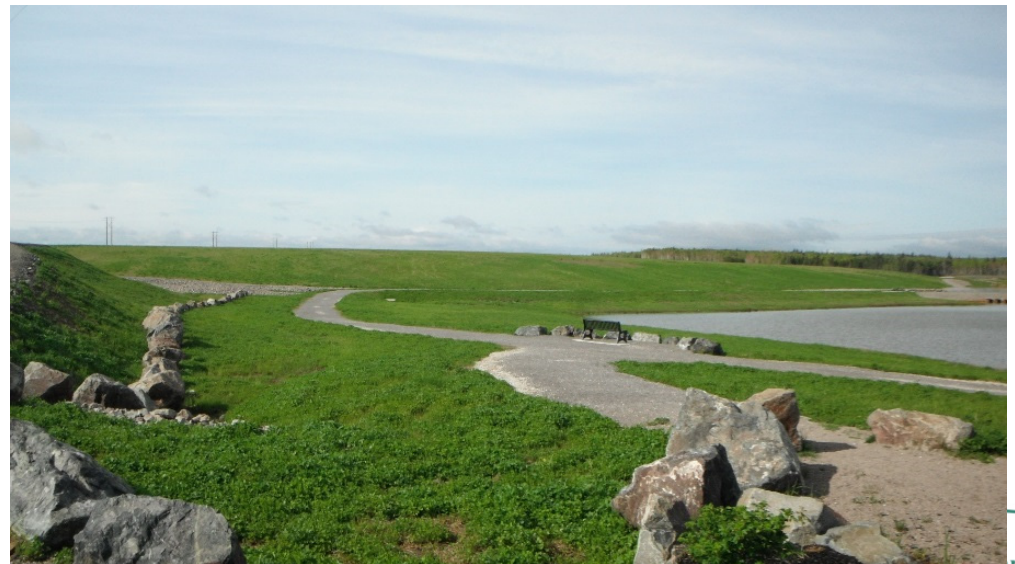
Reclaimed Summit WRP

- Footprint of ~44 ha
- Thickness of 1.5 m to 10 m
- Plateau 3% slope transitioning to 7:1 side slopes
- Runoff ditch constructed around the perimeter

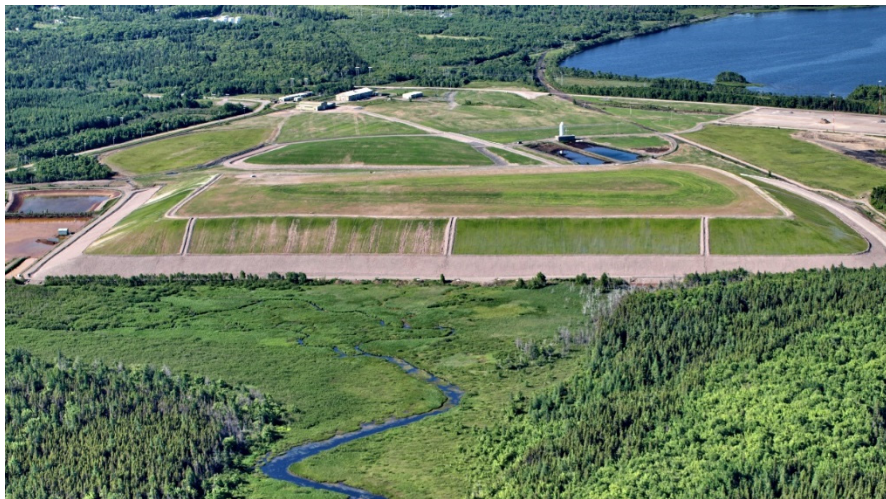
Reclaimed VJ WRP

- Footprint of ~26 ha
- Height of 40 m
- Plateau 7%
- Side slope 3:1
- Runoff ditch constructed around plateau channels flows to drop structures on side slopes

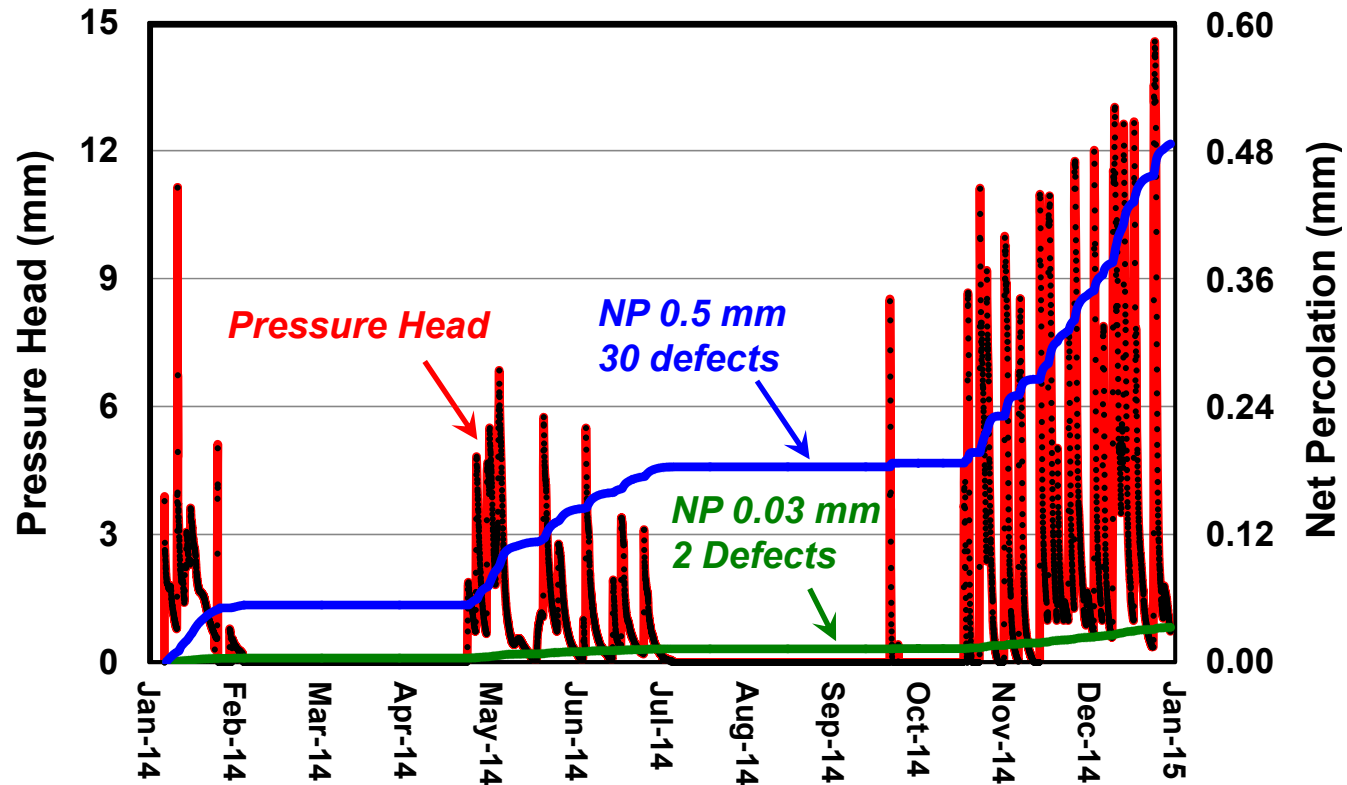
Simulated Net Percolation – VJ

- Simulated pressure head using measured lateral drainage
- Maximum pressure head ~12 mm
- **Risk for NP is low** under range of defects

But need to consider restriction to flow at the drainage layer outlet

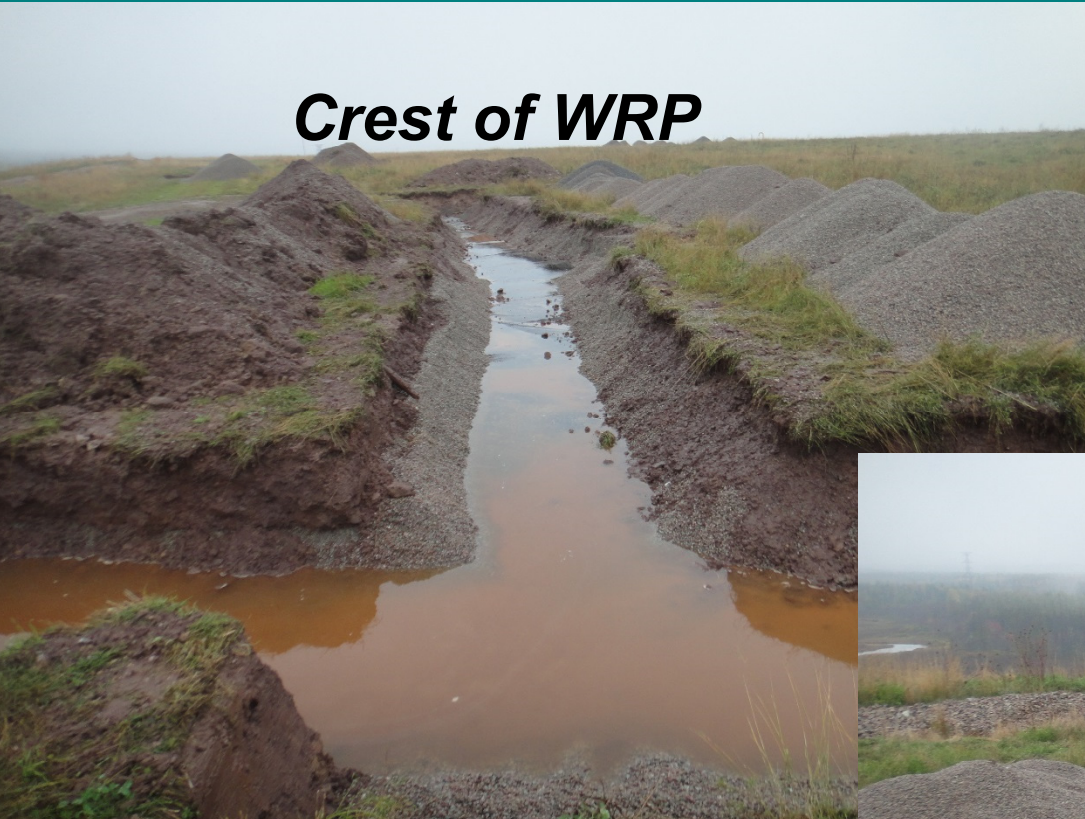
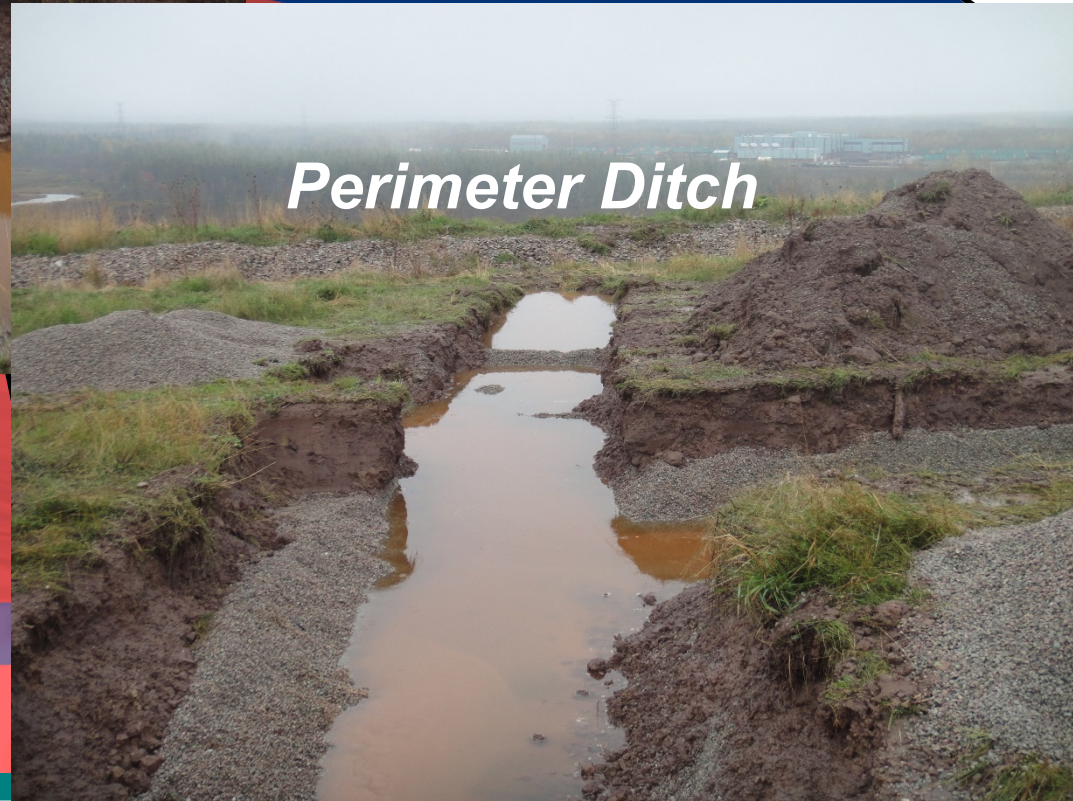
Measured Performance – VJ

Crest of WRP

the outlet to the

Perimeter Ditch

Geomembrane

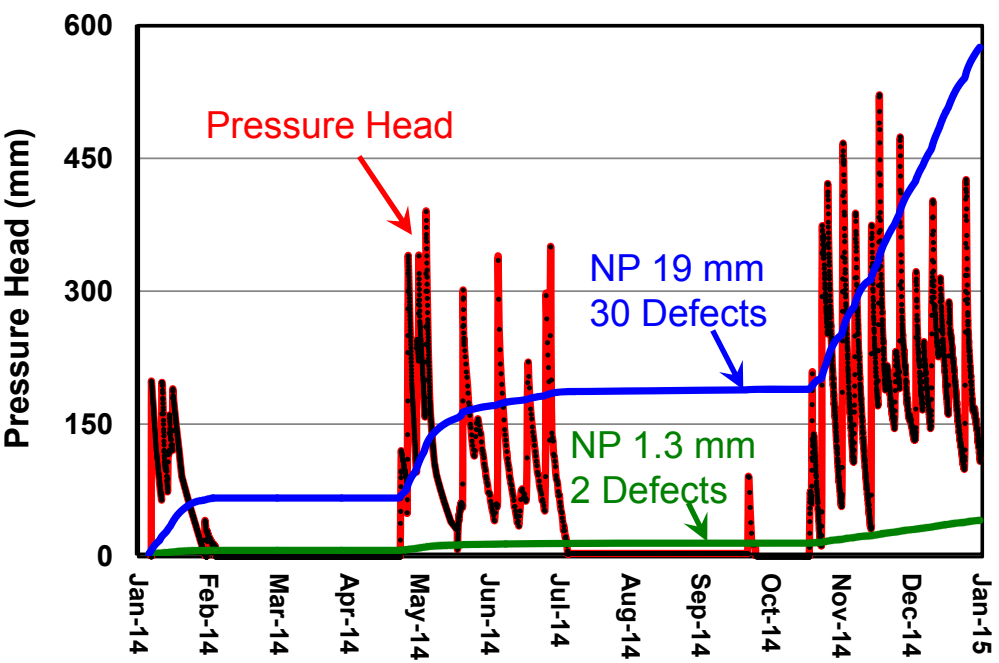
Simulated Net Percolation – VJ

- Measured pressure head reaches ~450 mm
- Simulated **NP for the landform is very low** < 2 mm
- **~6%** of surface area contributes to **70% of NP**

Daily Flux Rate (cm/s)	Head (mm)	Defects per hectare		
		2	15	30
Net percolation (mm/yr)				
Adequate drainage (94% of surface and 30% of total NP)				
transient	transient	0.03	0.2	0.5
Inadequate drainage (6% of surface and 70% of total NP)				
transient	transient	1.2	10	19
Landform		0.1	0.8	1.6

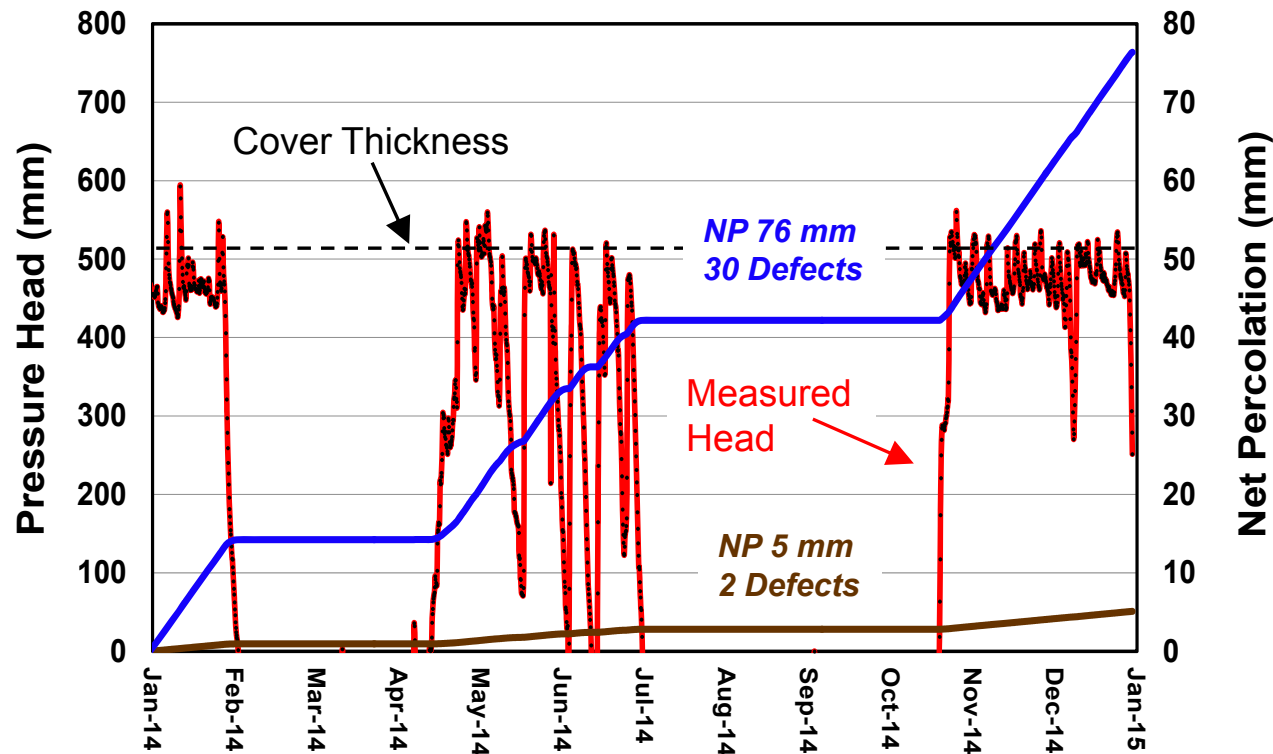
Measured Performance – Summit

- Maximum head is **~500 mm over prolong periods**
- NP is **76 mm or 5% of PPT** for 30 defects
- **Loading** to receiving environment would be **different under the simulated range of NP**

Risk Associated With Leakage is High

...Defects are a Concern! Number, Size, Distribution

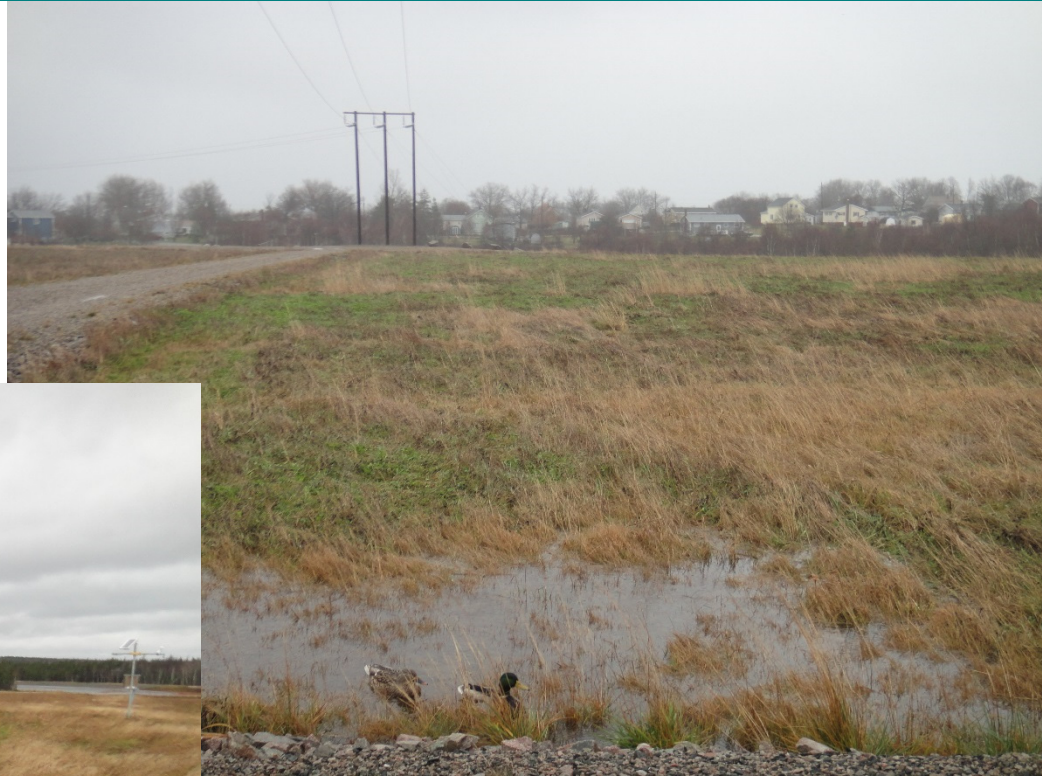
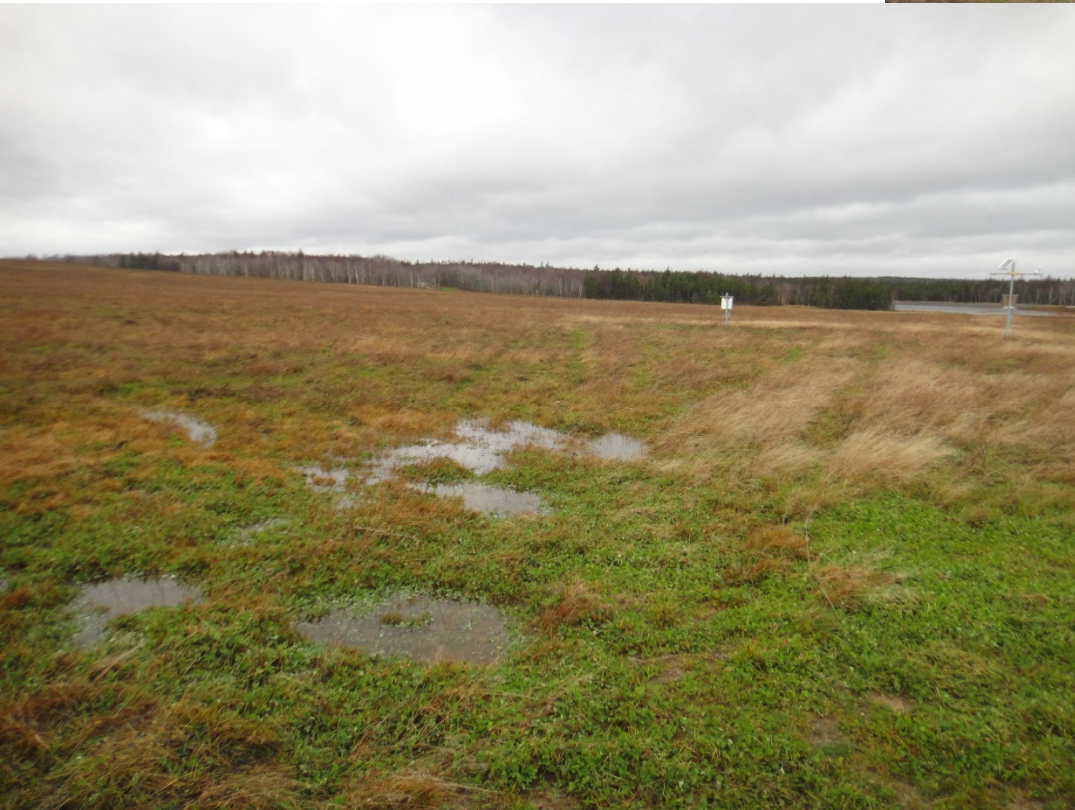
Seepage Erosion – Summit

- Monitored performance provides understanding of ***mechanism causing erosion*** (i.e. seepage erosion >> runoff) and ***approach used to stabilize cover system***

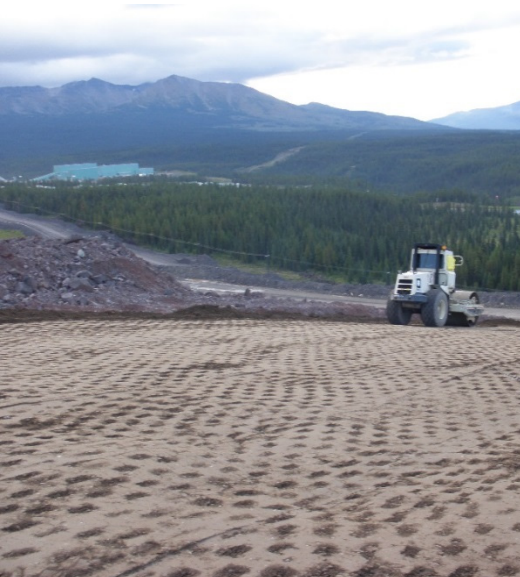
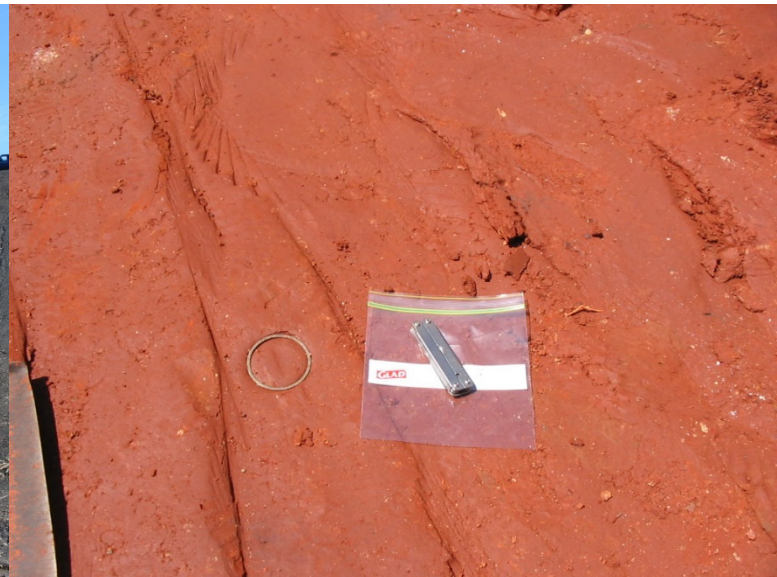
- CCL in Composite Cover System
 - *Tramplining* or *folds* may limit intimate contact with geomembrane
 - Borrow material not adequately defined, CCL does not meet design criteria

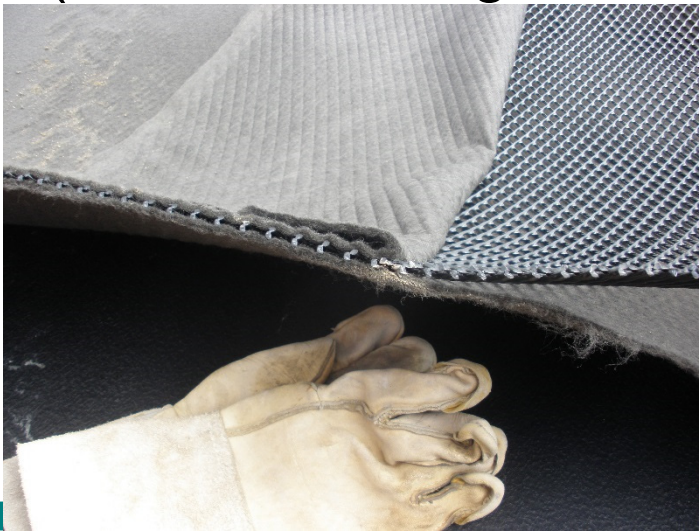
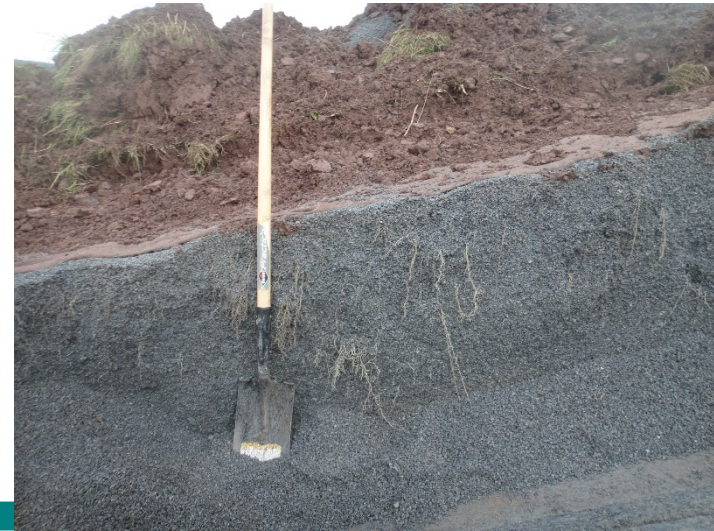
- GCL in Composite Cover System
 - **Incompatible** with in situ conditions (i.e. cation exchange), **K_s increases**
- Drainage layer (granular or geonet)
 - **Reduction factors** decrease K_s (i.e. root matting, fines ingress, deformation...)

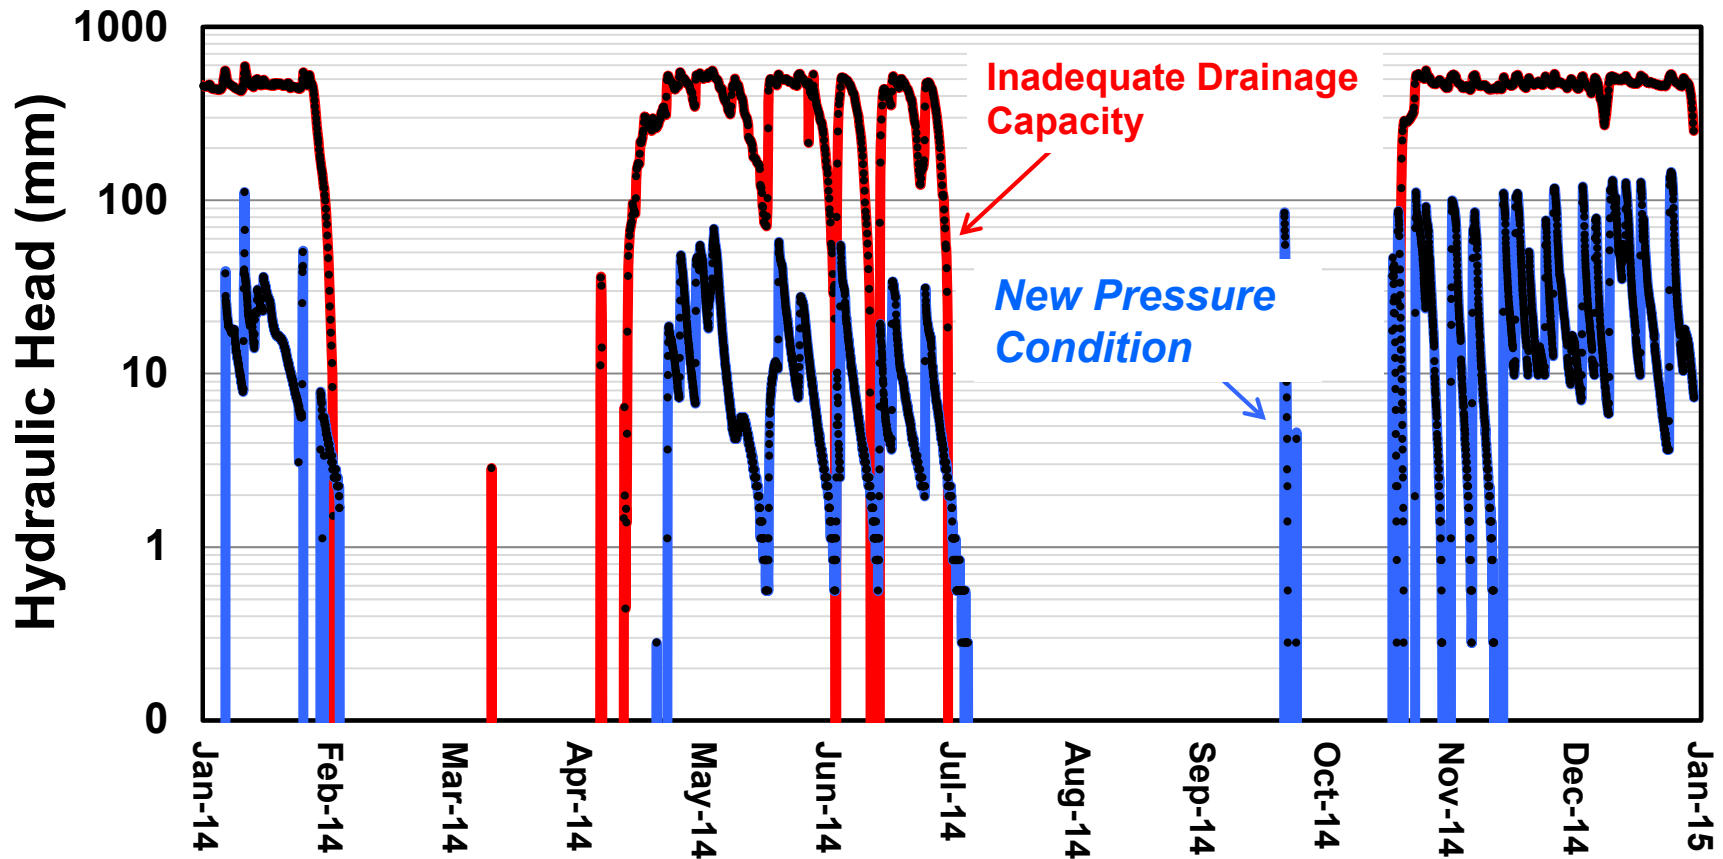
Cost, Complexity and Performance

- Ks of drainage layer decreases from 1 cm/s to 0.1 cm/s
- Establish new pressure condition

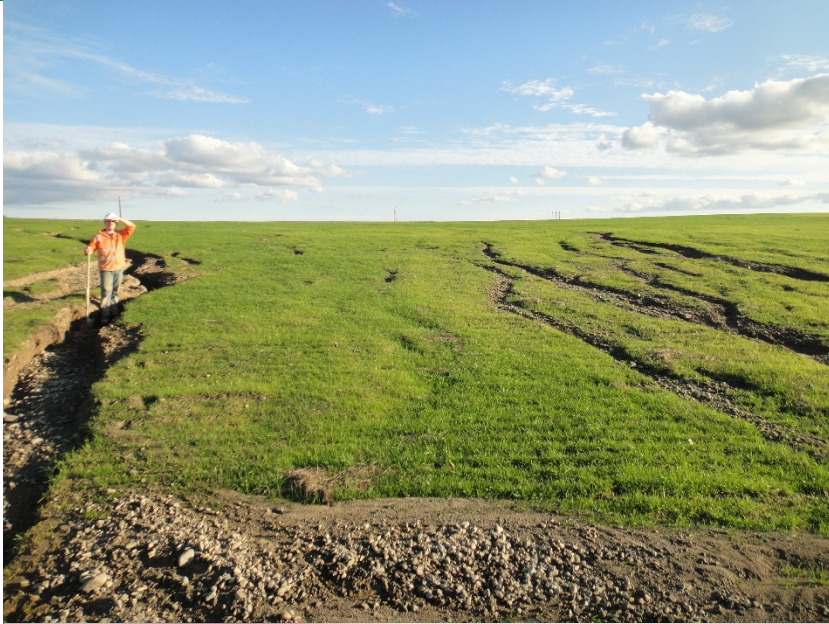
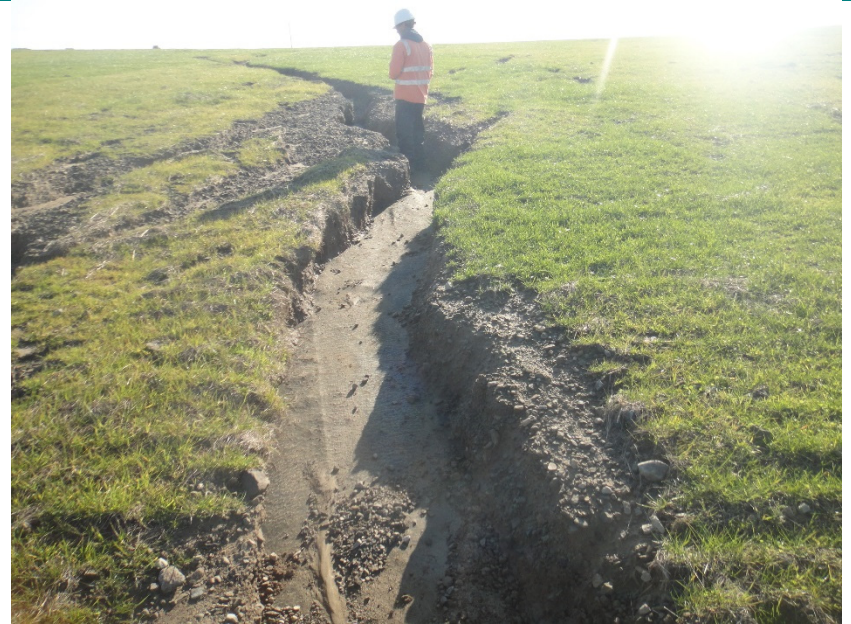
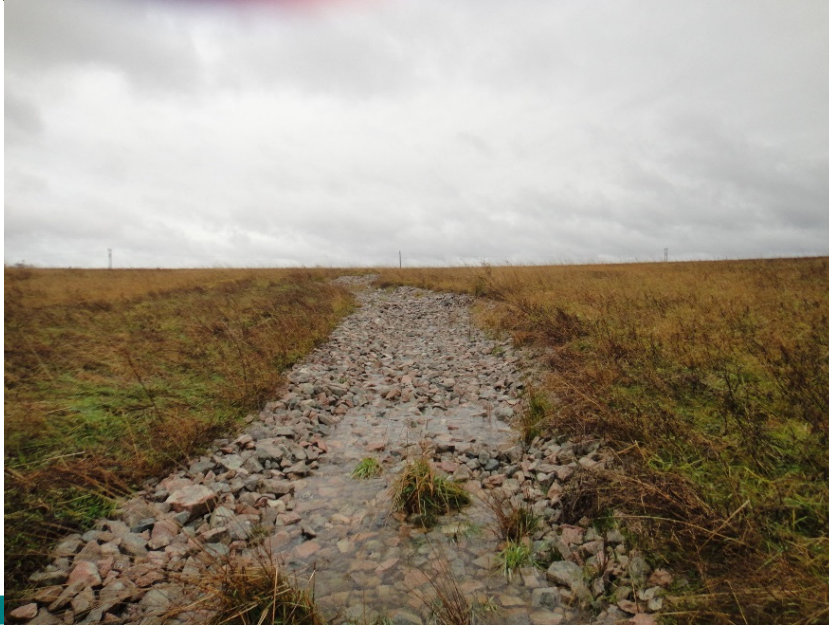
Seepage Erosion – Summit

- Monitored performance provides understanding of ***mechanism causing erosion*** (i.e. seepage erosion >> runoff) and ***approach used to stabilize cover system***

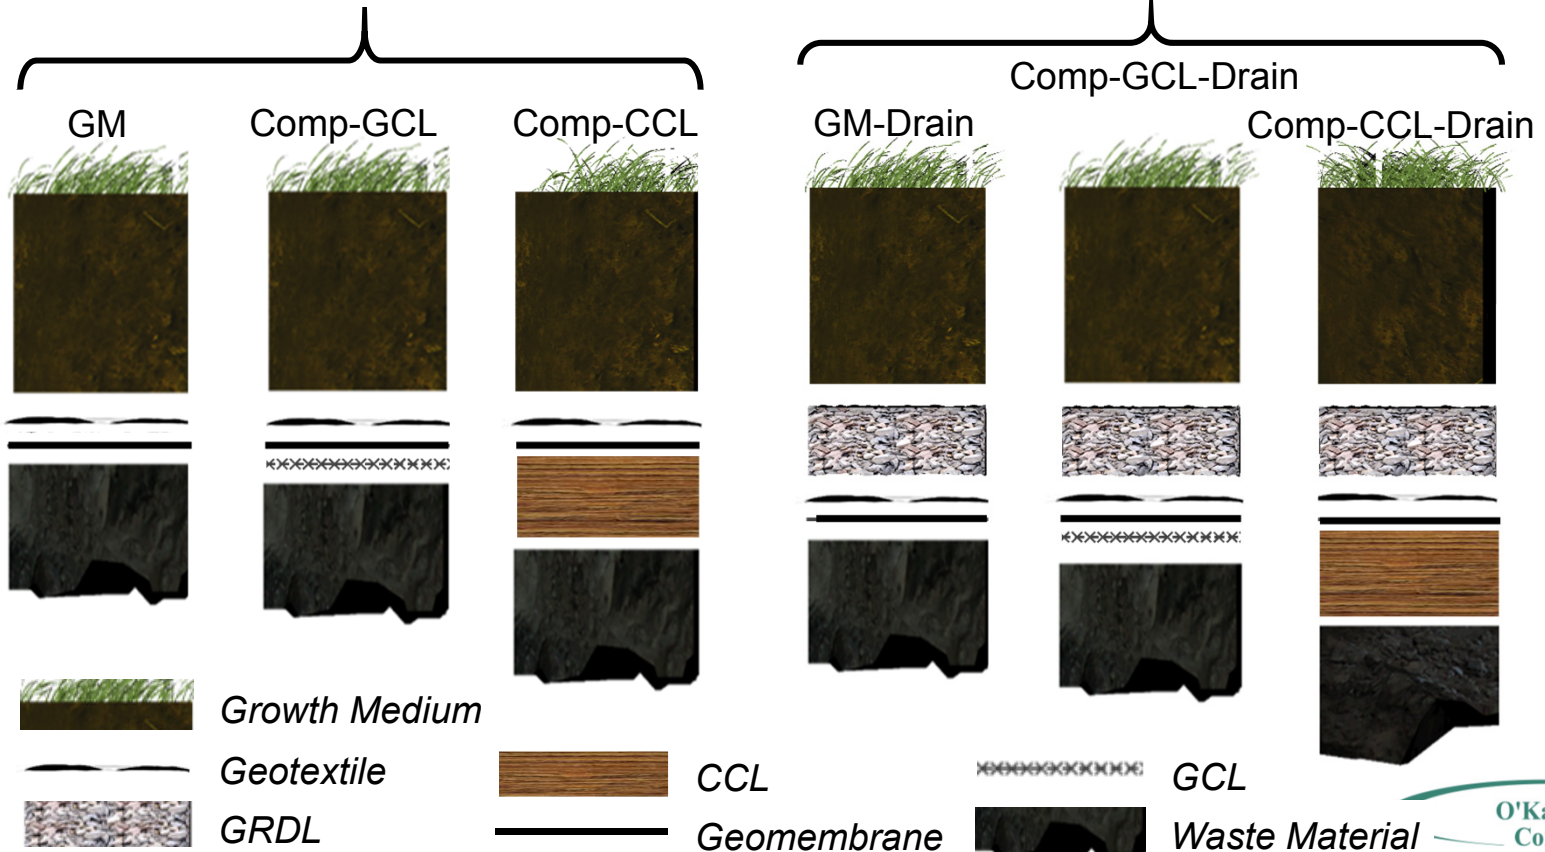
Cost, Complexity and Performance

Net Percolation (mm)

Inadequate Lateral Drainage Capacity

Adequate Lateral Drainage Capacity
