# Baker Creek Remediation

**GIANT MINE REMEDIATION PROJECT**

12 September 2018 – Carcross YT

# Baker Creek Remediation at Giant Mine

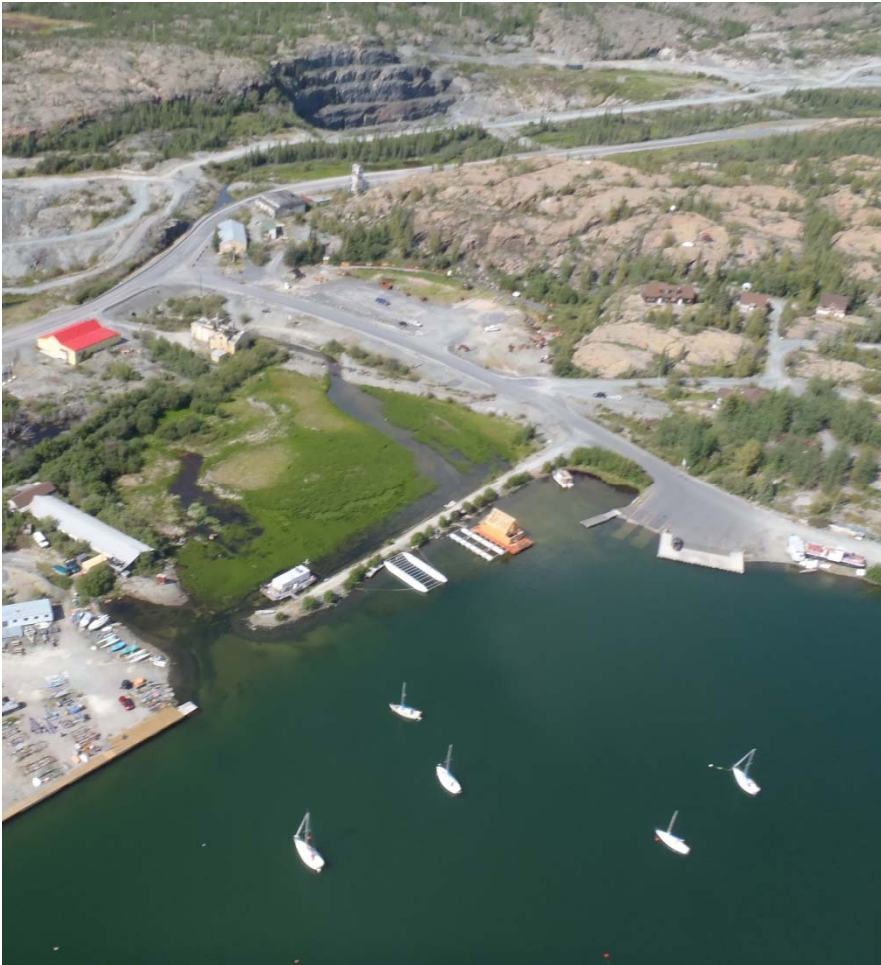
## CLOSURE CONSIDERATIONS

- Flood risk to underground mine and closure infrastructure
- Mobilization of tailings and contaminated sediments
- Baker Creek water quality
- Fish habitat at closure

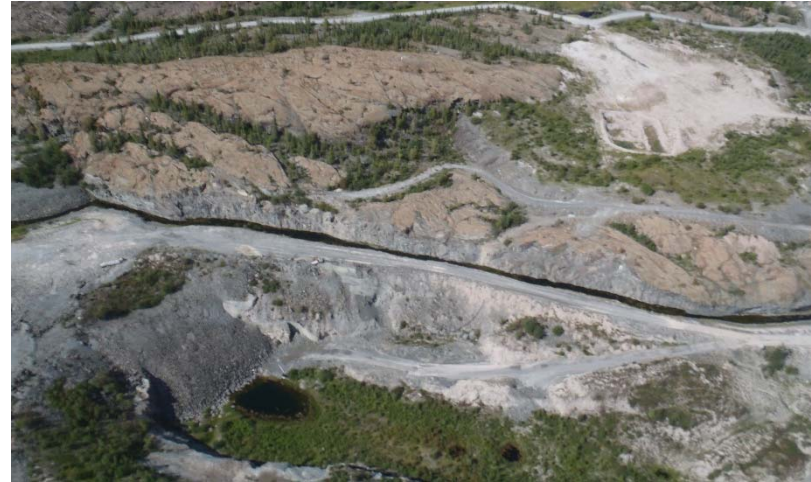
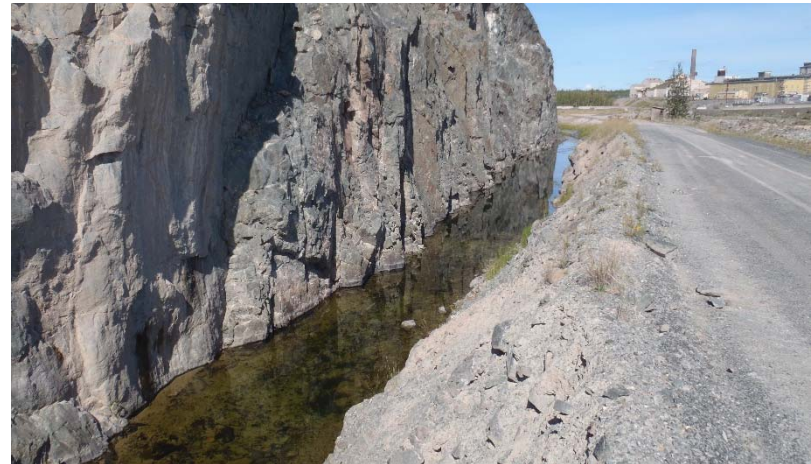
- Mine pits adjacent to Baker Creek represent a potential flow path to the underground mine
- Channelization of the creek has reduced flow capacity and increased risk of blockage due to ice and debris

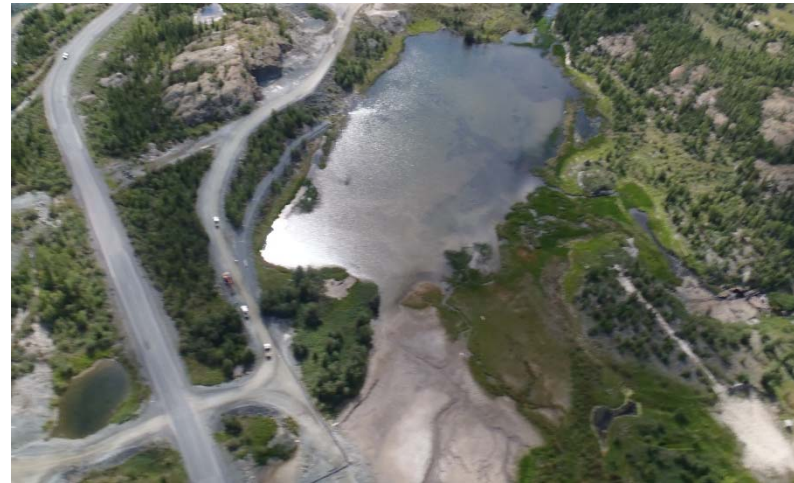
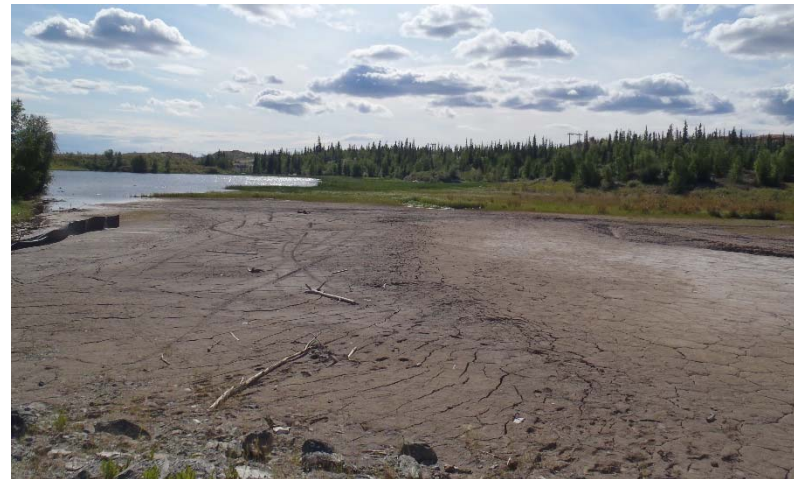
- Fine sediments in Baker Creek and Baker Pond include contaminated sediments and some tailings
- Distributions of these sediments are irregular but they contribute to ecological and water quality effects

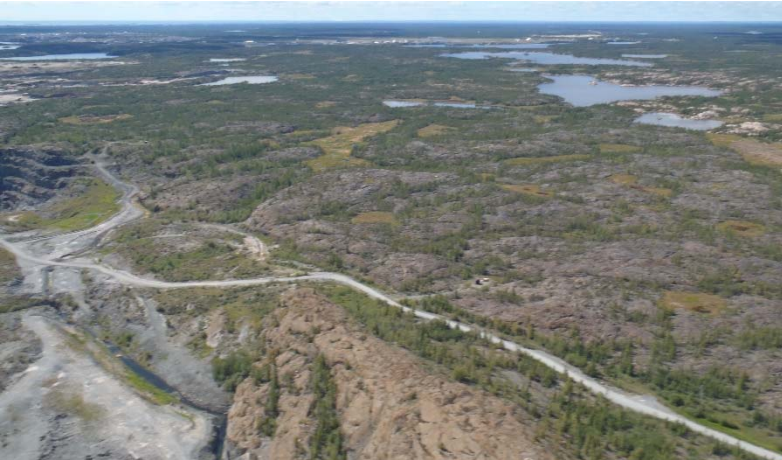
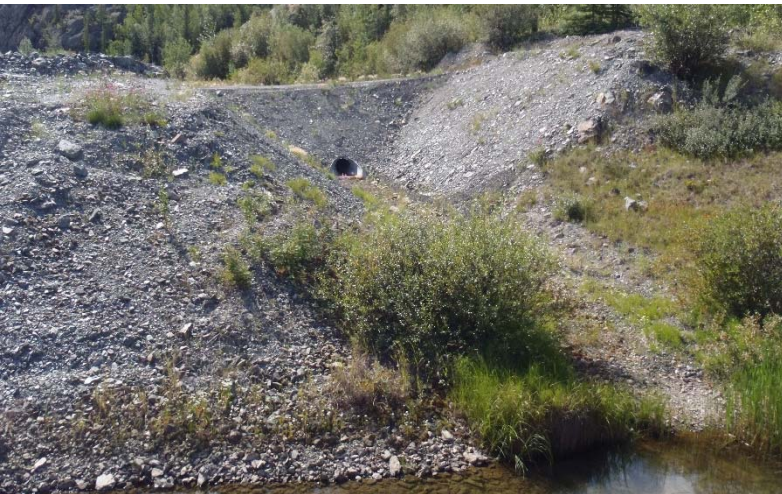
- Water quality at the mine is affected by upstream and local runoff, due to historical aerial deposition of contaminants
- Baker Creek arsenic concentrations almost double from 40 to 70  $\mu\text{g}/\text{L}$  through the mine site, on average

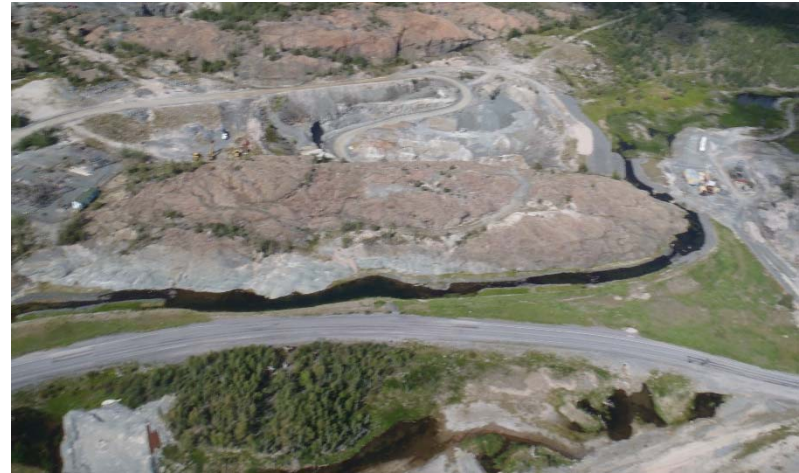
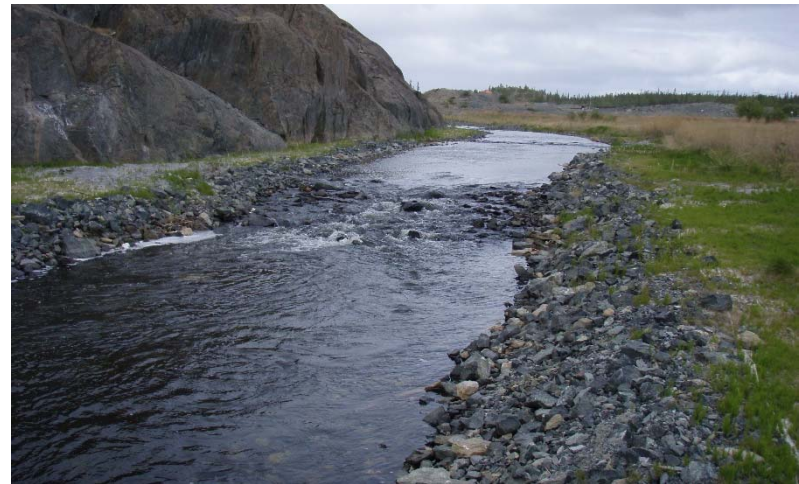
- Baker Creek currently provides spawning and rearing habitat for spring spawners (e.g., Arctic grayling)
- Fish passage is naturally blocked by a waterfall above Baker Pond

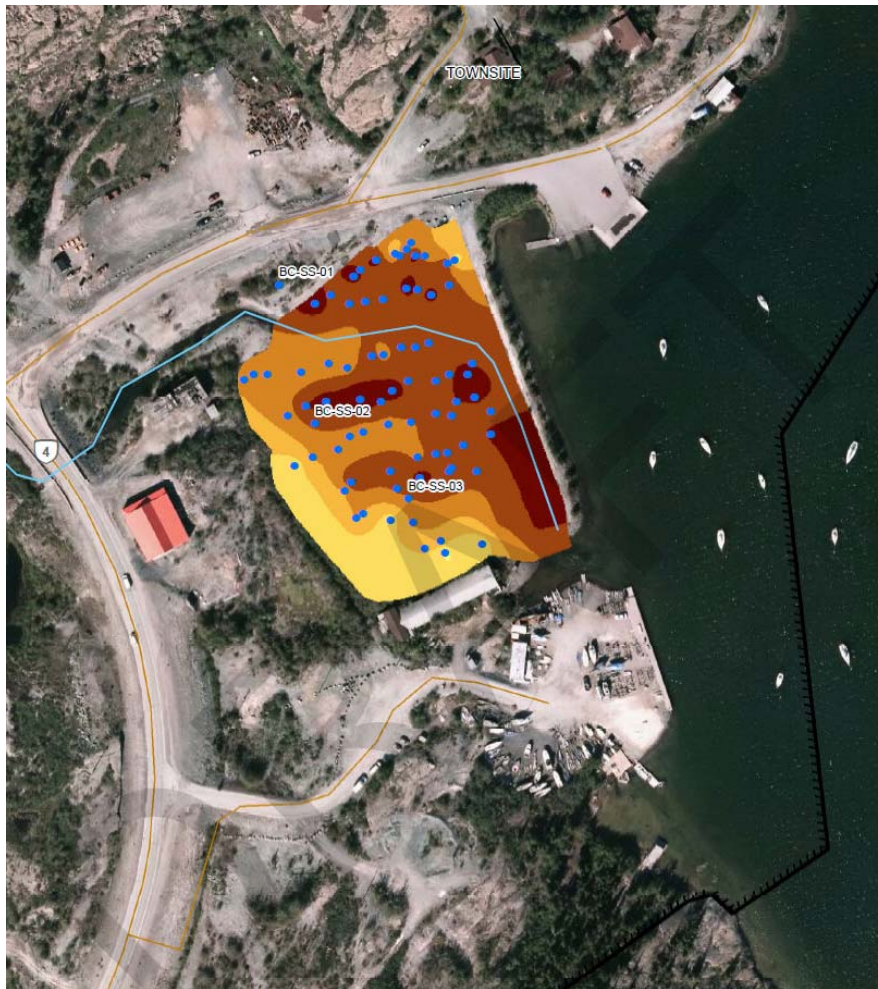
### Fine Sediments:

- Fine sediments – including tailings where present - will be removed from Baker Creek where present
- Replacement with clean substrates

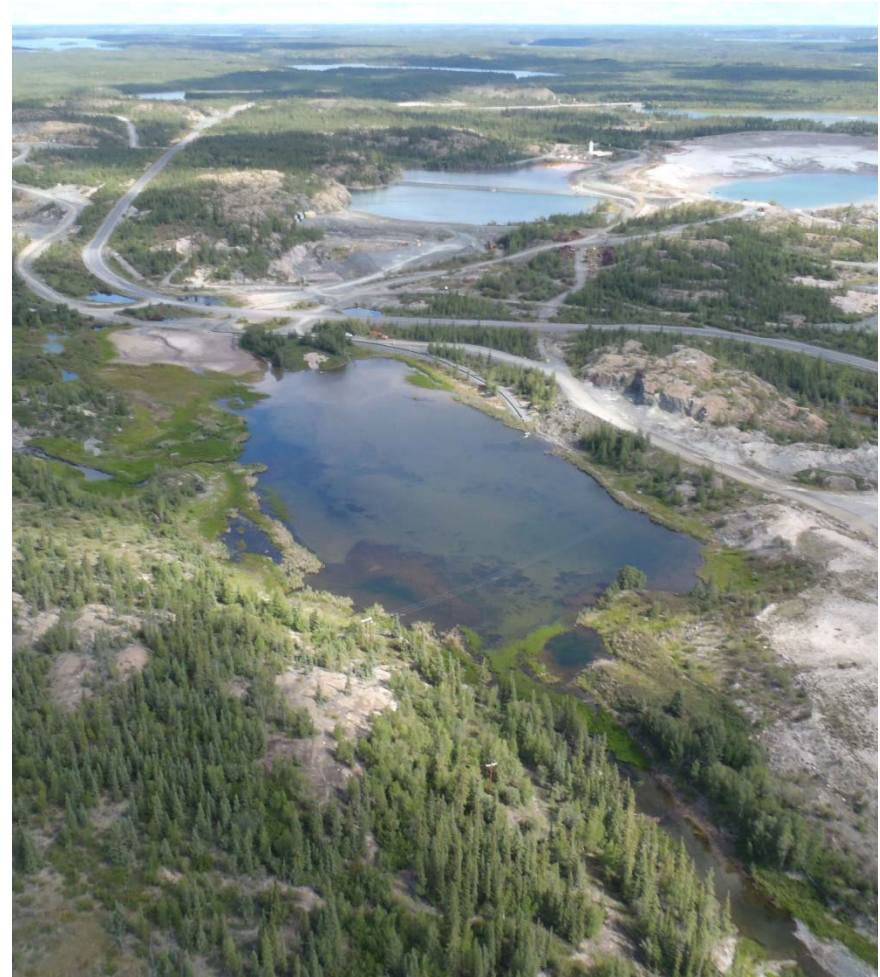
### Water Quality:

- Treated mine water will no longer be discharged to Baker Pond
- Contaminated soil remediation, tailings covers and site water management will reduce arsenic loading
- Treatment wetlands are subject of reclamation research plan

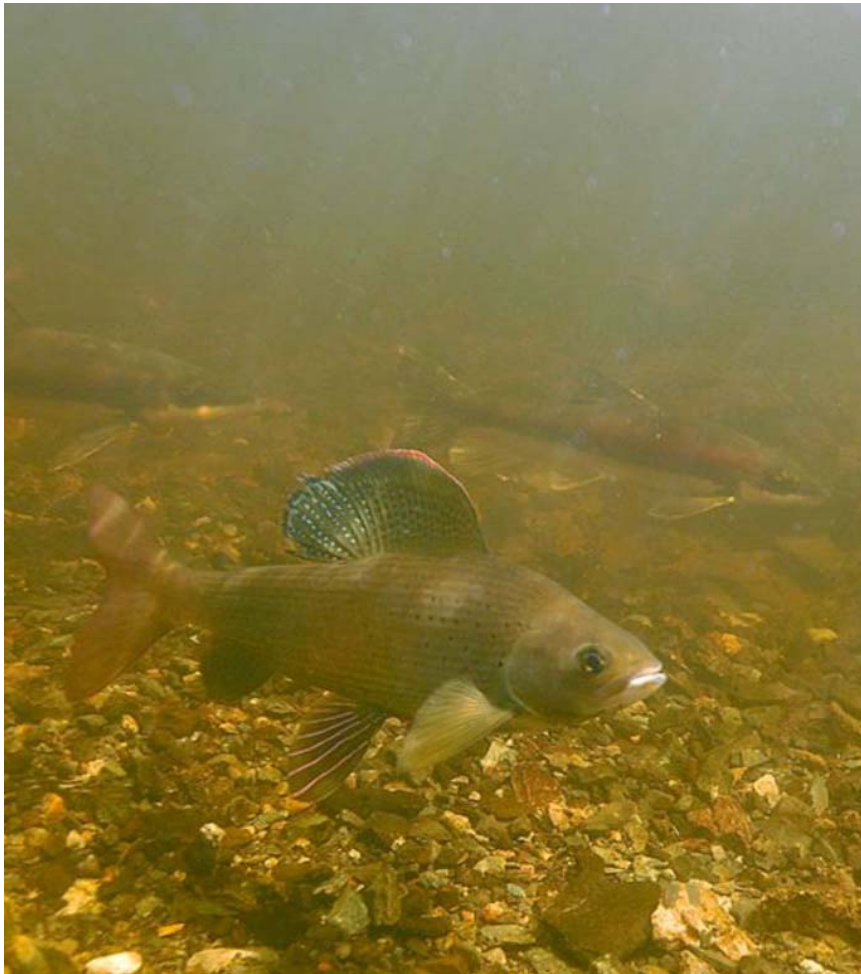
### Fish Habitat:

- Whether to provide fish access and habitat at Baker Creek was discussed during Surface Design Engagement
- The Project is currently involved in discussions with Fisheries and Oceans Canada to determine fish habitat and potential offsetting requirements.
