Tulsequah Chief Mine Remediation Options

D.Ritchie, D.Taylor, R.Brown & S.Theben
Northern Latitudes Reclamation Workshop,
Whitehorse
September 12, 2018

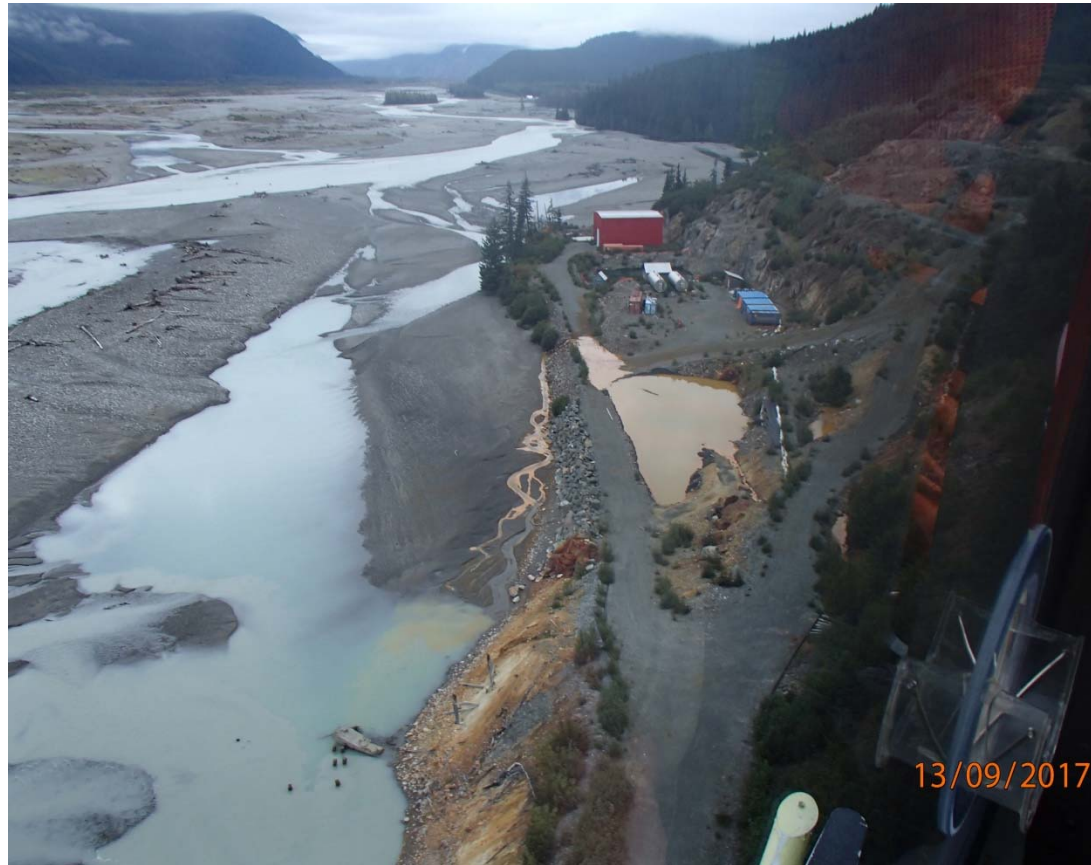
SITE OVERVIEW

- Abandoned underground base metals mine operated from 1951 to 1957
- Currently acidic waters drains directly to the Tulsequah River
- Water treatment plant was constructed and operated January 2011 until June 2012
- Plant shut-down due to of poor efficiency
 - very dilute sludge
 - 6 km haul to pond

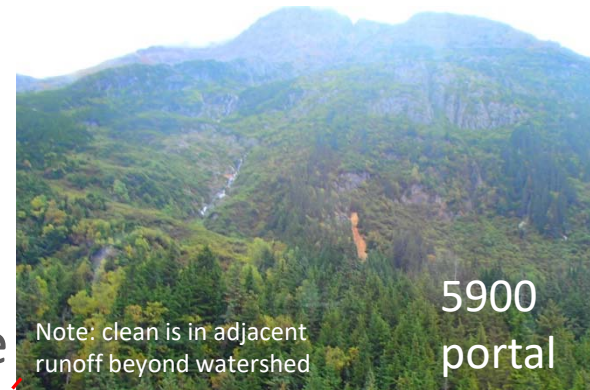
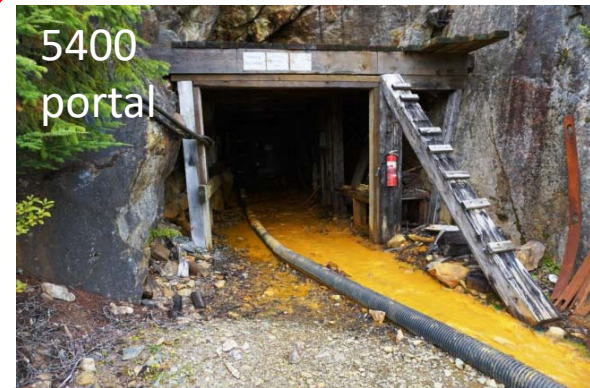
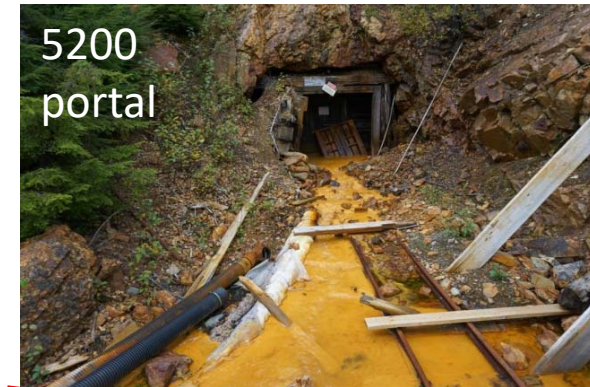
Current conditions

- Acidic drainage emanating from portals
- Flows are all within Portal Creek drainage

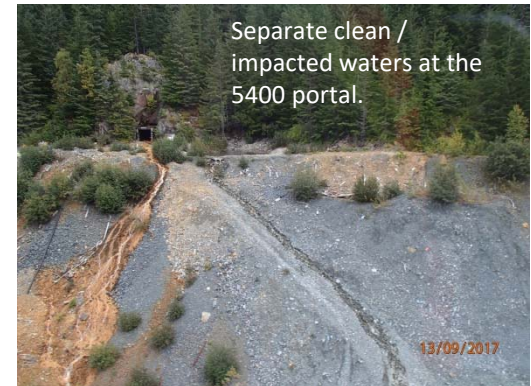
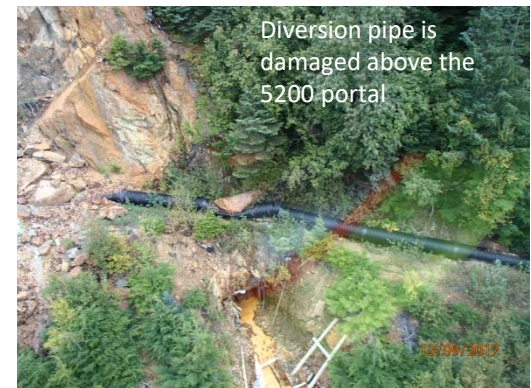
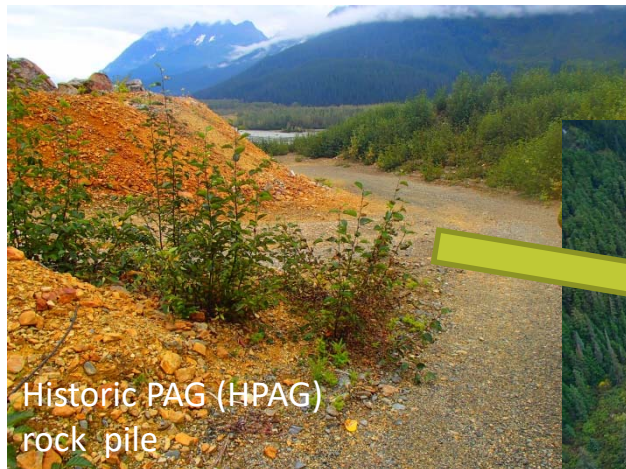
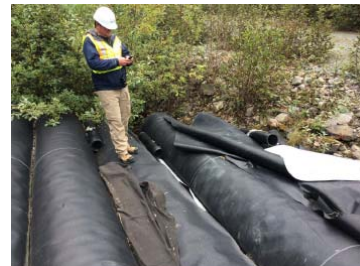
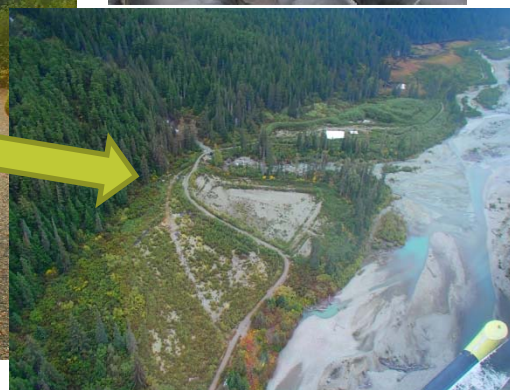
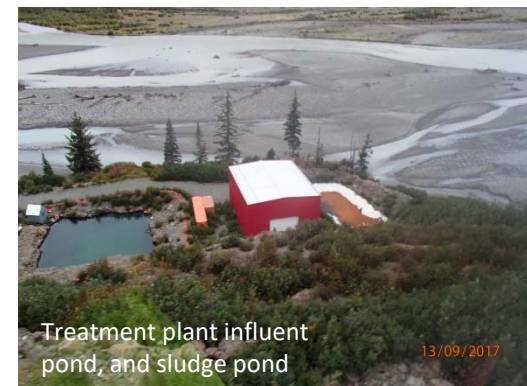
Site features

- Remediation work in 2011:
 - Water diversions constructed but are now damaged
 - Historic PAG (HPAG) facility construction started (grading, no liner)
 - Liner materials at site + some equipment

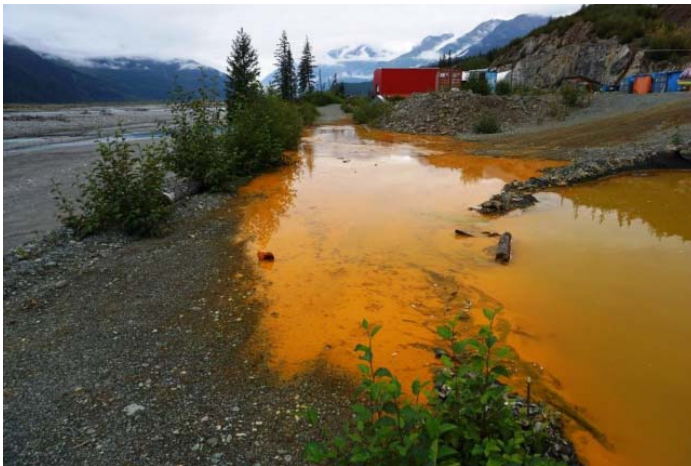
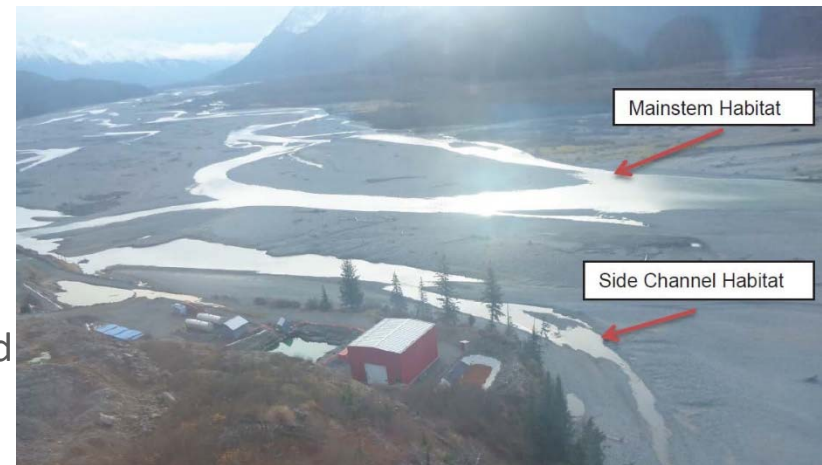
Ecological impacts

- 2016 SLR AERA study by SLR:
 - Site-specific fish toxicity levels
 - Al, Cu, Zn exceeded BC WQG 225m from pond
 - Toxicity Reference Values exceed for Cu, Zn
 - No fish toxicity at 2.5 km transect
- Impacts appear to be predominantly due to surface water overflow
- Possibly minor impacts from pond seepage
