## PIT LAKE TREATMENT AT LES MINES SELBAIE

### Abstract

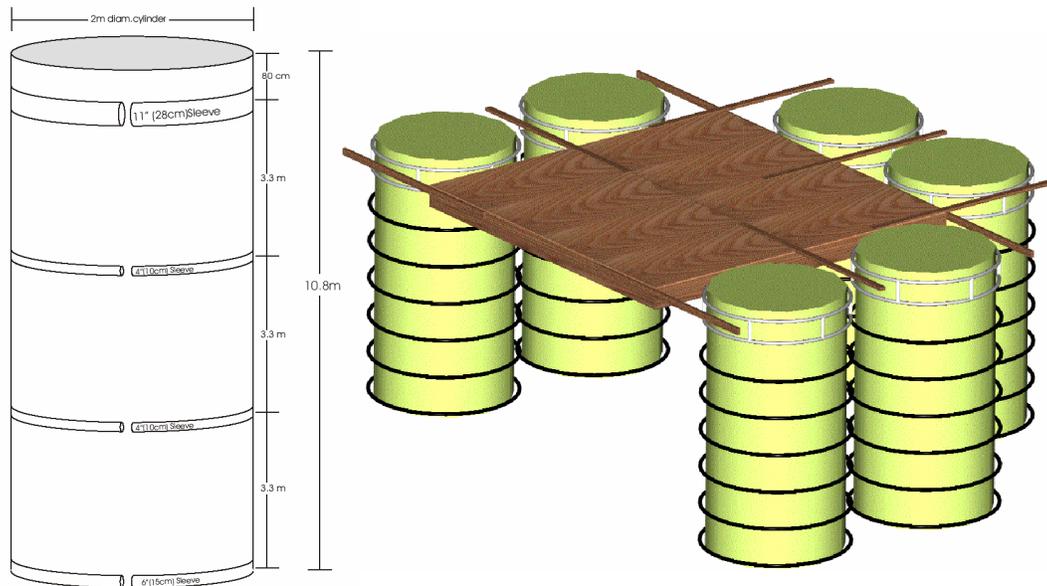
The laboratory tests were followed by limnocorral experiments in the field. Limnocorrals are experimental enclosures, which are open at the top and bottom and isolate a portion of the water column from lateral mixing within the lake. The limnocorrals used in this project were 2 m in diameter and 10 m in depth (see Figure 1). Limnocorrals were designed to isolate the mixed surface layer (epilimnion), which according to previously collected data was in the 4 to 6 m depth range.

A 16' x 16' raft with six bays for attaching the limnocorrals was constructed and deployed at the site. Limnocorrals were fabricated from polyethylene tarp material with support rings (1/2" diameter plastic pipe) inserted into sleeves every two metres along the tube to ensure the tube maintained a cylindrical shape (Figure 1). Floatation was provided by foam cylinders inserted into a sleeve at the top of the tubes. A collar extended approximately 30 cm above the lake surface to reduce waves and spray from outside the limnocorrals entering the isolated water column. The bottom of the tube was weighted with sand-filled plastic pipe. The contained water volume was about 31 m<sup>3</sup>.

Figure 1: Limnocorral Dimensions and Design of Raft

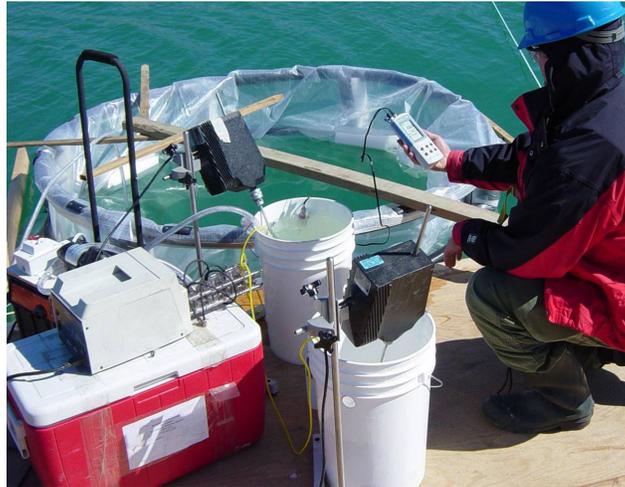
The two recirculation tests to treat Limnocorrals #2 and #3 took 5 to 6 days respectively. Recirculation treatment was effected with a 10 L/min diaphragm pump, conveying untreated water to a 20-L pail where pH was controlled by lime slurry addition (see Figure 2). A pH probe was inserted near the overflow of the treatment bucket and monitored regularly to ensure continuous treatment to the setpoint pH. Lime addition was controlled using a variable-speed peristaltic pump transferring lime slurry obtained from the Selbaie Lime Plant. Both the lime slurry and the treatment buckets were continuously stirred using agitators. Treatment was conducted for 6 to 8 hours per day because operators could not monitor the treatment system at night and during meal times.

Figure 2: Recirculation Treatment of Limnocorral #2

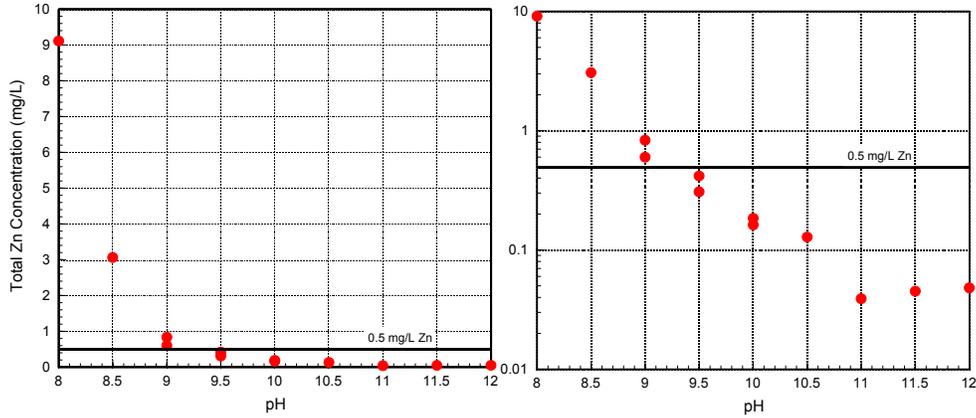
The treatment goal was to attain a total Zn concentration of less than 0.5 mg/L. Figure 3 shows the lime treatment results on both a linear and log scale for better resolution at low concentrations. Duplicated tests show excellent repeatability as illustrated by the points at pH values of 9, 9.5, and 10. Overall, these results indicate that the target concentration of 0.5 mg/L of total Zn is attained at a pH of 9.5. Also evident is a significant improvement when increasing the pH to 10.0, with further minor improvement when raising the pH to 11 or higher.

Figure 3: Zn Concentrations with Respect to pH for Lime Addition Tests

Given these results, a pH of 10 was selected as setpoint for further test work. Reason is that the Zn concentration when treating at pH 9.5 was only marginally below the target of 0.5 mg/L by 0.1 mg/L. By adding a little more lime and treating to a pH of 10, the final Zn concentrations were below 0.2 mg/L. According to Figure 4, the lime consumption was actually lower for the pH 10 setpoint but this is attributed to experimental error. The difference between the two lime consumption measurements was 0.03 g/L and the balance used to measure the lime consumption had a precision of 0.01 g/L. The logarithmic graph clearly shows a linear relationship between lime consumption and pH, except that the pH 9.5 value is an outlier.

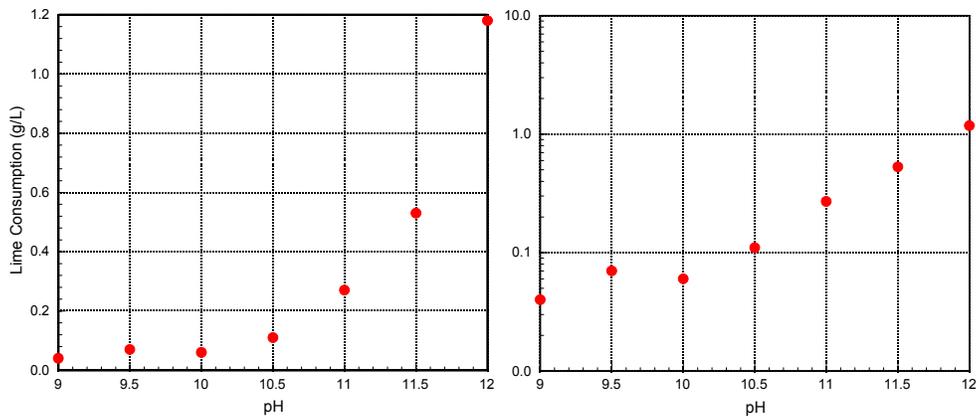
Figure 4: Lime Consumption with Respect to pH

The treatment system was installed in late summer of 2005 and commissioned on September 15<sup>th</sup>. The treatment objective was to gradually inject 2,000 tonnes of quicklime while ensuring proper dissolution efficiency. To promote dissolution while treating quickly, the lime injection rate was to maintain a pH between 11.5 and 12 at the discharge of the piping. A higher pH would decrease the lime dissolution efficiency and result in significant settling of unreacted lime particles. A pH of less than 11.5 would reduce the feed rate of lime and prolong the required time for complete treatment. According to the laboratory tests (Figure 4) this pH range represented a hydrated lime injection rate between about 0.5 and 1.2 g/L.

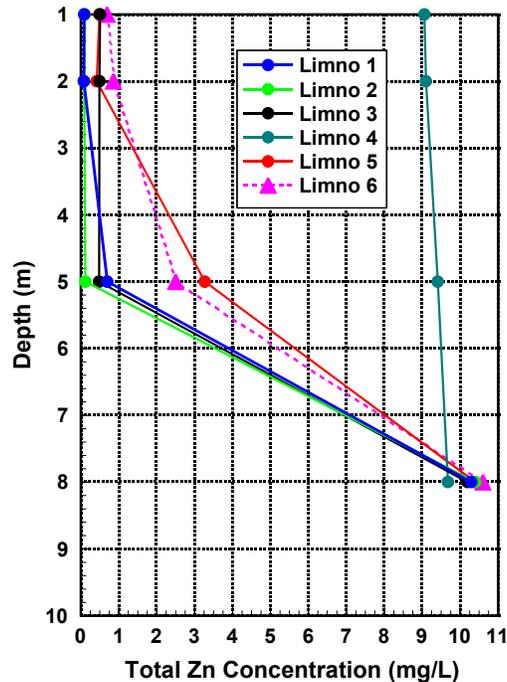
Figure 5 shows the initial profiles taken after the primary treatment in each of the 5 limnocorrals that were treated (limnocorral #4 was kept as a control). Surface treatment

in limnocorral #1 proved that surface lime addition can successfully treat the epilimnion (warm upper layer of the lake). The treatment in this limnocorral did not successfully penetrate the thermocline as the sample taken from a 5-m depth did not meet the 0.5 mg/L target. These results agreed with surface treatment to a pH of 9.5 in limnocorrals 5 and 6, which resulted in Zn concentrations near but not below the target of 0.5 mg/L at 1 and 2-m depths. The 5-m depth was above 2 mg/L for both limnocorrals, thus showing that surface treatment does not penetrate the thermocline.

Figure 5: Zn Profiles in Limnocorrals Following Treatment

The results from Limnocorral #2 showed that recirculation and discharge at surface can not only treat the epilimnion but also penetrate the thermocline as the Zn concentration at the 5-m depth was 0.12 mg/L. Unfortunately, it was not possible to properly ascertain the treatment efficiency at depth because the lake hypolimnion (deep cool layer of water) mixed with the lower portion of the bottomless limnocorrals. Limnocorrals were

In Limnocorral #3, treatment was accomplished by drawing water at the surface, liming it, and injecting it at depth. Due to the mixing at the bottom, this treatment method was unsuccessful in the limnocorral. Measurements taken during treatment nevertheless indicated that injecting treated water at depth can quickly increase the pH up to the bottom of the thermocline.

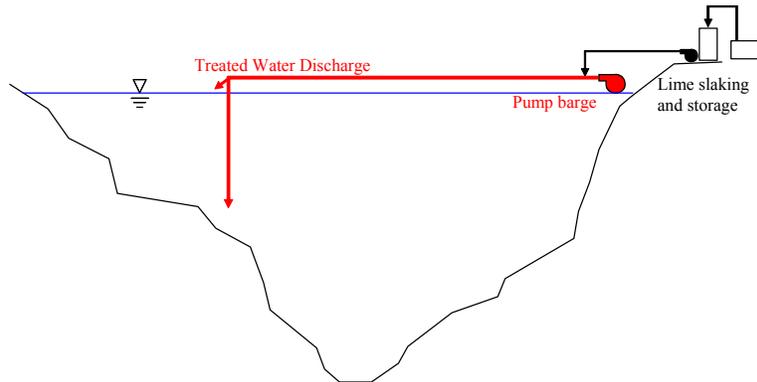
Based on these findings, EnvirAubé proposed the conceptual design of a recirculating treatment system to batch treat the entire 22+ Mm<sup>3</sup> of water (see Figure 6). The conservative lime consumption estimate used an expected lime efficiency in the order of 75%.

SNC-Lavalin Inc. completed the detailed design, commissioning, and operation of the pit lake treatment system. It consisted of a portable batch slaking system, agitators, and two slurry pumps (all rented) plus a lime slurry storage tank, and two water recirculating systems. Conceptual drawings are shown in figures 6 and 7 for the cross-sectional and plan views respectively. Figure 8 shows a photo of the treatment system with identification of the key elements.

Figure 6: Conceptual Representation of the Treatment System (cross-section)

The water pumping system consisted of two submersible pumps of 1,300 and 1,400 m<sup>3</sup>/h capacity for water recirculation from the surface (2 m depth) to depth (40 m depth). These pumps were supported by a barge near the existing access ramp. Lime slurry was injected at the pump discharge into the 18" HDPE pipes that conveyed the treated water to the South and North discharge rafts, positioned respectively 330 m and 480 m away. The pipes themselves floated either just below the water surface or up to 2" above during operation.

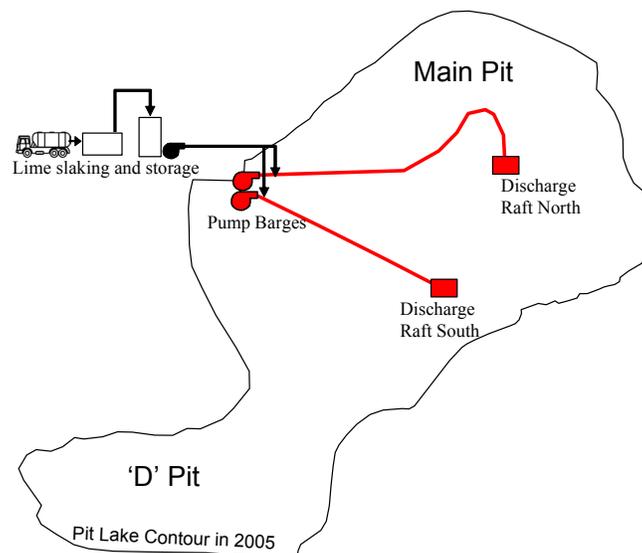
Figure 7: Conceptual Representation of the Treatment System (plan view)

All sampling campaigns were done at multiple locations in the pit. This was important to ensure homogeneous treatment, particularly because the “D” Pit is partially separated from the Main Pit where treatment was accomplished (see Figure 7). Profiles taken at different locations were always reasonably similar during treatment and essentially the same before and after treatment. For this reason, only the results from the central location of the Main Pit are described here.

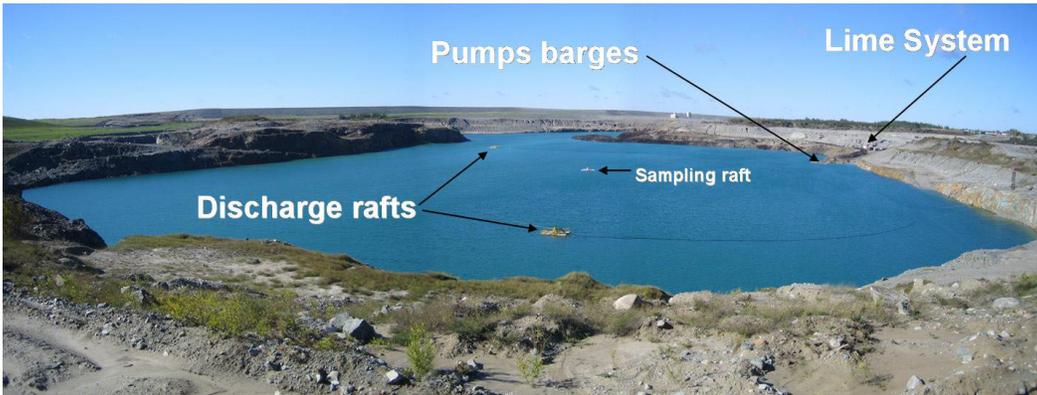
Figure 8: Photo of Treatment System soon after Commissioning

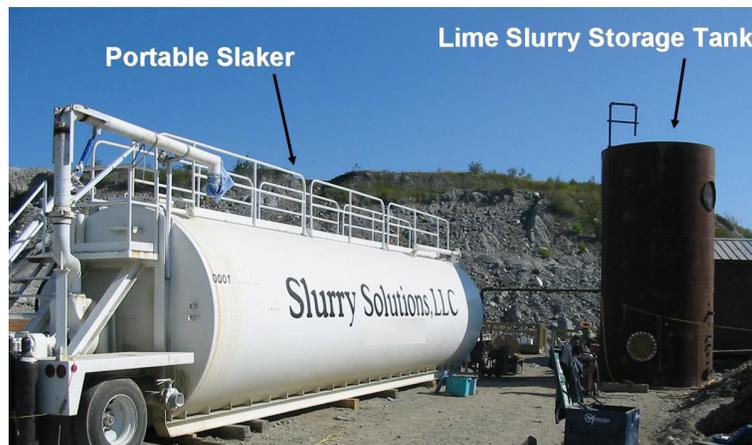
The lime system (including portable slaker, lime storage tank, and pumps) was installed near the pit ramp on a solid bed of crushed rock, as shown in Figure 9. The two submersible pumps were installed on a floating barge, accessed by a ramp from the shore. The most challenging phase was the installation of the 40-m steel downpipes. As the mining benches below water were 10 m by 10 m, it was necessary to float the steel downpipes out before bringing them vertical. The pipes were capped at one end to enable them to float. An excavator was used to guide the pipe out before attaching it to the discharge raft and getting it vertical. Figure 10 shows the excavator gently pushing the out the downpipe with the sealed end toward the viewer and the diffuser end submerged. Next to the downpipe is half the pump barge with the pump piping already attached. The two halves of the pump barge were attached following deployment.

Figure 9: Lime Slaker and Slurry Storage Tank

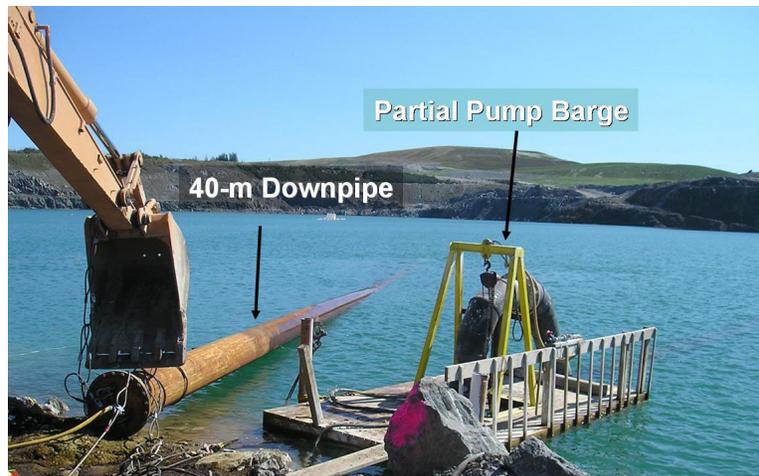
Following the use of the excavator, the downpipe was moved out into the pit lake by attaching it to the discharge raft and pulling it out with a boat. To bring it vertical, a valve installed at the sealed end was opened to allow air out and water to enter from below. Once it was vertical, the downpipe was attached to the raft and fully deployed.

Figure 10: Deployment of Downpipe

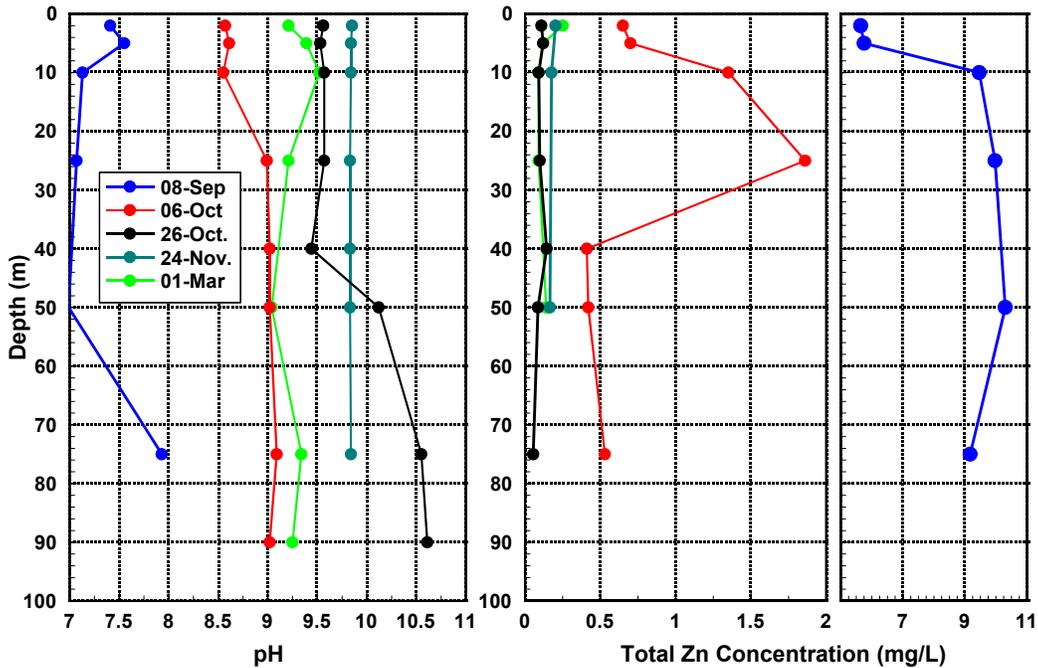
Figure 11 shows some of the pH and Zn profiles measured in the pit lake during and following treatment. As shown in Table 2, the initial average pH was 7.2. The pH values quickly increased during operation. Due to weather conditions, it was not possible to complete the profiling immediately following treatment, which is why the final pH measurement was taken 19 days after treatment was discontinued. It is likely that the pH had reached the target of 10.0 as in that 19-day interval there had been significant precipitation which may have decreased pH. On October 26, 10 days before the end of treatment, there is a clear increase in pH below the 40-m injection depth. This is caused by the partial settling of limed water due to its' higher density. At this time the water column was of a relatively uniform temperature of 7°C. Earlier in the treatment campaign, the water being injected had a temperature above 10°C while the water at depth was at 6°C. With initial temperatures, the treated water did not noticeably settle. The surface temperatures decreased naturally due to the decreased air temperatures, but the treatment system itself equalised the temperatures quickly due to the high rate of surface water injection at depth.

The right side of Figure 11 shows the Zn concentration profiles measured at different times in the pit lake. The graph is divided to better show the initial total Zn concentrations (scale of 5 to 11 mg/L) as well as the eventual decrease in concentrations (scale of 0 to 2 mg/L). The initial Zn concentrations were near 10 mg/L at depth and 6 mg/L at surface. The Zn concentrations decreased rapidly and the expected target of 0.2

mg/L was met after only 35 days of treatment. All of the profiles from October 26 onward are not discernable as they are all below 0.25 mg/L.

Figure 11: Profiles of pH and Total Zn in Pit Lake
