THE CONTINUING REHABILITATION OF THE KAM KOTIA MINE SITE: AN ACID-GENERATING ABANDONED TAILINGS SITE

Abstract: Ontario's Ministry of Northern Development and Mines (MNDM) continues to rehabilitate the Kam Kotia Mine site. This site, located within the municipality of Timmins, in northeastern Ontario, Canada, is considered by many to be one of the worst abandoned mine sites in Canada.

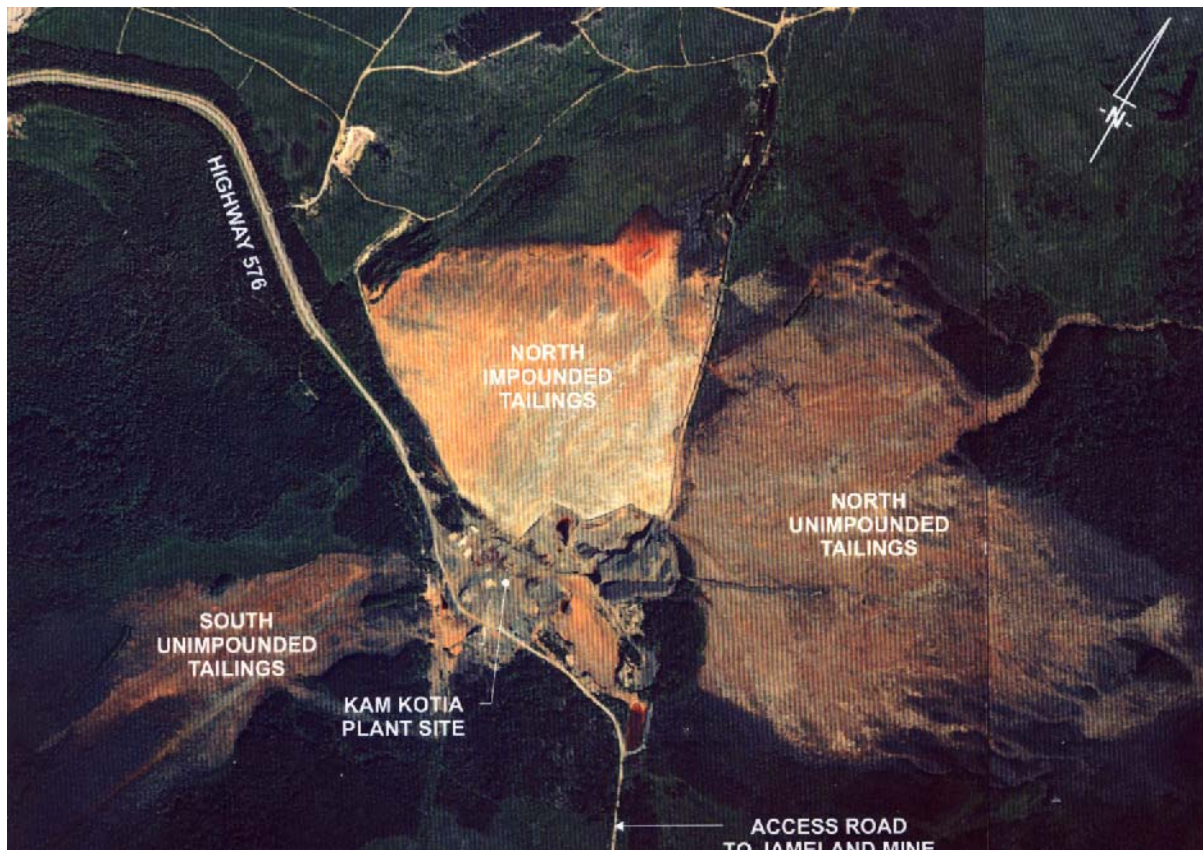
The three main tailings areas located on the Kam Kotia Mine site are shown in the Figure 1 site plan below and are referred to as follows:

- a) the “North Unimpounded Tailings” or “NUT” located in the northeast area of the site,
- b) the “North Impounded Tailings” or “NIT” located in the northwest area of the site, and
- c) the “South Unimpounded Tailings” or “SUT” located in the southern area of the site.

Fig. 1: An aerial view of the Kam Kotia Mine site prior to the commencement of rehabilitation.

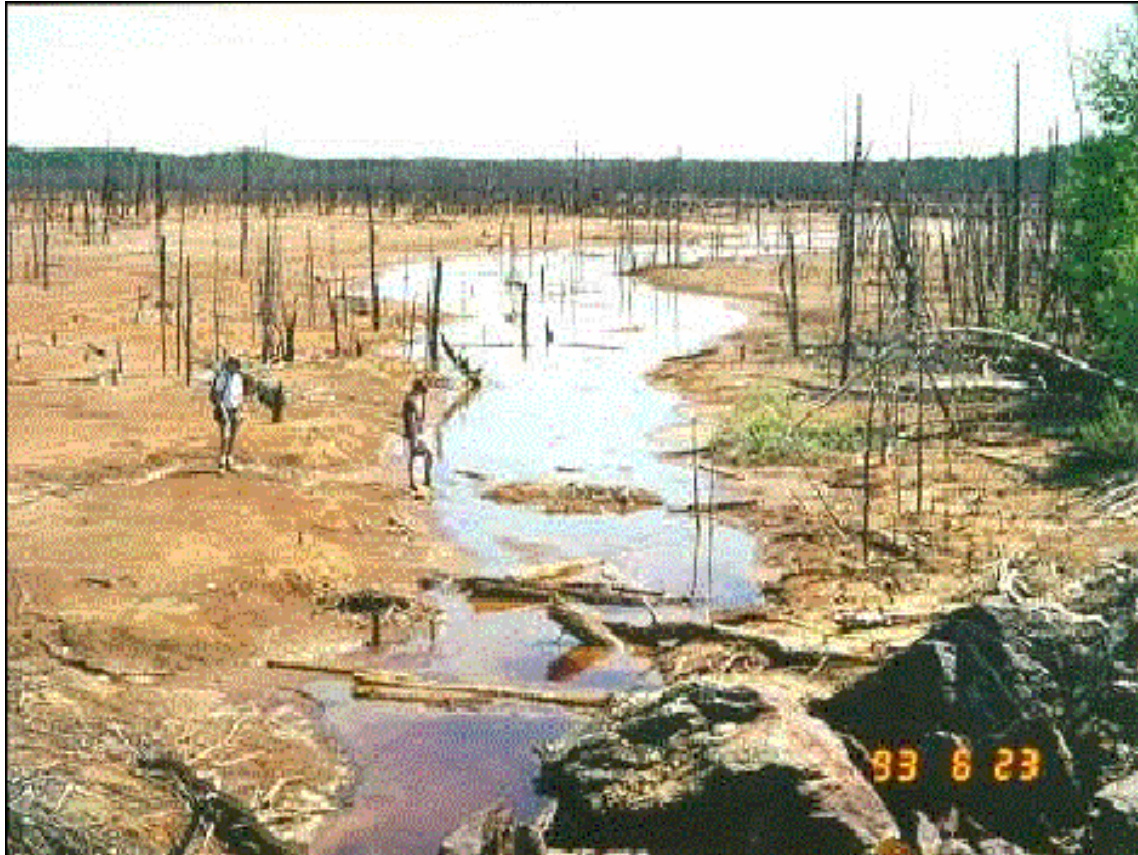
The areas to the north and northeast have been similarly impacted by contaminated drainage from the NUT area, and the Kamiskotia River to the north of the mine site has been almost as heavily affected as the Little Kamiskotia River. (See Figure 2 for a view of the NUT area and one of the acidic seeps.)

Fig. 2: A view of the NUT area, and the northeast seep with a pH of 2 to 3, prior to rehabilitation.

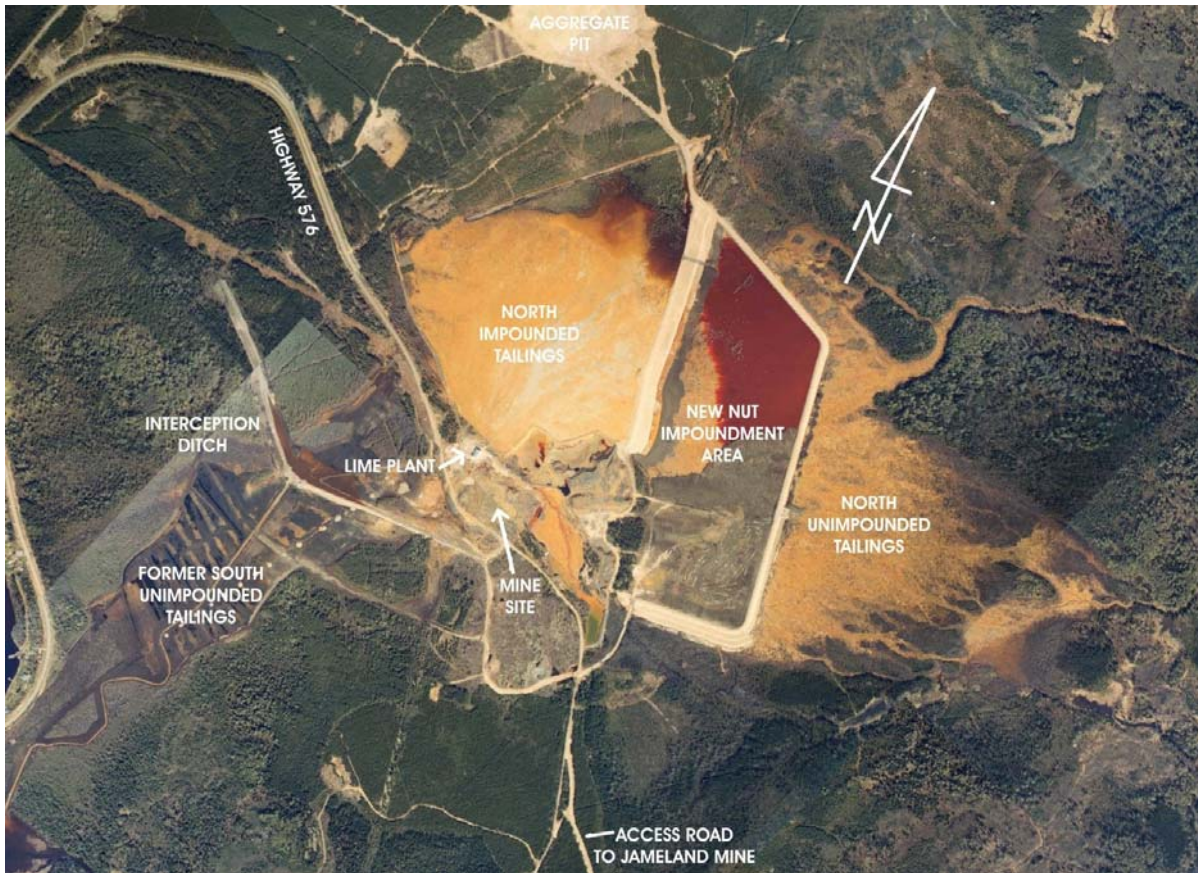
Fig. 4: Aerial view of the Kam Kotia Mine site after the completion of Phases “A” and “B” (May 2003).

The completion of the Phase “A” and “B” work meant that, other than the contaminated pore water in the area from before the SUT tailings were removed, there would be very little, if any, further new effluent discharged to the areas to the south and southwest of the mine site – the areas where there is human habitation.

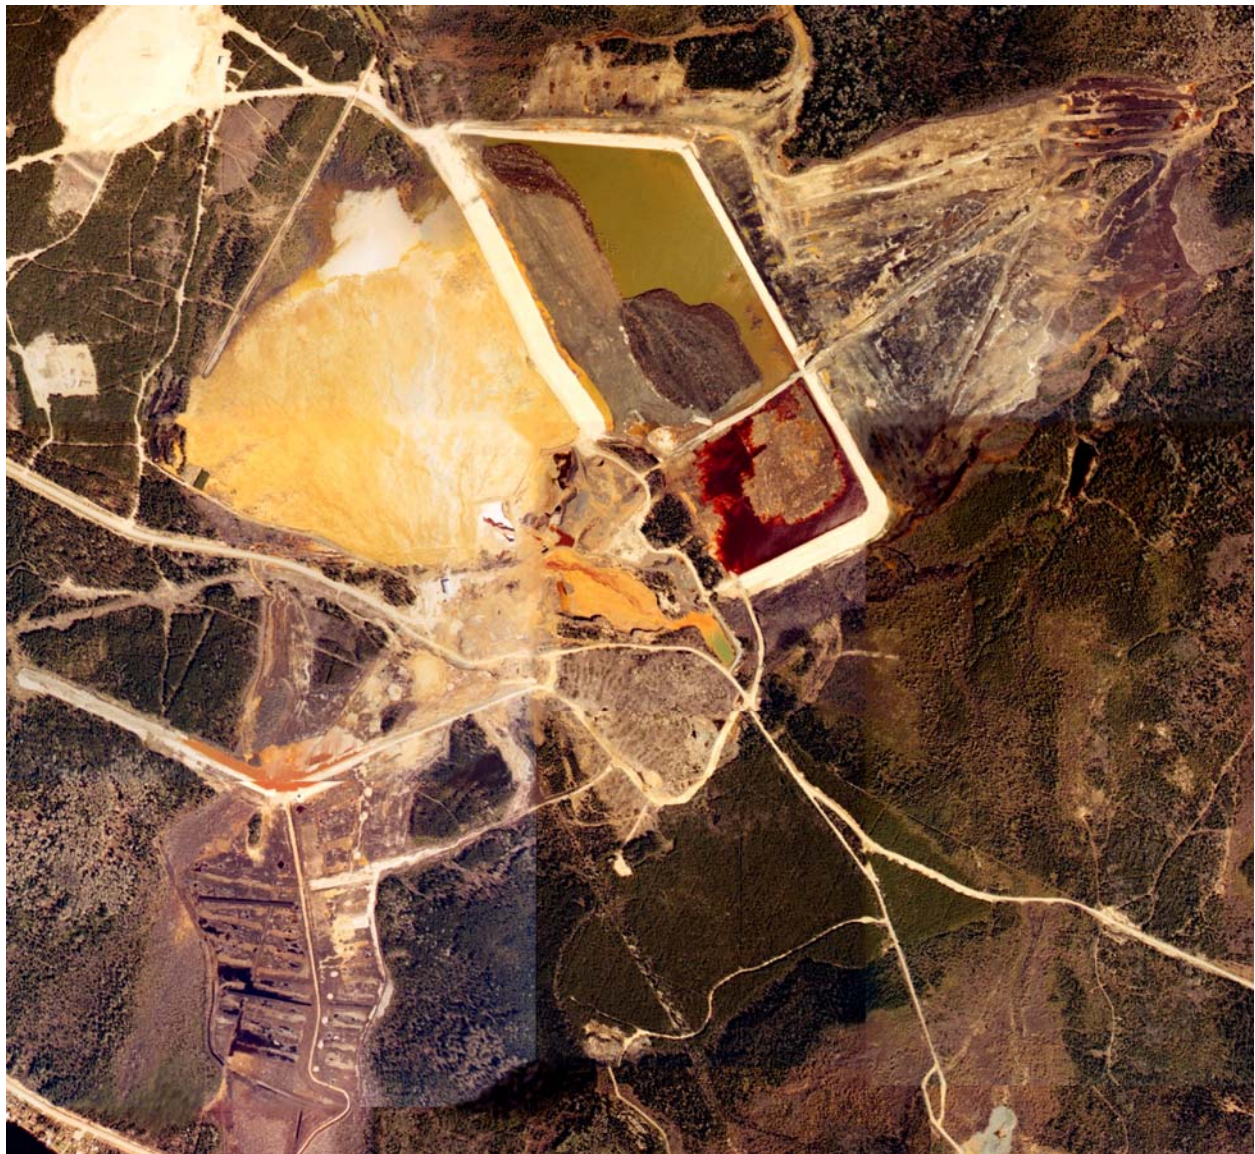
was to be treated and pumped over to the higher elevation NIT area. However, with the much greater than expected volume of contaminated water that collected this was not possible and the NUT impoundment area began to fill with contaminated water that could not be discharged to the environment without undergoing treatment first. The initial collection of this water (aka “the pond”) can be seen in the northeast corner of the NUT impoundment area of Figure 4, and then throughout the NUT impoundment area in Figure 5.

Since placing the Phase “C” tailings in the proper location would result in the discharge of the contaminated pond water out the dam’s spillway, MNDM had the choice of either postponing or cancelling the Phase “C” contract, or to find some other way to conduct the project. It was decided that the tailings would be stacked along the west and south sides of the pond so that the work could proceed without causing any displacement of the contaminated pond water. (Please see Figure 5.)

Fig. 5: Aerial view of the Kam Kotia Mine site after the completion of Phase “C” (May 2004).

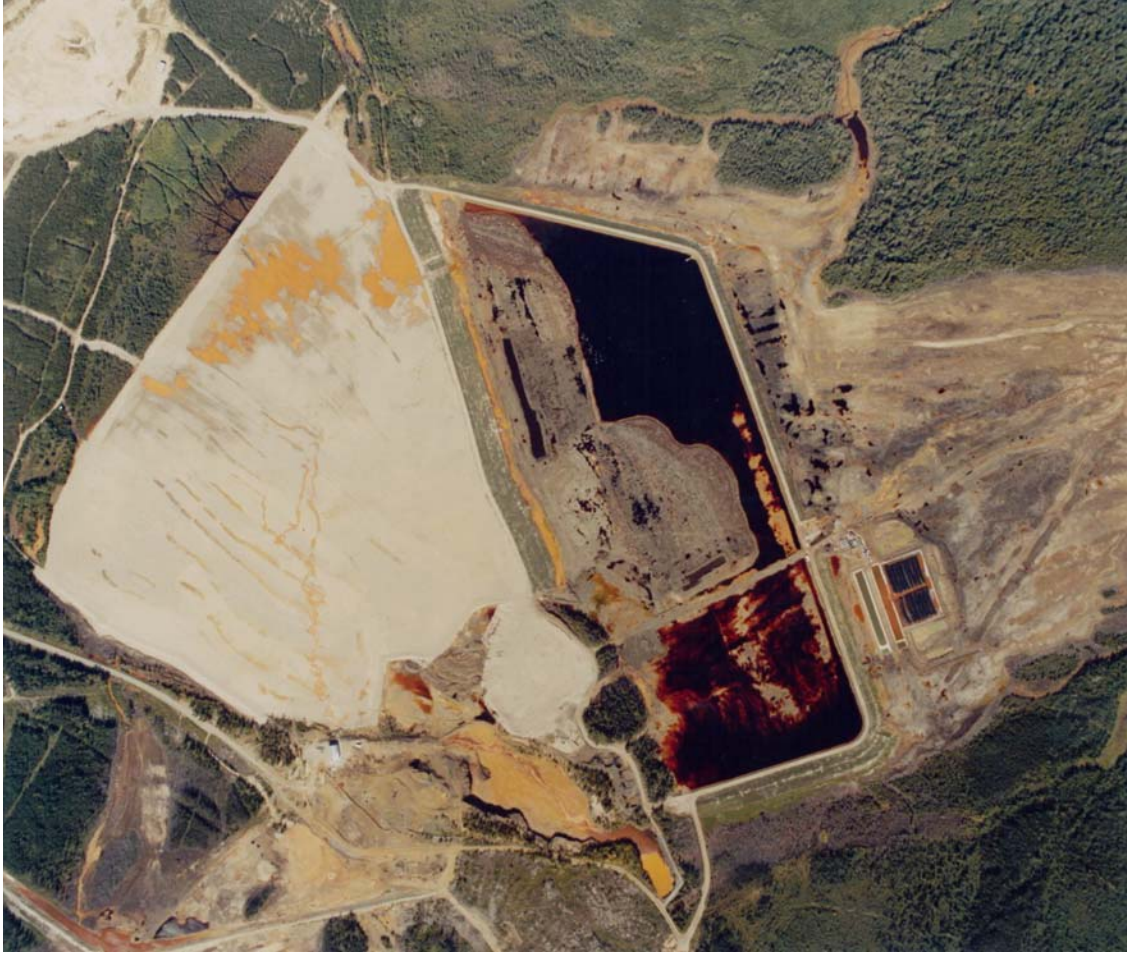
Fig. 6: Aerial view of the Kam Kotia Mine site after the construction of the NIT cover capillary break layers and the installation of the NUT area temporary water treatment plant near the southeast corner of the NUT impoundment dam (Hazco - June, 2005).

After the in-situ treatment did not work, MNM hired a consultant during the summer of 2004 to determine all different options of how the contaminated pond water could be treated and then to recommend a preferred option. The consultant determined that it would be better to batch treat the contaminated water using a large temporary treatment plant. The water would be neutralized with caustic, and would then be pumped into one of a series of geotextile filter bags until the sludge settled out and the clean, treated water filtered through so that it could be discharged. See Figure 6 for an aerial view of these geotextile bags, which are also visible on the Google Earth™ image of the Kam Kotia site at the time of writing this paper.

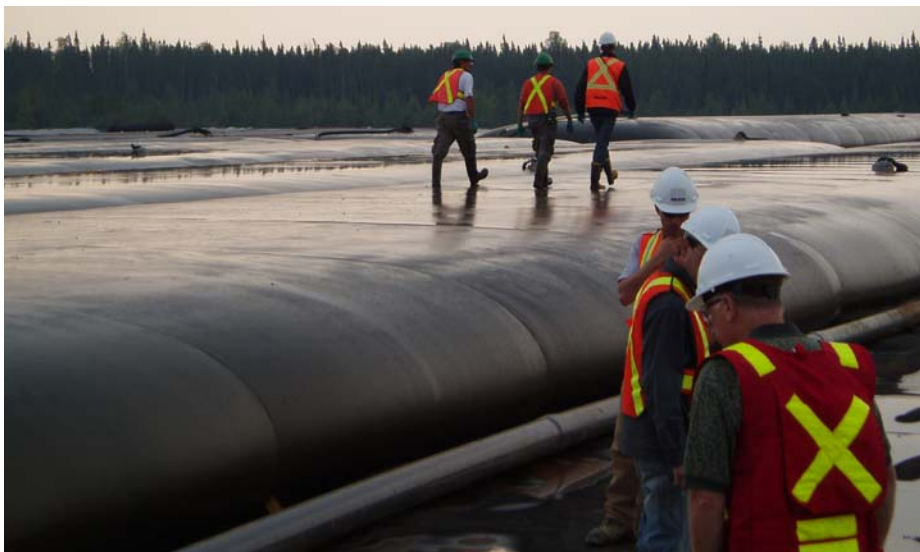
Fig. 7: The geotextile filter bags used for the temporary treatment of the contaminated pond water.

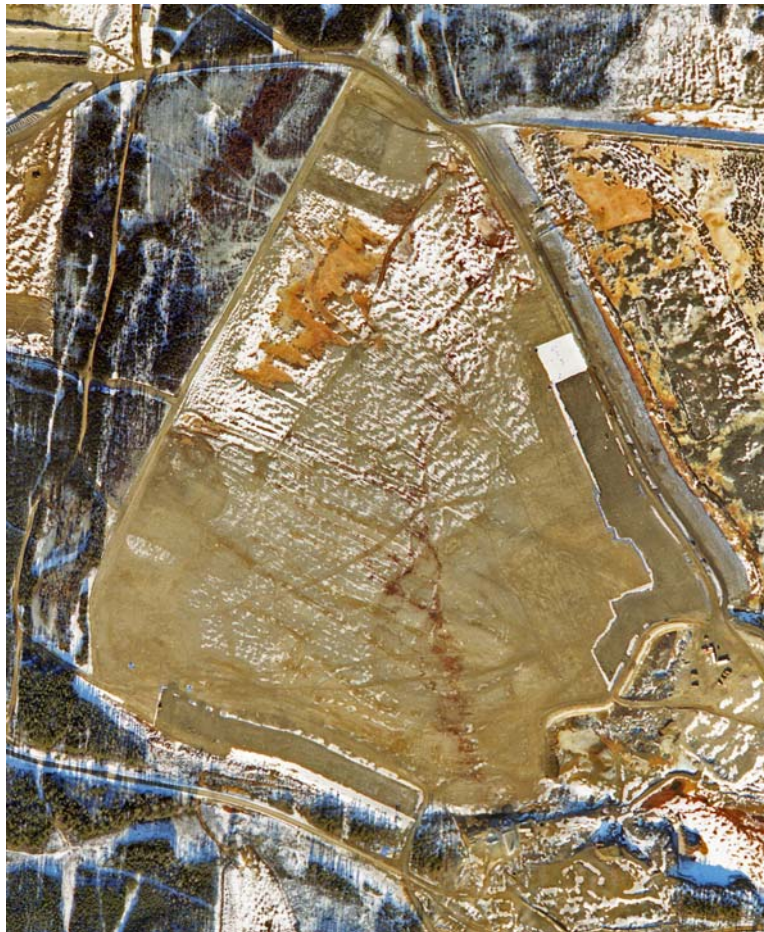
Fig. 7: Aerial view of the NIT area of the Kam Kotia Mine site during the construction of the remaining layers of the NIT cover. (Hazco - November, 2006).

1. A GCL installed over the NIT area capillary break layer, after the surface of the capillary break was appropriately re-graded and prepared. See Table 1 for the GCL specifications required under the contract.

2. A 300 mm. layer of clay over the GCL. The clay available on-site was of sufficient quality and did not need to be compacted as it is only required to act to keep the GCL hydrated, and is not required to act as the cover's barrier layer.

3. A 500 mm. layer of granular fill (i.e. the granular-B material available on the site).
 4. A 150 mm of "topsoil" *.
 5. Revegetation of the "topsoil" layer of the cover by applying an appropriate shallow-rooted seed mix.
