The 1B Hydraulic System

MEND Manitoba Workshop
Changes in Acidic Drainage for Operating,
Closed or Abandoned Mines

Winnipeg, Manitoba
June 5, 2008

Joe Shea
Cape Breton Development Corporation

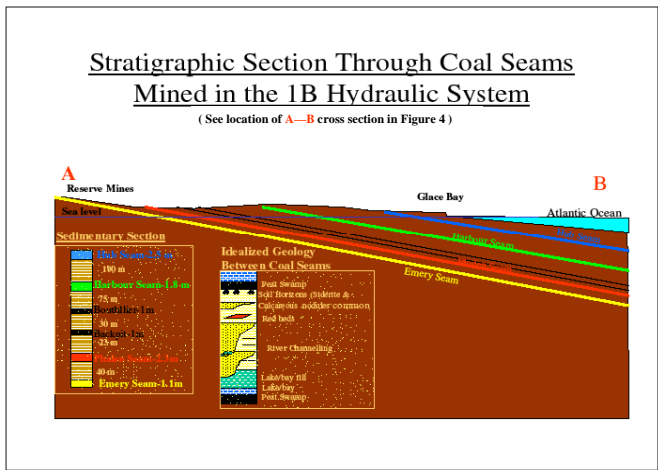
Figure 5 – Stratigraphic Section

sandstone, and minor carbonaceous limestone, which are indicative of deposition in fluvial & lacustrine environments (Figure 5). Faulting did not impact the operations of these mines.

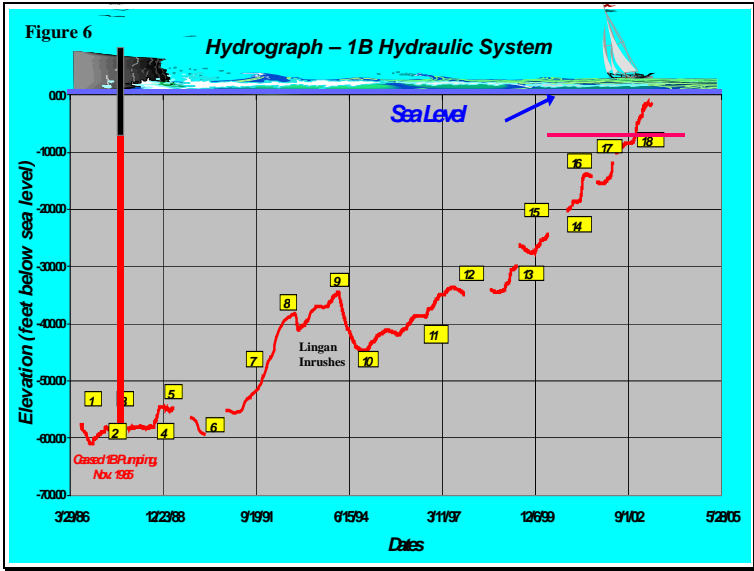
Figure 6 Hydrograph – 1B Hydraulic System

The No.26 Colliery was lost to a mine fire in 1984 and a decision was made in 1985 to shut off the 1B Shaft pumps. This decision set in motion an accelerated rate of flooding for the entire 1B Hydraulic System. The ensuing history of flooding in the 1B System has been recorded by water level measurements taken in the 1B Shaft. These measurements were used to construct the hydrograph shown in Figure 6. The hydrograph portrays the typical mine water rebound curve, however it also identifies several occasions where the rising mine water reverses direction due to underground dam failures and inrushes at operating mines. One such incident occurred in 1992 when 5 East longwall at Phalen Colliery, located in the Phalen seam, retreated below the flooded No.26 workings in the Harbour seam, continued below an 1100 ft barrier pillar of coal, and then retreated below the Lingan workings. The result was a sustained, major inrush of water (up to 7000 US gpm) through the compromised barrier pillar that had been designed to separate the workings of Lingan and No.26 (Figure 7). Pumping was immediately re-established to lower the level of water in the 1B Shaft. The objective was to reduce the pressure head acting on No.26 Colliery (300 psi) and stop the inrush of mine water into Lingan. However, the quality of the discharged mine water at the 1B Shaft proved to be unacceptable (very high iron and TDS) and the pumping operation was stopped (Figure 8). The compromised barrier pillar and the inability to pump from the 1B Shaft led to the closure of Lingan Colliery. It was determined that it was no longer safe to work the mine with the high risk of catastrophic mine water inrushes.

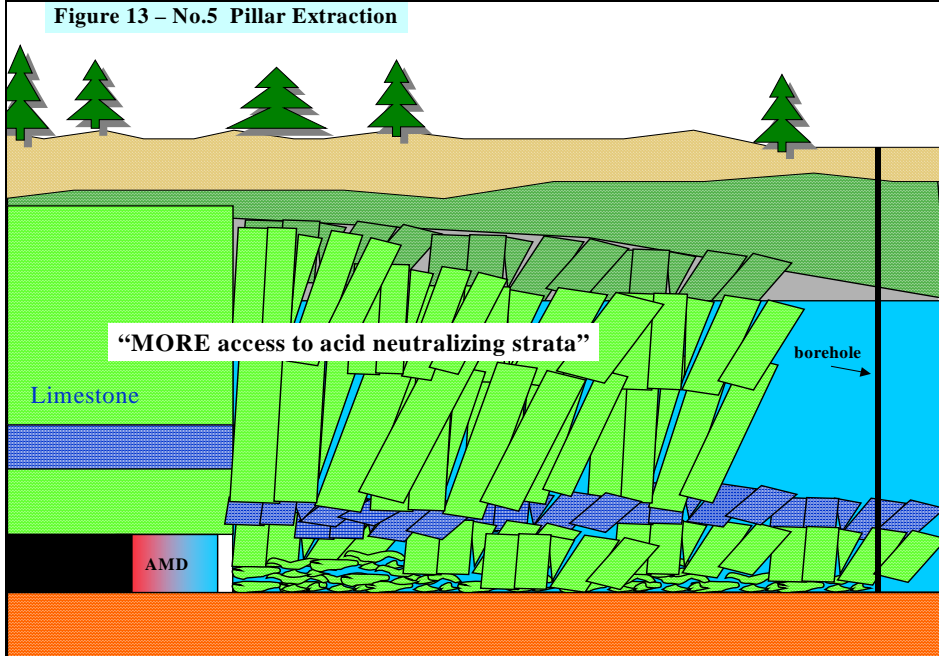
Figure 12 – No.1A Room and Pillar workings

The earliest and shallowest mines in the 1B System were located under land and used the room and pillar method of extraction. This resulted in the extraction of 40 to 50% of the coal with the remainder left as pillars to support the mine roof. However in many cases, the remnant pillars were removed by over zealous mine managers which led to widespread collapse of roof strata and ground subsidence at surface. In No.5 Colliery, extensive areas of de-pillaring took place, with almost 100% of the coal removed over large portions of the mine with some areas having less than 100 ft of vertical cover. In No.1A Colliery, room and pillar mining with very little pillar extraction was practiced, probably because this mine was located directly below the more heavily populated community of Dominion. As the mines proceeded under the sea, very regimented room and pillar mining was employed, with pillar sizes always erring on the side of safety. Full extraction longwall mining was practiced when vertical, solid rock cover to the seabed exceeded 900 ft..
