# Soil Covers in the Canadian North

Daryl Hockley,  
Maritz Rykaart, Michel Noël  
SRK Consulting Inc.

# Overview

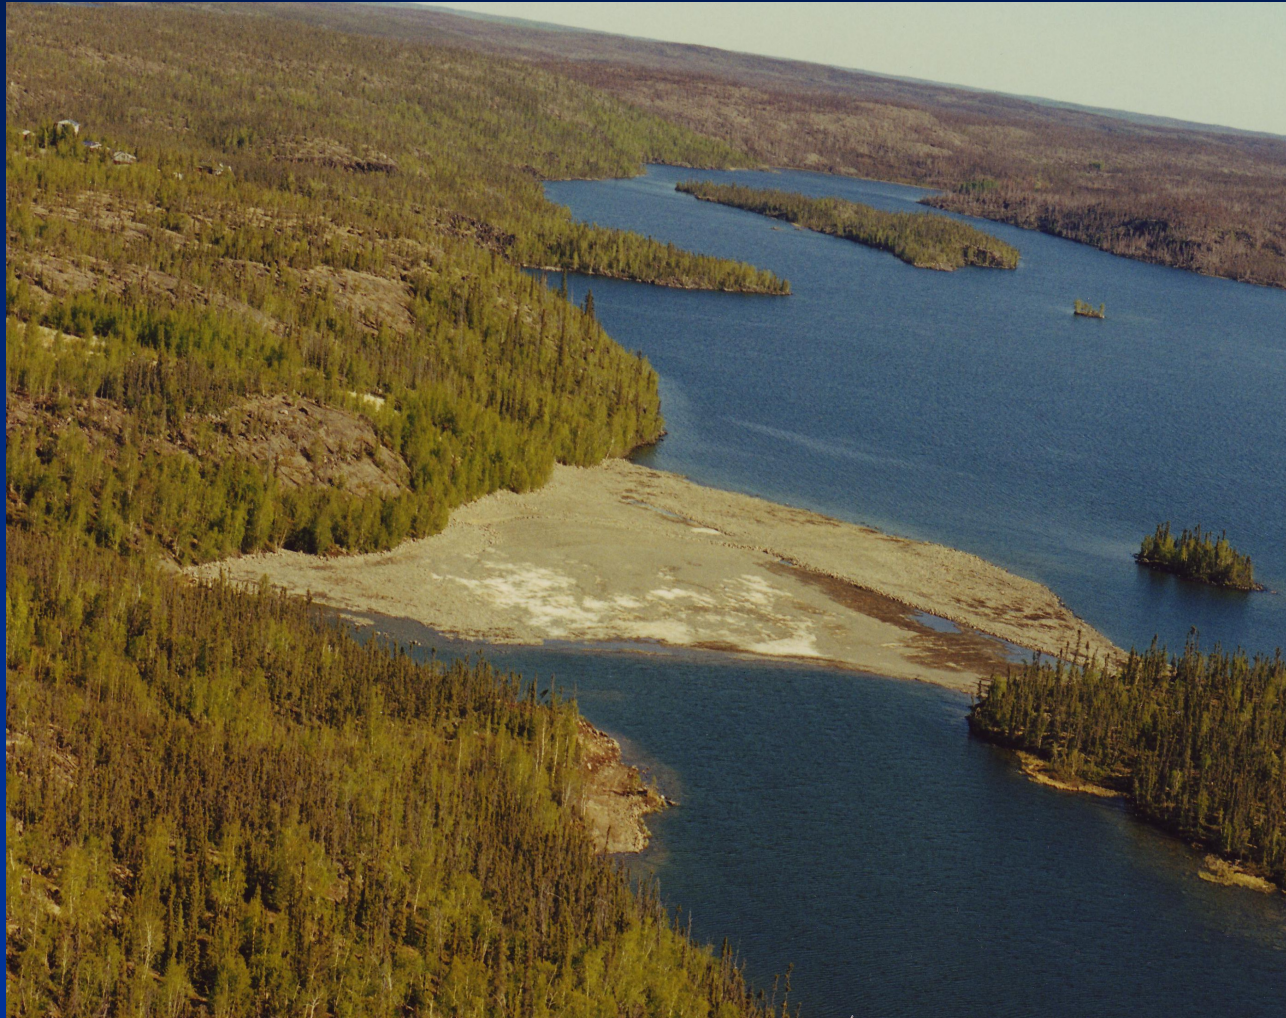
**3 ha tailings  
delta in  
Giauque Lake**

- Delta tailings covered with GCL overlain by 20 cm crushed rock in 1997
  - Site accessible only by ice road
  - GCL best for winter application
  - Rock layer provides confinement for GCL swelling
- Inspections in 1998
  - Significant settling due to ice lenses melting
  - Repairs needed
  - Performing well since then

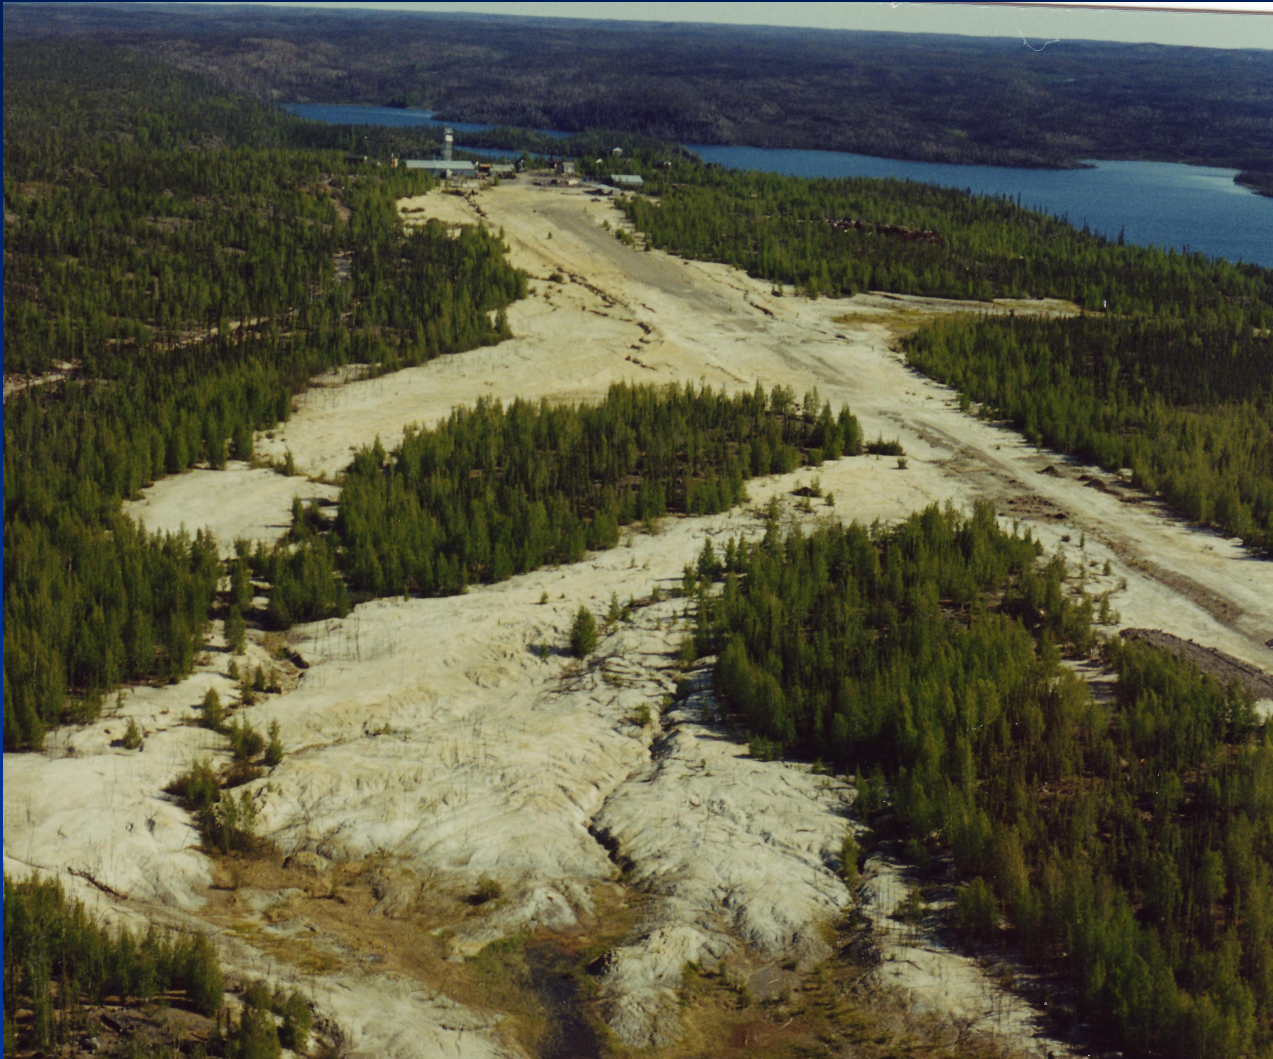
**30 ha tailings  
on land**

**No containment**

- Upland tailings covered in 1998 and 1999
  - Re-grading and surface compaction
  - Borrow source development and wind-rowing of clayey silt
  - Place 30 cm of clayey silt
  - Topped with 30 cm of 100 mm crushed rock

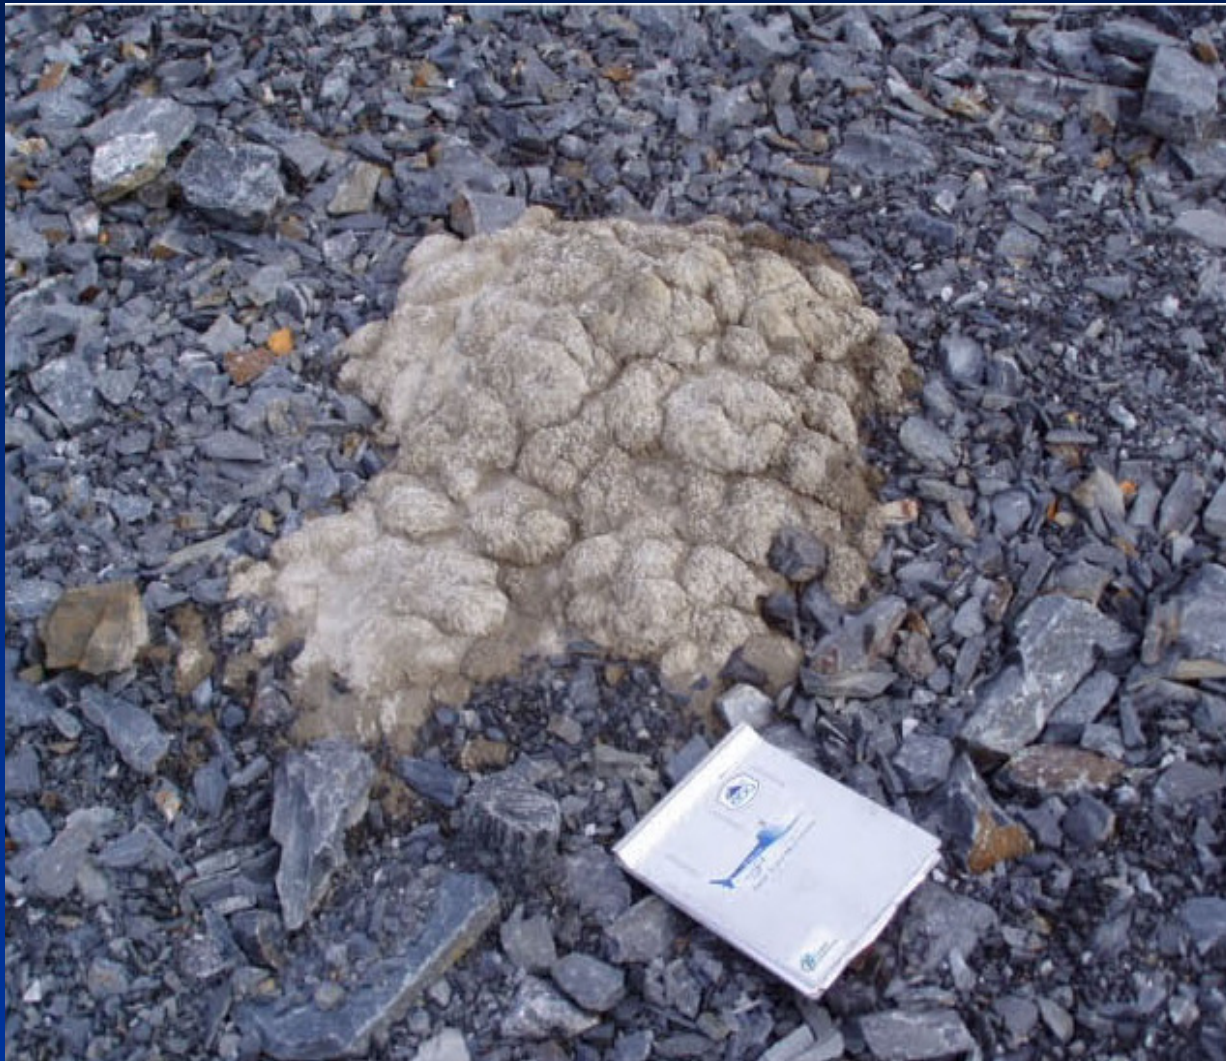
**Inspections in  
2003**

**Boils on surface  
of crushed rock**

**Mechanisms  
similar to  
patterned  
ground?**

**Also permafrost  
degradation in  
borrow pit**

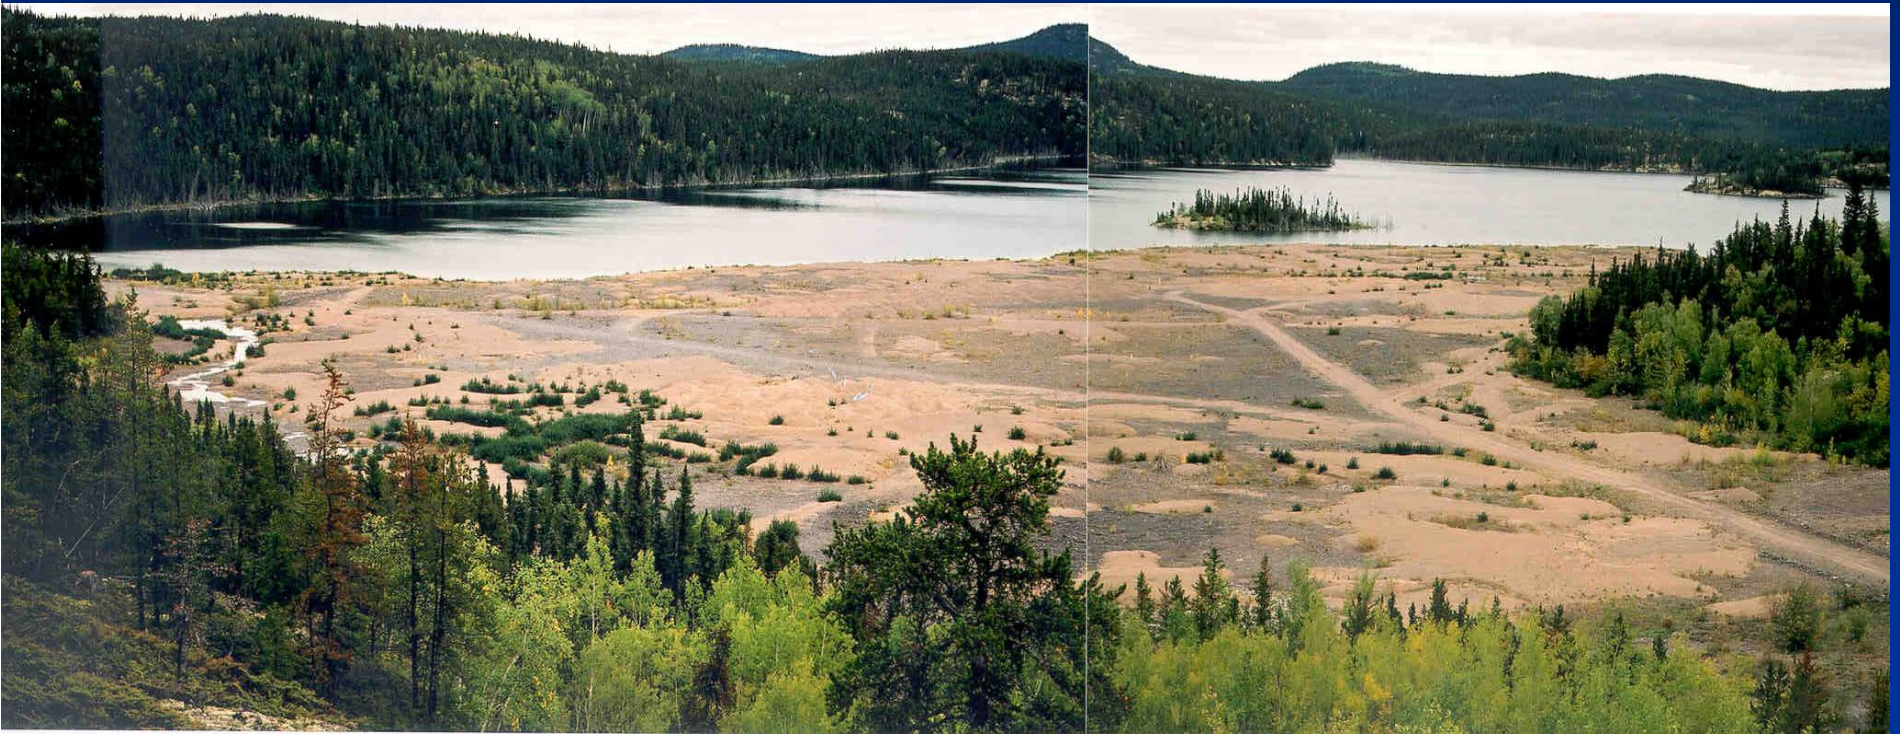
- Tailings delta in Fookes Lake covered by coarse rock to prevent radiation release

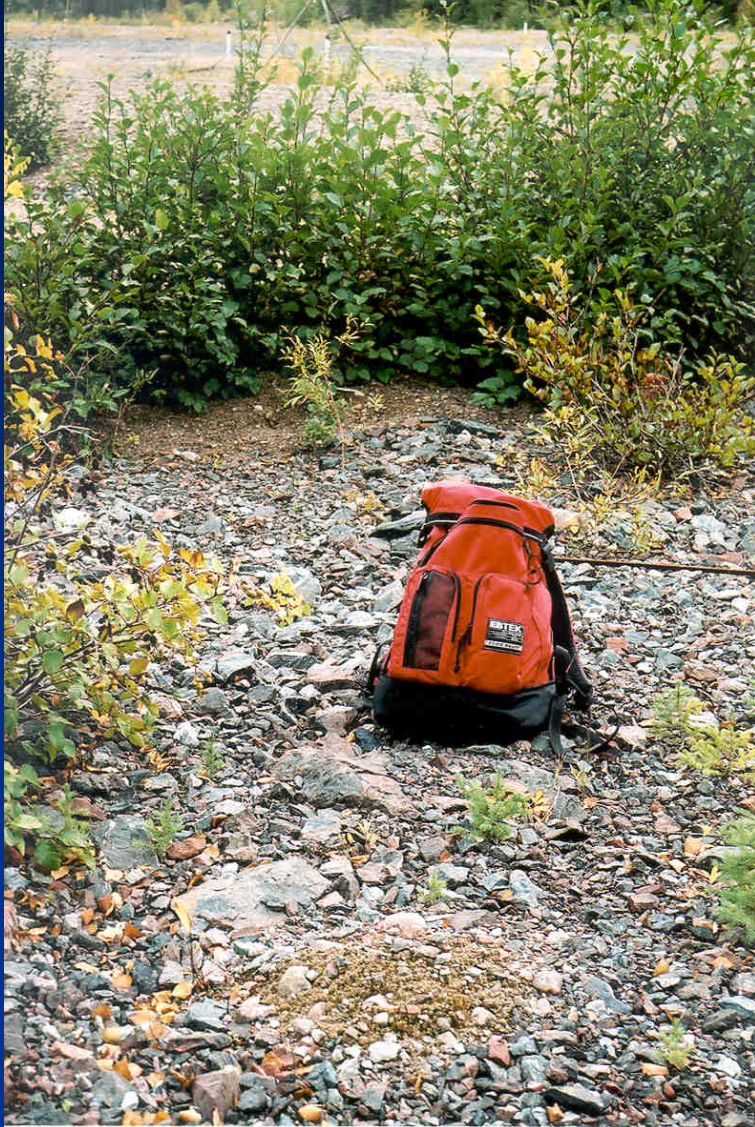
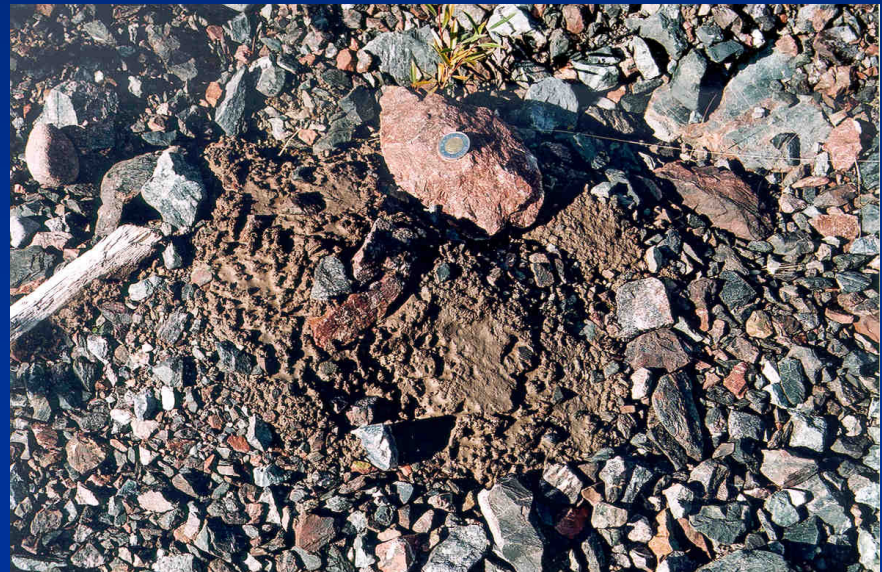
- Inspections in early 1990's found tailings boils on surface
- Initially proposed “frost boils” as explanation
- Other cryoturbation phenomena also suspected

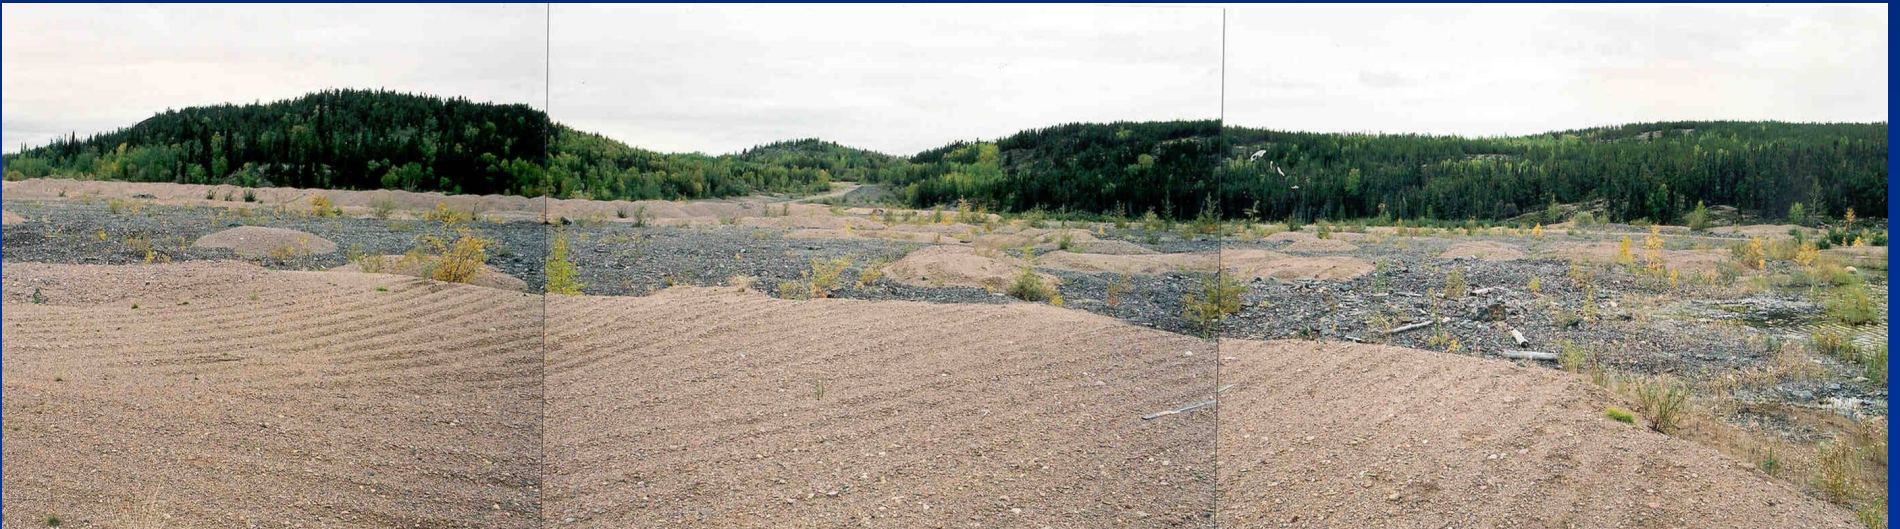
- Solution to problem has to been to place additional cover material that is properly graded to prevent upwards piping of tailings

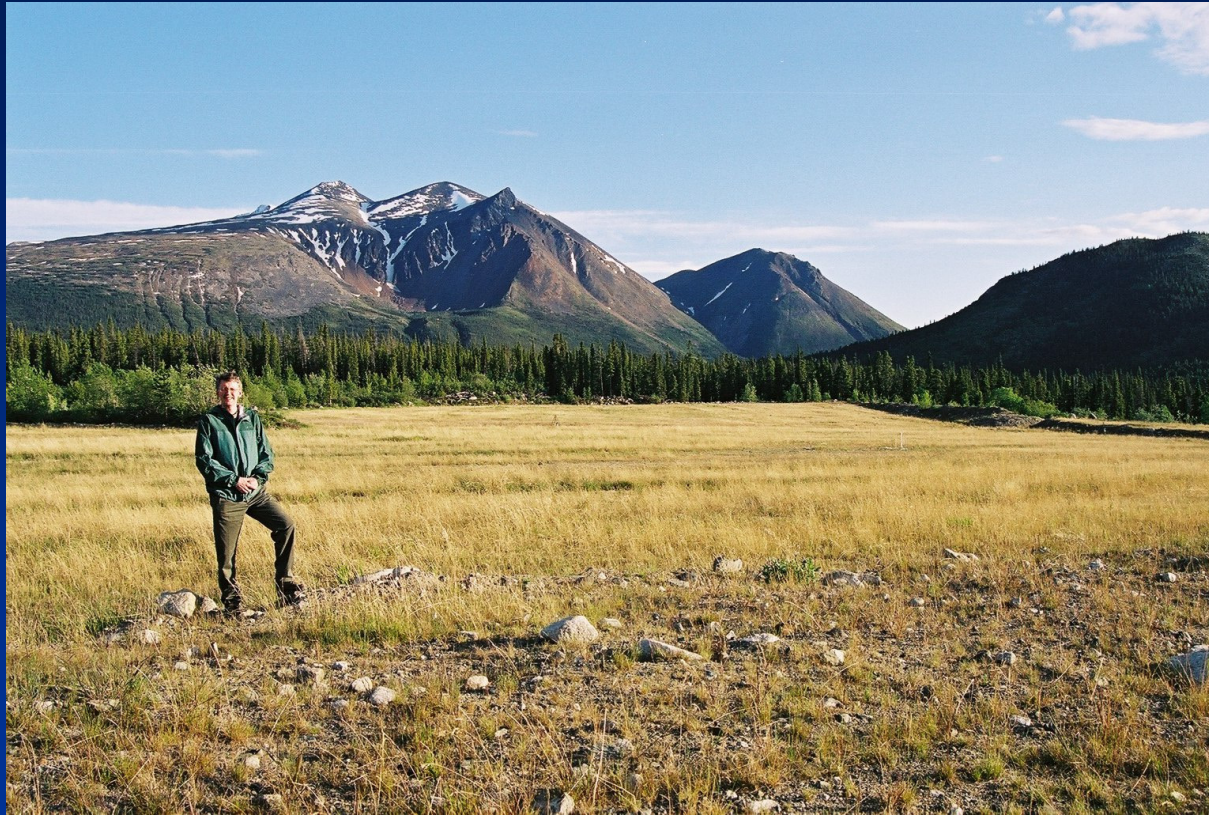
**Healthy growth  
of vegetation in  
most areas**

**Some evaporite  
crystals in one  
low-lying area**

**Dessication  
cracks**

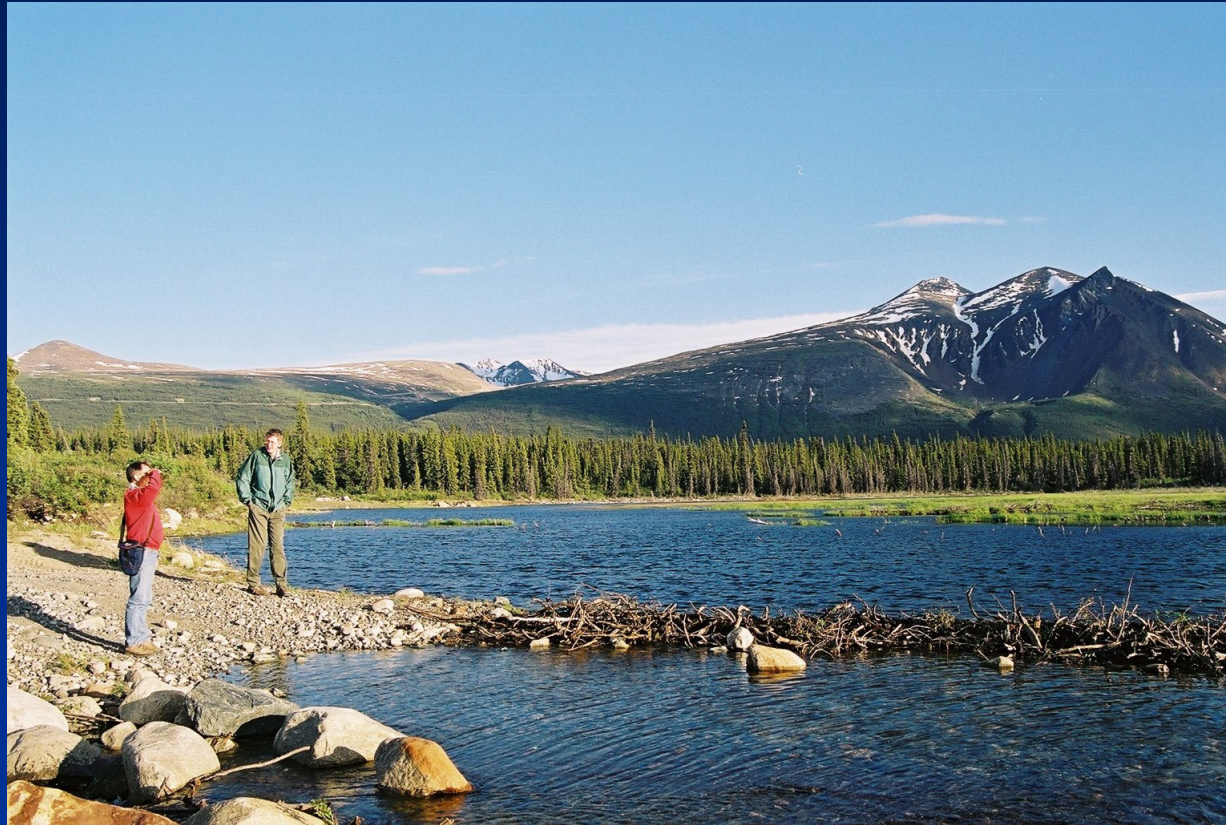
**Tailings and  
arsenic inputs to  
lake eliminated**

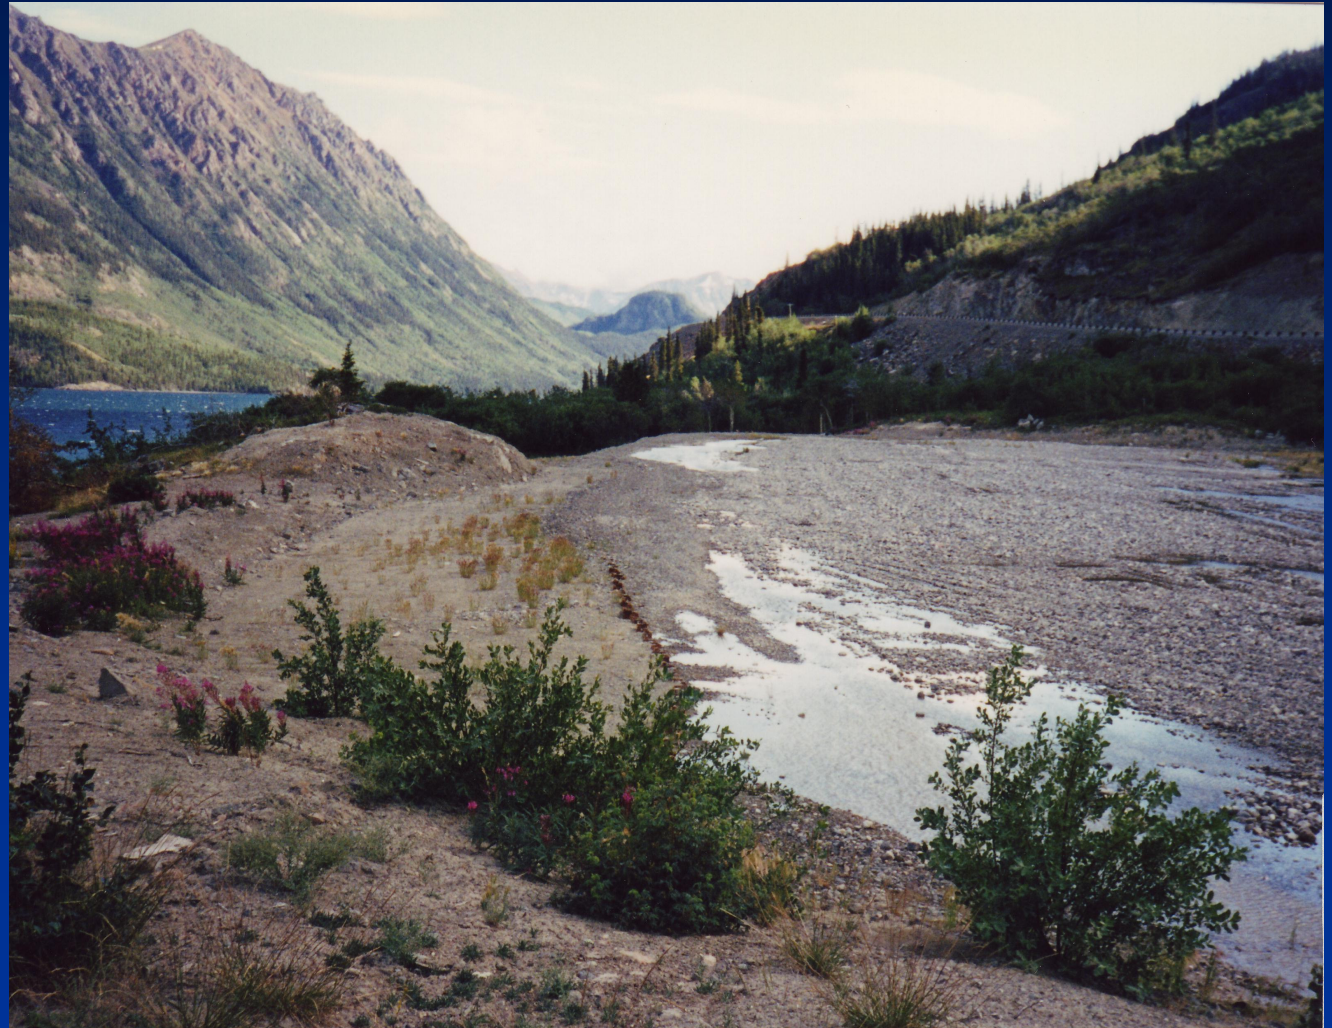
**Groundwater  
from slopes to  
north  
discharges  
just uphill of  
tailings**

**Probably also  
through the  
tailings**

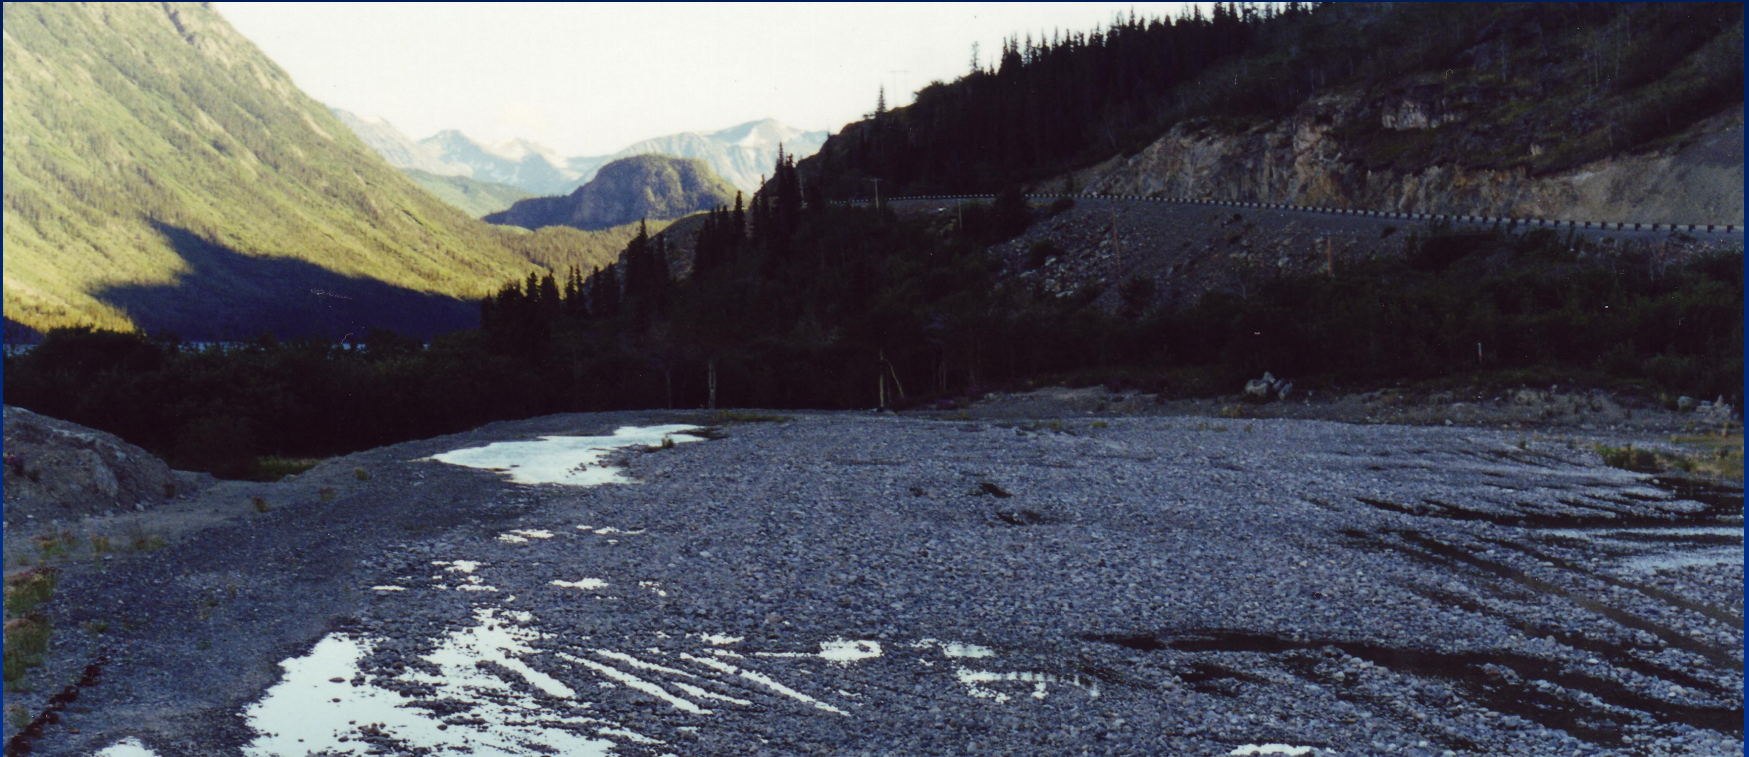
- Design considerations
  - Dry cover very difficult
  - Wet cover more sensible
  - But concern about exposure of contaminated water and uptake of arsenic by berries
- Selected wet cover
  - Constructed Waterloo Barrier sheet pile wall on downhill side to manage water level
  - Placed geosynthetic and inert gravel on top of tailings

- Two years later
  - Extensive settlement of gravel cover
  - Contaminated water and tailings on surface
  - Placed additional 30-50 cm of gravel
  - Unique design requirement
    - Gravel must be same colour as previous!

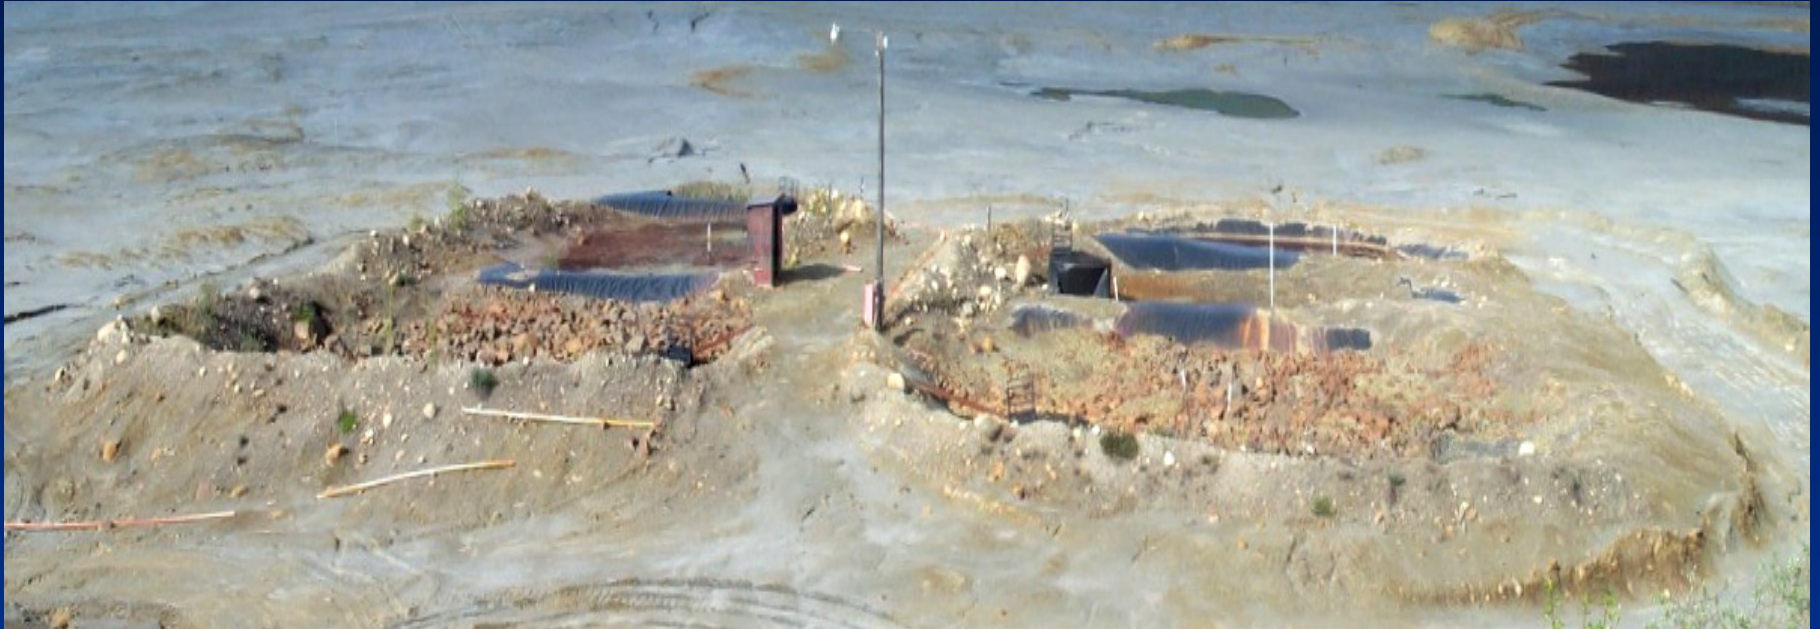
- Original Impoundment cover test area
  - Constructed 1992 – operated 5 years
  - Significant damage from freeze-thaw and poor maintenance

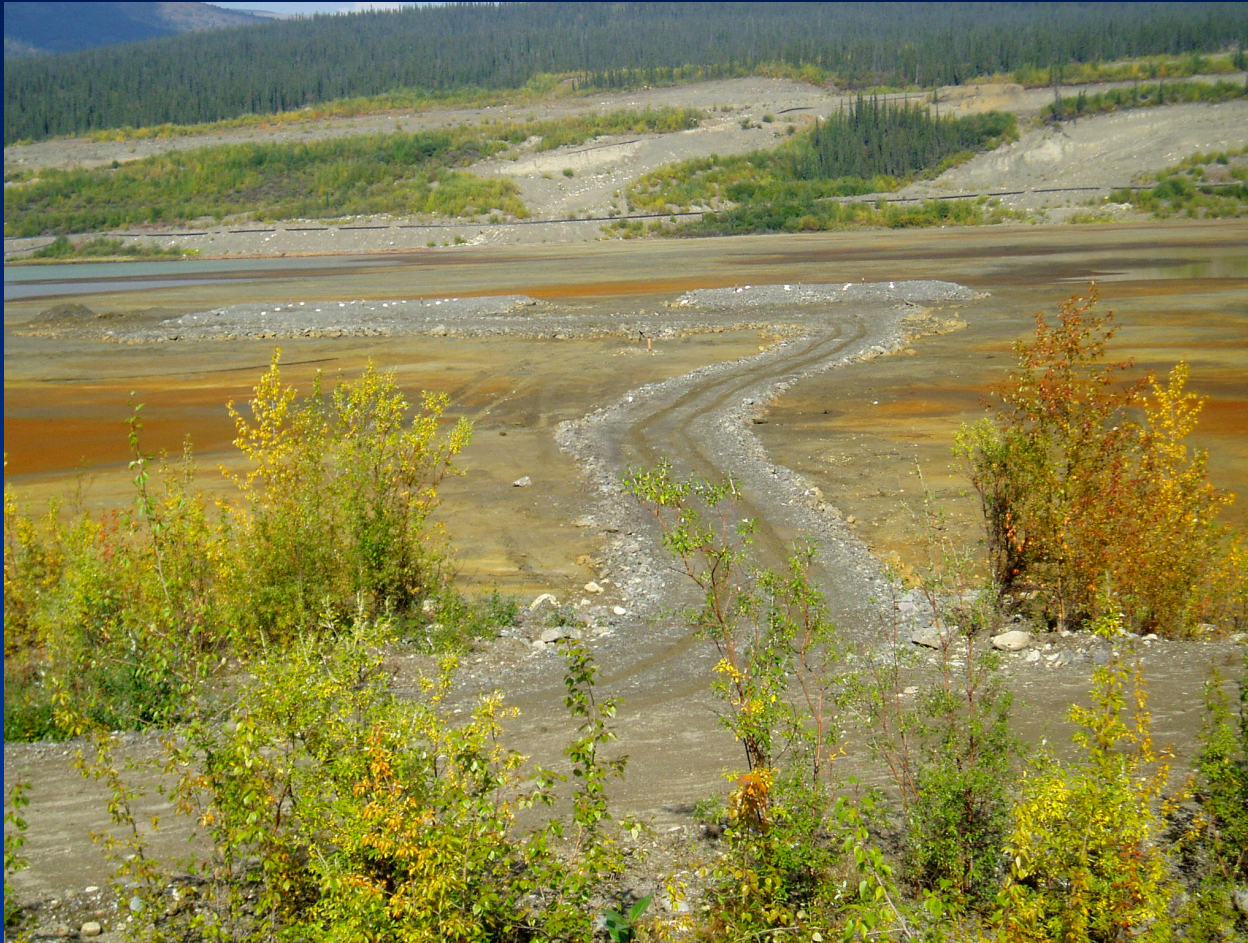
**New trial  
areas initiated  
in 2003**

**Construction  
limitations  
only**

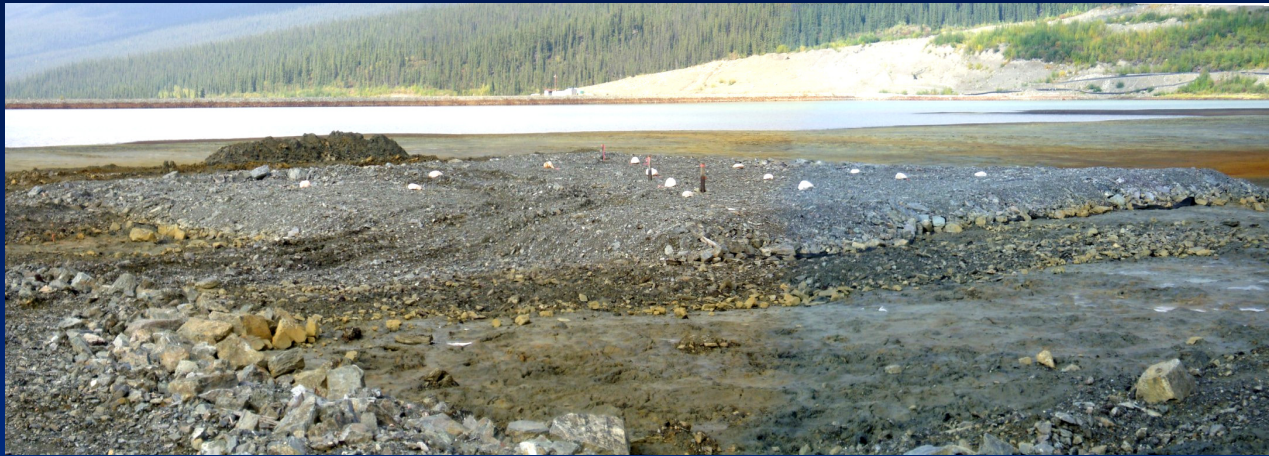
**With & without  
geotextile filter  
layer**

**Settlement  
monitoring**

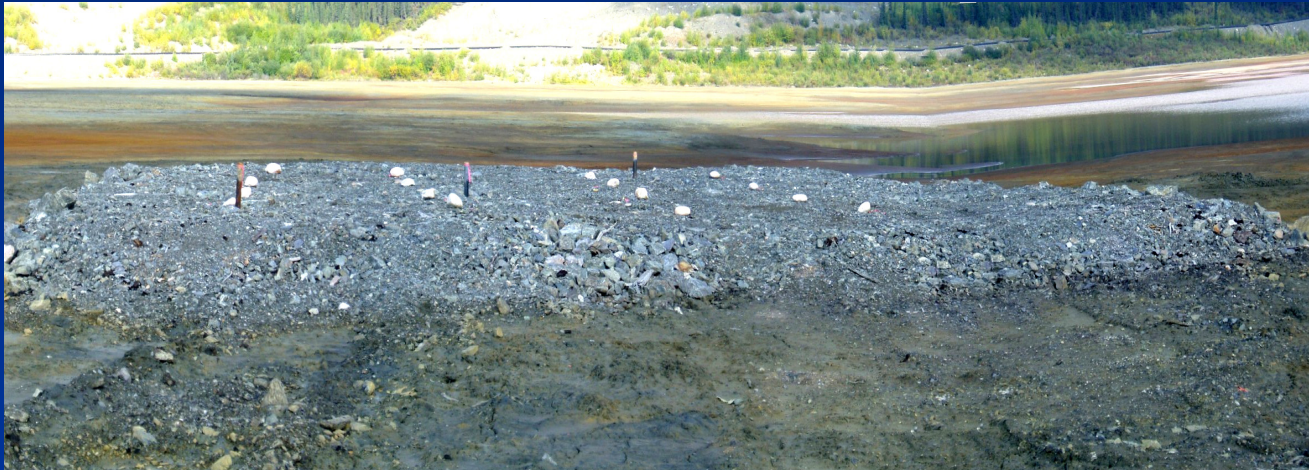
**Test pits to  
examine piping**

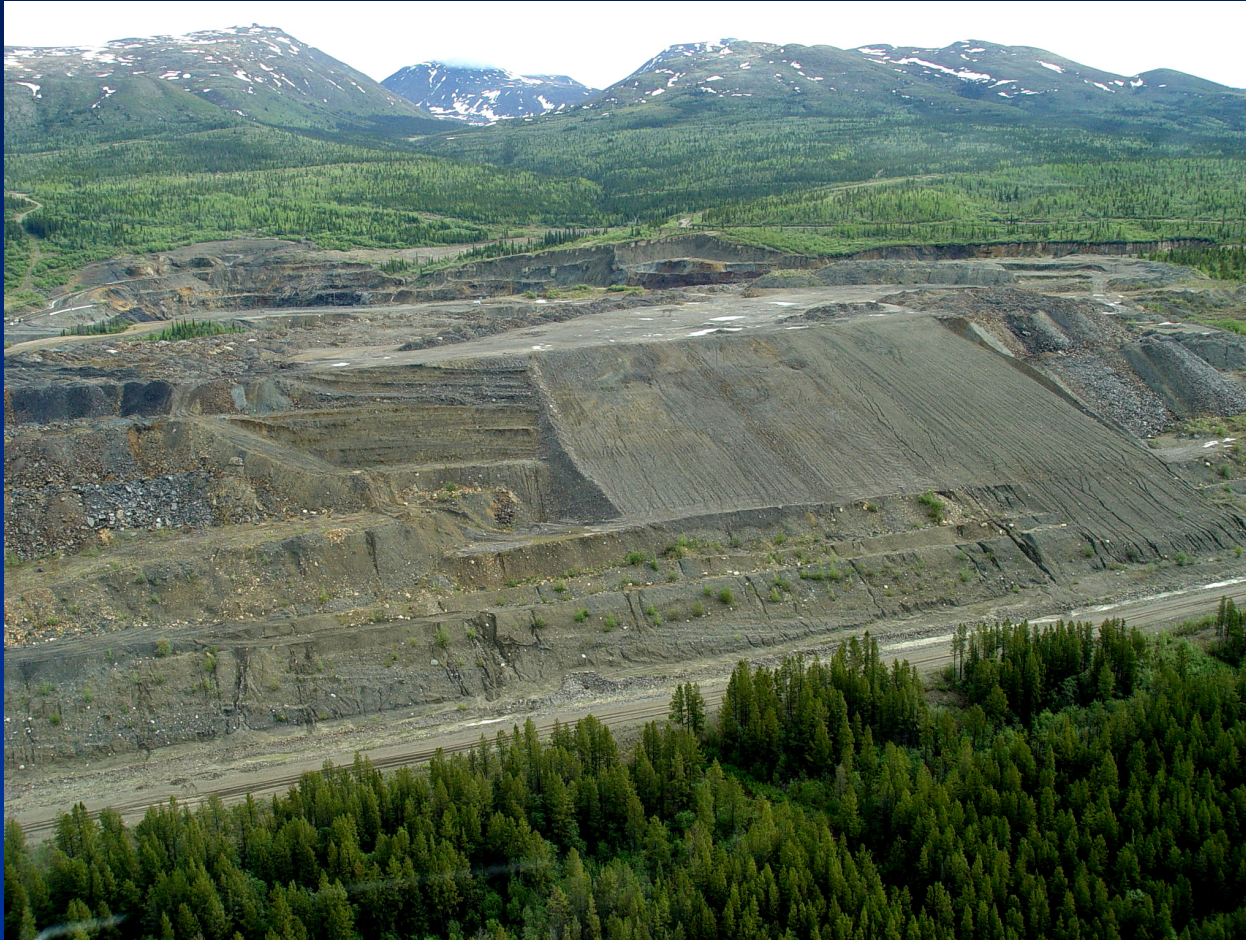
Cover test area  
built in 1994

Resloped to 2.5:1

Cover profile

- 1 m loosely compacted till
- 1 m highly compacted till

Not vegetated

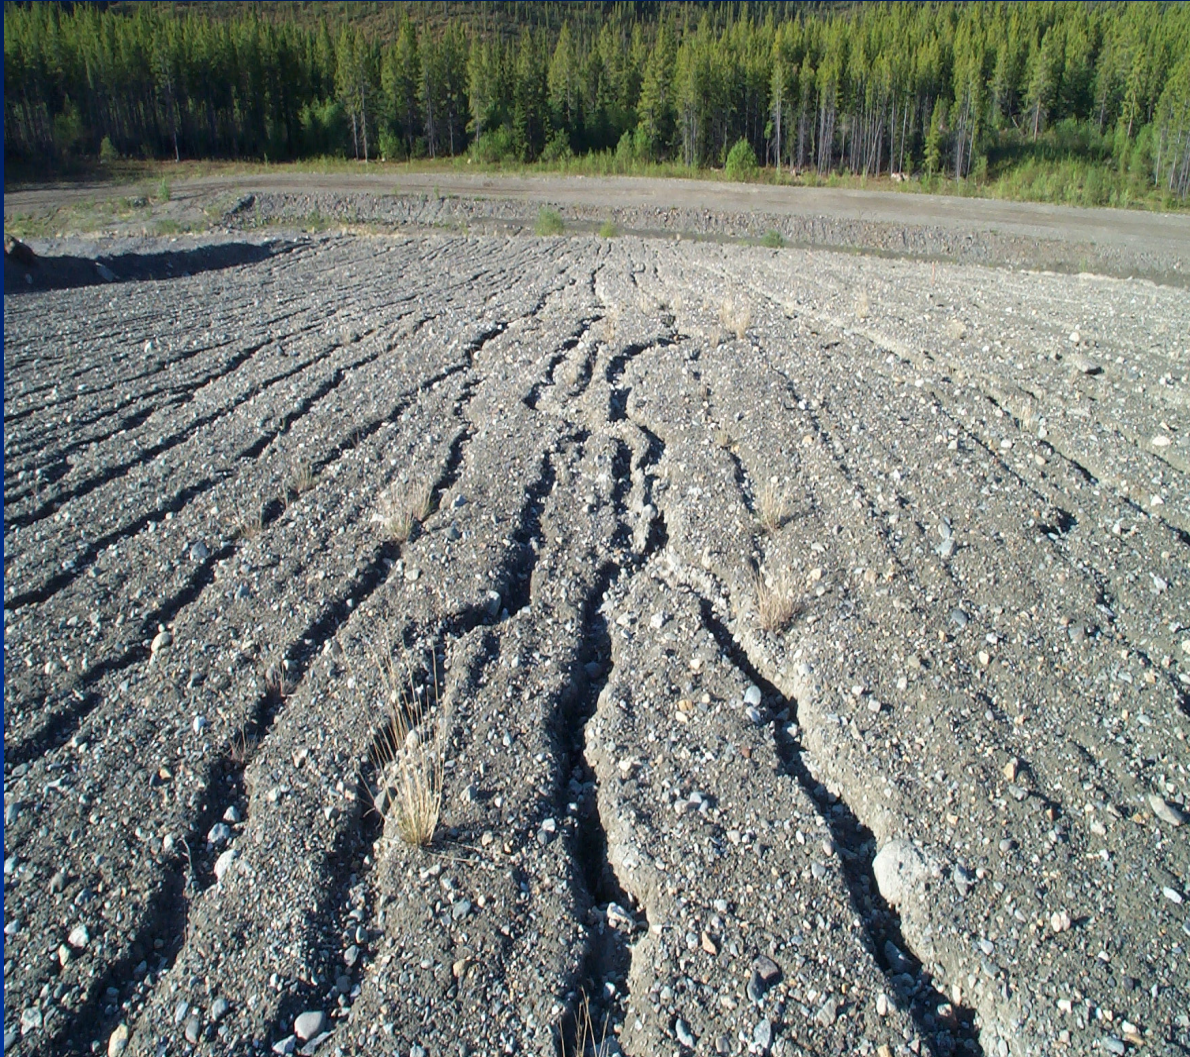
Till cover material

- Low-plasticity clayey silt
- Prone to erosion
- Frost sensitive

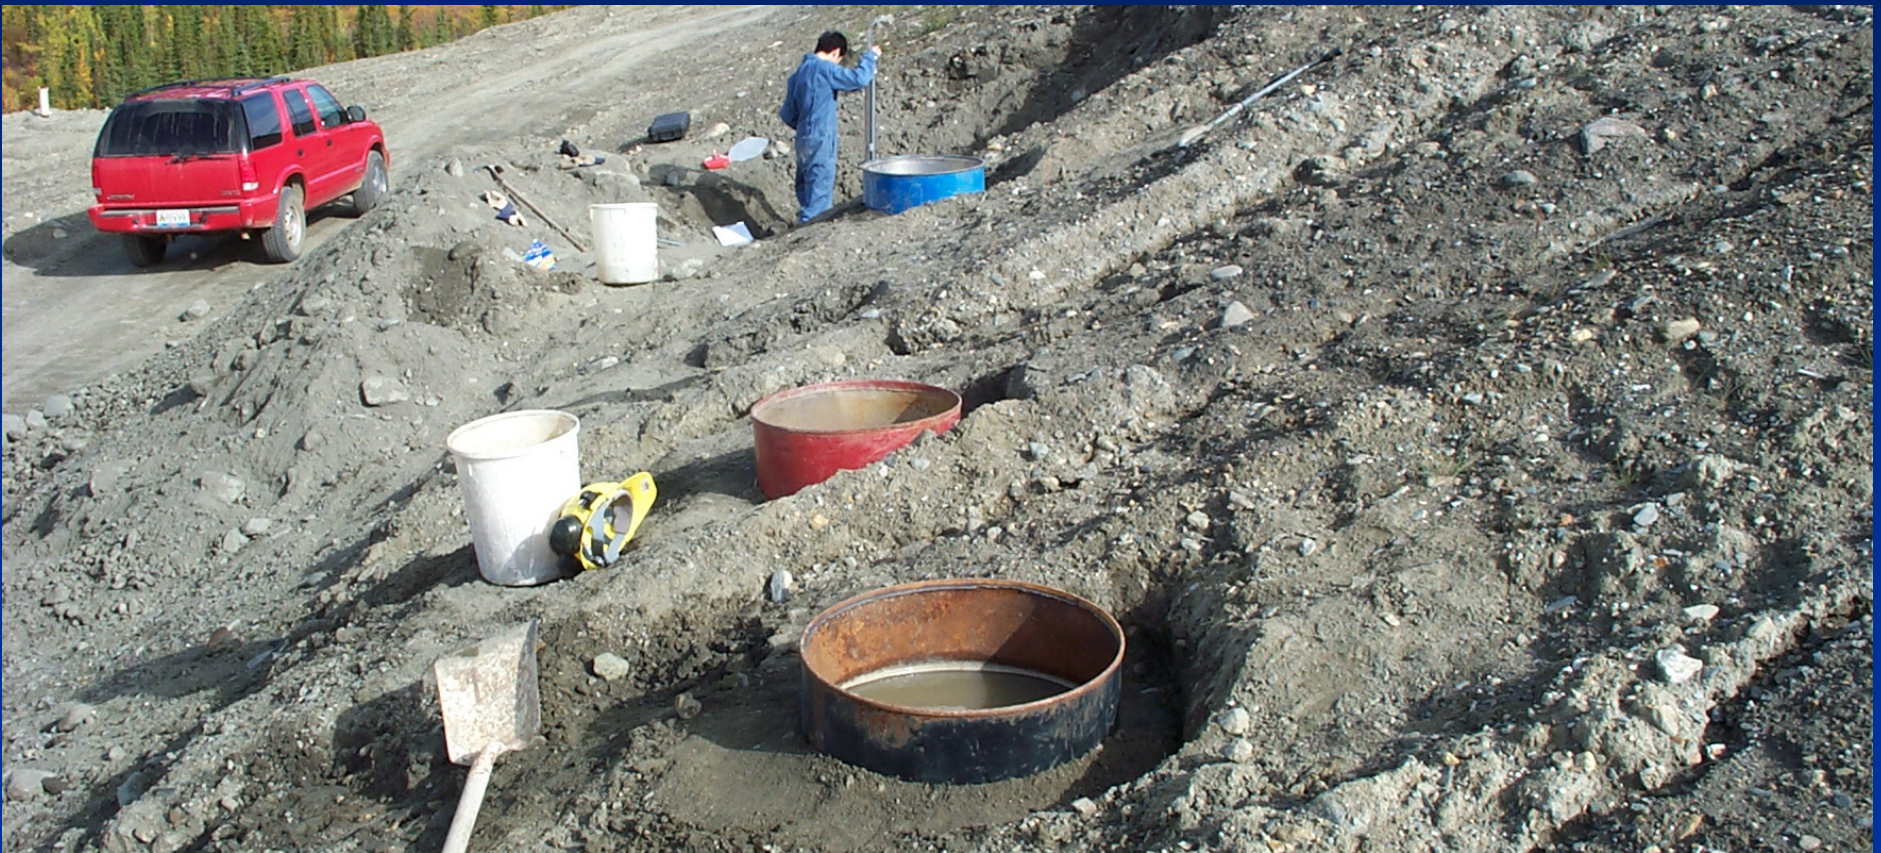
- Field tests in 2003 showed permeability of  $10^{-4}$  to  $10^{-5}$  cm/s

- Construction QA samples showed density of 95-100% standard proctor
- Field tests in 2003 showed density of 90% standard proctor
- Difference in density means 1-2 order of magnitude increase in permeability

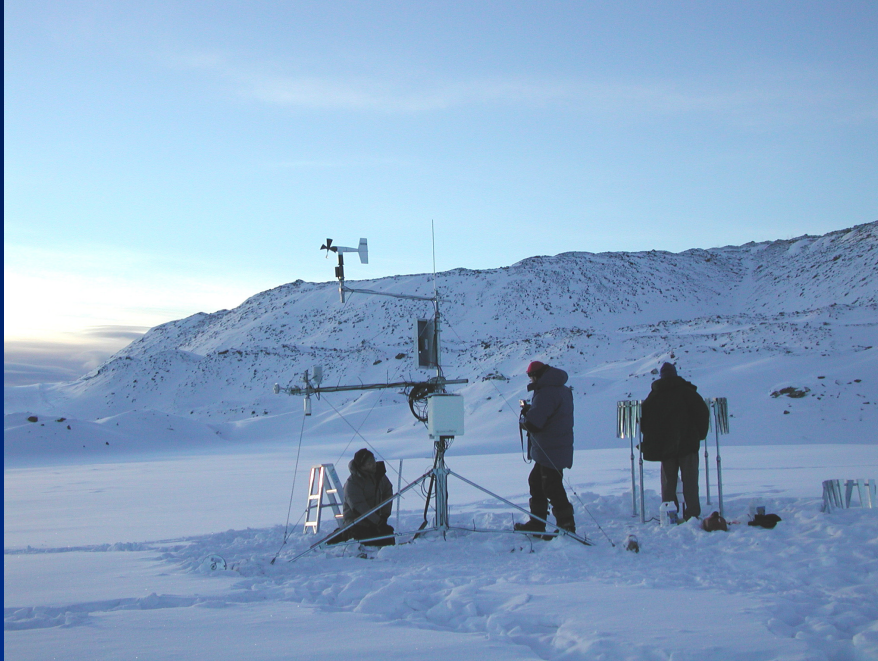
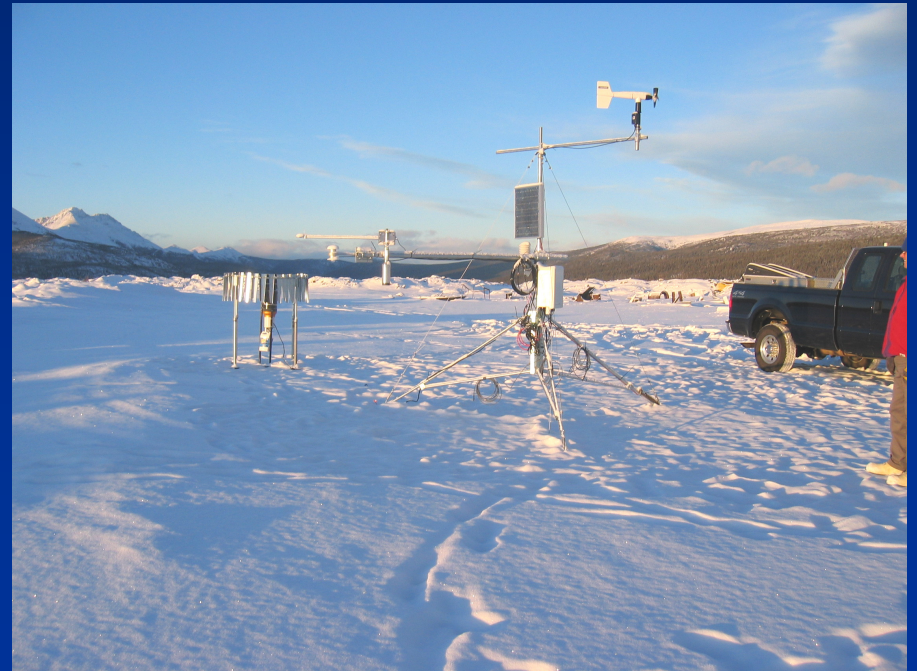
- Meteorological stations established in Dec 2003
- Cover trials in Sept 2004

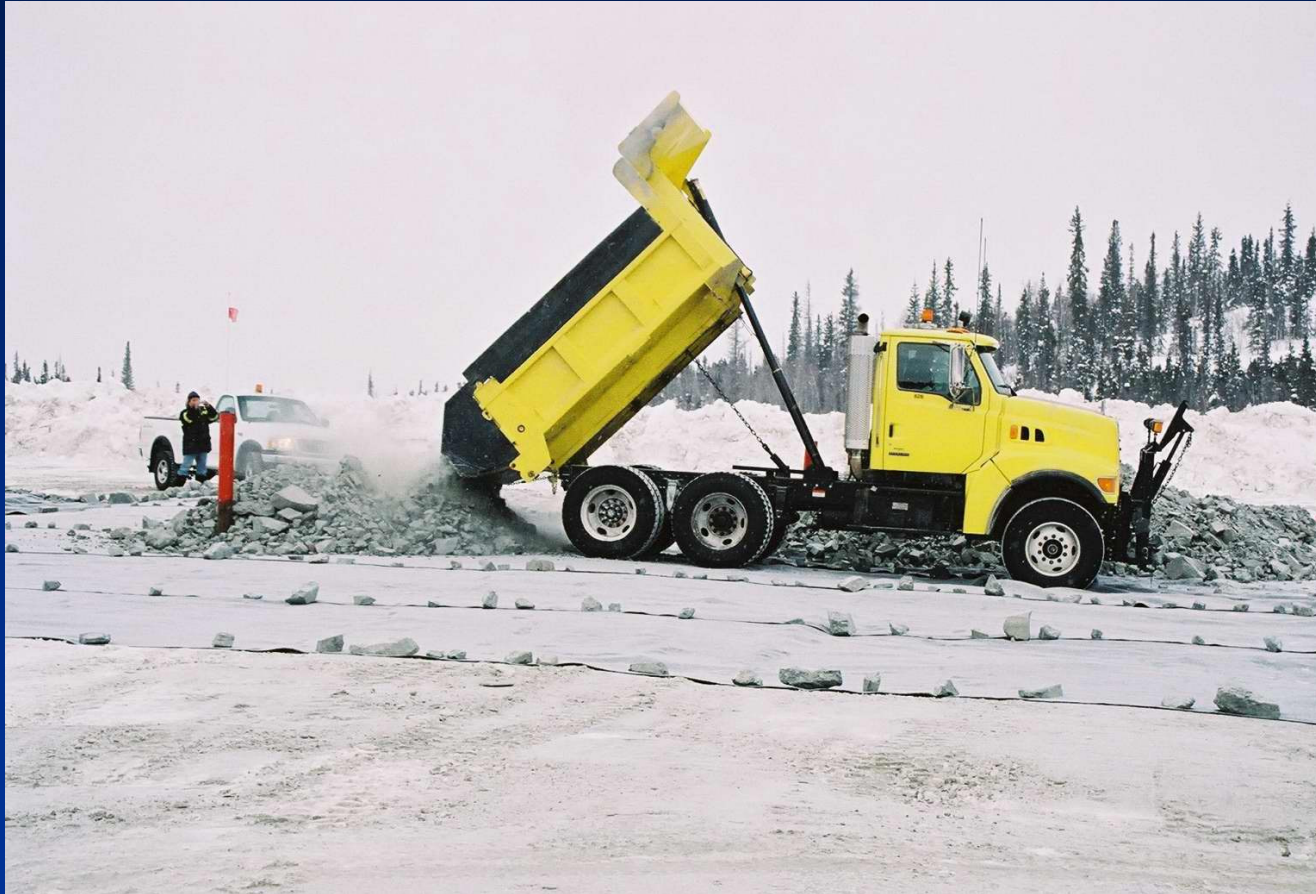
**Test of winter  
construction in  
2003**

- Rock fill cover
  - Use waste rock from mine area
- Concern about rough surface being an obstacle to caribou
  - Run-of-mine for 80 cm
  - Sorted to 4" minus for top 20 cm
- No revegetation
- Questions as to constructibility and whether geotextile separation layer is required
