# Soil Covers in the Canadian North

Daryl Hockley,  
Maritz Rykaart, Michel Noël  
SRK Consulting Inc.

# Overview

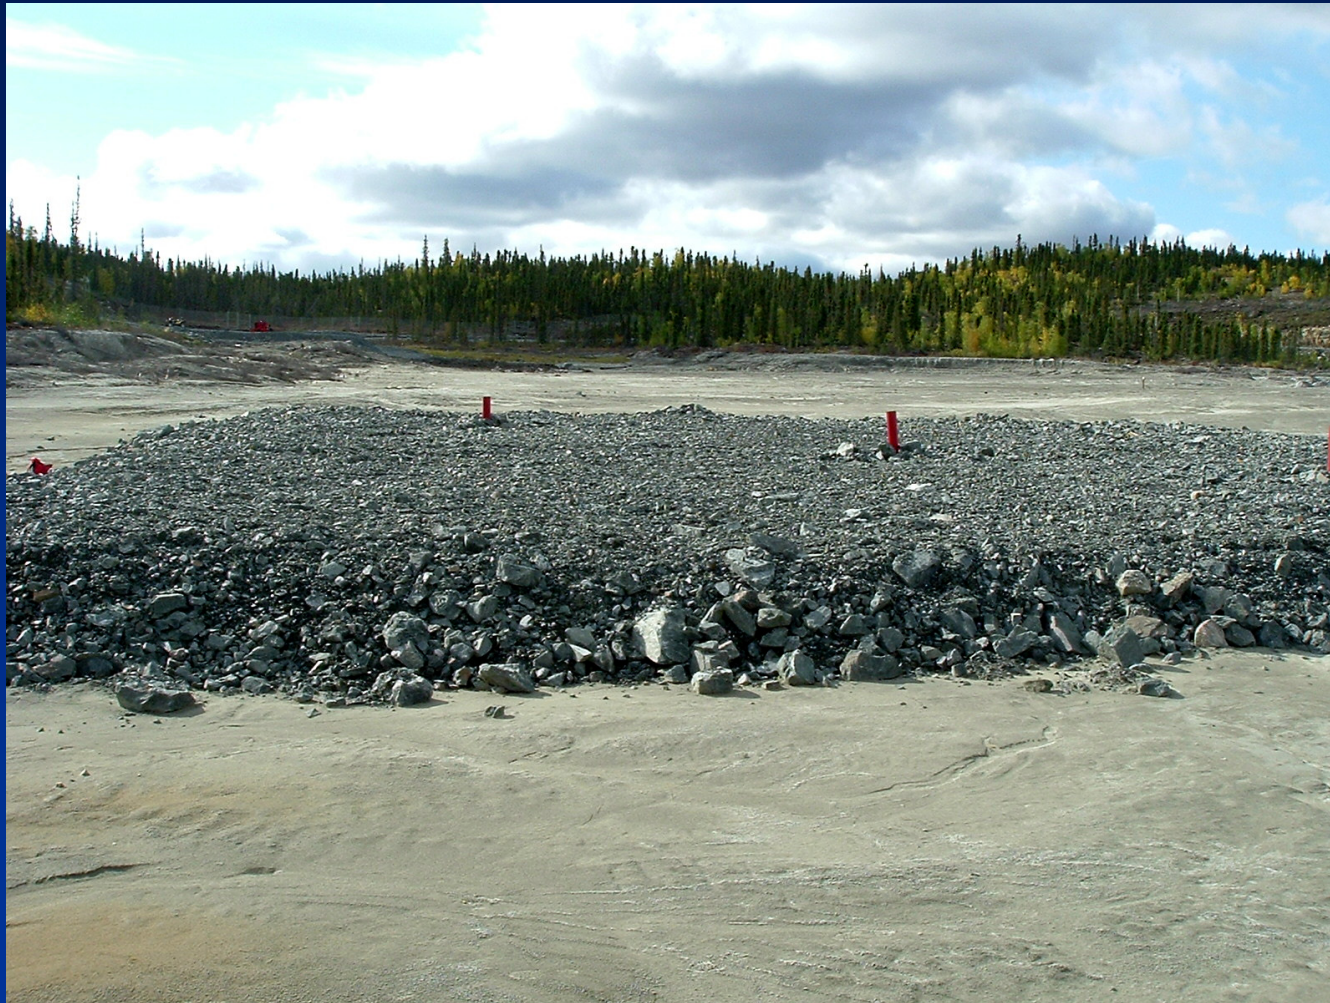
**Monitoring  
test areas for  
settlement  
and upwards  
migration of  
tailings**

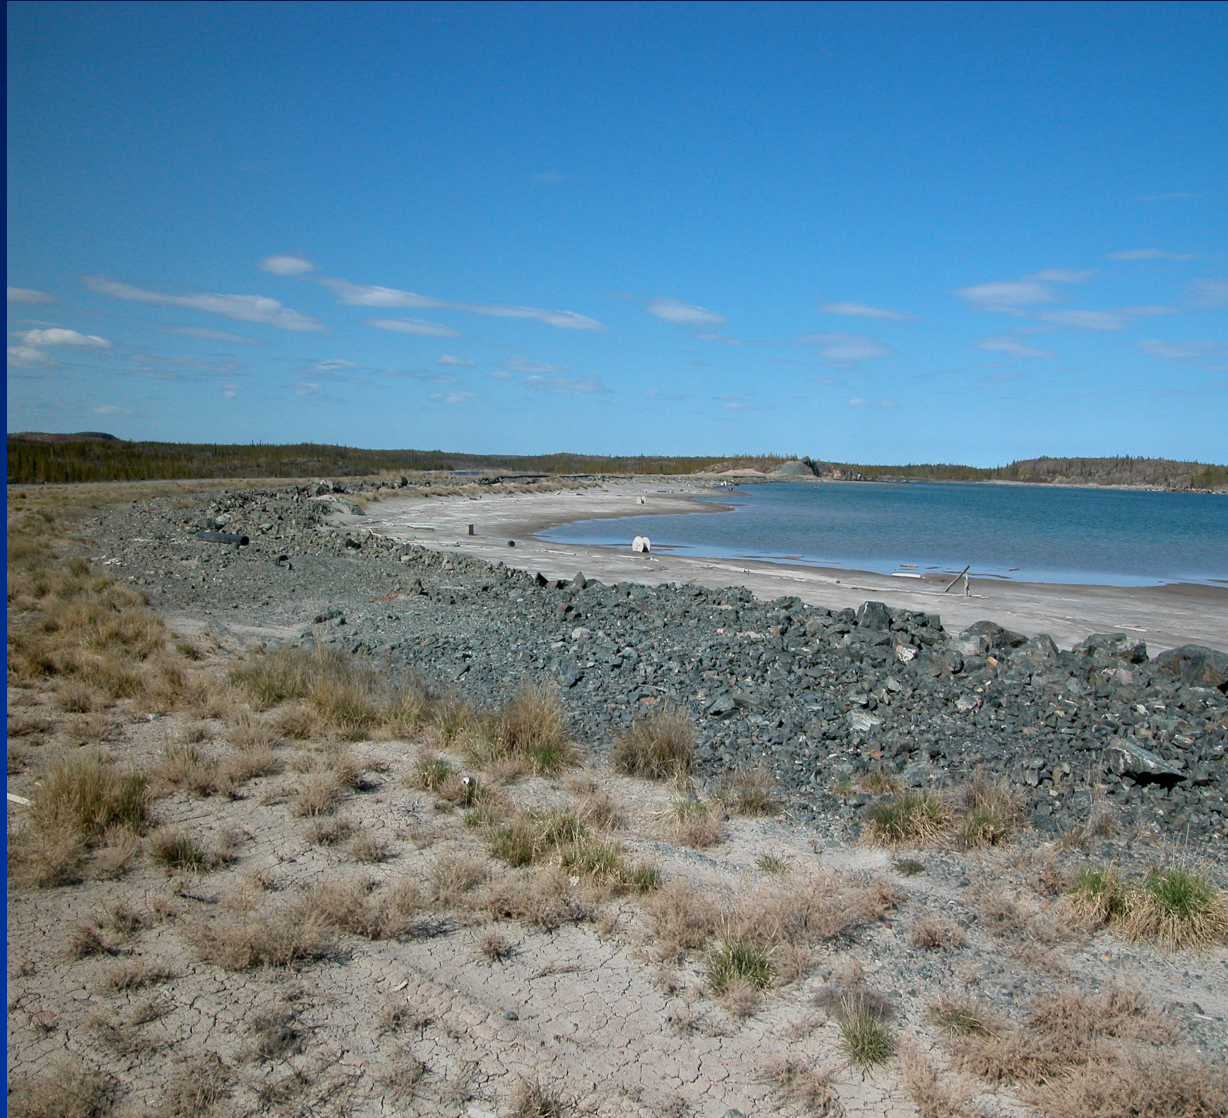
**Test program in  
planning for  
2005**

**Water storage**

**Integrity of  
capillary break**

**Need for  
geotextile  
seperation  
layers**

- Design objectives for tailings covers:
  - Stop dust and direct exposure
  - Minimize contaminated surface water
    - Need to prevent upwards flux of contaminants by evaporation
    - Suggests two-layer cover with capillary break
  - Allow future recreational use of surface
    - Local concerns about ATV users
    - Need one of the layers to be coarse material
