Presentation to 16th ANNUAL BC/MEND METAL LEACHING /
ACID ROCK DRAINAGE WORKSHOP

Acid Rock Drainage Dry Covers Site Closure Program

Sydney Coal Fields

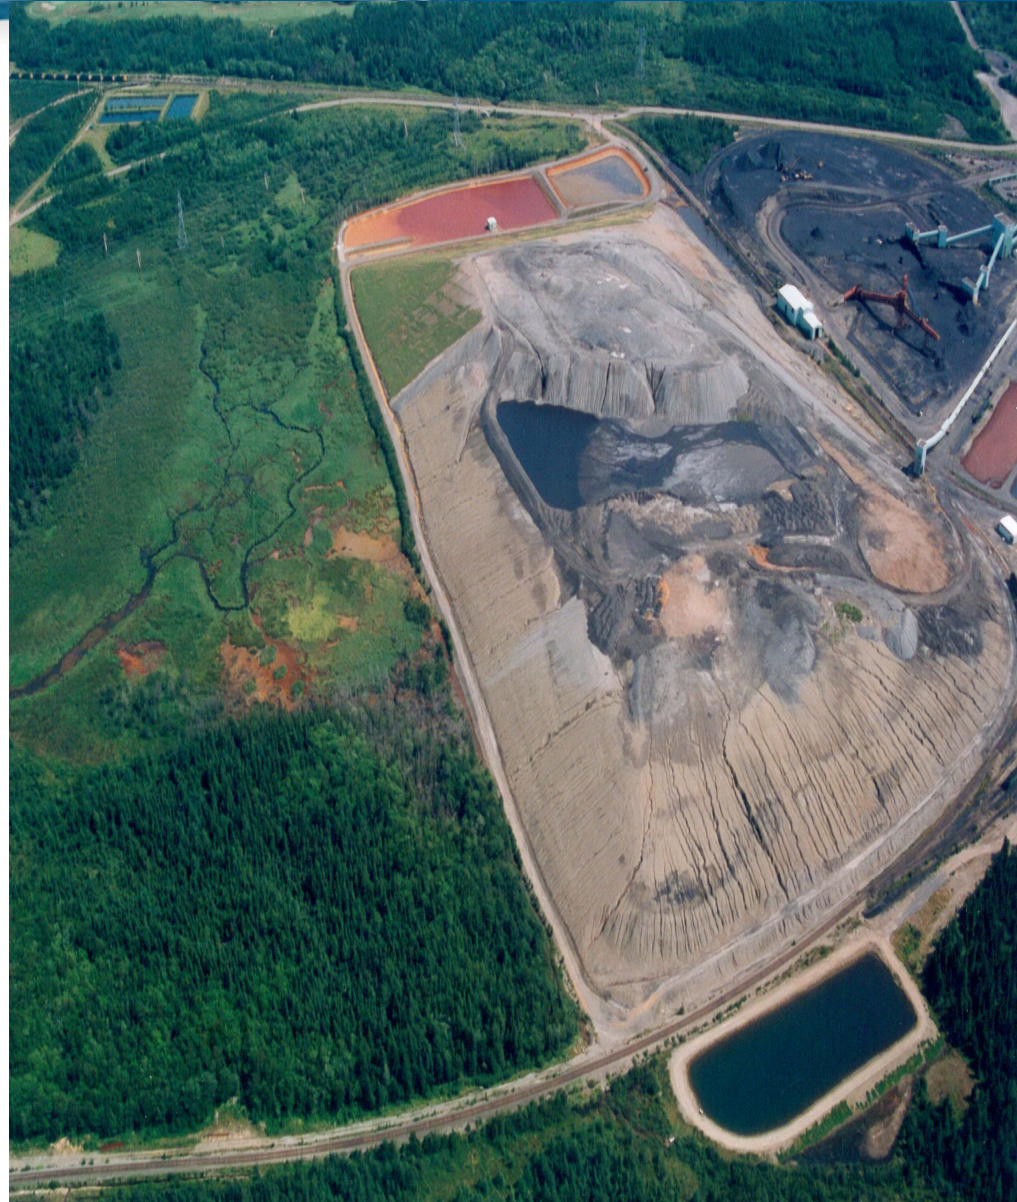
Victoria Junction Coarse Waste Pile

- Operated from 1976 to 1998
- 1000 tph coal preparation plant
- Coarse waste Pile = 26 Hectares/40 meters in height
- 9 million tonnes of materials
- Contained coal tailings & waste rock from the process plant
- Constructed on a wetland

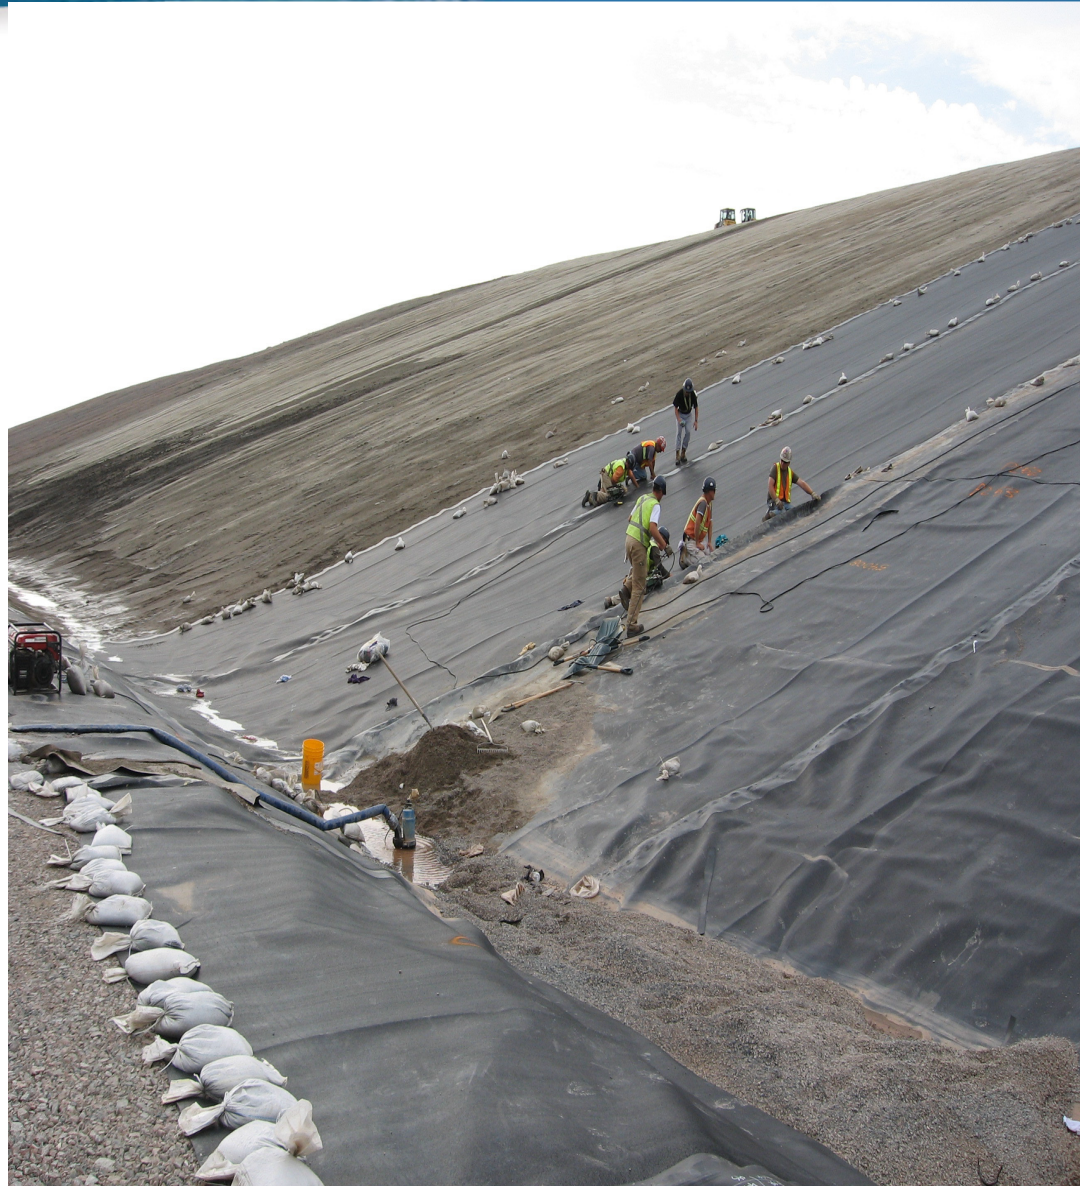
HDPE Liner

- 6 mm HDPE liner
- Textured for slopes
- Multi layer Design
- Incorporate down slope drainage ditches
- Toe drain collection system

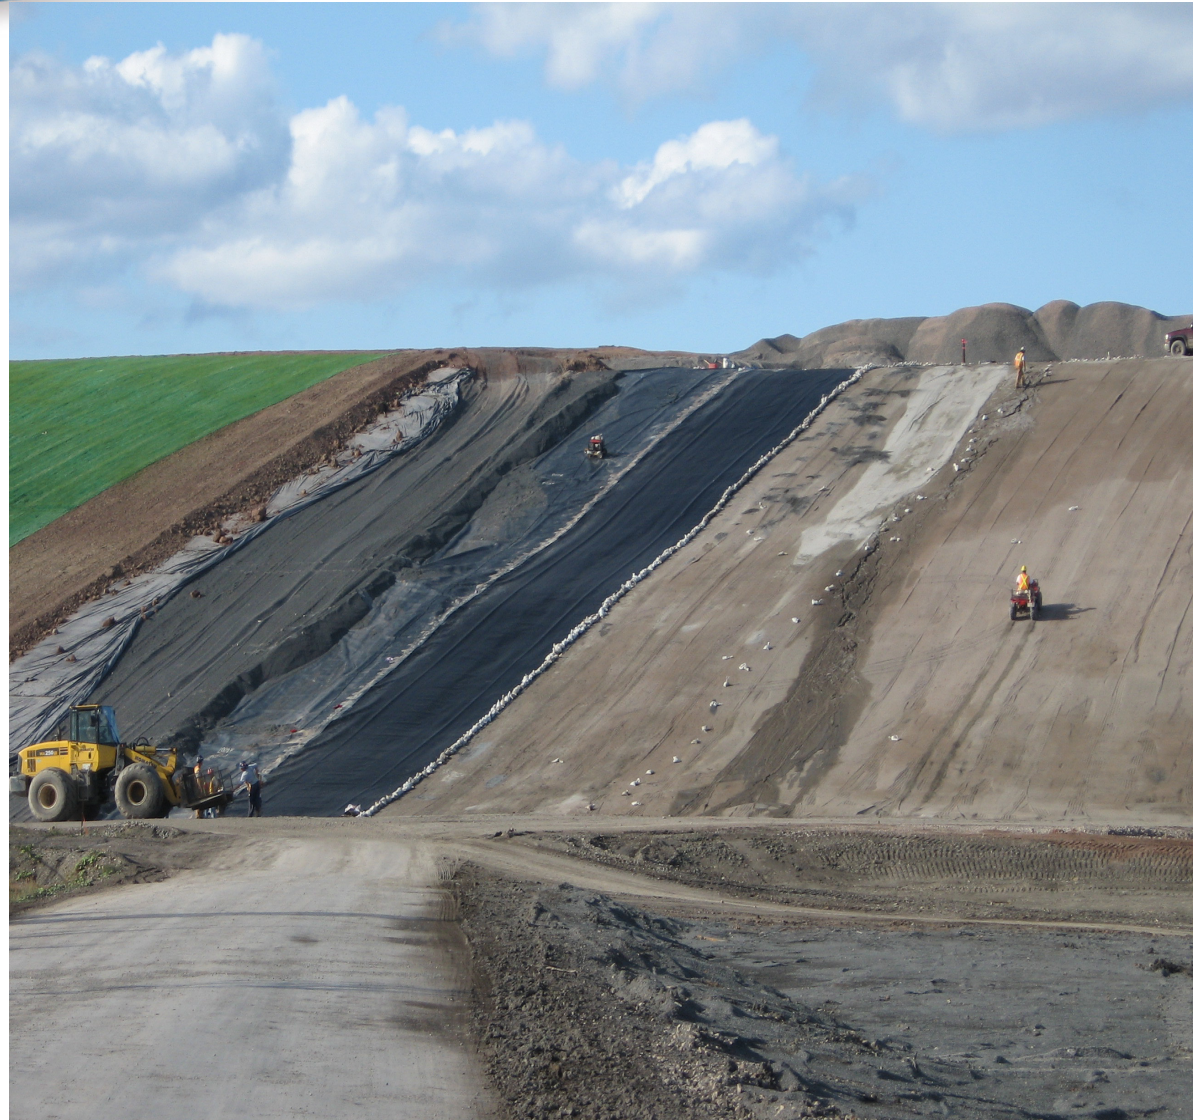
Liner Installation - Multi Layer

- Sloped Waste Rock Compacted
- 100mm sand bed
- HDPE liner
- 400 mm Drainage Layer
- Type A Geotextile
- 400mm Vegetative Cover
- Hydro seeded with erosion control measures

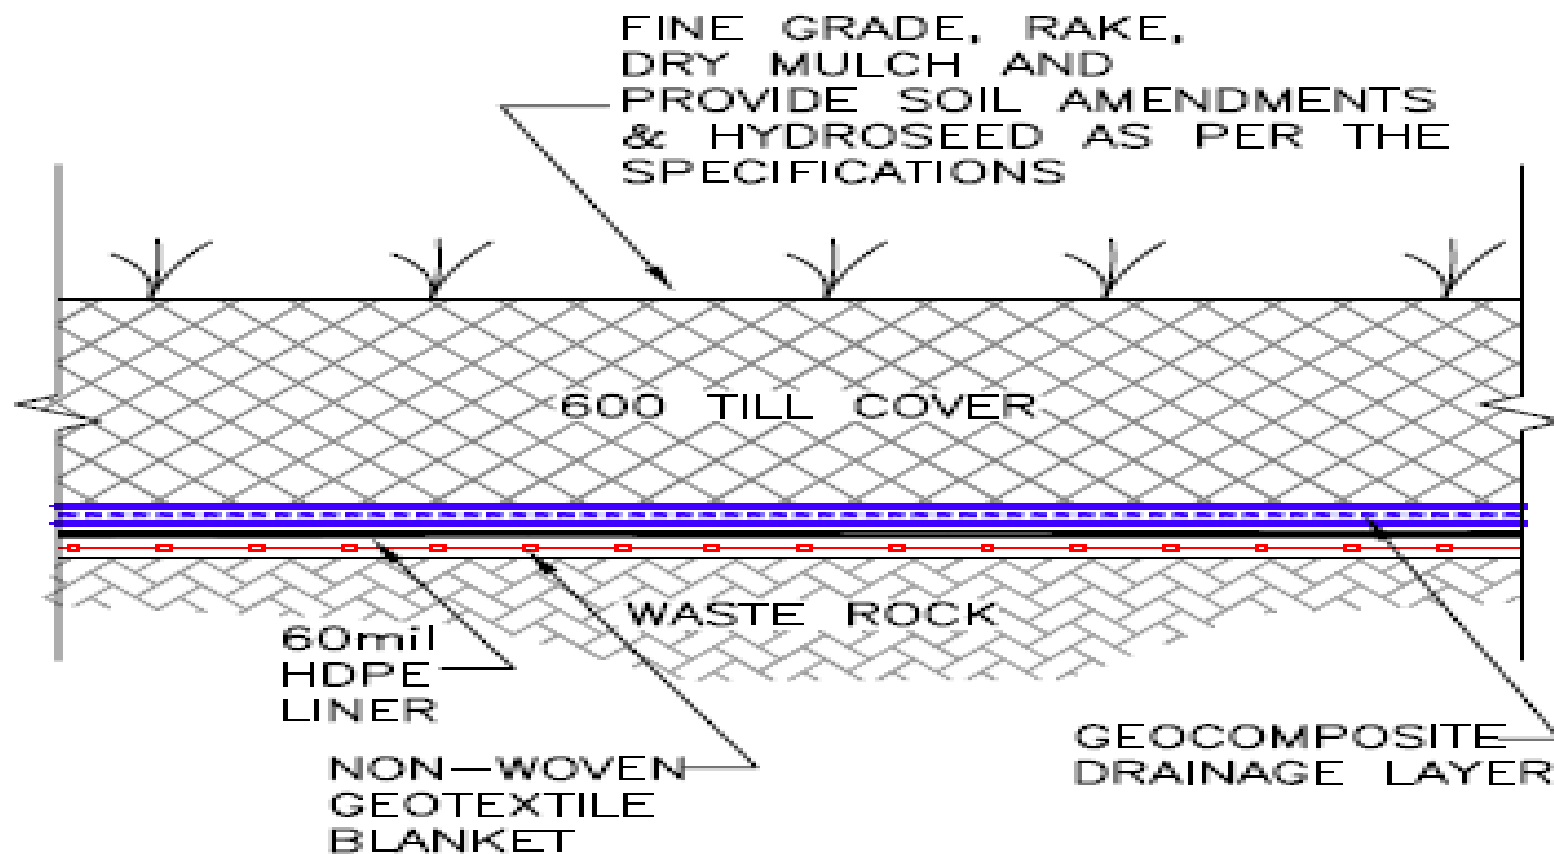
Capping Option

OPTION #1 — 60mil HDPE
