The Rehabilitation of The Kam Kotia Mine Site:

An Exercise in Cover Construction and Water Management

The Construction of the NIT Cover

The NIT Cover

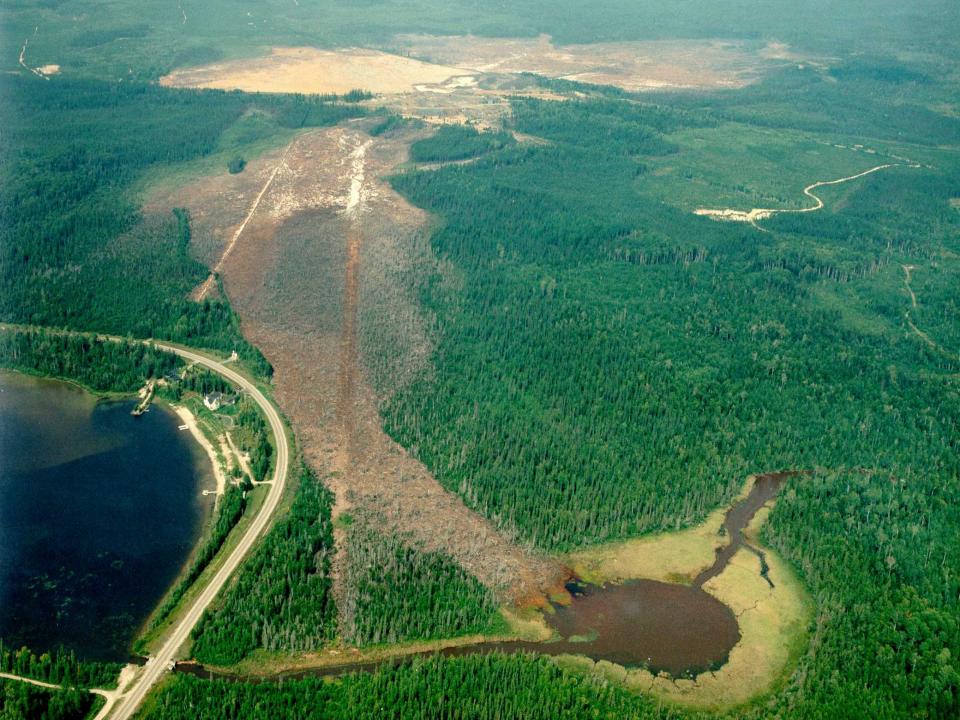
The mine plant area. 17-1

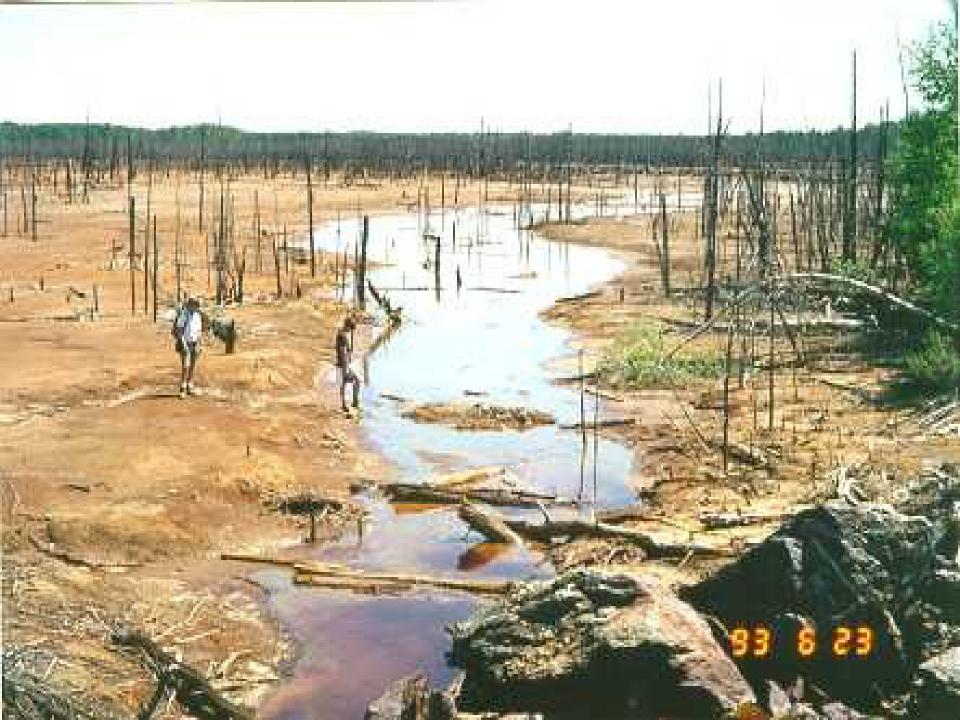
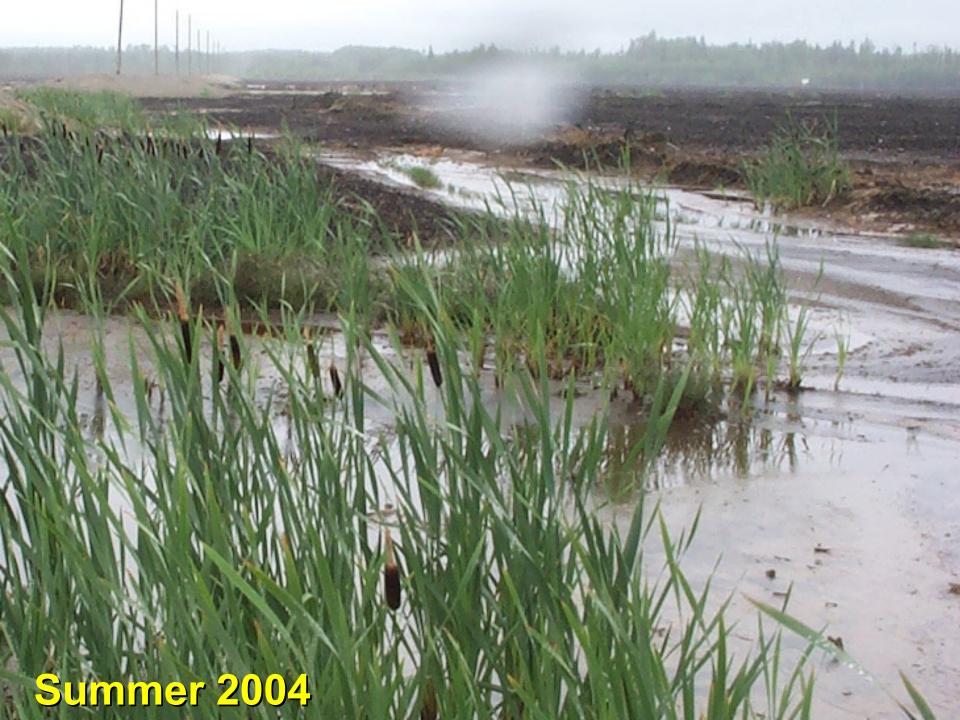
June 2003

FORMER SOUTH UNIMPOUNDED TAILINGS MINE SITE
> FORMER NORTH UNIMPOUNDED TAILINGS

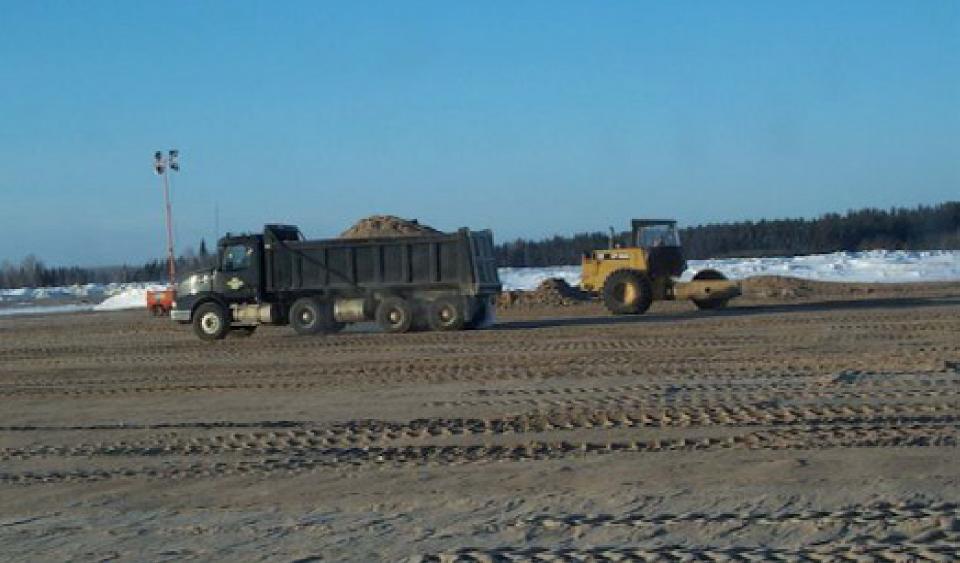
Layer 2: Granular B

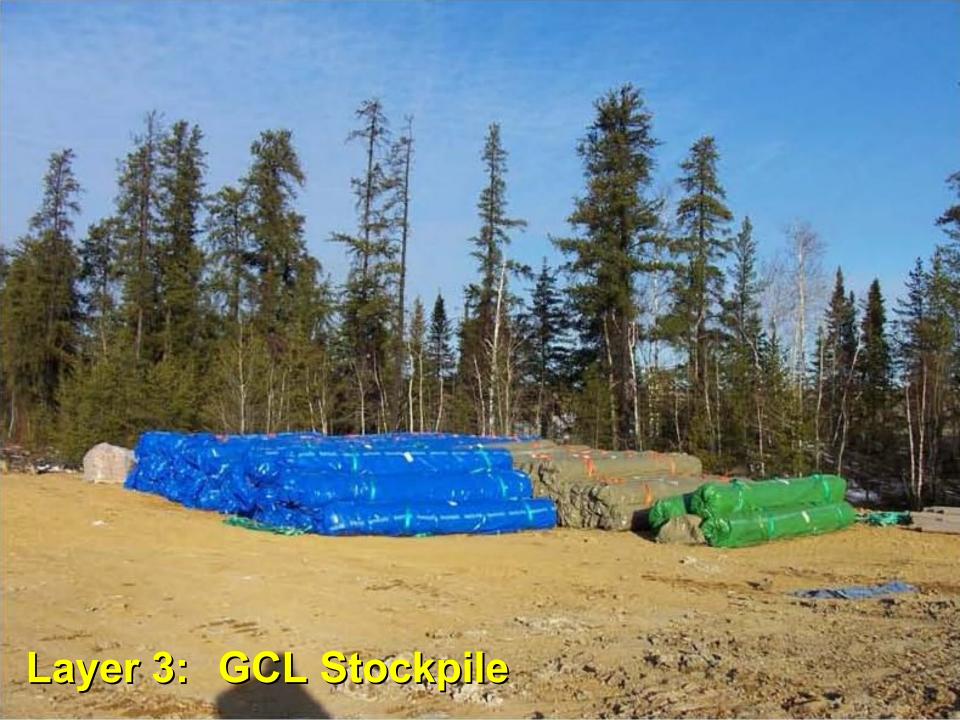
Layer 3: GCL Arriving

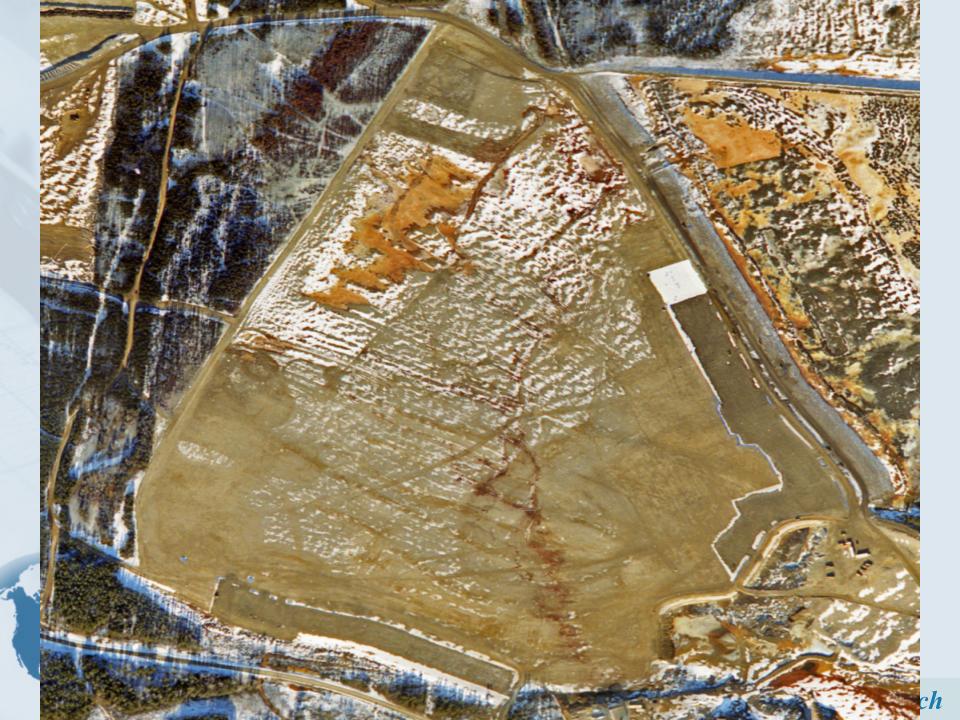
Layer 4: Clay

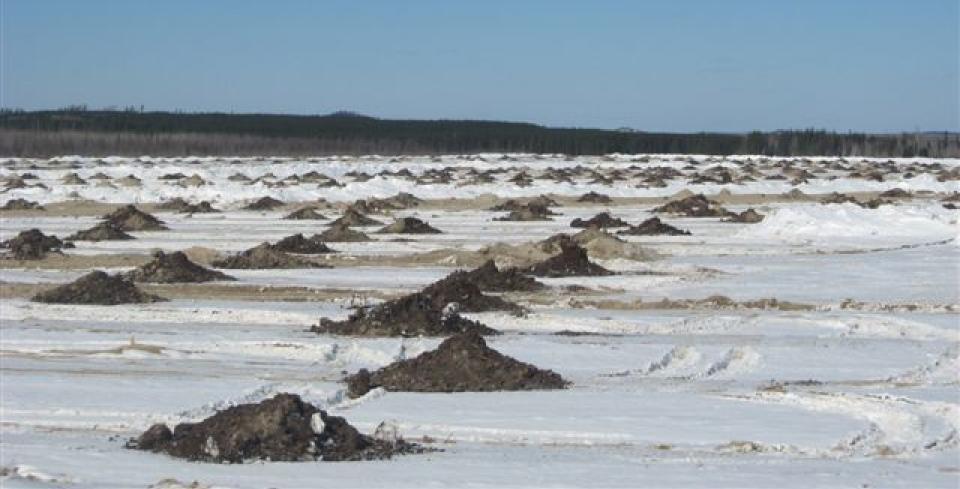
Layer 6: Topsoil & Vegetation

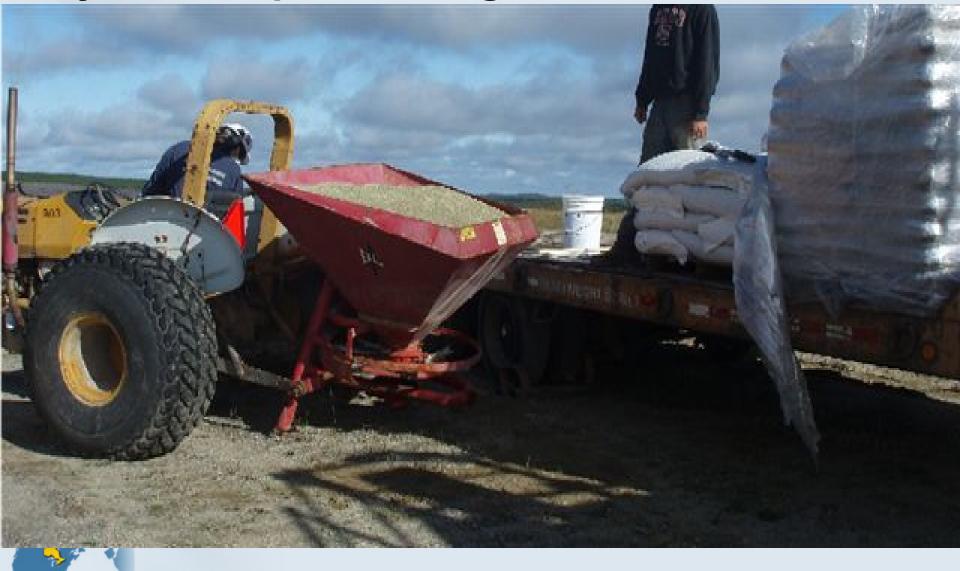
Layer 6: Topsoil & Vegetation
