The Owl Creek Pit Part 1: Relocating Mine Rock from Surface Stockpiles to the Pit to Mitigate Acid Drainage

1-EcoMetrix Incorporated

2-Goldcorp, Porcupine Gold Mines

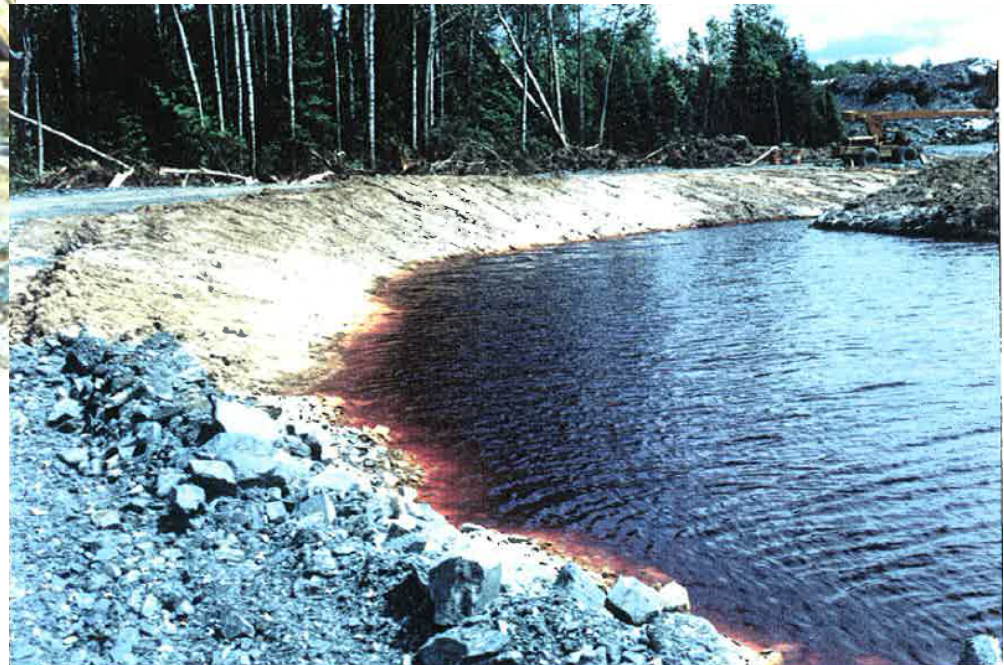
Spreading Lime on the stockpiles as an Interim Measure

- Constructed cutoff berms
- Constructed impoundment at North Dump
- Piping to pump acidic water to the Kidd Creek tailings management area for treatment
- Local application of lime on stockpiles
- Initiated surface and groundwater monitoring
- Hired consultants to investigate cause

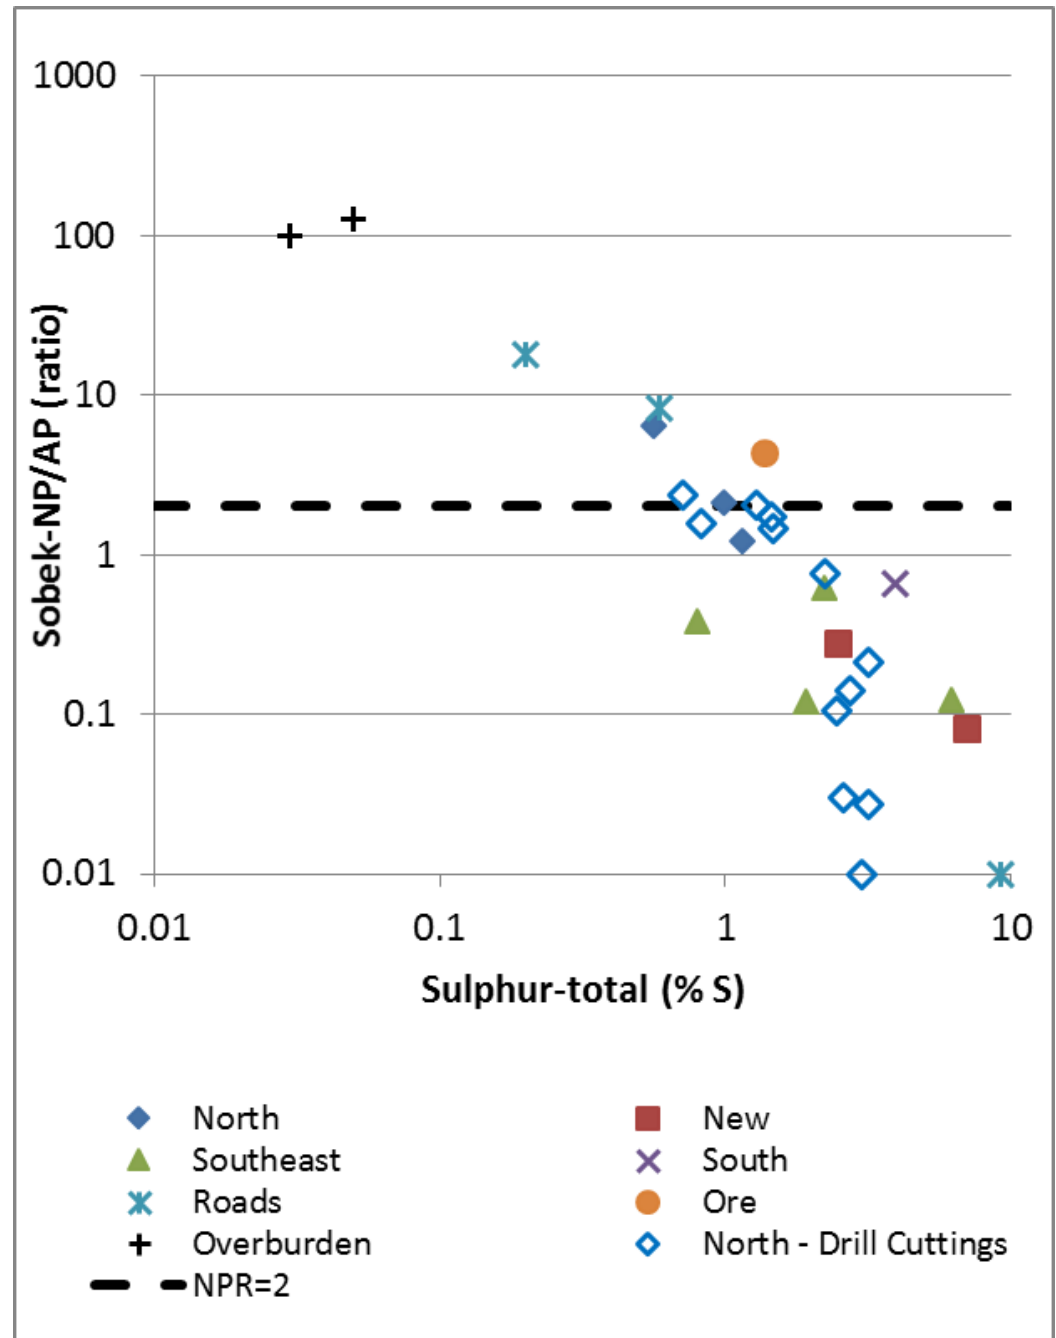
Waste Rock Characteristics

Original Data from SENES (1990)

- Three main waste rock types, with pyrite & carbonate alteration:
- Metavolcanics and Greywacke
 - typically less than 1% S & classified as non-PAG
- Graphitic Argillite (schist)
 - typically 1 to 10% S and classified as PAG
- Only 10% of waste rock was Argillite but it was mixed with non-PAG rock and overburden

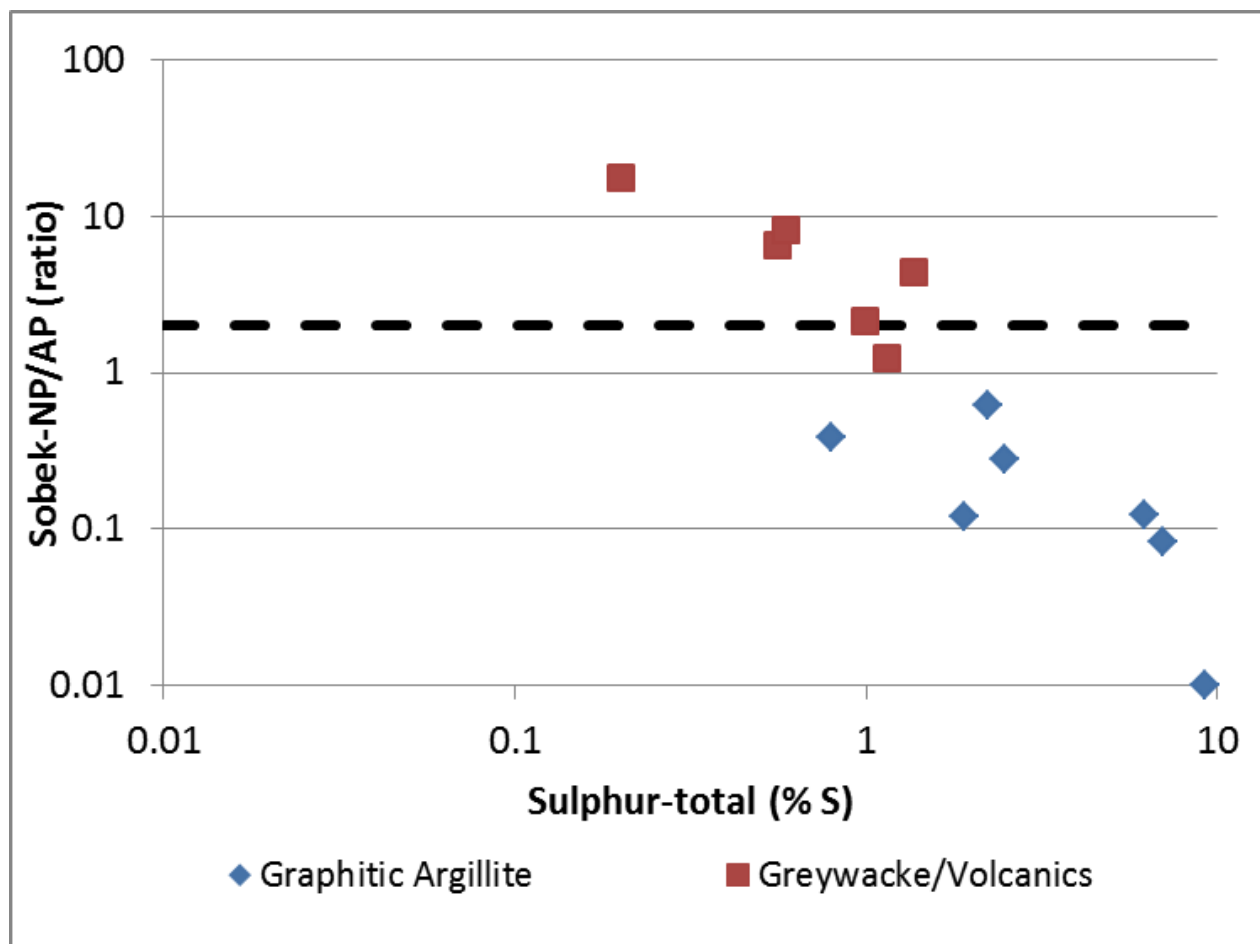
Argillite (PAG) and Other (non-PAG) Rock Types

Original Data from SENES (1990)

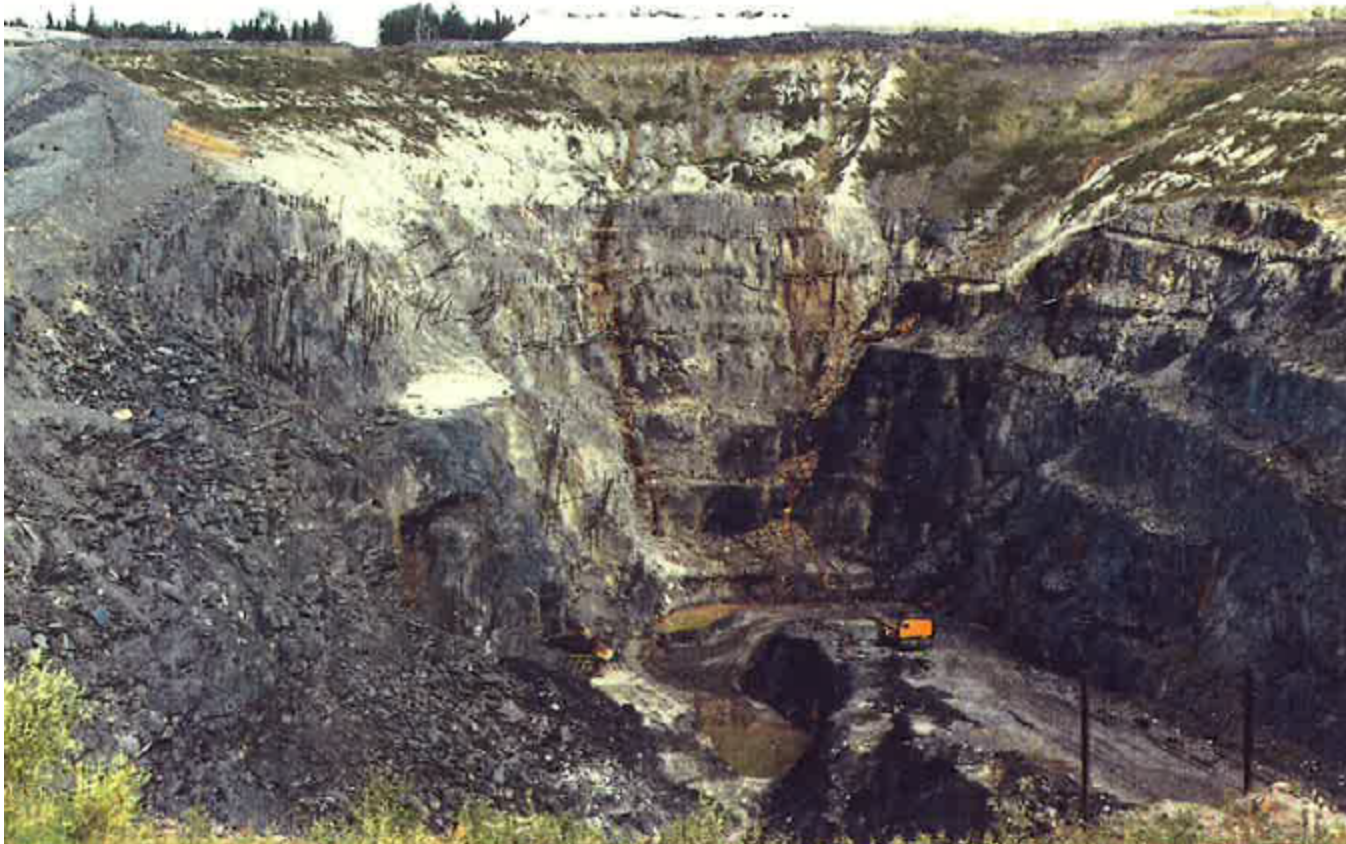
Owl Creek Pit prior to backfilling and flooding

- Relocated 3.26 M tonnes to pit in 1991-1992
- Placed as 1.5 m thick layers of rock and overburden
- Crushed Limestone added at a rate of 5.5 kg/t-rock for a total of 15,400 tonnes, spread between layers of waste rock
- Pit allowed to flood naturally with some pumping of water from Porcupine River
- Water level rose above backfilled rock in Spring 1993
- Overburden side slopes around pit were graded for stability
