# **Mount Polley Mine Tailings Embankment Breach – Update on Remediation and Rehabilitation**

December 1, 2016

# Mount Polley – Remediation and Rehabilitation

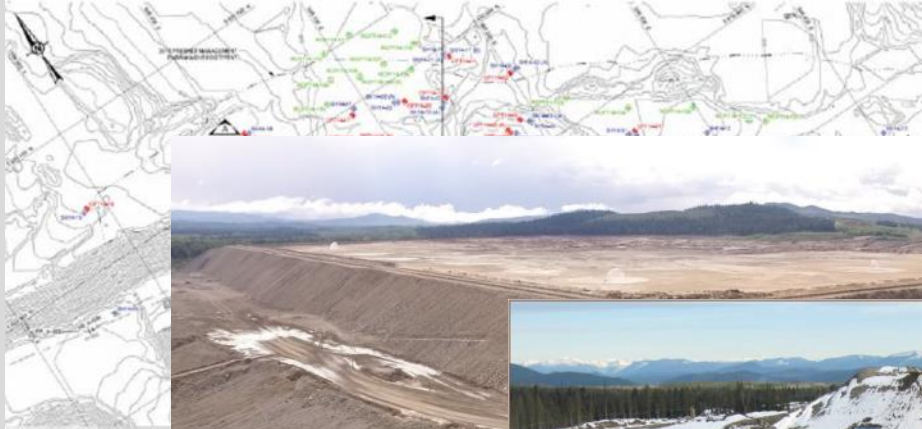
# TSF Breach Repair & Buttressing

## Failure Investigations

- MPMC (Golder)

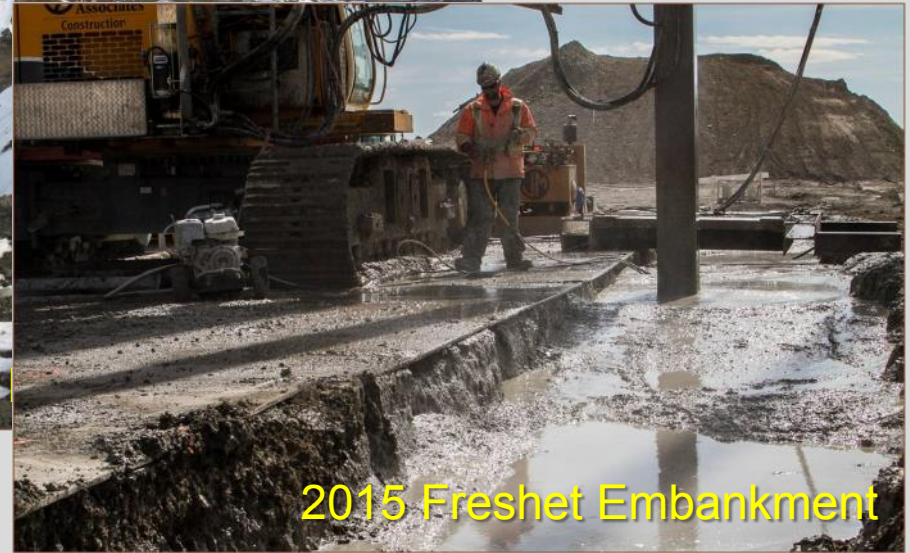
2015 Freshet Embankment

# Embankment Repaired

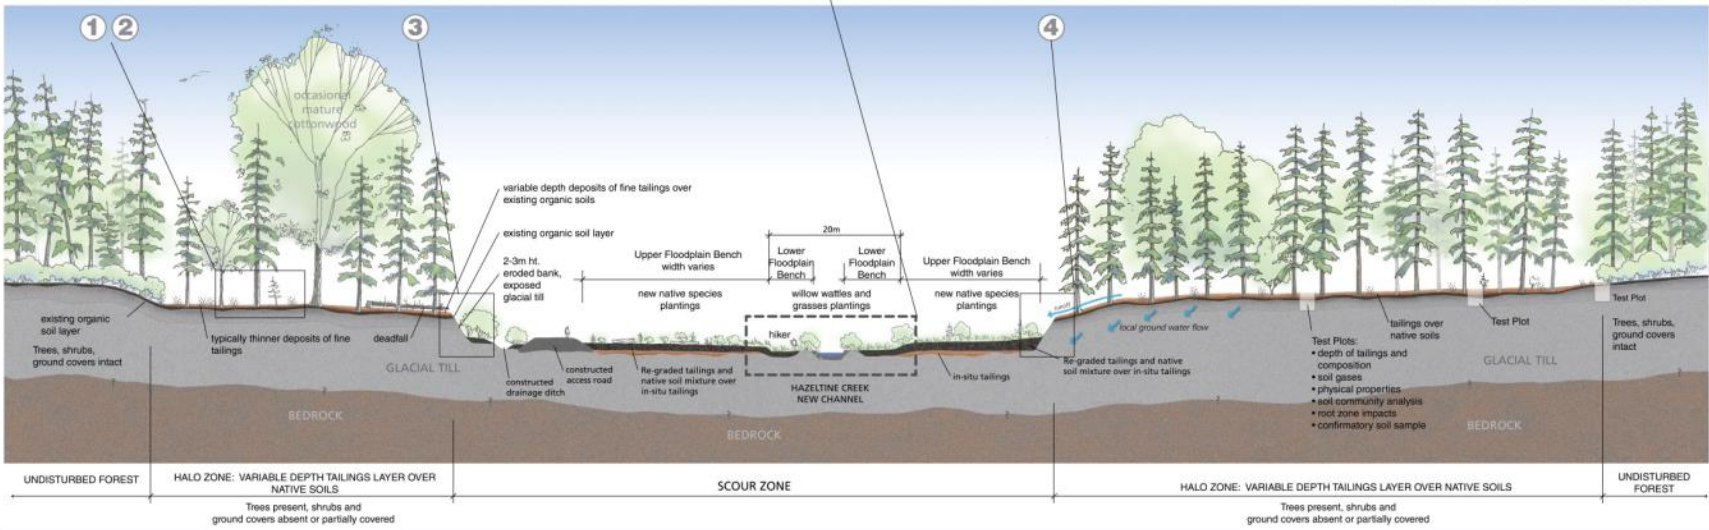
REPRESENTATIVE SECTION: HAZELTINE CREEK - STATION 2+000

INFORMATION NEEDED	
Confirmation of Remediation	Risk Assessment
• Survey elevation/ thickness of remaining tailings	• Plant tissue and soil sampling
• Volume estimates of remaining tailings	• Soil invertebrate and soil sampling
• Confirmatory soil sampling	• Confirmatory toxicity testing
• Photo documentation	• Survey of ecosystem health (test plots)
• Drawings by representative reach	• Oxygen profiles with depth in forest halo zone
• Groundwater assessment	• Dust assessment

CONCEPTUAL SITE TAILINGS DISTRIBUTION AND EXPOSURE MODEL

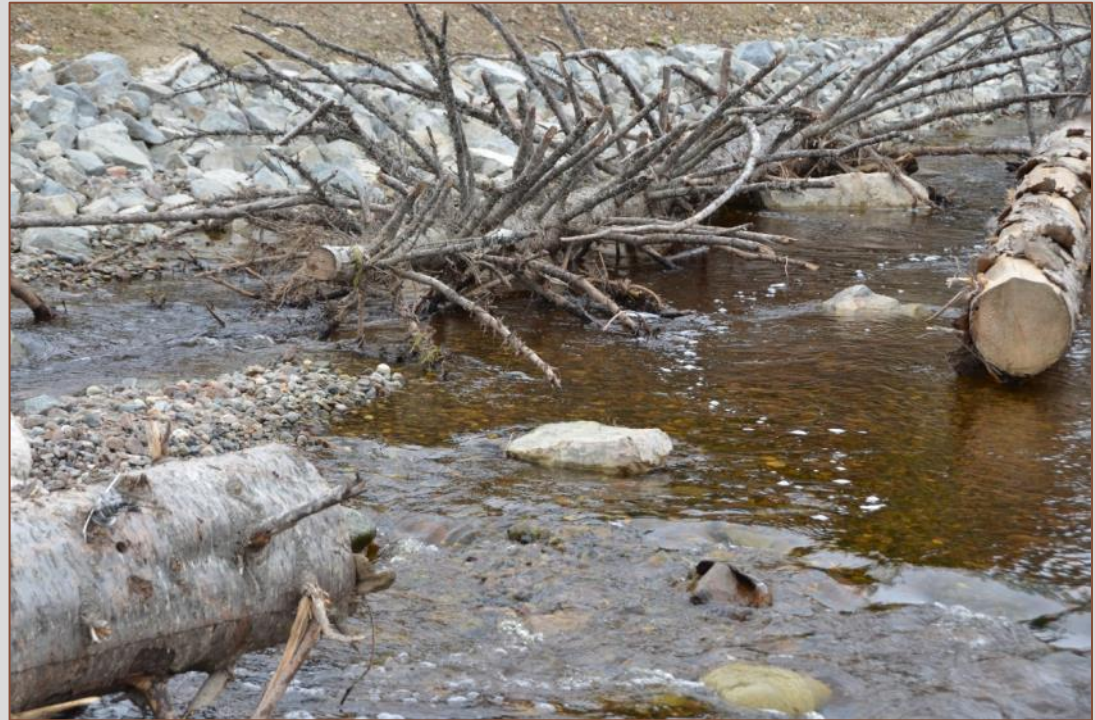
- Edney Creek Mouth was damaged in the debris flow
- Channel was rocked in and open by February 2015
- Fish habitat features were constructed in August 2015
- Edney Creek supported endangered Interior Coho Salmon and was rebuilt as a high priority

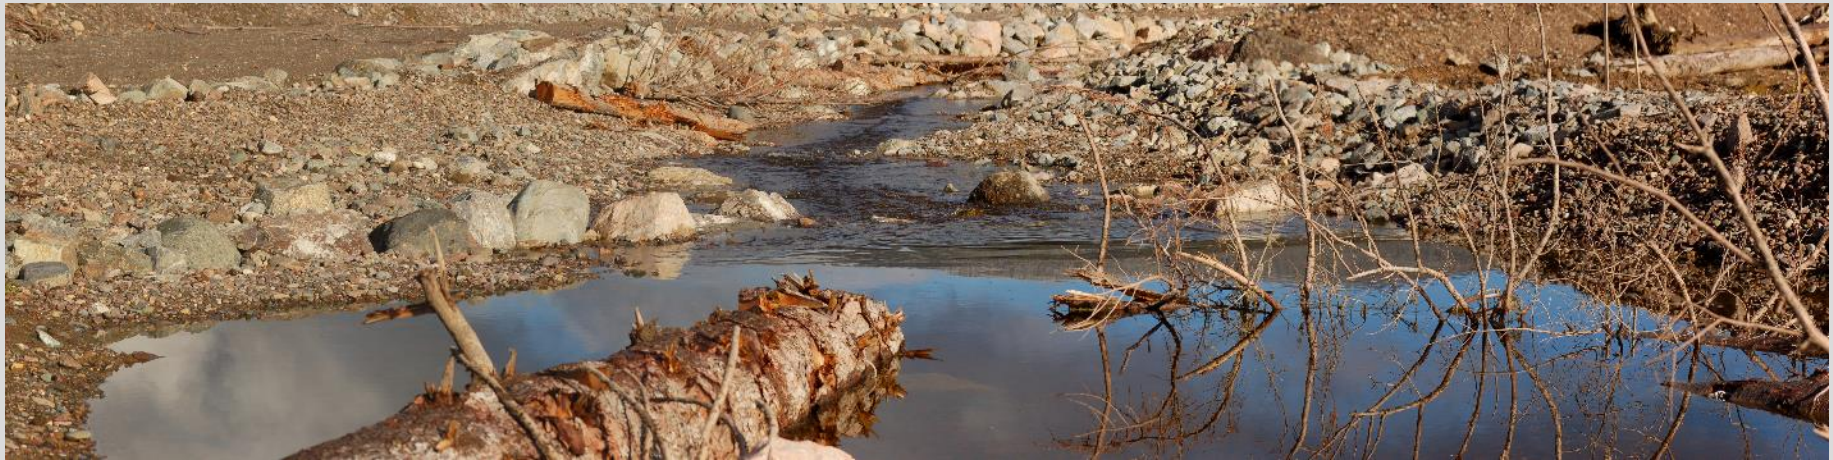
# Edney Creek – Reconstructed portion

Results of fish sampling in the rebuilt section of Edney Creek show that it is providing habitat, as intended:

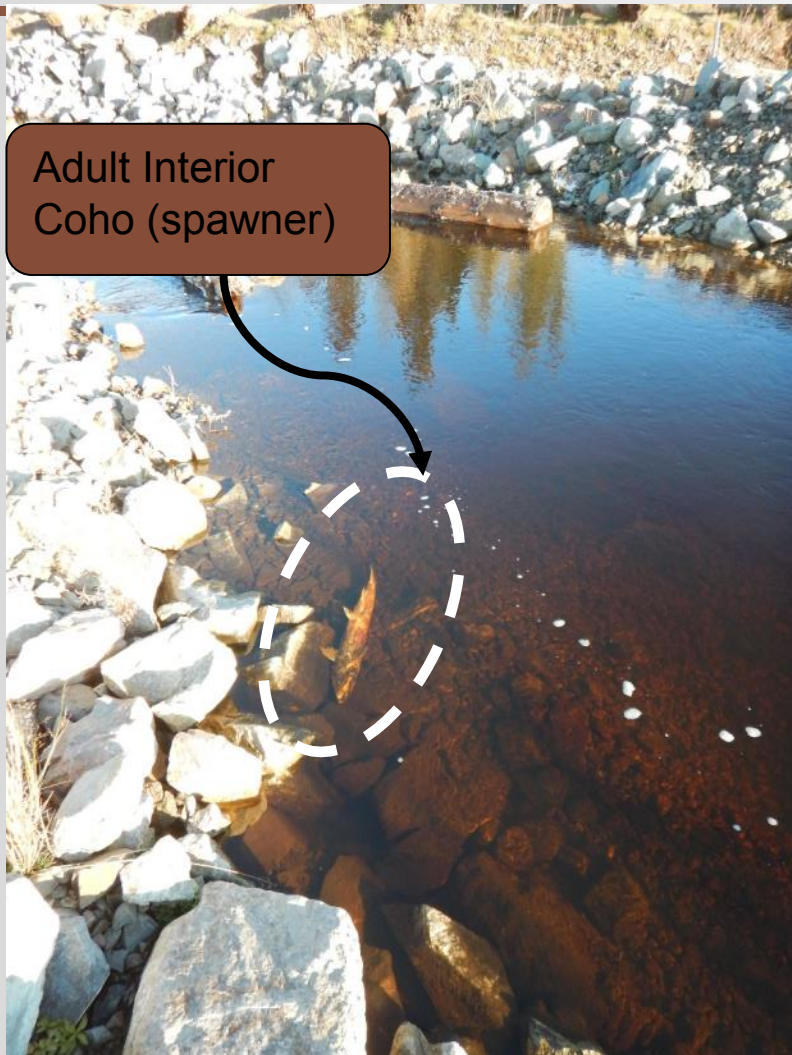
# Edney Creek – November 2016

- Juvenile Interior Coho salmon (endangered race!)
- Rainbow trout
- Longnose dace
- Northern pike minnow
- Longnose sucker
- Redside shiner; and
- Burbot

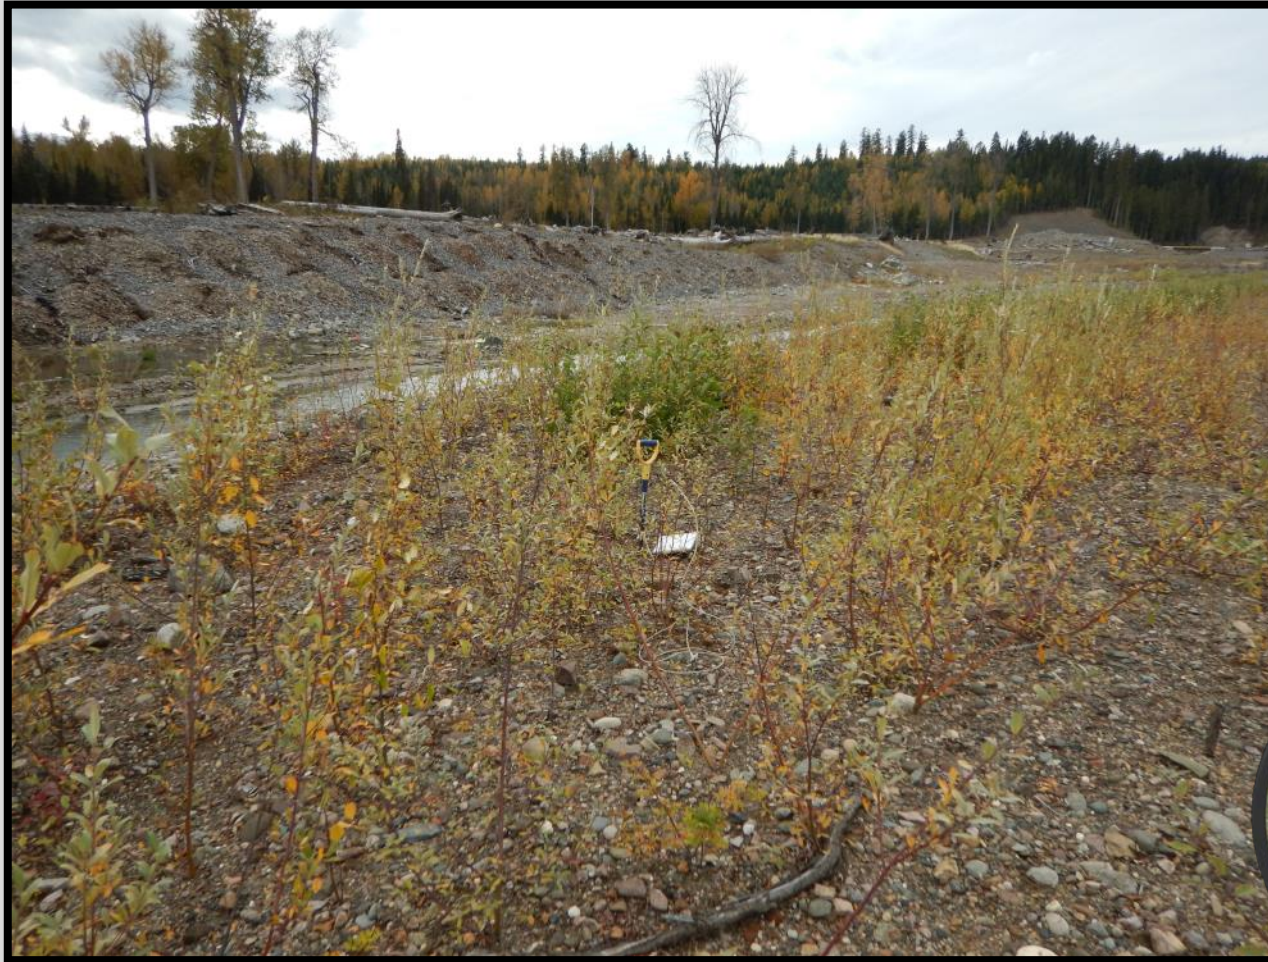
Lower Hazeltine willow stakes and seedling (planted 2015)

- Ten (10) Survival plots – throughout the creek (modified silviculture plots)
- Twenty-nine (29) Terrestrial monitoring plots (HHERA)
- Monitoring the survival, percent cover per species, natural ingress, health and vigor.
- Information is included in the Risk Assessment and used to inform future species selection and planting densities.
- Daily tracking of planting and grass seeding

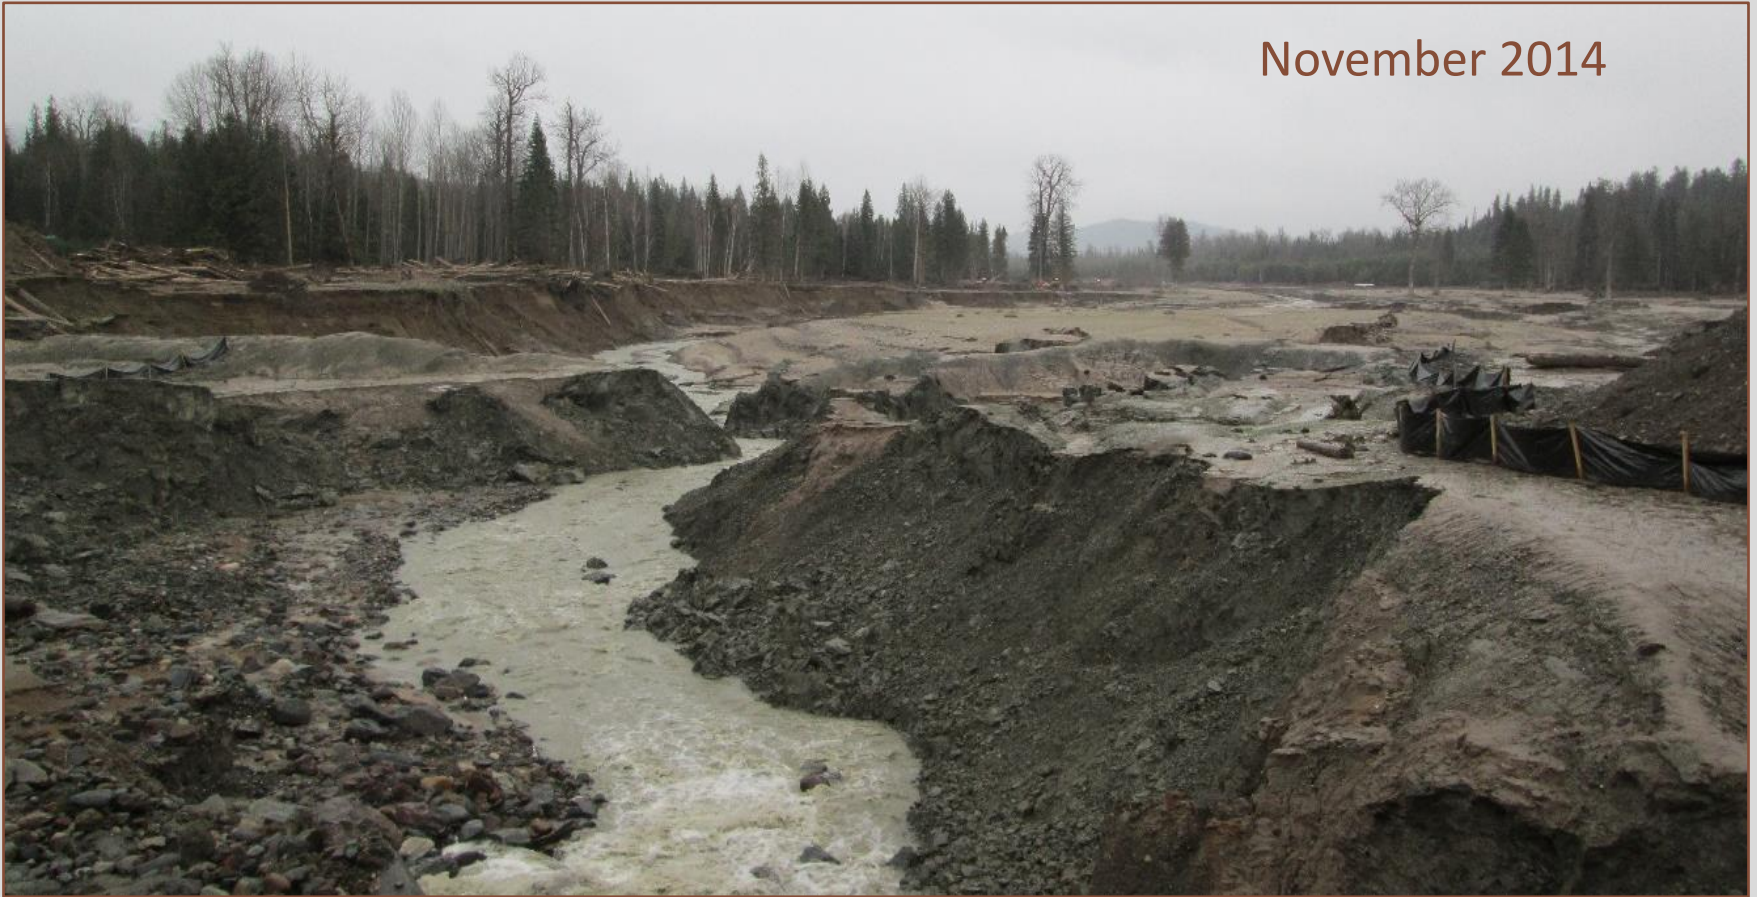
November 2014

# Terrestrial Rehabilitation
