# Closure Activities – Progress over the last 10 years, Britannia Mine

BC MEND ML/ARD Workshop  
28 November 2018

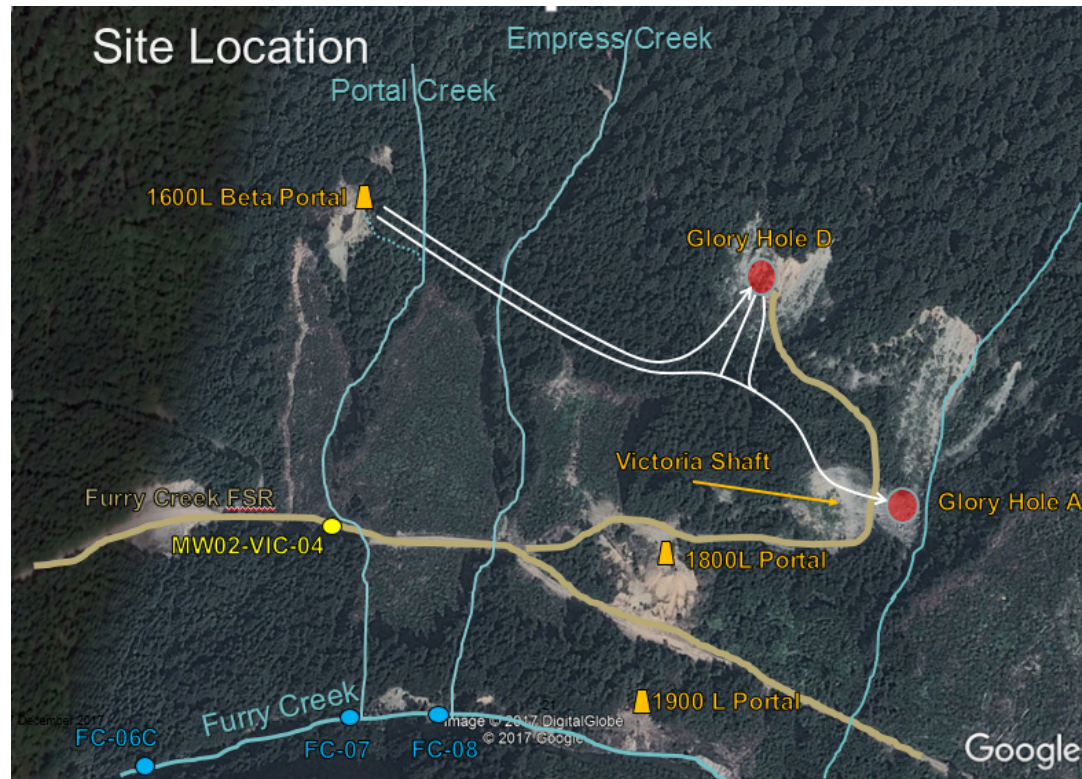
- Preferred Option - Re-injection into the Glory Holes (GH)
- Construction completed in 2016

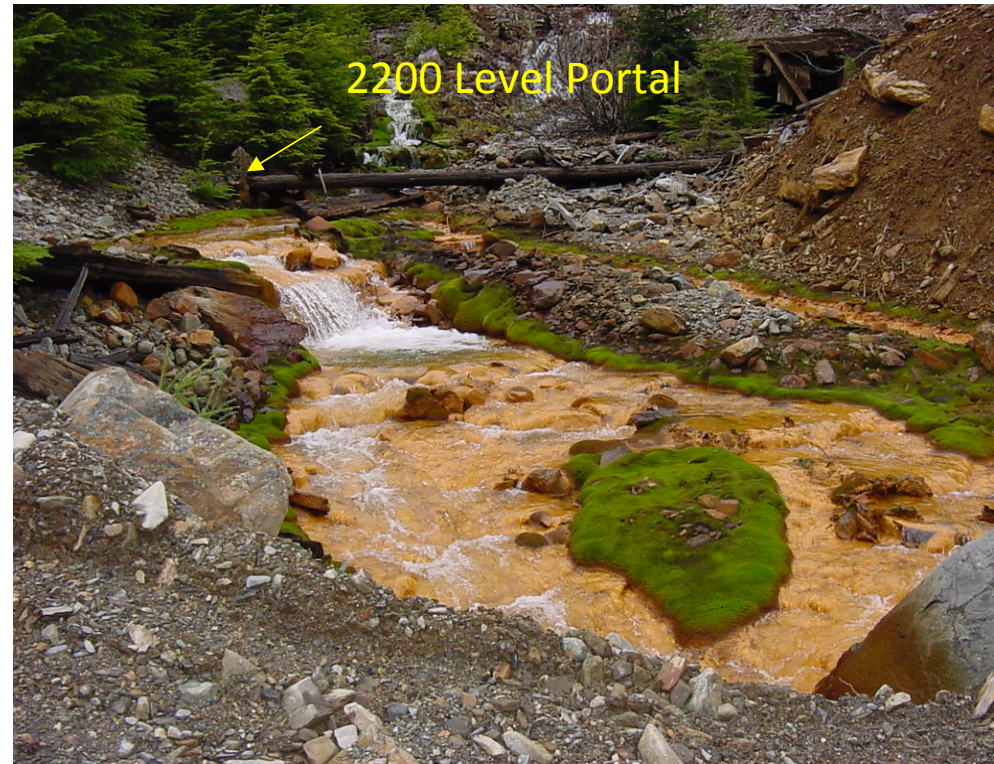
- Identified as a primary source of loading of Cu loading to Howe Sound during earlier remedial phase
- Plug installed in 2001

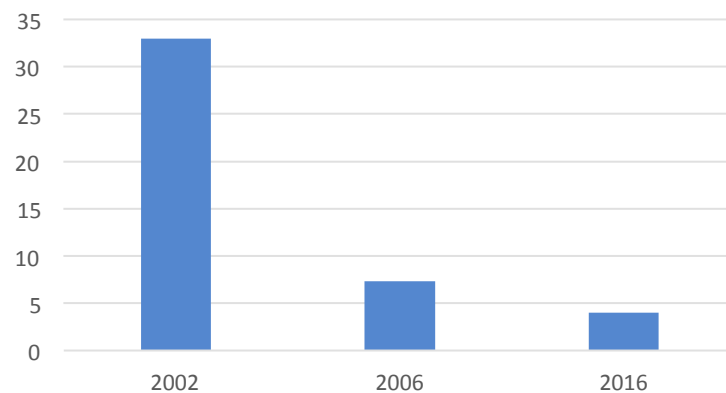
Dissolved Copper in Groundwater (mg/L)

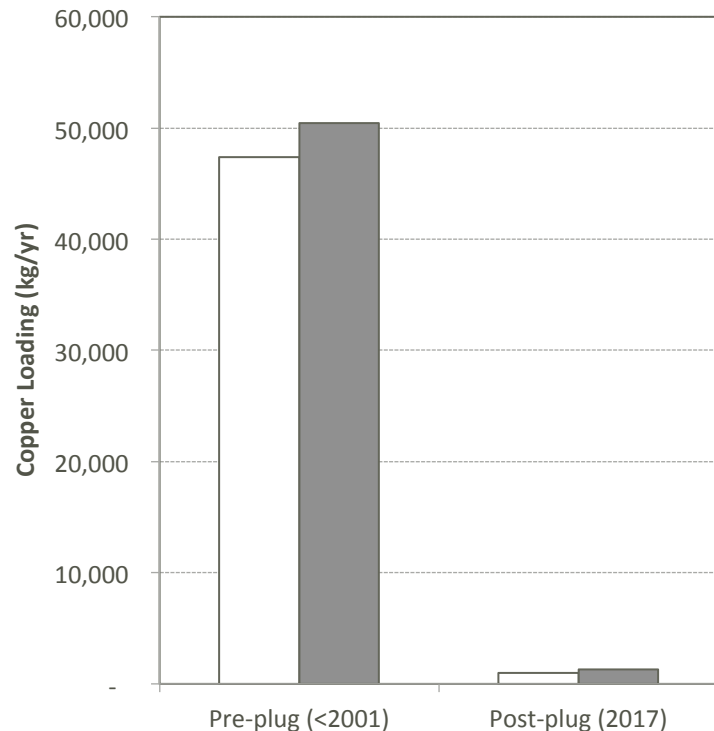
Copper in Britannia Creek

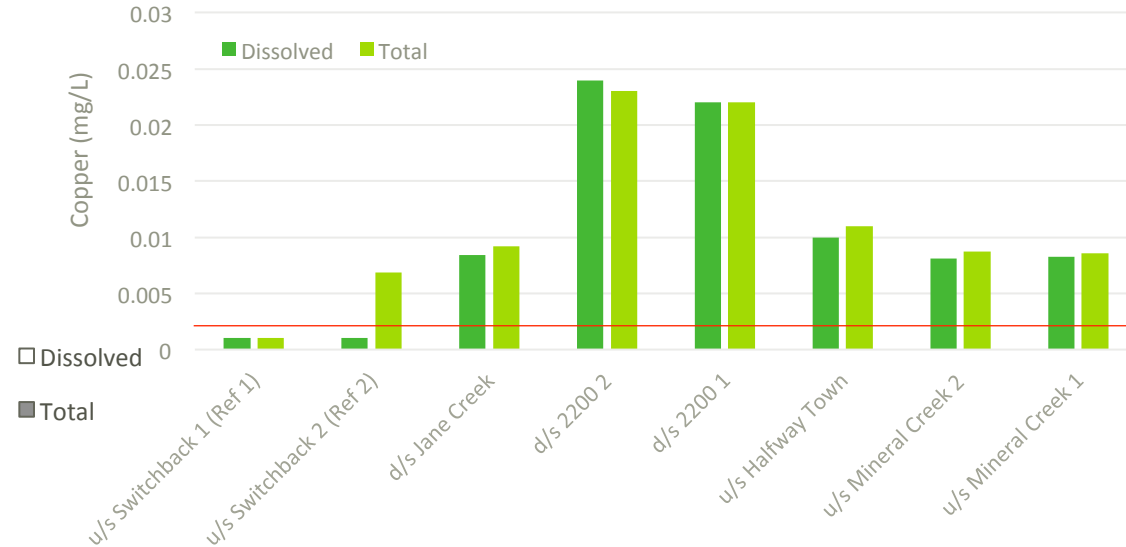
Loadings to Britannia Creek

- 2200 L is still primary source of copper loading to Britannia Creek

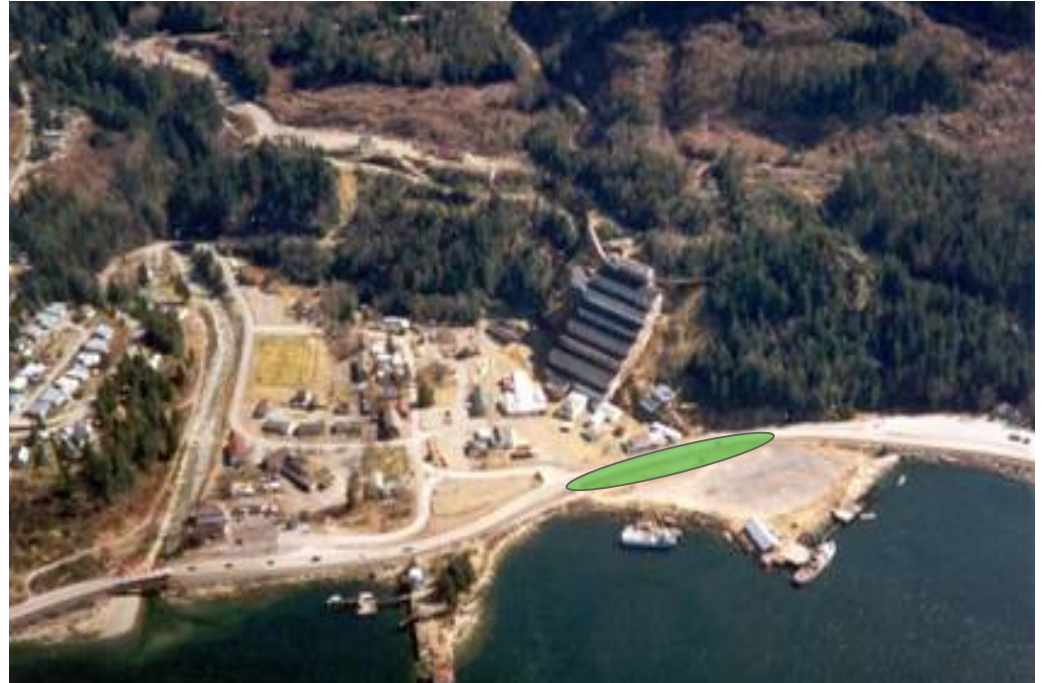
- Objective: Capture most highly contaminated groundwater in Fan Area
- Pumped up to treatment plant
- Operational since 2005

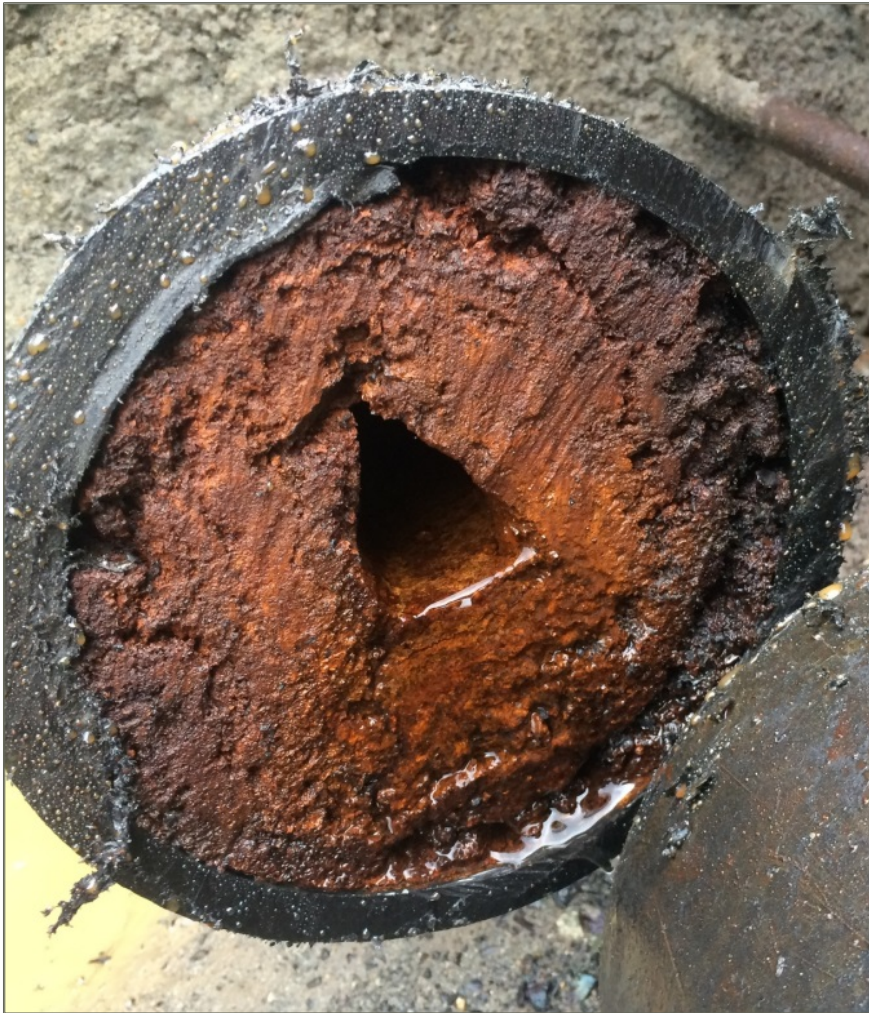
Iron scale formation  
restricting flow of  
groundwater to  
treatment plant

- Options analysis
- Bench scale testing
- Preferred option selected: Injection of 37% HCl
- Through ITT process, work awarded to Quantum Murray

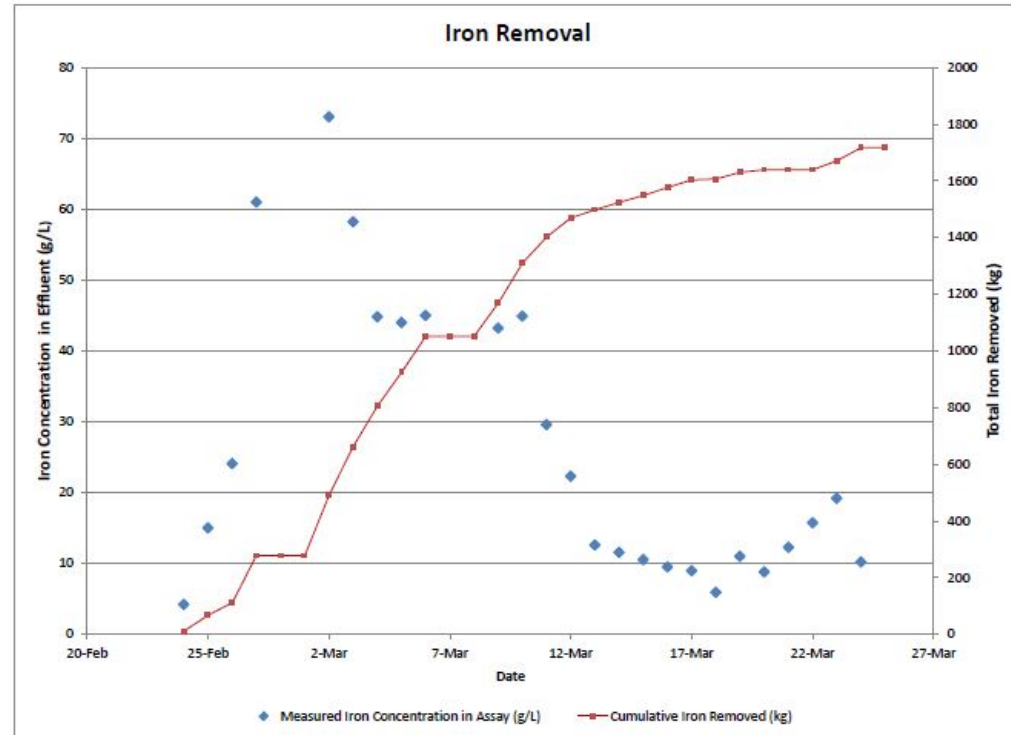
Results of daily assays for iron during cleaning stage

- Total process took 8 months
- Cleaning stage took 5 weeks

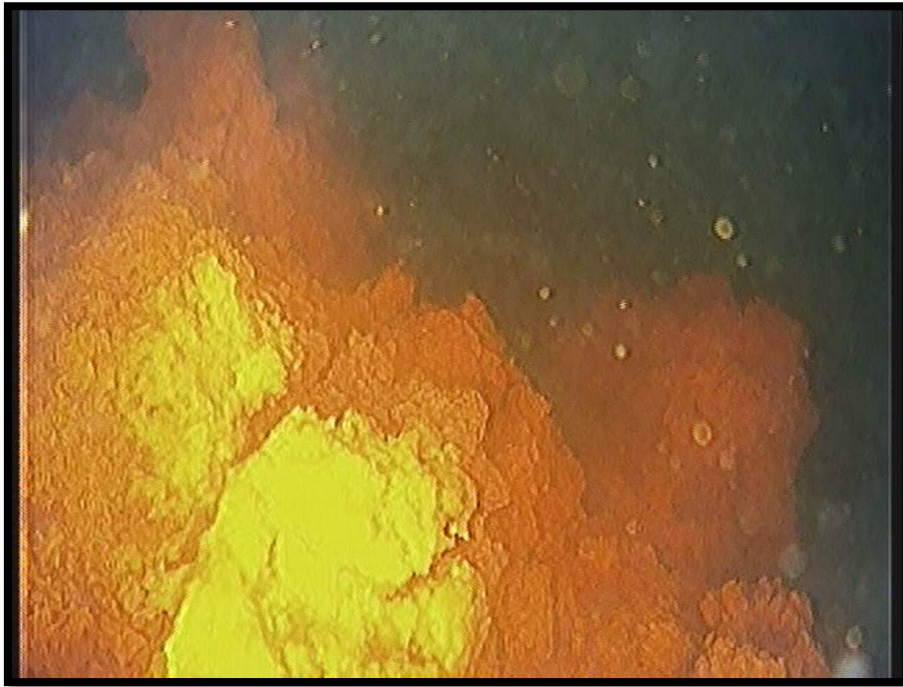
Residual Scale Concretions

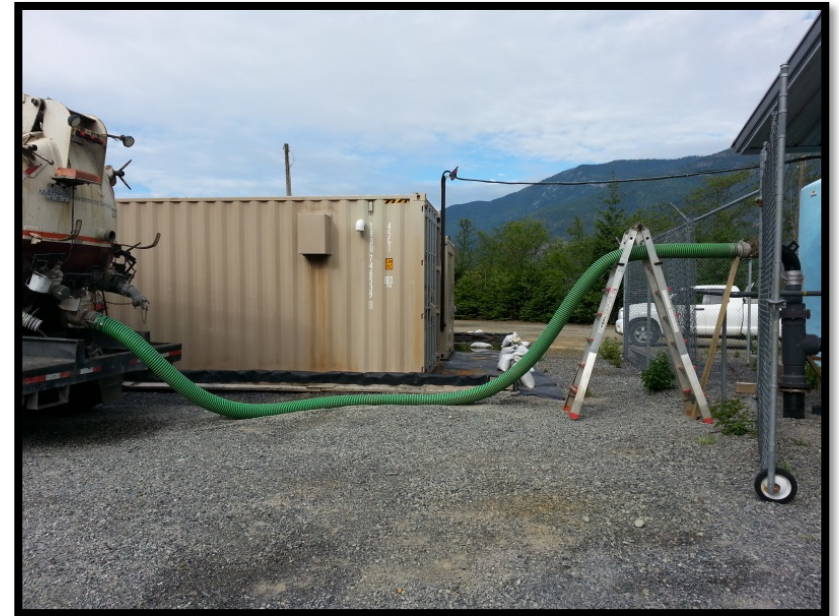
Charge flushing

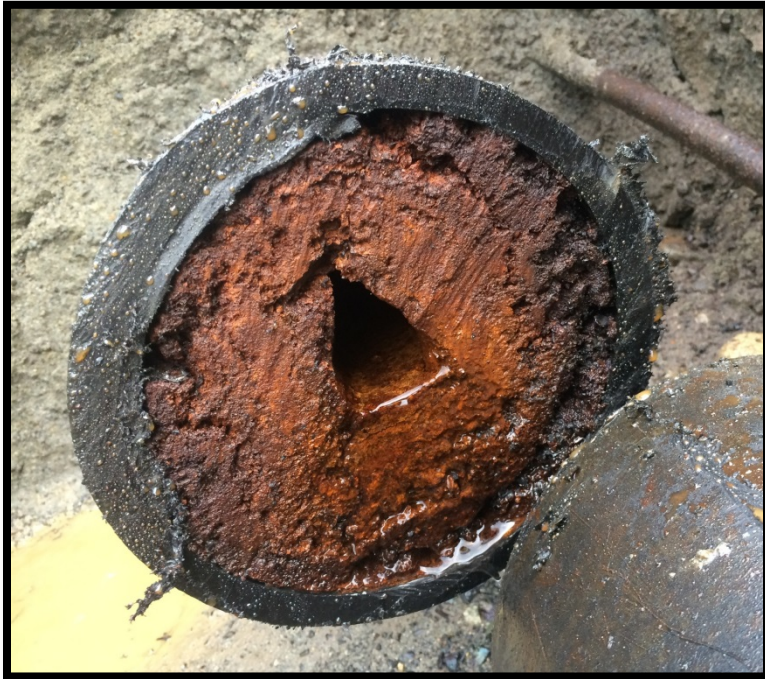
Initial condition

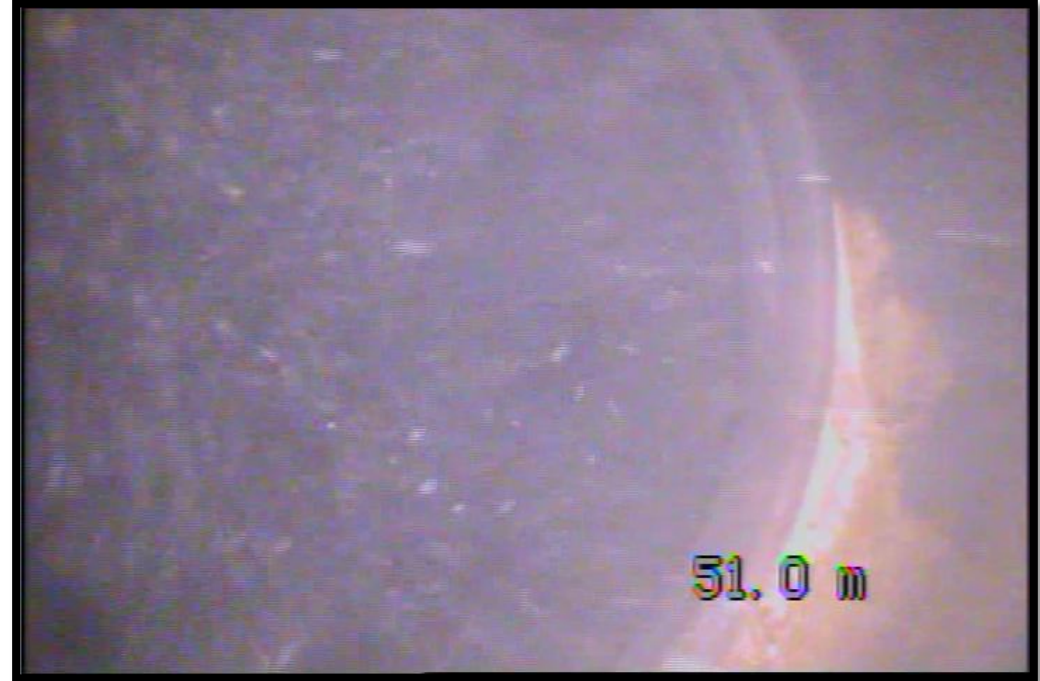
Final condition
