Equity Mine – 25 Years of Closure

Cody Meints – Site Supervisor, Equity Mine

November 29, 2018

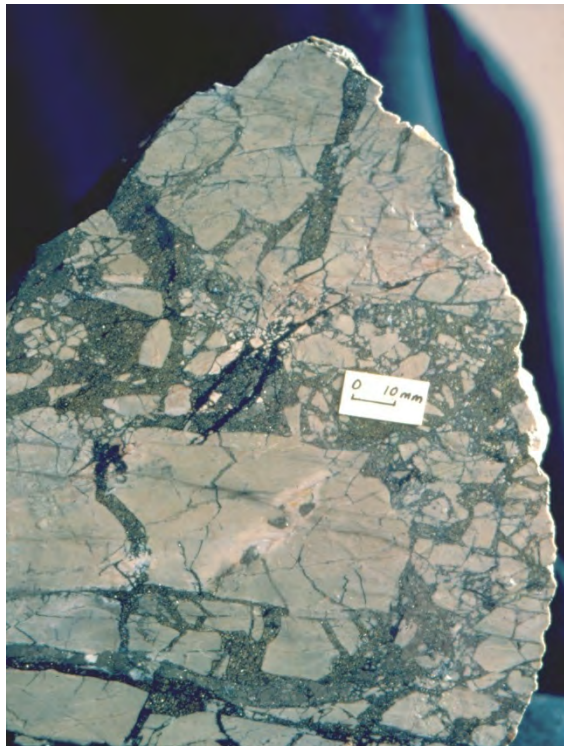
ARD Generation

Equity first learned that the waste rock and ore would oxidize and produce ARD in 1982 after a year and a half of construction and two years of production

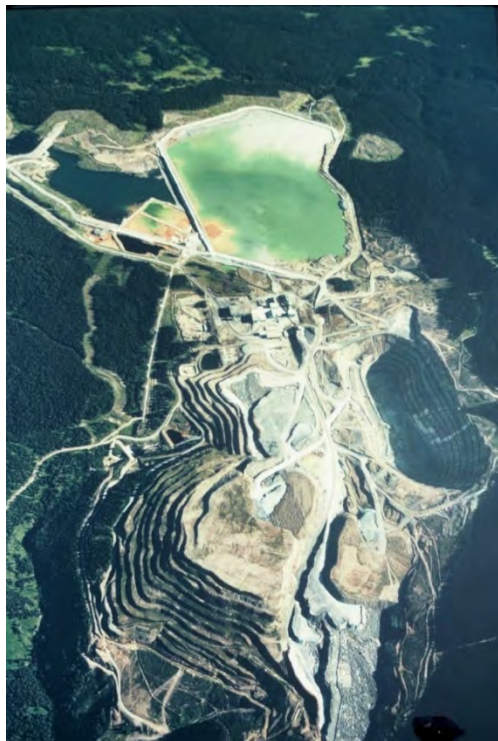
Mine Plan

With no thought of ARD mitigation the mine plan was developed strictly to economically mine the deposit:

- Initial waste rock was used for the plantsite backfill, a tailings starter dam, and road construction
- The mining started with the Southern Tail pit as it had the highest metal values and could pay down the debt quicker
- The waste rock dumps were constructed close to the open pits, in an area that sloped down towards Bessemer Creek

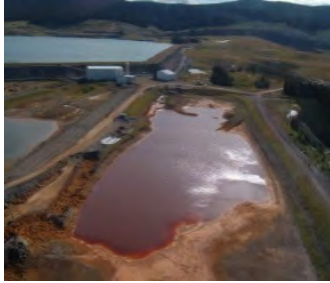
ARD Sources

#1 Dam
Seepage
20% volume
4% acidity

Waste Rock
Stockpiles
65% volume
94% acidity

Reclaimed
Plantsite
15% volume
2% acidity

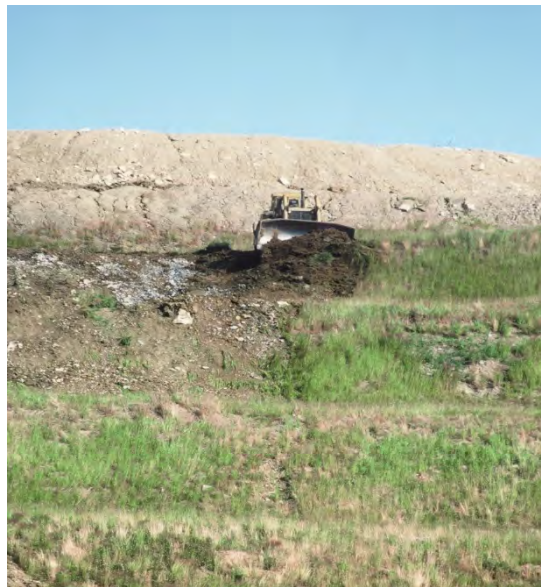
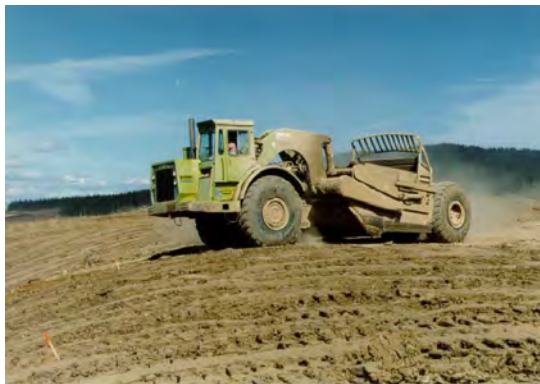
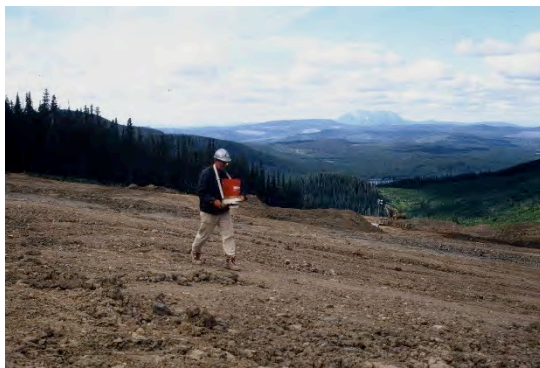
Waste Rock Dump Cover

Original waste dump cover was 1 metre of uncompacted till

- 40% infiltration

Final cover started in 1990 to reduce water infiltration

- 0.5 m compacted till
- 0.3 m uncompacted till
- expected 2 to 5% water infiltration & decreased oxygen infiltration

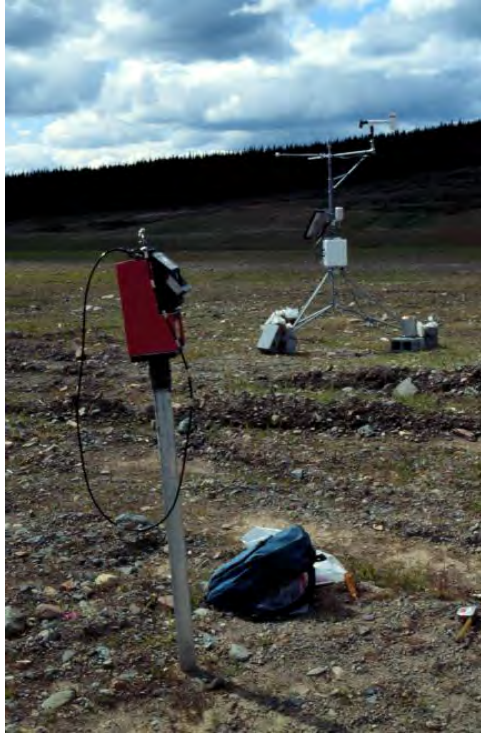
Cover Moisture Content

Neutron probe measures moisture content within the cover.

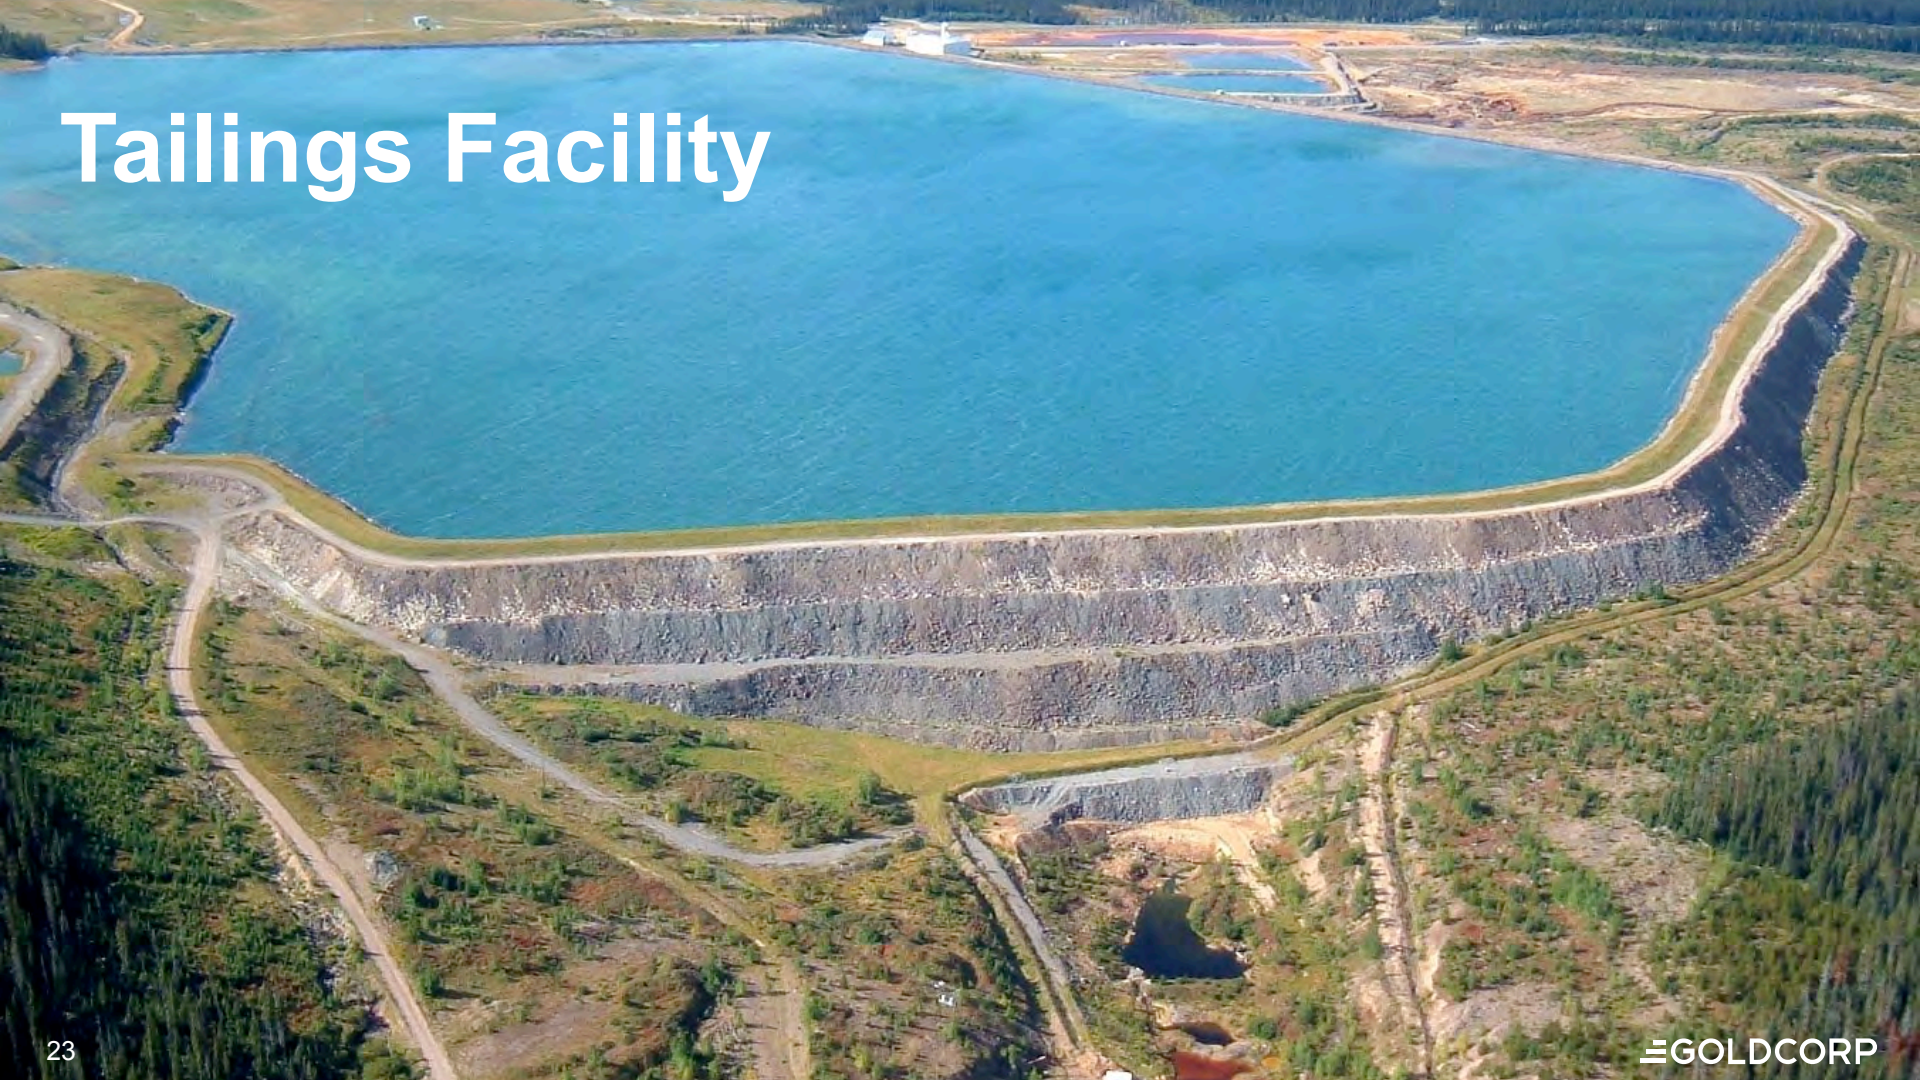
Tailings Facility

- 35 million tonnes PAG tailings in a 120 Ha pond
- Water cover 1.5 m to 8 m (5.6 Mm³)
- Decant/pump excess water to Diversion Pond or Main Zone pit for discharge
- Periodic lime slurry addition to raise pH
- Potential for reprocessing to remove Au, Ag, S
- Annual geotechnical review, daily inspection by staff, automated monitoring system

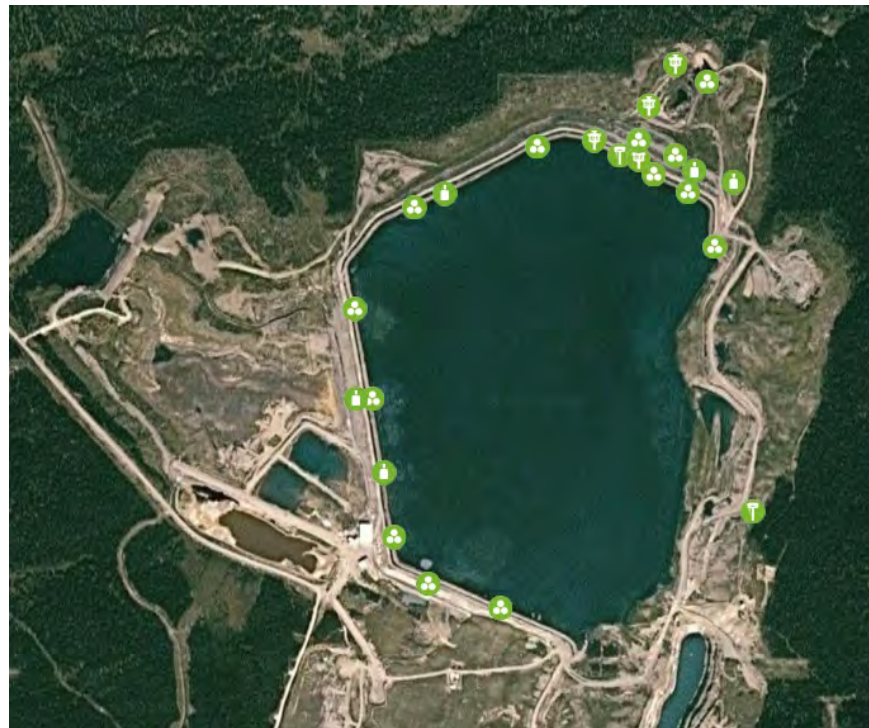
Tailings Dams Remote Monitoring

Instrumentation includes:

- 10 GNSS (GPS) receivers
- automatic total station (6 prisms)
- 18 piezometers
- 5 cameras
- 1 weather station
- 2 pond water level stations

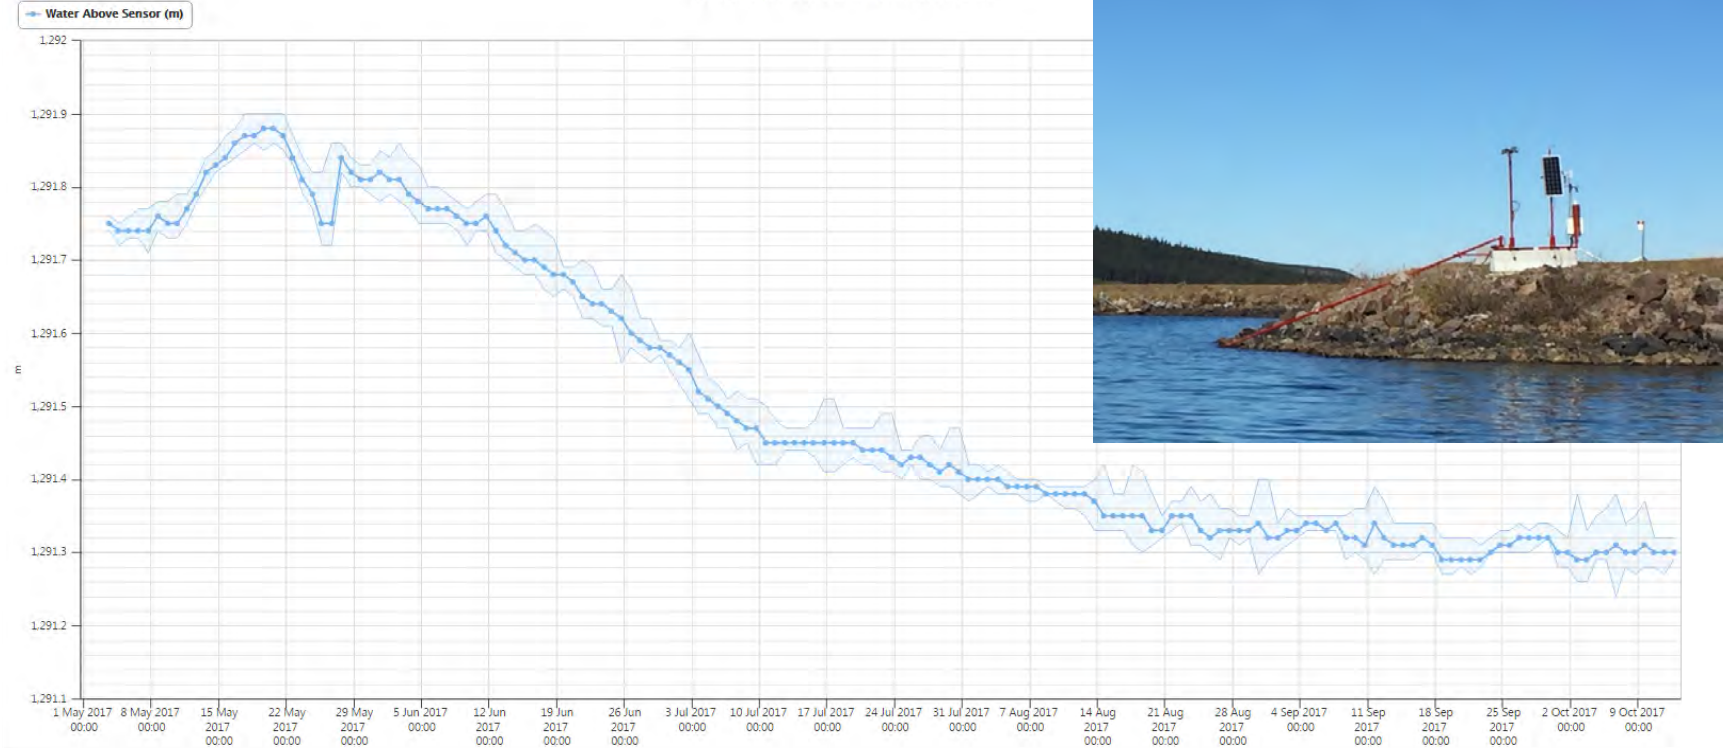
Remote Monitoring – Water Level Indicators

Dam No. 1 Pond Elevation (Water Level Sensor)

From 01/05/2017 12:45:42 to 12/10/2017 12:45:42

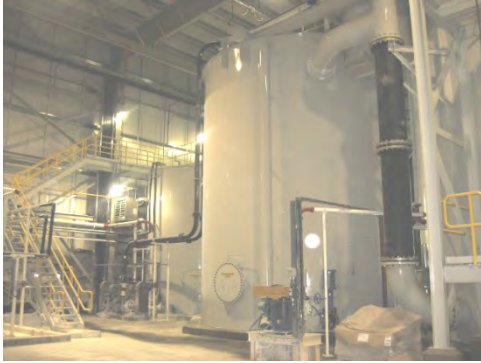
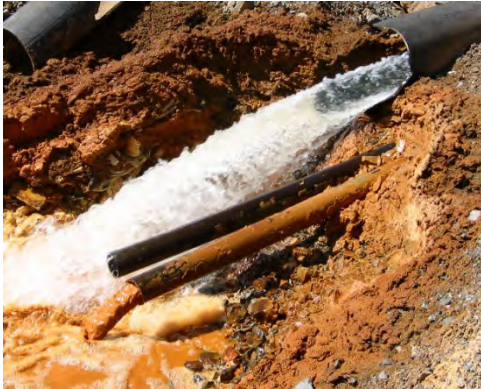
High Density Sludge (HDS) Treatment Plant

- 2,500 USG/min normal operating flow rate
- Capable of 5,000 USG/min emergency flow rate in “low density mode”
- 2 high volume paste slakers
- Lime addition to pH 8.5 for metals removal
- 25 m diameter clarifier, flocculant addition
- Sludge recycle to create high density sludge which quickly settles
- Treated water and sludge to Main Zone Pit

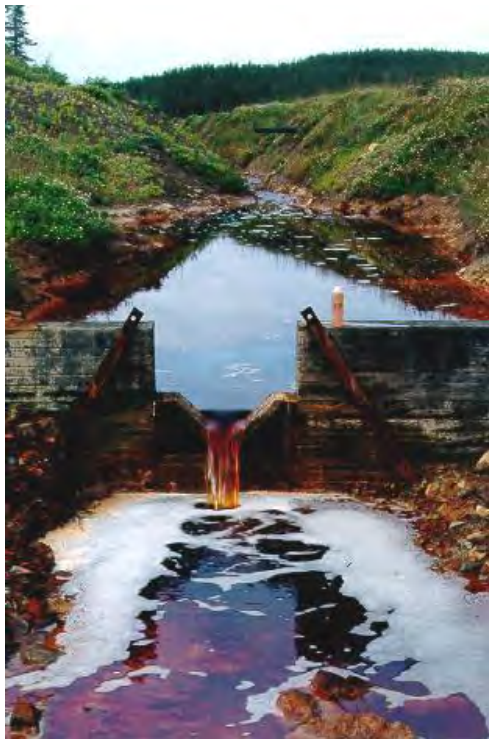
ARD Treatment and Statistics

1985 to 2017 Averages:

- Treated ARD volume: 970,000 m³
- Lime consumption: 4628T

pH	Acidity	Copper	Iron	Zinc
	(pH unit)	(mg/L CaCO ₃ eq)	(mg/L)	(mg/L)	(mg/L)
ARD Avg	2.6	7585	54	817	117
ARD Min	2.0	2290	17	176	39
ARD Max	3.2	17200	120	1941	240
Treated Avg	8.6	0	0.0096	0.104	0.017

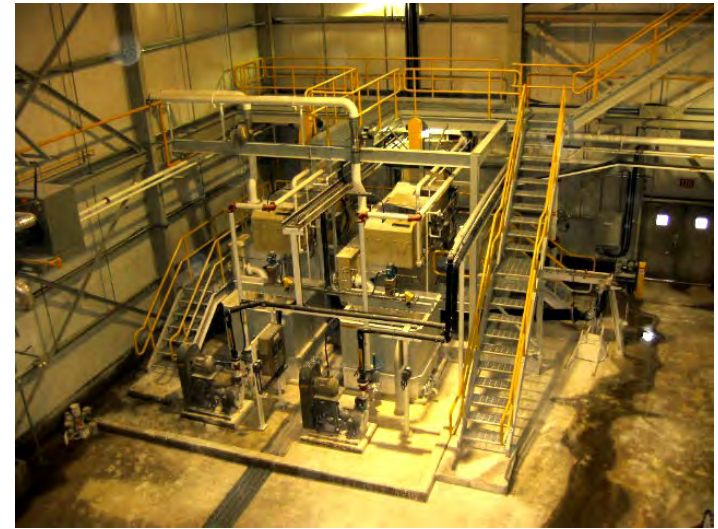
Lime use

- 700 T lime storage
- 4628 T annual usage
- 970,000 m³ ARD treated
- Average acidity 7585 mg/L

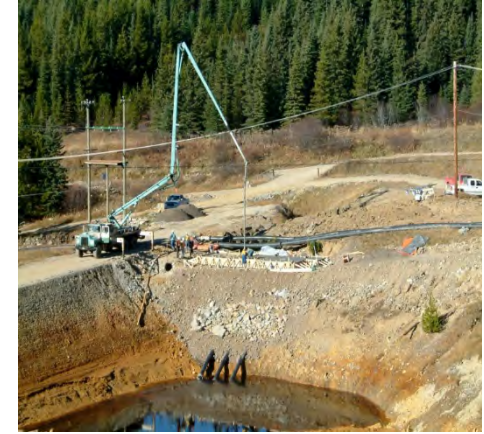
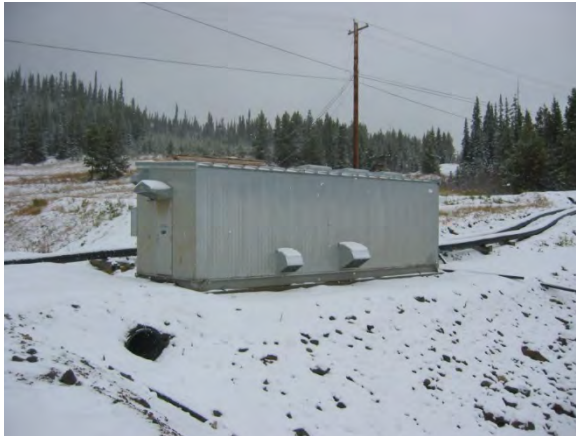
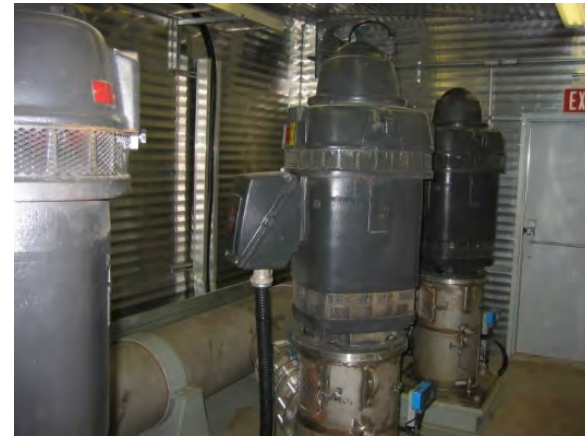
Main Pond Pumphouse (Upper)

- Three 250 HP pumps each capable of 2,000 USG/min
- Two 16" pipelines to Storage Pond with connection to HDS plant
- Can be operated using with emergency backup power
- 10,000 USG/min pumping capacity from Main Pond with old and new pumphouses

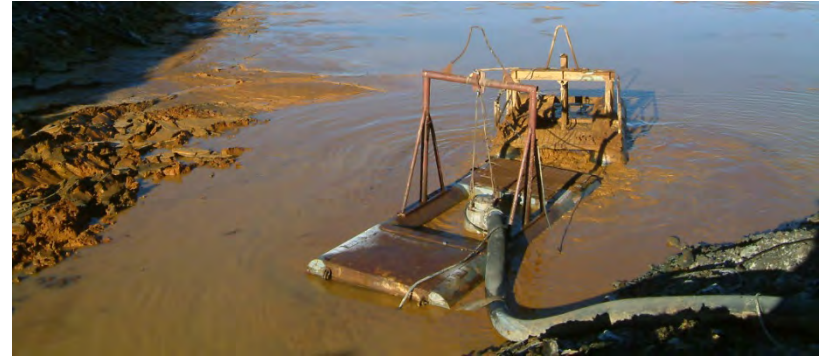
Emergency ARD Storage – Sludge Removal

Sludge removal to MZP

- Thick sludge could be hauled
- Wetter sludge could be pumped

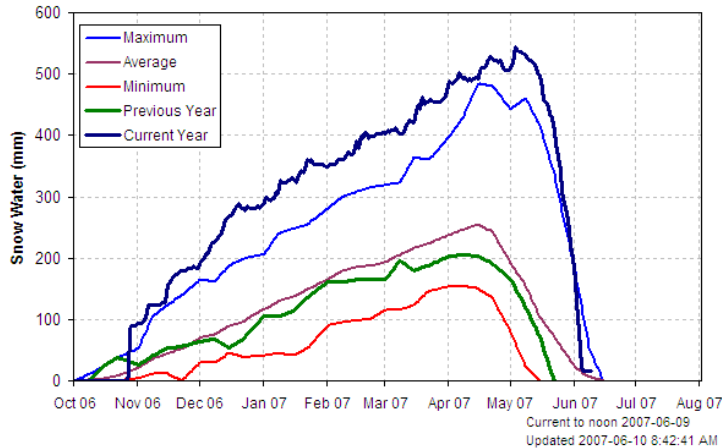
2007 Freshet – Highest on record

- 2007 freshet started with 100 cm snowfall in October 2006
- Highest snow pack on record for site and region
- Rapid melt after mid May
- Regional flooding
- No issues at Equity site

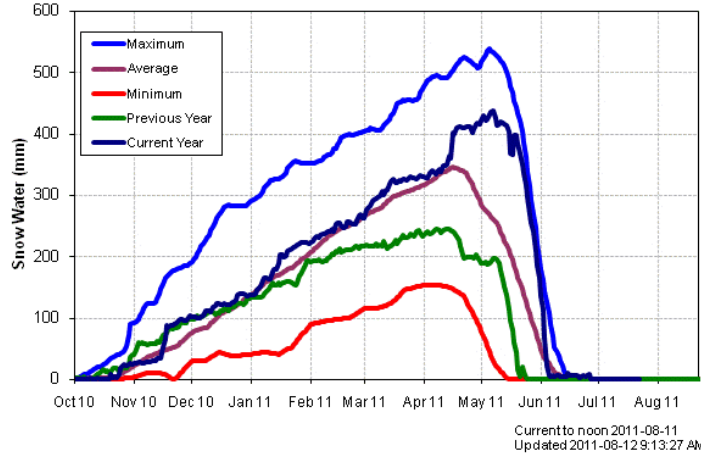
2011 Freshet

- Average Snow pack until mid April
- Significant precipitation in April and May (rain and snow)
- Regional flooding
- Emergency ARD Pond used for 20,000 m³ of ARD
- 161,000 m³ collected from Main Pond during peak week

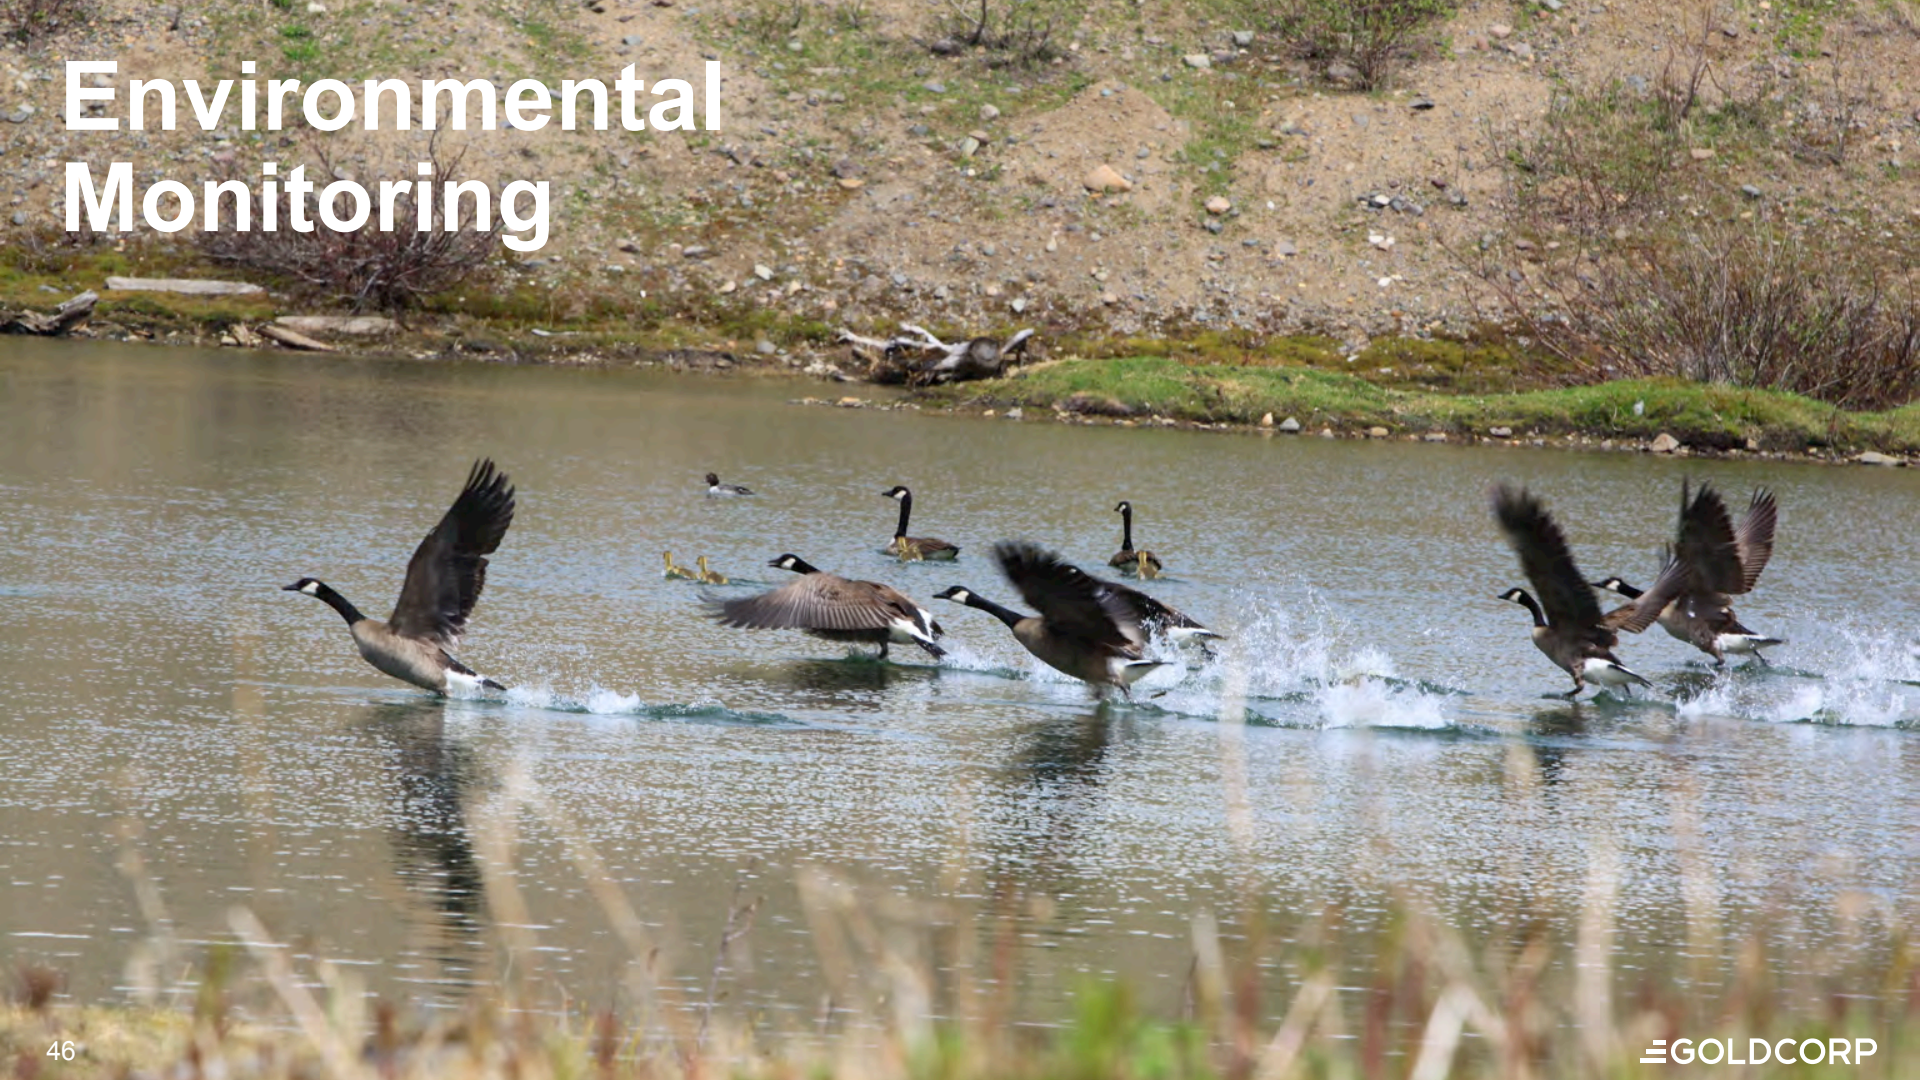
A photograph showing a dam structure with water flowing over it. The dam is constructed with a series of stone or concrete blocks, creating a stepped appearance. The water is white and turbulent as it flows down the face of the dam. The surrounding area is a dense forest of tall evergreen trees, and the sky is overcast.

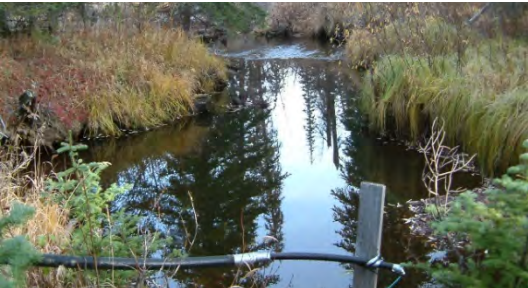
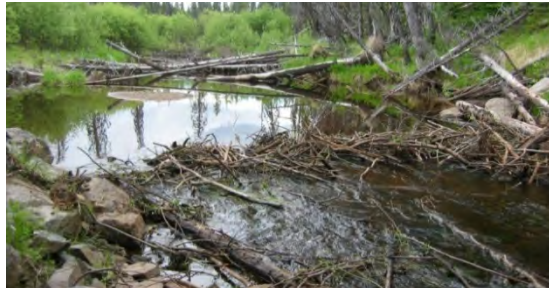
- 2002 to 2017 average
2,190,000 m³ water
discharged off site
- 2/3 discharged to Buck Creek
- 1/3 discharged to Foxy Creek
- 3:1 Dilution Required by MoE
Permit
