# Seven Years of Cover Performance at Mine Waste Rock Piles: Insights from the Sydney Coalfield

*BC MEND MLARD Workshop*

*9<sup>th</sup> December 2021*

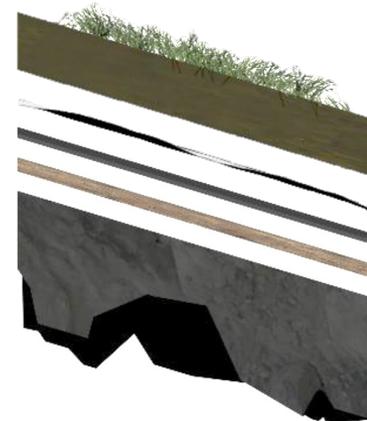
## Covers with Geosynthetics

Growth Medium

Geotextile

HDPE

Bedding Sand

Waste Rock

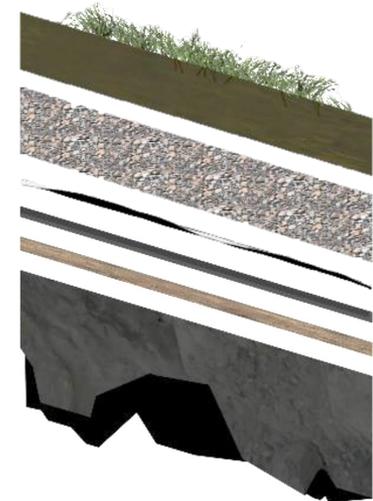
Soil  
Drainage Layer  
Geotextile  
HDPE  
Bedding Sand  
Waste Rock

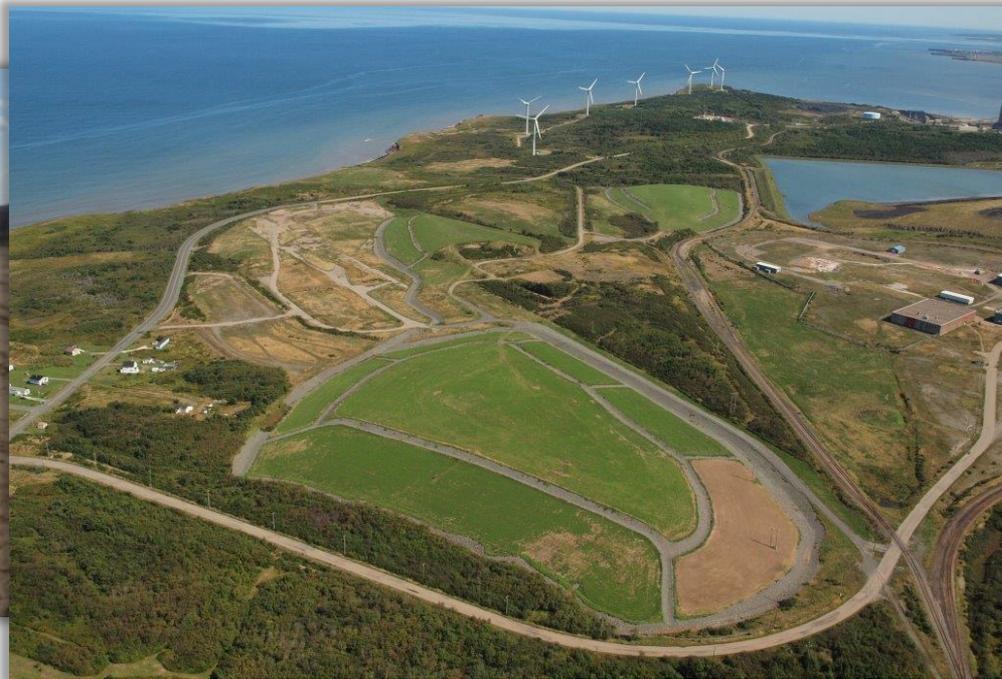
## Lingan

- 646,000 tonnes of fill/waste rock
- Footprint of 82,028 m<sup>2</sup>
- Thickness at center = 15 m
- Cover installed in 2011

**Growth Medium**

**Waste Rock**

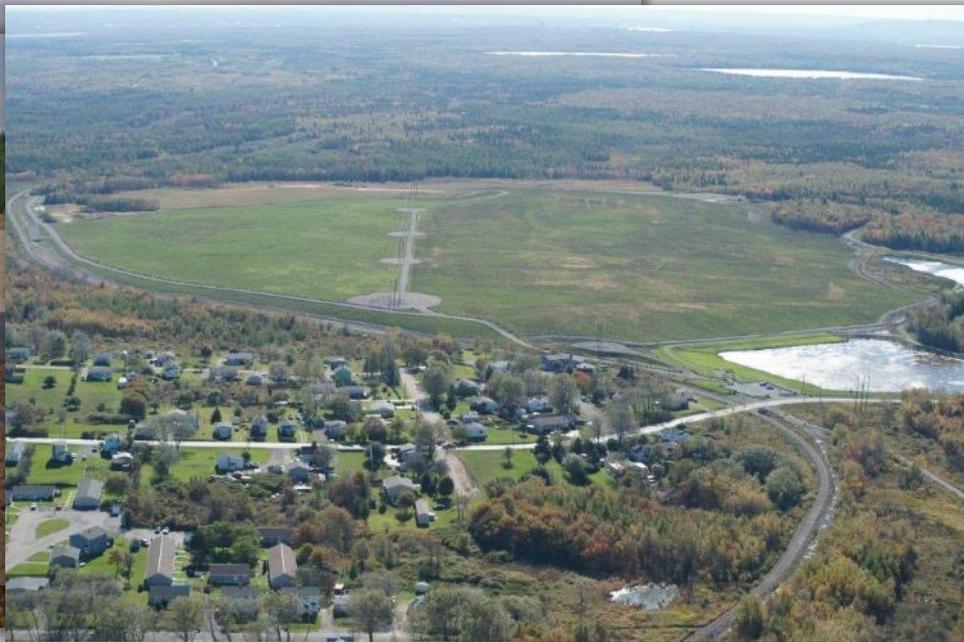
## Scotchtown Summit

- 2.5 million tonnes of fill/waste rock
- Footprint of 370,000 m<sup>2</sup>
- Thickness range from 1.4 m to 10 m
- Cover installed in 2011

Growth Medium

Geotextile

**HDPE**

Bedding Sand

Waste Rock

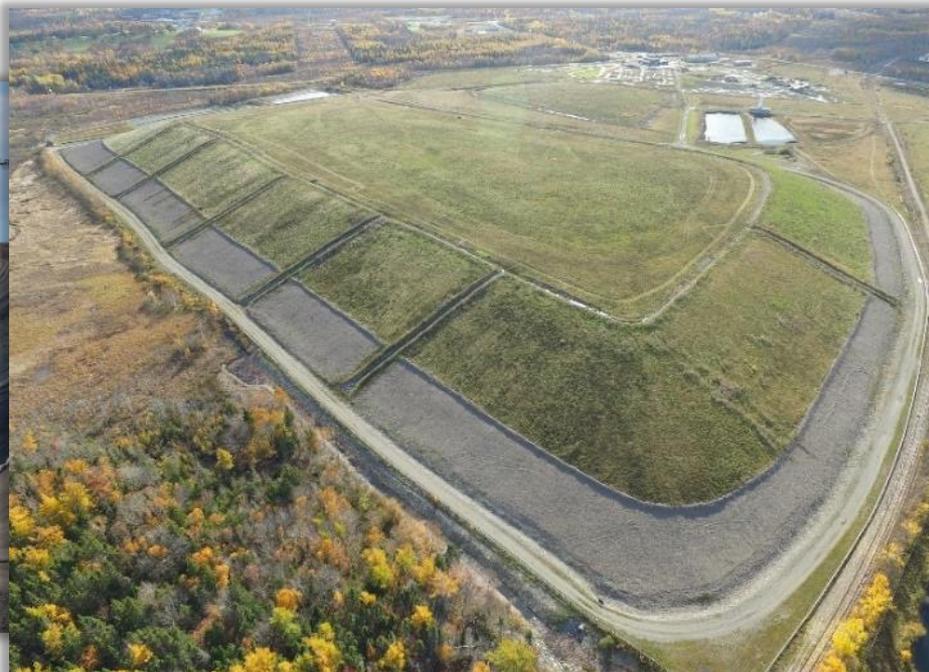
## Victoria Junction

- 10 million tonnes of fill/waste rock
- Footprint of 260,000 m<sup>2</sup>
- Waste rock height = 40 m
- Cover installed in 2007

Growth Medium  
Drainage Layer  
Geotextile  
**HDPE**  
Bedding Sand  
Waste Rock

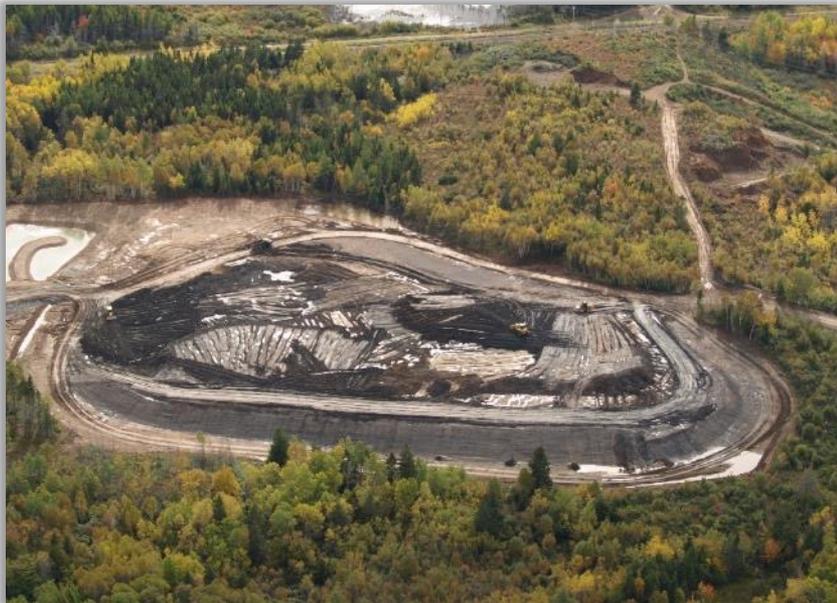
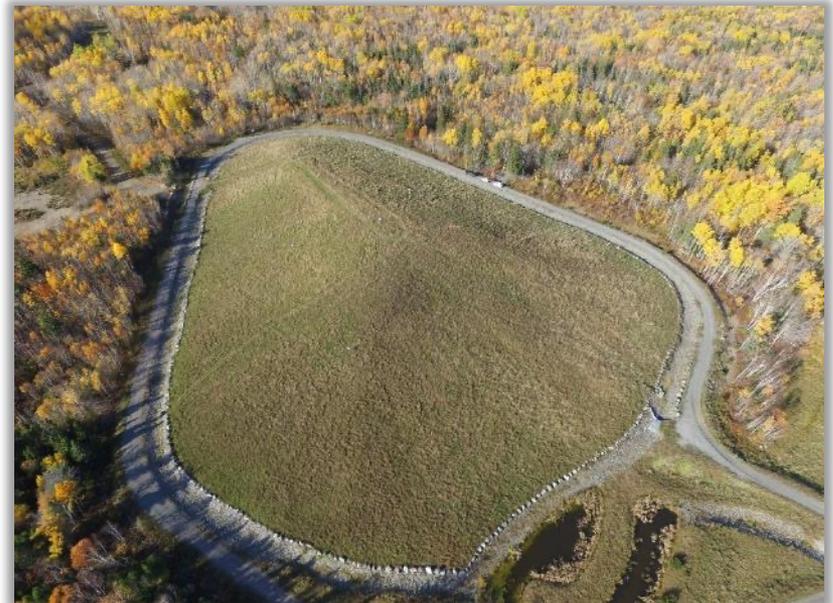
## Franklin

- 319,005 tonnes of fill/waste rock
- Footprint of 31,000 m<sup>2</sup>
- Thickness at center = 11 m
- Cover installed in 2010

Growth Medium  
Drainage Layer  
Geotextile  
**HDPE**  
Bedding Sand  
Waste Rock

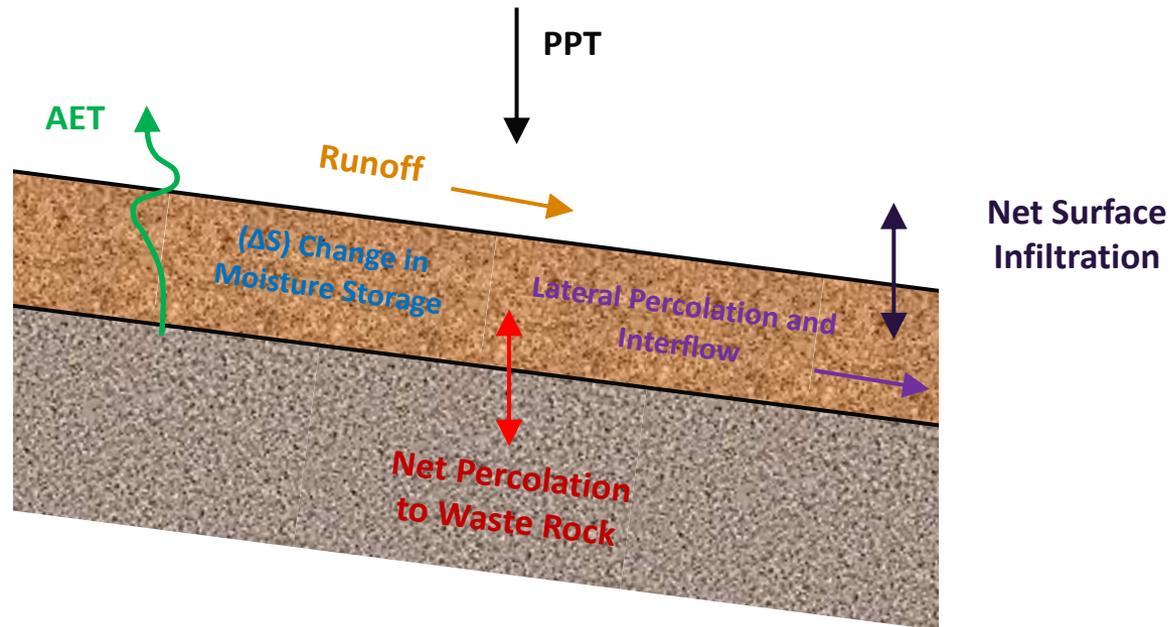
- Water influx
  - Comprehensive water balance

$$\text{PPT} = \text{R} + \text{AET} + \Delta\text{S} + \text{LP} + \text{NP}$$

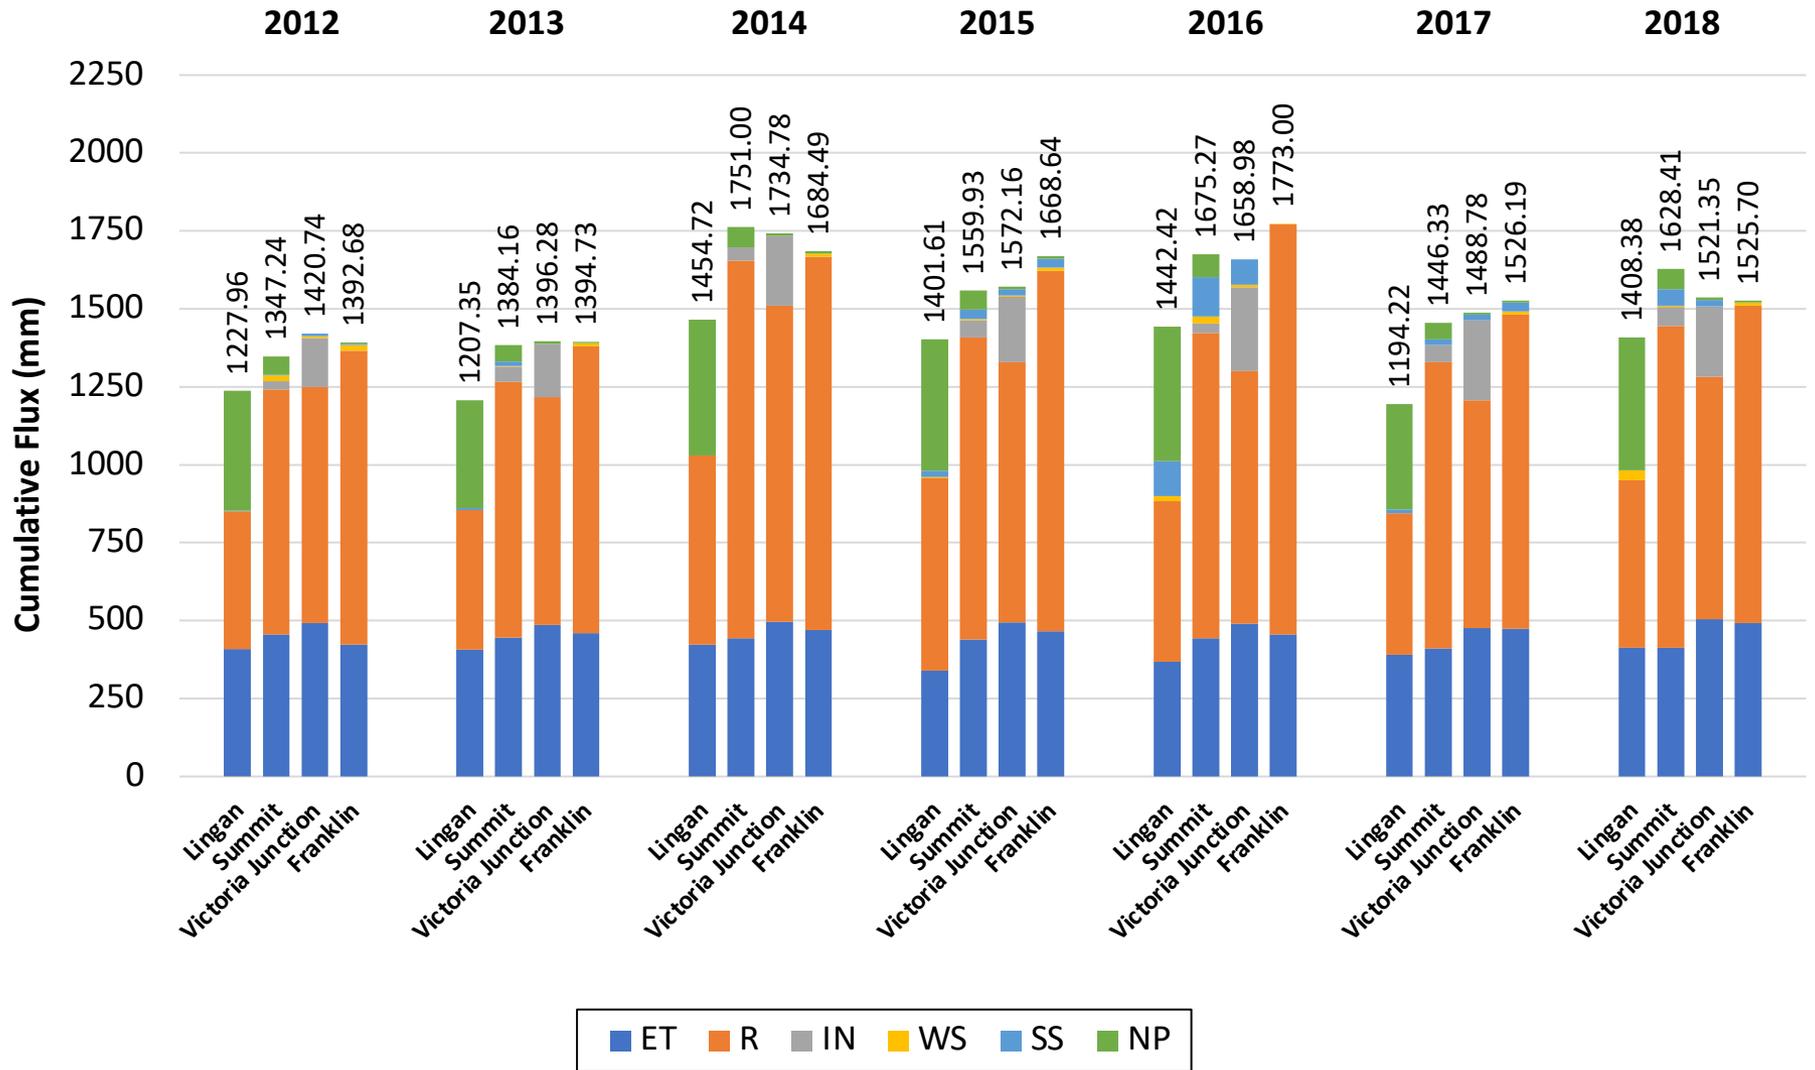
- Water influx – Net Percolation

Year	NP (mm)				NP (%PPT)			
	Lingan	Summit	VJ	Franklin	Lingan	Summit	VJ	Franklin
2012	384.18	24.45	3.78	0.48	31.29	1.85	0.28	0.035
2013	347.14	22.79	4.71	0.49	28.75	1.65	0.42	0.035
2014	436.21	27.93	4.72	0.59	29.99	1.60	0.28	0.035
2015	421.26	24.61	5.18	0.57	30.06	1.61	0.40	0.034
2016	431.93	36.30	5.99	0.61	29.94	2.17	0.37	0.034
2017	336.87	32.50	4.39	0.51	28.21	2.55	0.38	0.035
2018	426.32	32.36	5.00	0.33	30.27	2.68	0.33	0.024

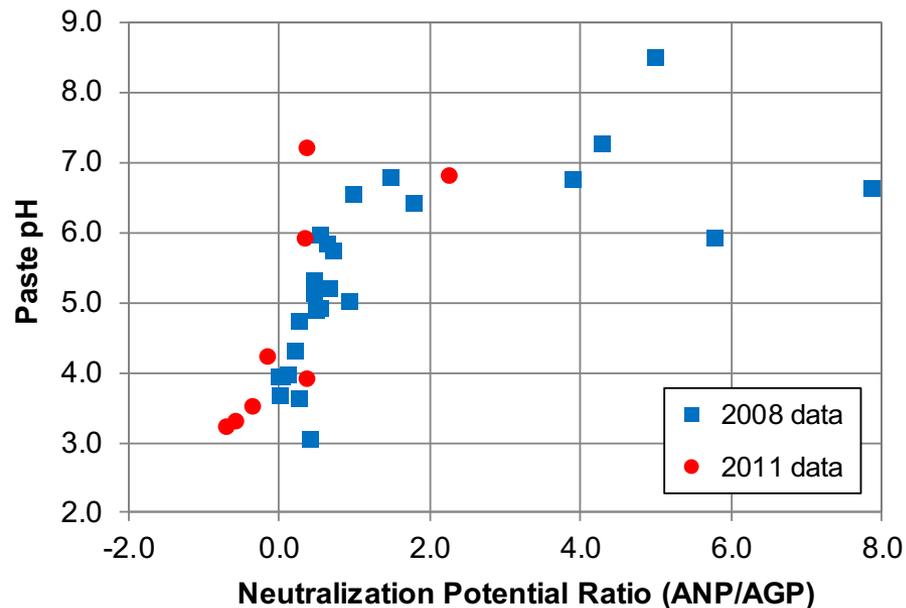
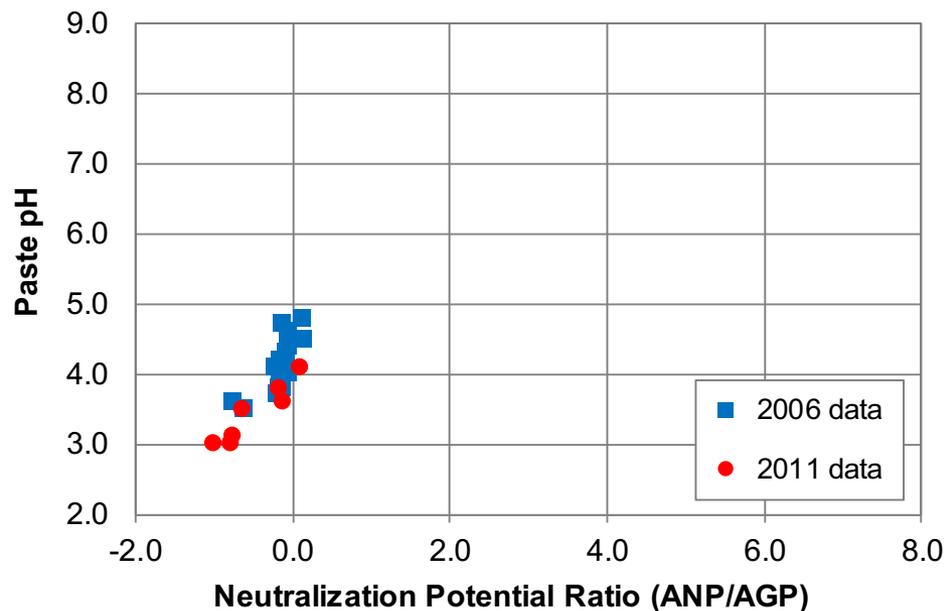
Parameter	Value	Unit
Paste pH	3.2 - 7.2	-
Acid Gen Potential	3.1 - 18.6	kg CaCO <sub>3</sub> /t
Potential Acidity	7,432	tonnes
Stored Acidity	6,922	tonnes

Parameter	Value	Unit
Paste pH	3.0 - 4.1	-
Acid Gen Potential	0.1 - 37.7	kg CaCO <sub>3</sub> /t
Potential Acidity	27,925	tonnes
Stored Acidity	43,088	tonnes

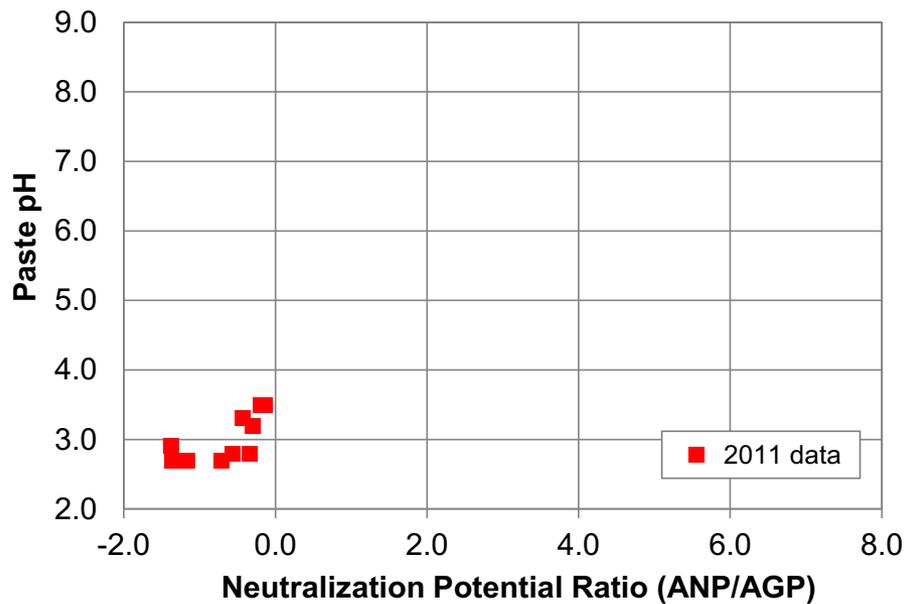
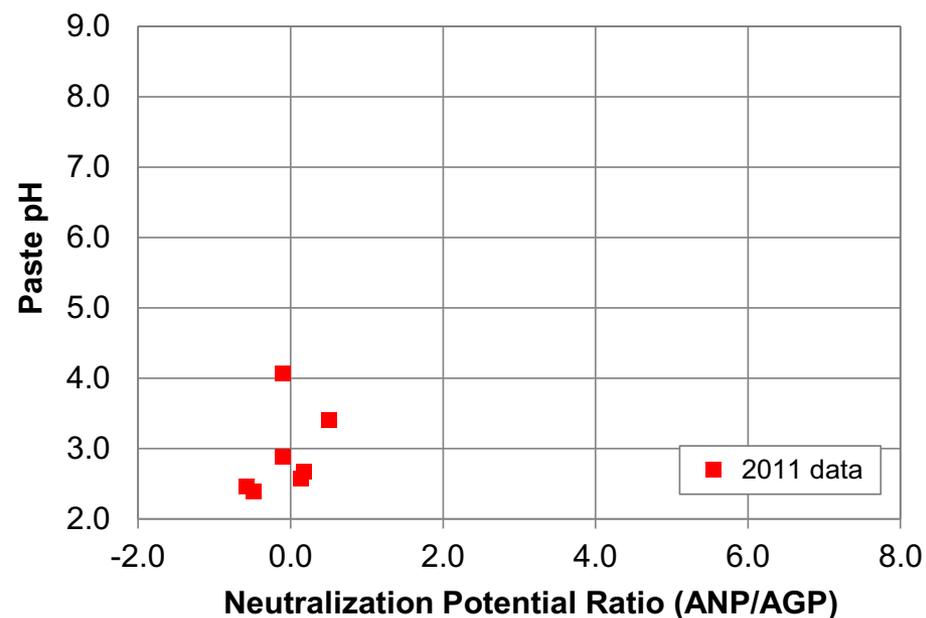
Parameter	Value	Unit
Paste pH	2.7 - 3.5	-
Acid Gen Potential	12.2 - 44.1	kg CaCO <sub>3</sub> /t
Potential Acidity	229,006	tonnes
Stored Acidity	355,653	tonnes

Parameter	Value	Unit
Paste pH	2.4 - 3.4	-
Acid Gen Potential	8.1 – 21.5	kg CaCO <sub>3</sub> /t
Potential Acidity	5,579	tonnes
Stored Acidity	5,981	tonnes

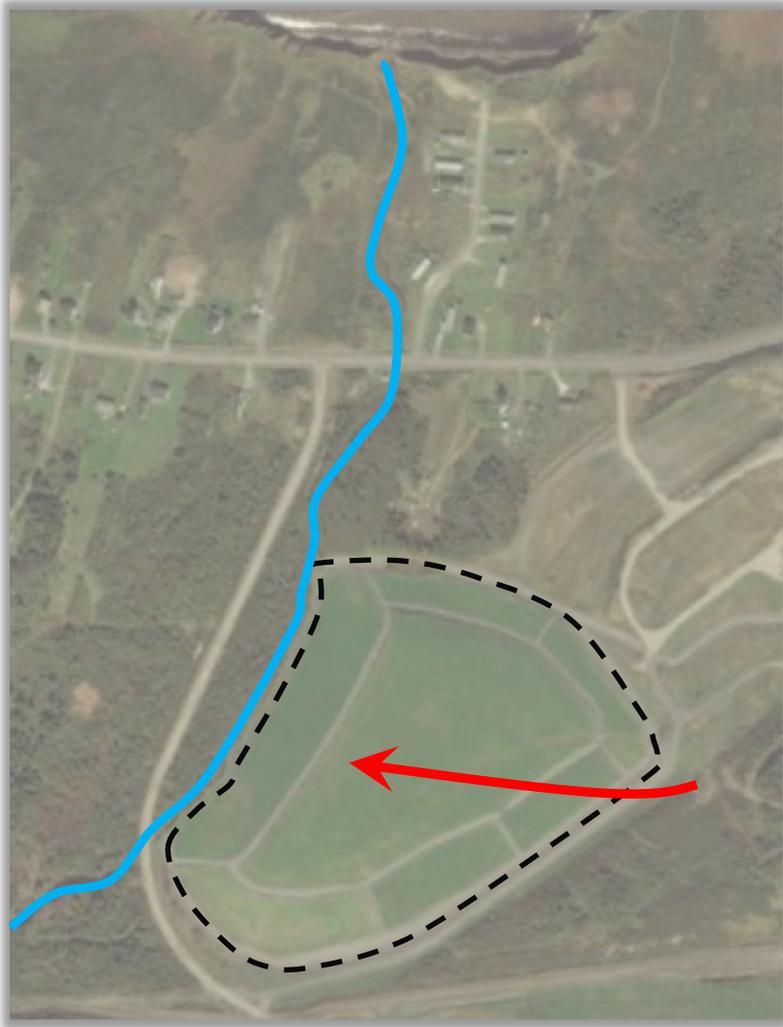
- Lingan

- Acid mine water leaves through base of WRP to **groundwater** flowing in N-W direction to ocean
- Acid water through toe of WRP to **surface water** (Graces Brook) flowing west of WRP to ocean

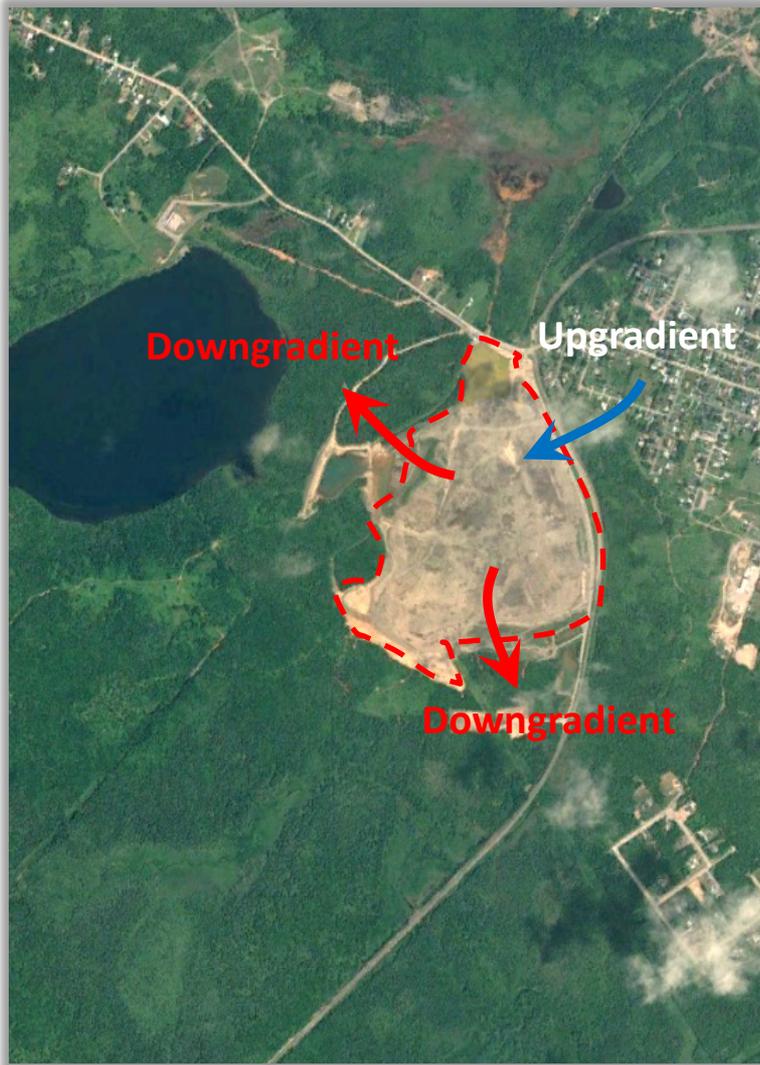
- Scotchtown Summit

- AMD leachate leaves through base of WRP to **groundwater** flowing to N-to-NW and S-to-SE

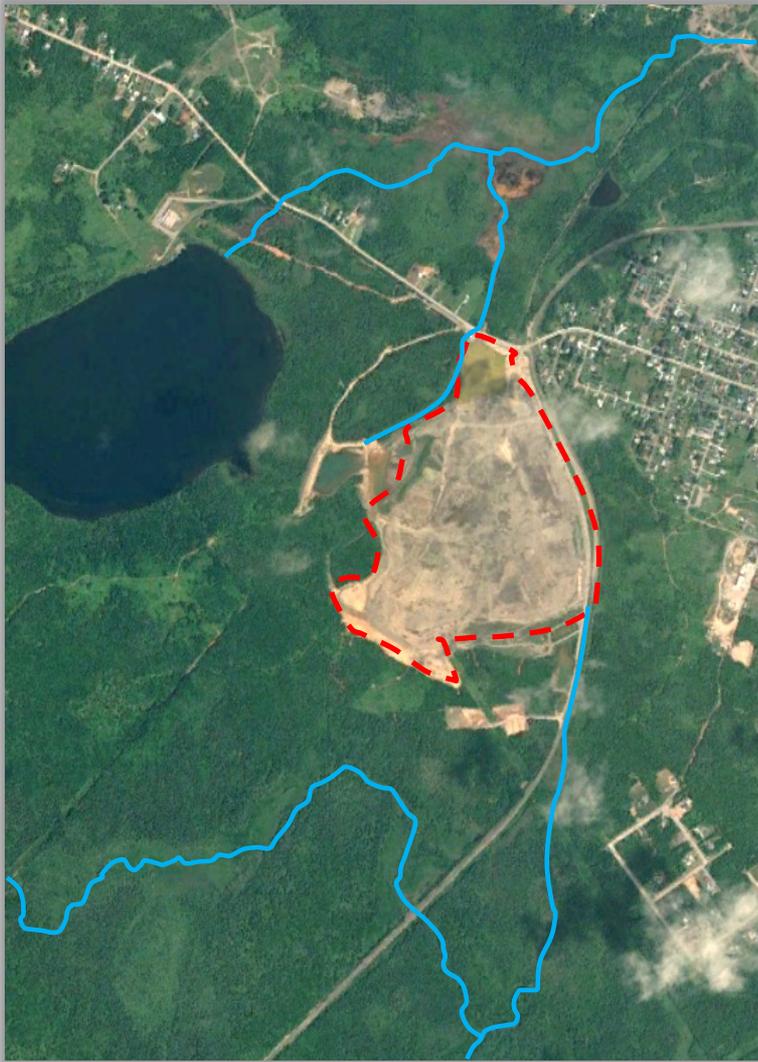
- Scotchtown Summit

- AMD leachate leaves through base of WRP to **groundwater** flowing to N-to-NW and S-to-SE
- **Surface water** runoff water to perimeter ditches and key watercourses at the site

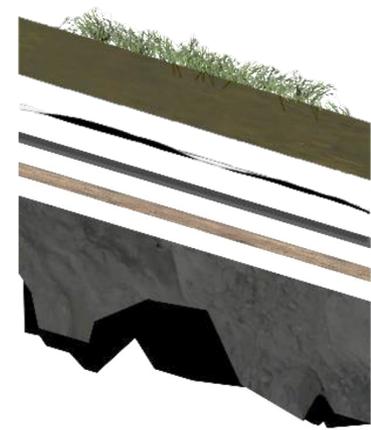
## Scotchtown Summit

### Geosynthetic Cover 1

Growth Medium

Geotextile

HDPE

Bedding Sand

Waste Rock

- Cost: \$38 per m<sup>2</sup>
- Works in humid climate
- Effective barrier to water and oxygen
- Poor vegetative growth
- Eliminated contaminated surface runoff
- Improved quality in all receptors
- Satisfied all closure objectives
