Geochemical Characterization of Tailings and Waste Rock to Support Closure Planning, Langlois Mine, Québec, Canada

December 2nd, 2025
B.C. MEND ML/ARD Workshop

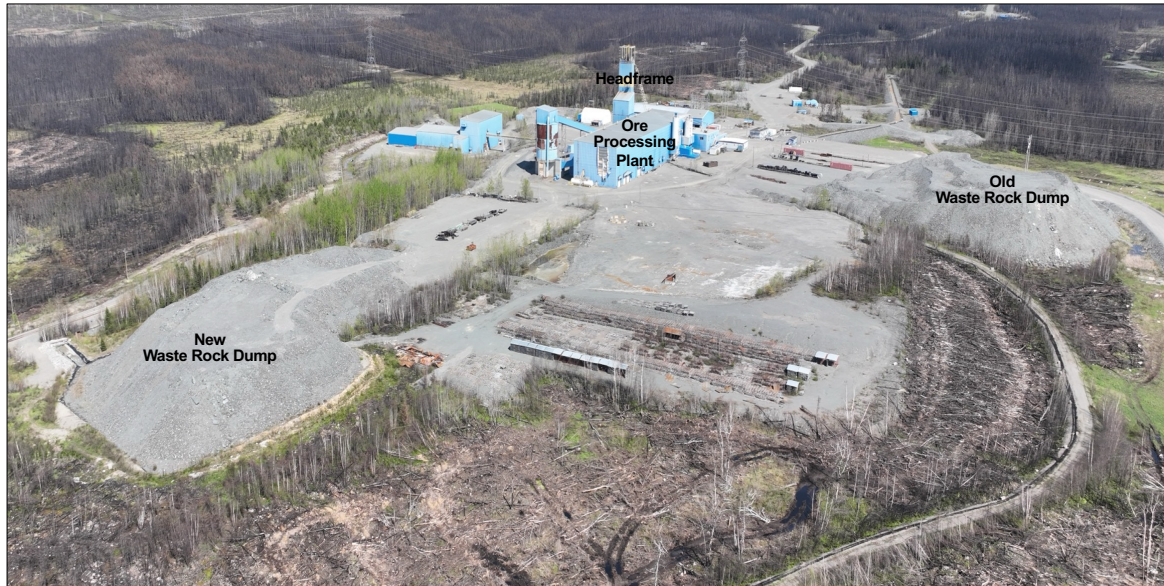
Mill Area

Here's a close-up of the Mill Area, where the headframe and the other main buildings are located. This was really the heart of the site during operations.

Ore came up through the shaft, and straight into the processing plant, which processed roughly over 6 Mt of ore, over the life of the mine.

About 40% of the tailings produced here were thickened, filtered, and mixed with cement and used as backfill for the underground workings, and the rest was mixed with lime and was sent to the TSF.

And regarding waste rock, any material that couldn't be used underground also came up and stored in these two surface dumps. The Old WRD and the New WRD. The New WRD is a lined facility with a geomembrane liner underneath. Aside from these two WRDs, Waste rocks were also used to build the mill area and all the access roads to different areas of the site.

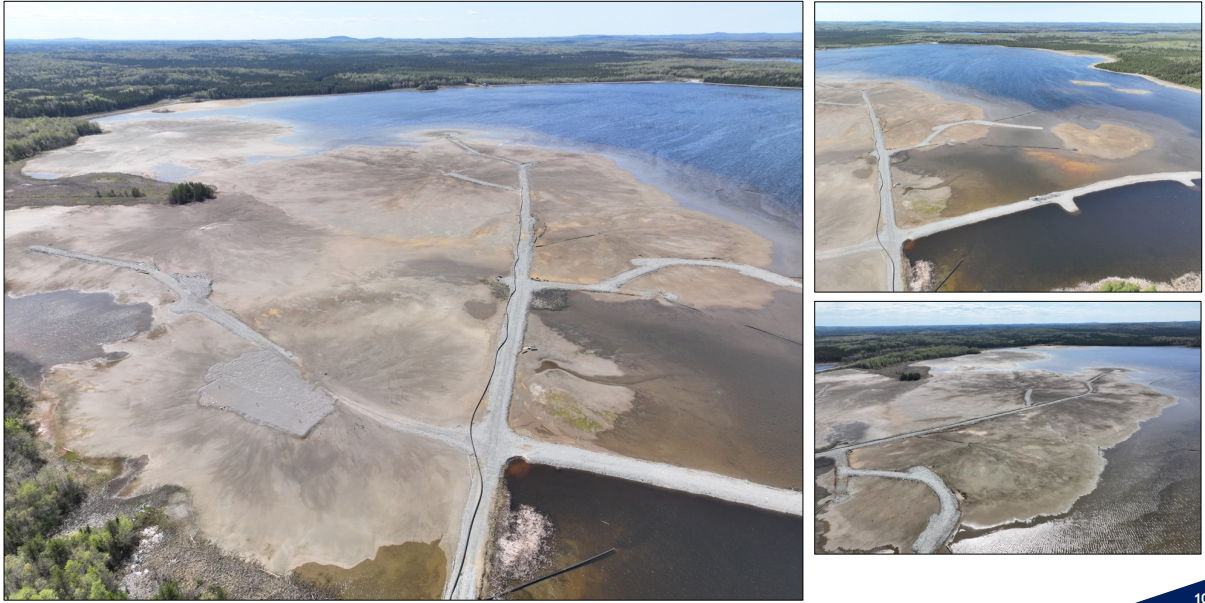
Tailings Beaches – May 2024

Here are some recent drone images from May 2024 showing the tailings beaches.

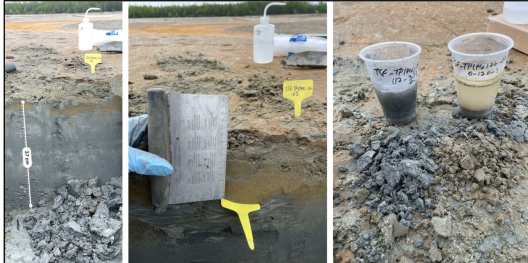
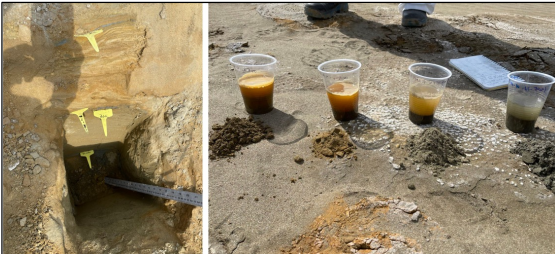
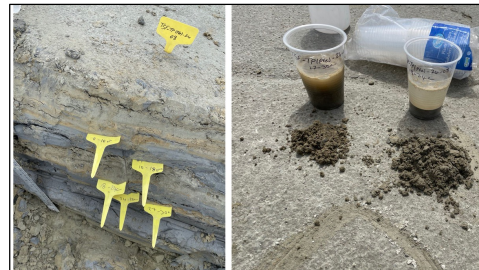
Here are a few examples of the excavated test pits and in-situ rinse tests. As you can see, the extent of oxidation was quite variable from a few centimetres in some locations and to tens of centimetres in other locations.

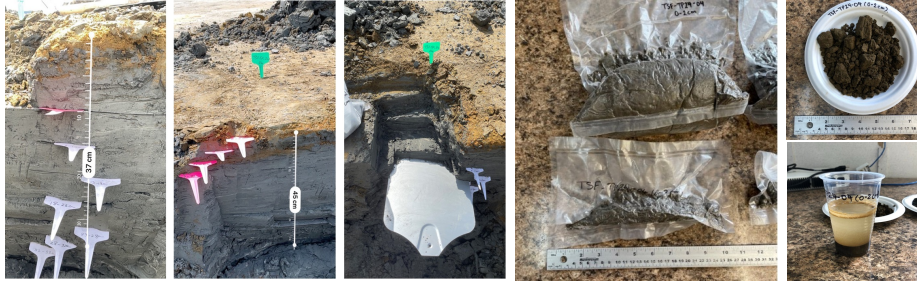
Sample Collection & Analysis Overview

Challenge: Collecting and preserving enough material from fine intervals

- Opened in nitrogen-filled glovebox (to prevent oxidation)
- Analysed for Moisture content, ABA, Near-total metals, PSD and Mineralogy via TIMA

- Porewater extracted by centrifugation
- Tested for pH, EC, acidity, alkalinity, major anions, dissolved metals
- ICP-MS used for dissolved metals analysis

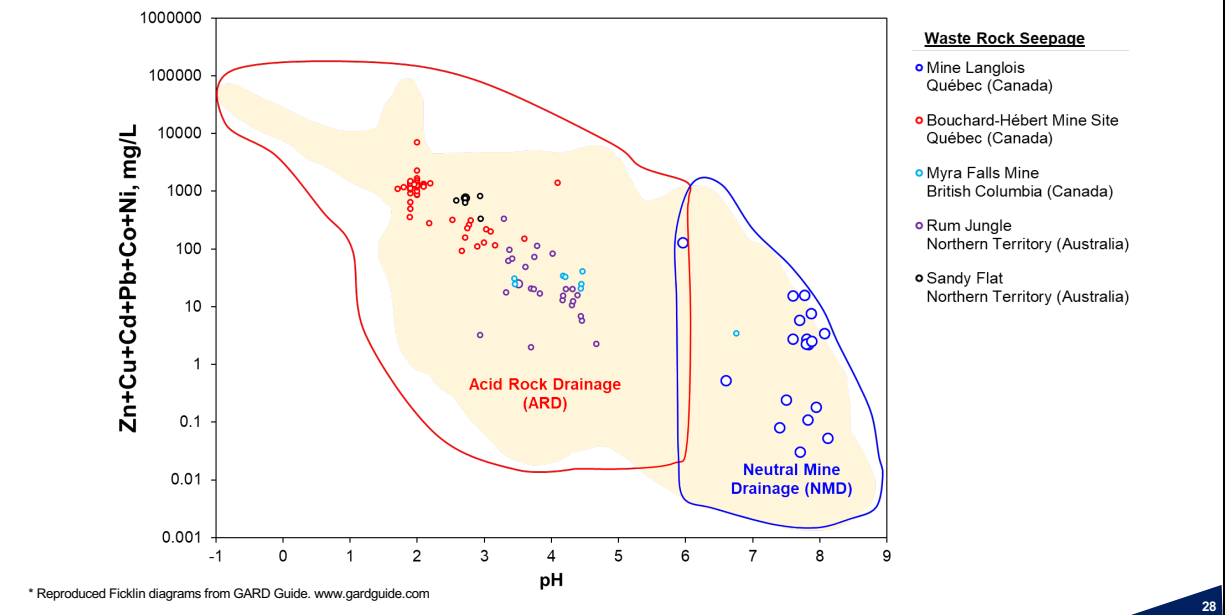
Results: Waste Rock Seepage

We did a comprehensive study on waste rock geochemical characterization across Mine Langlois. We excavated ...66 test pits excavated to natural ground/bedrock, with 117 waste rock samples collected from the profiles.

All samples were sieved to -19 mm in the field; rinse tests were completed on -2 mm material on site.

About 1 kg of each -19 mm sample was sent to SGS. Lab analyses included ABA, and near-total metals by aqua regia digestion, XRD for mineralogy, and leach tests of SPLP, TCL, and CTEU-9 for selected number of samples

Seepage samples were also collected from bottom of test pits, toes of WRDs etc.

Most seepage samples collected in 2021 and 2022 show circum-neutral to slightly alkaline pH and low SO₄ and metal levels, so they fall in the NMD range. This includes seepage from the WRDs, Mill Area, and access roads. A few samples contain elevated Cd, Cu, Se, and Zn, and Zn can exceed Directive 019 limits, but their overall chemistry still aligns with NMD. Results match the SFE patterns for waste rock. The only clear outlier is a ponded sample from TP22-59C with very high Zn, likely due to stagnant water; it classifies as SD but is not representative of flowing seepage. Overall, seepage from non-PAG and most PAG materials at surface is predominantly NMD, with only minor groundwater impacts observed on site.

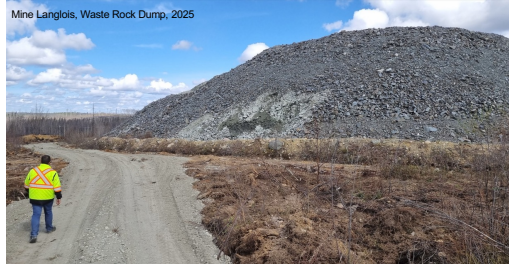
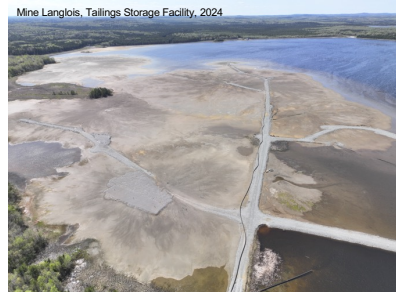
- Once sulphide minerals exposed at the surface, they become unstable and react with oxygen and water.
- Oxidation of sulphide minerals, especially **pyrite (FeS_2)**, produces acidic drainage and releases toxic metals, known as Metal Leaching (ML) and/or Acid Rock Drainage (ARD).

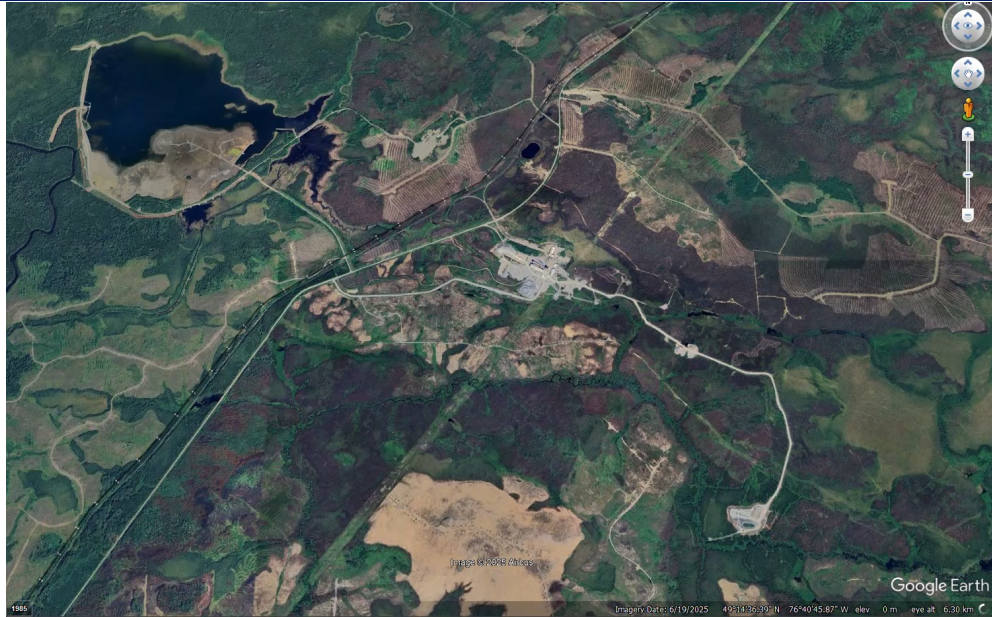
Flyover – June 2025

Here is a short video flying over the mine site. Starting from the Gerev B Mine site. This Mine was a smaller deposit in association with Mine Langlois which has its own WRD. Then there is an access road to the Mill area. All access roads were partially constructed from waste rock.

There are two Waste Rock Dumps in the Mill Area that contain sulphide-bearing waste rock. The Old and New WRD. New WRD has a liner underneath. Waste rock was also placed as fill in the Mill Area in order to provide level working surfaces. And then we have the main access road and the road to the TSF. Tailings were mixed with lime and discharged to the TSF. All discharged tailings was under water prior to 2013 and they were required to be kept under 1 m of water cover during operation and post closure. However, as you see it did not stay as intended and tailings beaches started to emerge since 2013, when TSF was operating. Which was mainly due to lack of frequent moving of the discharge pipes during the winter-time when pipes were stuck in ice, led to deposition of tailings at discharge points.

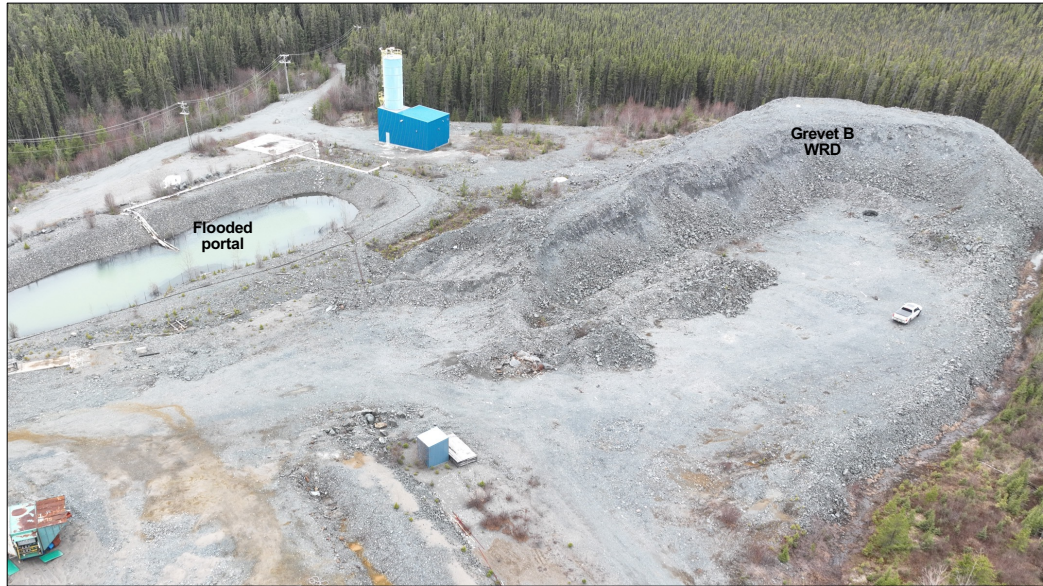
Grevet B Area

The TSF closure plan is still under option assessment stage. However, given the large 2.3 Mm3 capacity within the pit and underwater cover, a high potential option is to relocate all waste rocks from Grevet B, Mill Area, access roads and waste rock dumps into the TSF and also dredge the exposed tailings to the deeper parts of the TSF.

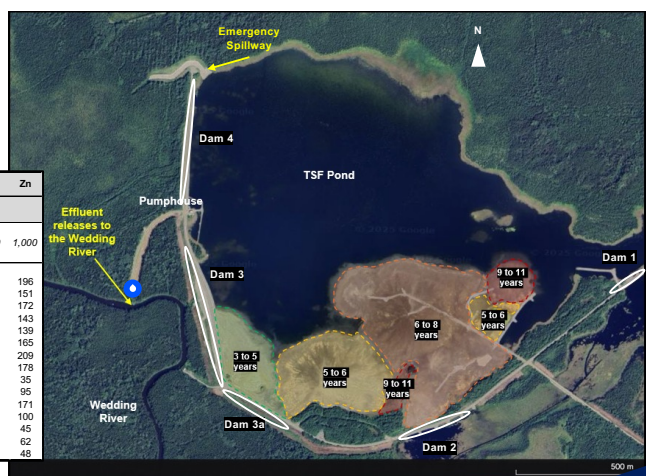
Results: Moisture Content and PSD

Why is the oxidation front more advanced in tailings with shorter exposure durations compared to locations that have been exposed to subaerial conditions for longer?

As plotted on these bar charts, we found that average fraction of sand sized tailings are higher for tailings close to Dam 3a with advanced oxidation front, than the other two locations. Therefore, these tailings are unable to retain the moisture content effectively and provide a barrier against oxygen diffusion to deeper layer.

In addition, we also measured gravimetric moisture content in depth profile, showing lower values for the coarser tailings. So, the impact of grain size and moisture content and its retention are overpowering the duration of oxidation and **that's why the extent of oxidation got quite advanced in such a short time at this coarser grain area** compared to the other areas. We also looked at the mineralogy of tailings in detail, at TP24-10 in depth profile, and found out that pyrite crystals are very fine grain and they are highly exposed, compared to the carbonate grains,, which is another evidence for faster ARD generation here. I won't go through those mineralogy results today, given the limitation of time, but I'd be more than happy to discuss it afterward.
