HEALING AN OPEN SORE

REHABILITATION OF FORMER SHALE QUARRIES IN NOVA SCOTIA

By Scott MacKnight, Ph.D., CEA, CESA, OCL Services Ltd.

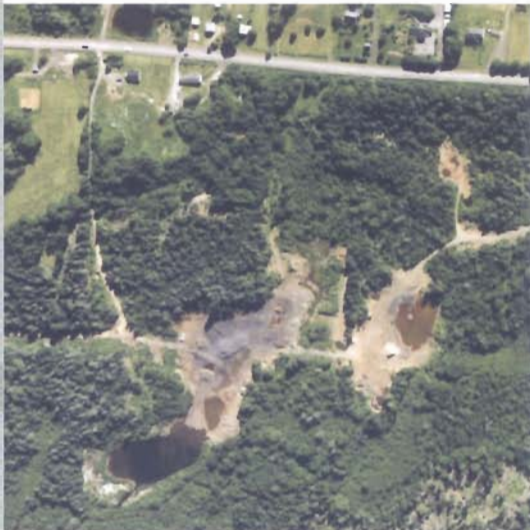
1997 aerial view of shale quarry at Northwest, Lunenburg County.

As in other jurisdictions, various attempts have been made to address acid drainage. The 1991 illegal quarrying of a former pit in Northwest, Lunenburg County, Nova Scotia resulted in acidic discharge to Martin's Brook and significant fish mortality at an aquaculture operation near the mouth of the Brook. This site, consisting of two pits (0.8 and 2 hectares) was started in 1948 and used extensively in the 1960s and 1970s. In response to the fish kill, a local non-government organization (NGO) group, Bluenose Atlantic Canada Action Program, used waste drywall board to create a dyke that could also "neutralize" the effluent. However, as has been encountered elsewhere, the result was a concrete-like mass of material that provided only temporary relief. Further attempts included spreading the waste drywall over sections of the quarry, grinding the waste and spreading the material, and diverting the flow into a

In 1998, the first large-scale trial of Remediation Matrix was attempted at the Northwest quarry. Mixture materials were carefully ground at the HCDR facility in Halifax, transported to the site and spread over all of the pit area to a depth of about 1 m. After natural consolidation of the material over a winter, the surface was covered with about 0.1 m of compost and seeded. Within six months, the site started to become a grassy field. Re-seeding in the autumn yielded a lush field of grass the following summer. Excess surface water drainage through the site resulted in sulphide odours during the next three years. This was mostly addressed by diverting surface drainage from other areas around the quarry site. Monitoring of Martin's Brook continued to show an increase in pH back to 6.5 and associated trace metal reductions; however, the community continued to express concerns about leachate from the construction and demolition materials used to create the Remediation Matrix.

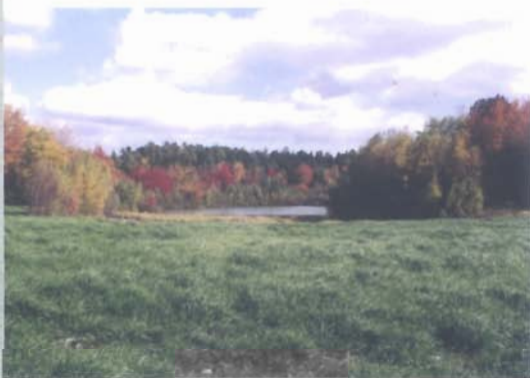
2001 view of Northwest shale quarry after rehabilitation.

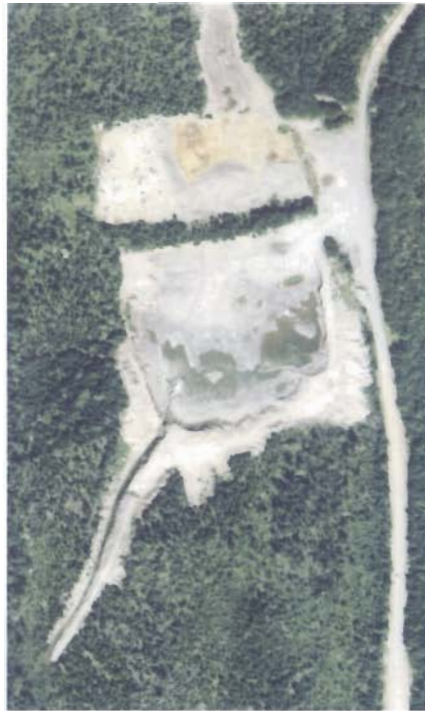
1999 summer aerial photograph of Antrim Shale Quarry.

In 1999-2000, a much larger trial of the Remediation Matrix was conducted at a quarry in Antrim near the Halifax International Airport. This 25-hectare site, consisting of two large pits, had been established in the 1950s and used until the late 1970s. The site drainage had a pH of 3. The resultant impact to Nuttall Brook created a very acidic aquatic habitat.

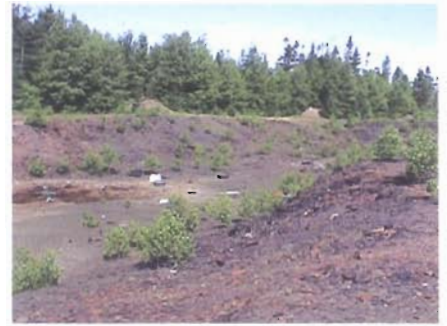
July 1999 view of Antrim Pit 2.

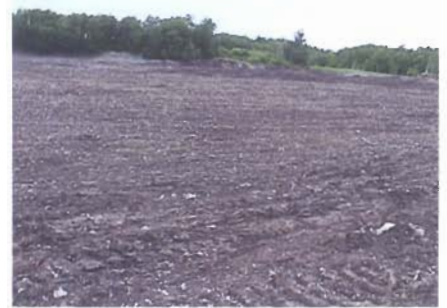
August 2003 view of Antrim Pit 2 after application of matrix and before seeding.

A total of over 10,000 metric tonnes of Remediation Matrix was placed in combination with a site drainage plan and drainage pipes. This large quantity of Remediation Matrix and compost was used to restore the natural topography and contours of the area, as well as remediate the acidic drainage.

Two key changes were made in the process: the Remediation Matrix materials were ground much finer than for the Northwest quarry to improve their chemical reactivity, and the amounts of drywall/plaster board were reduced to lessen the sulphide generation problem. By 2004, the former open sore had become two grassy fields.

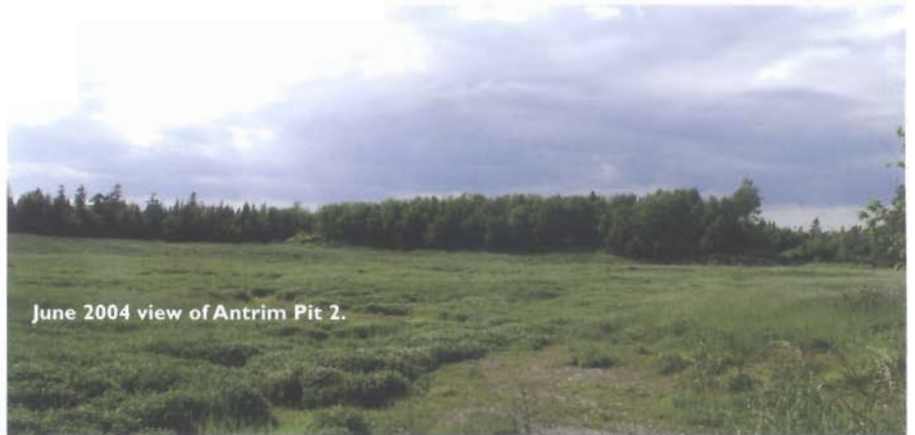
June 2004 view of Antrim Pit 2.
