**Tailings Management at Omai  
Gold Mines Ltd., (OGML)  
*Catalyst for Change***

Abrelle Poole  
OGML Environmental Coordinator

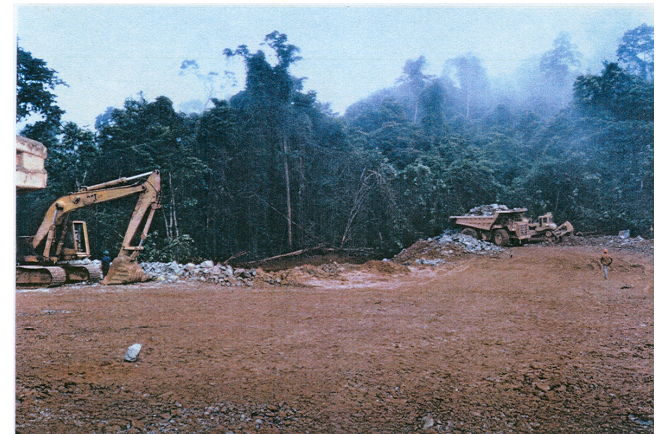
- Occurred August 19<sup>th</sup>-24<sup>th</sup>
- A major seepage through the tailings dam into the Omai River was discovered followed by a second breach observed also directly discharging effluent to the river

- Emergency response initiated:
  - Installation of pumps to transfer effluent to Fennell Pit
  - Building a coffer dam to stop main dam leakage
  - Building a diversion to route discharge to Fennell Pit
  - Filling sink holes on the upstream face of the affected dam to halt discharge
  - Informing Government and stakeholders
  - Water quality monitoring conducted throughout the incident
- **Emergency response actions were SUCCESSFUL in halting the discharge after 100 HOURS**

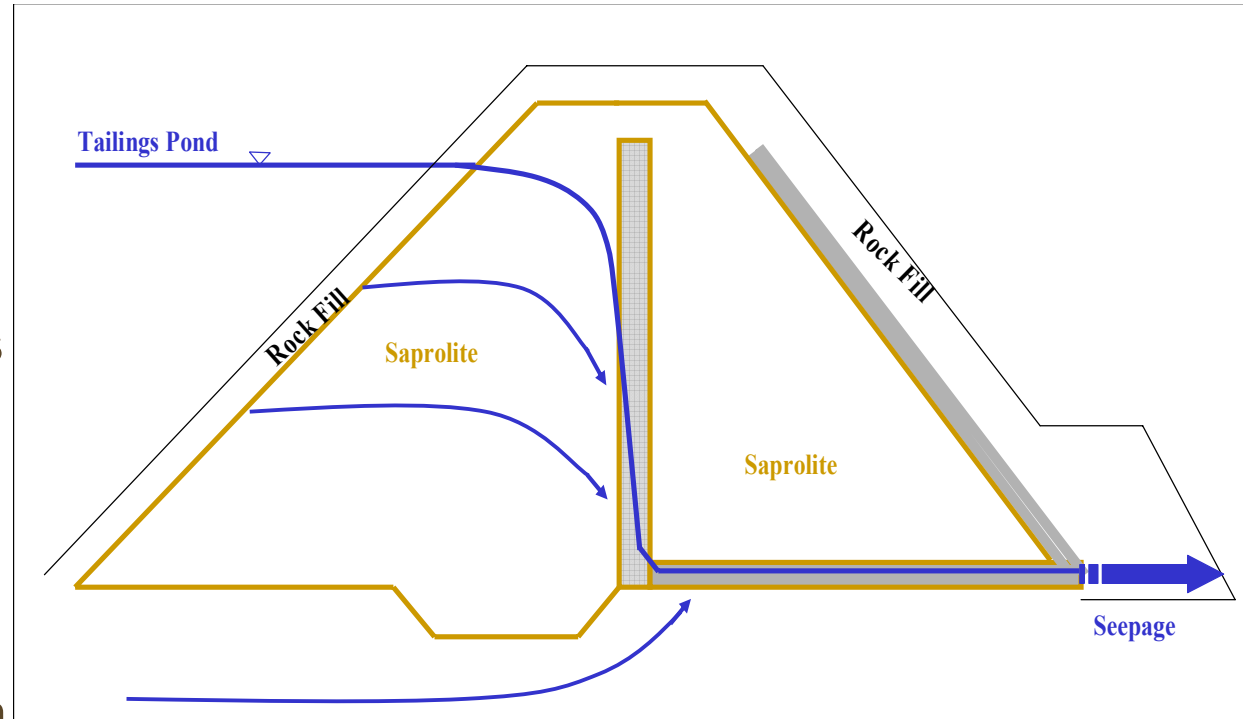
- No pipes through dams
- Very generous central impervious zone
- Phased construction provided minimum freeboard- 2 m

- Internal drainage system incorporated: vertical chimney drains, core drains at base and blanket drains beneath the section's outside shoulder

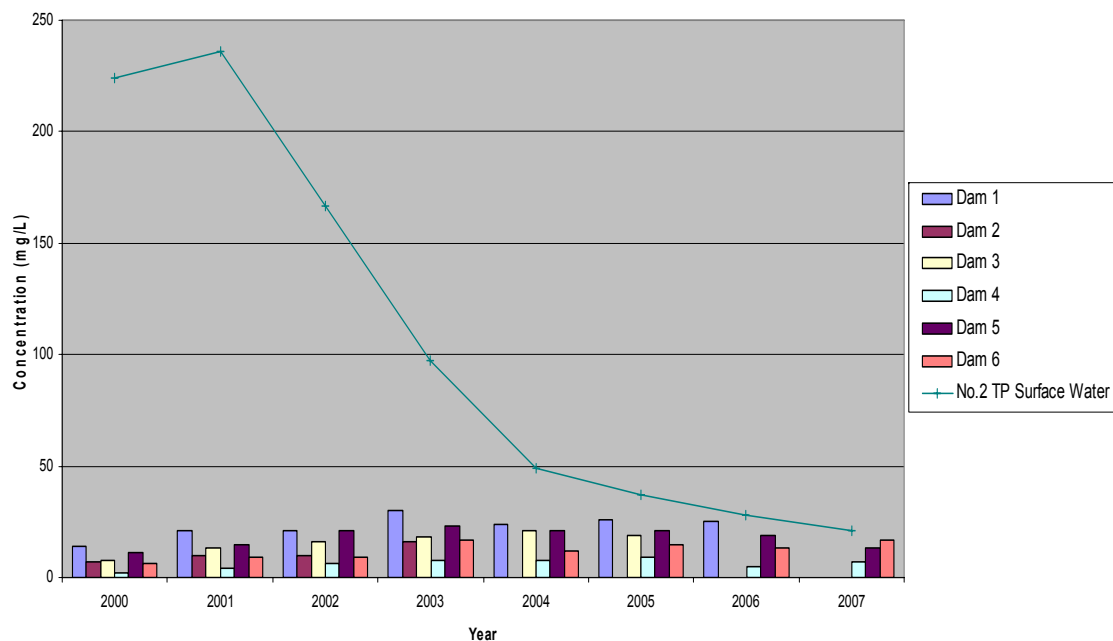
Summary of Sodium in No.2 Tailings Impoundment Surface Water versus Groundwater Representatives of Each Dam (Dams 1 to 6)

- Due to the successful construction, operation & closure key learnings the **results achieved** were:
- Excellent environmental performance (no groundwater/seepage impacts)
- Instrumentation measurements consistent or better than estimates/anticipations
- Evolution into successful, populated terrestrial and aquatic habitats
- GGMC & Guyana EPA inspected and recommended sign off by the Government of Guyana-June 2008
- Sign off by the engineer of record
