The Ongoing Rehabilitation of Ontario's Kam Kotia Mine: An Abandoned Acid Generating Tailings Site

Christopher D. Hamblin

**Project Coordinator
Abandoned Mines Rehabilitation Fund
Ministry of Northern Development & Mines
Ontario, Canada**

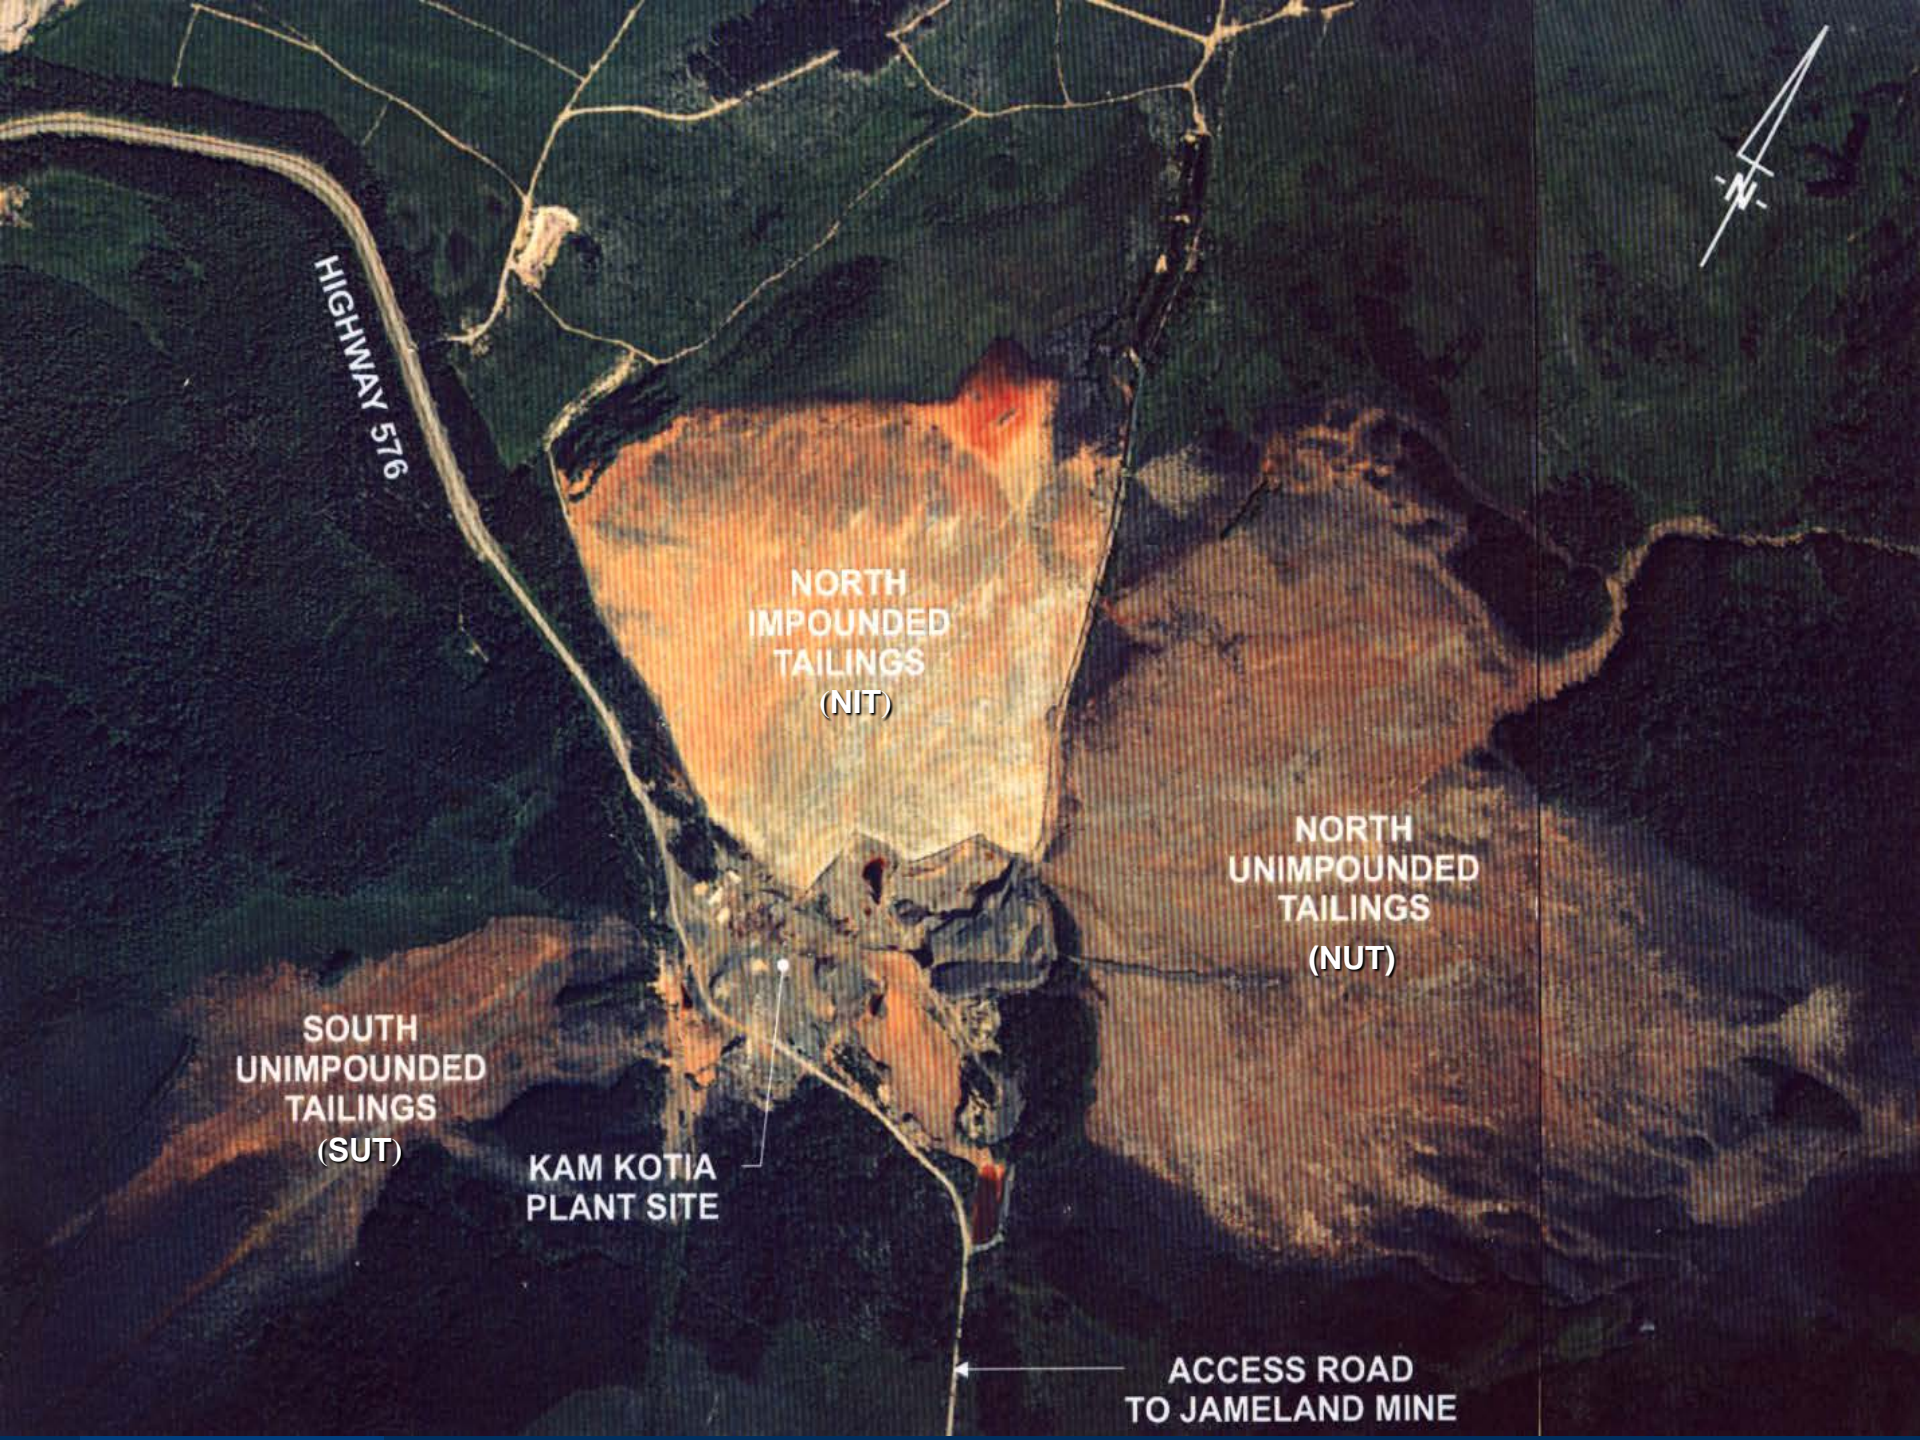
- Kam Kotia is a former Cu/Zn mine near Timmins, Ontario
- There were about 6 million tonnes of unmanaged acid generating tailings covering more than 500 ha
- Environmental impacts are locally significant
 - acidic leachate
 - dusting
 - aesthetics
 - physical safety
