16th Annual BC/MEND ML/ARD Workshop

**Soil, Geomembrane, and  
Non-Traditional Dry Covers**

# Aldermac Mine Site Restoration

**December 3<sup>rd</sup> 2009**

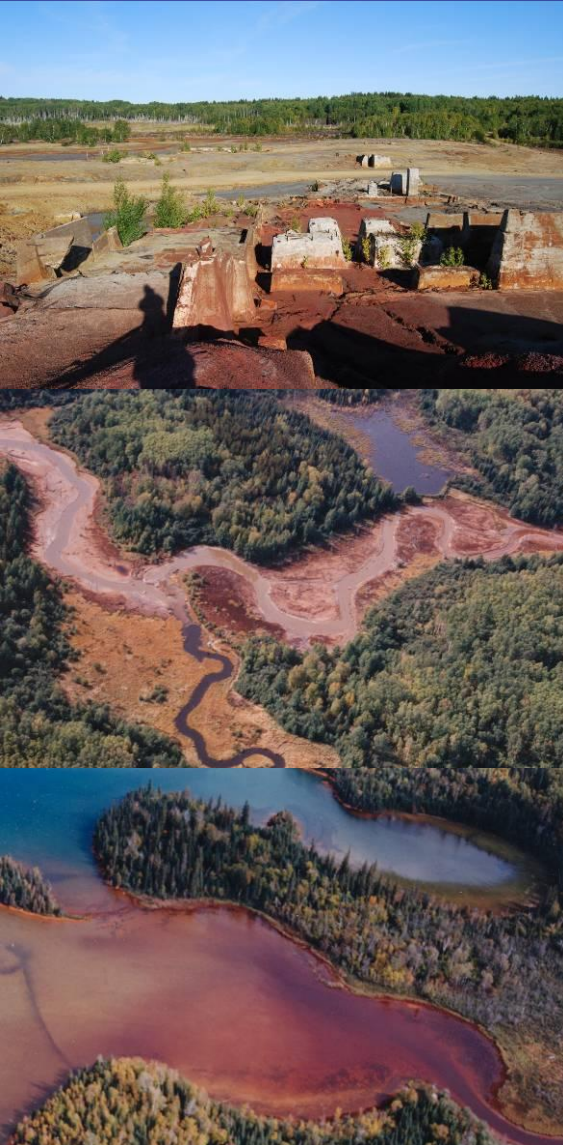
- 1.5 Mt of mine tailings have resulted in high acid mine drainage (AMD)
- 50 % in sulphurous minerals, significant concentrations of arsenic, cadmium, copper, molybdenum, zinc et sulphur
- Deposited without any containment precautions ⇒ **covering a 76 hectare area**
- **Areas affected by AMD**
  - Arnoux River and its tributaries
  - Arnoux and Dasserat lakes
  - Areas adjacent to the mine tailings
- **Majors environmental damages ⇒ considerable corrective measures required**
- **Indirect public health risk ⇒ food chain affected (sport fishing)**
- **No operator can be ordered to restore the site ⇒ abandoned site status**

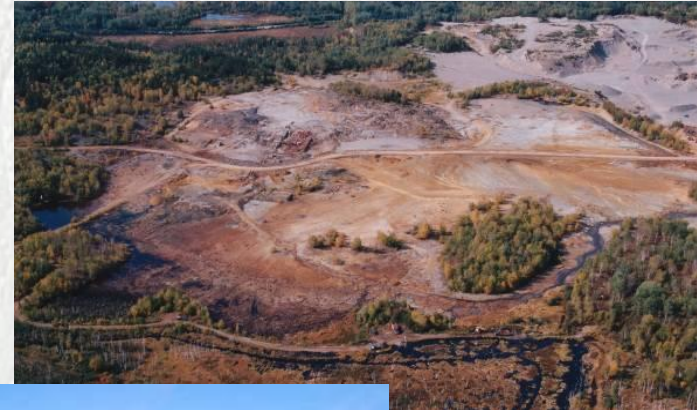
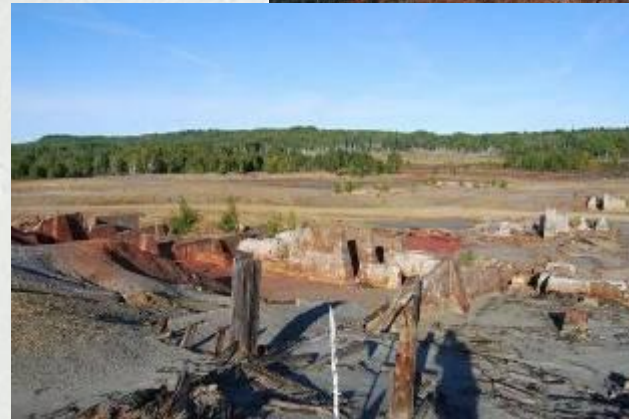
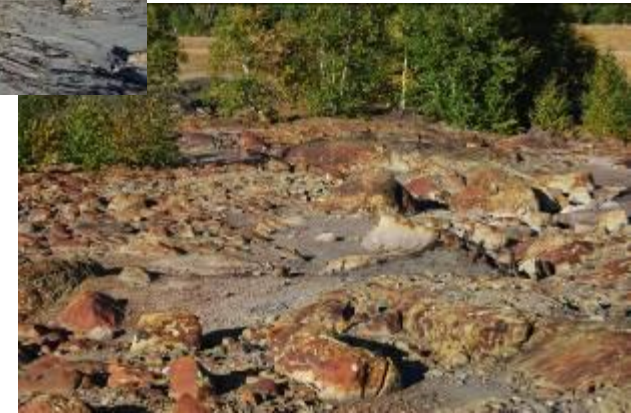
- Upstream of Intermediate Sector
- Rugged terrain with rock outcrops
- Origin of tailings spill, thickness reaches 6 m at former discharge point
- Remains of foundations of former mine buildings and shaft
- Relatively deep groundwater table (except to the east)

- Demolition of former mine and concentrator buildings
- Excavation and placement of tailings in a mound over a portion on the sector
- Liming of excavated sector
- Impervious covering of the mound with geomembrane
- Cleaning of rock outcrops
- Construction of small dike for creation of upstream wetland
- Revegetation of excavated and impervious covered sectors, including creation of a wetland

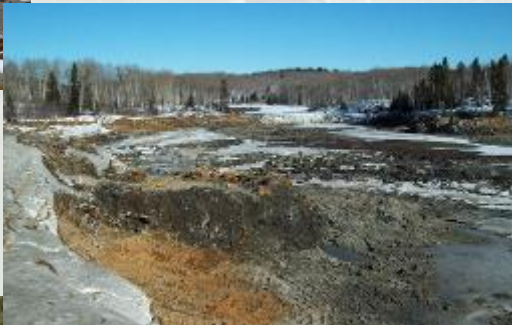
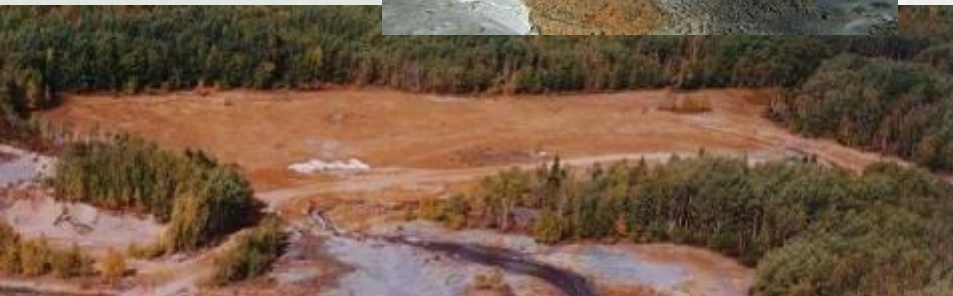
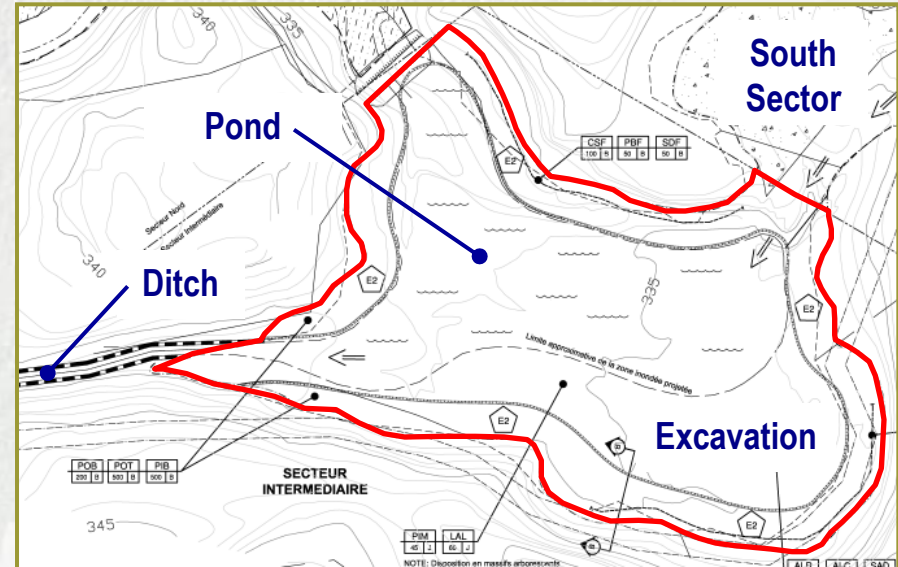
- Downstream of South Sector and upstream of North Sector
- Relatively small tailings thickness

- Excavation of all tailings and disposal in North Sector
- Liming and revegetation of the sector
- Creating a pond covering most of the sector

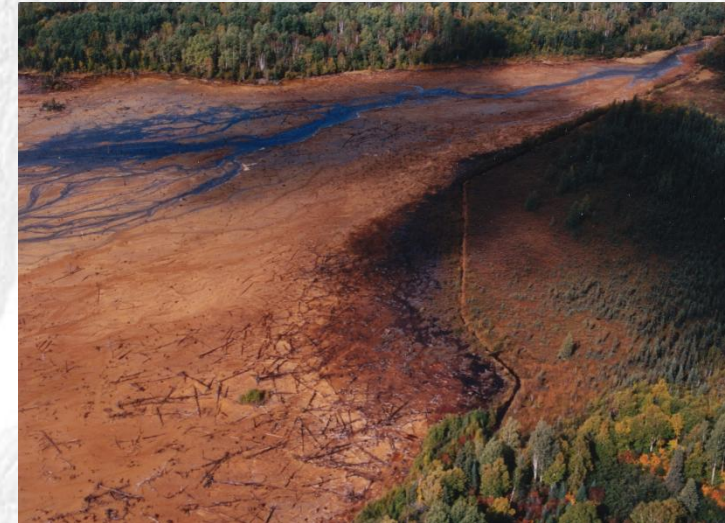
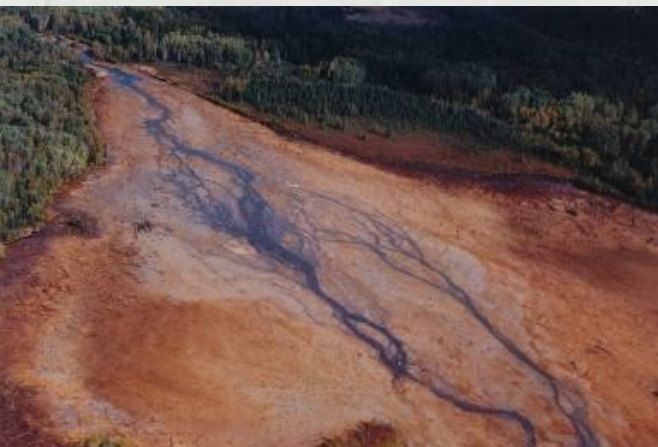
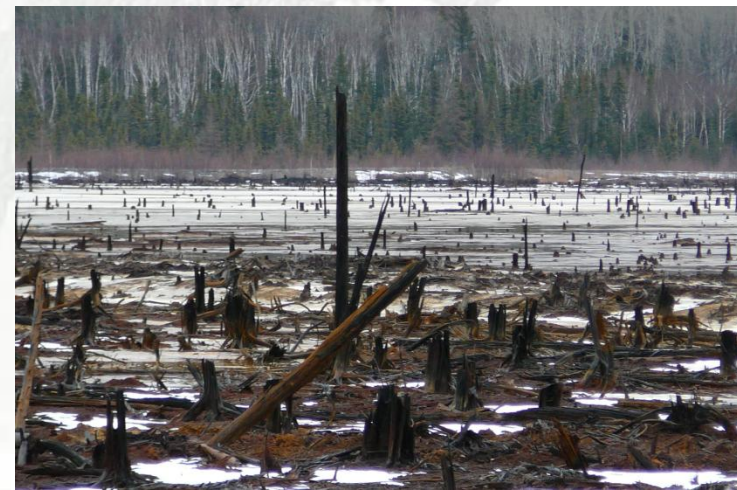
- Downstream of Intermediate Sector and upstream of Stream 1 Sector
- Sector covering the largest area (26.5 ha)
- Spill zone accumulating products of oxidation and showing high concentrations in metals
- Groundwater table near surface

- Development of two terraces using dikes
- Disposition of tailings excavated from Intermediate and Stream 1 sectors on these terraces
- Liming of the tailings
- Tailings in both terraces covered with a monolayer of granular material
- Revegetation of the terraces and creation of a settling pond

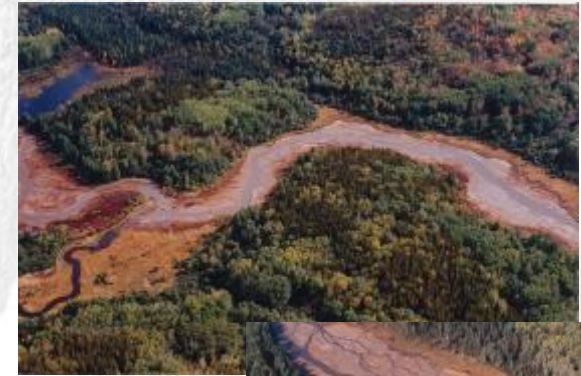
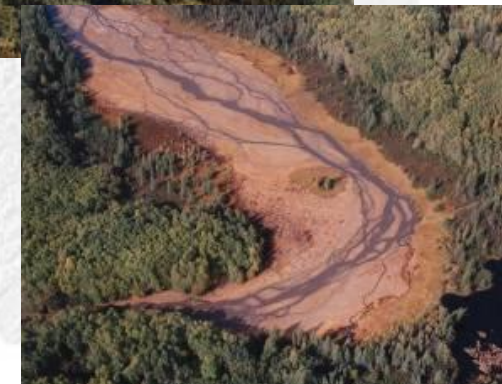
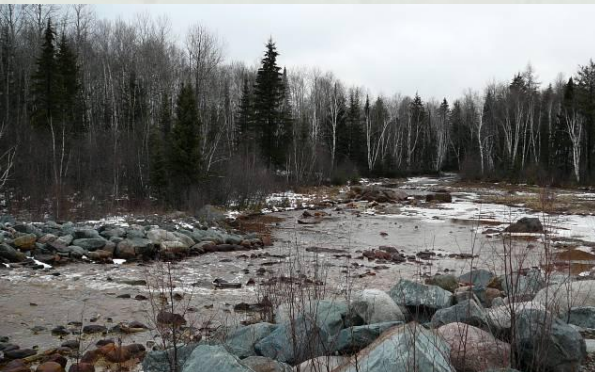
- Downstream of North Sector and upstream of Arnoux River
- Extends over 2.6 km and covers an area of 18.5 ha
- Presents two segments with distinct characteristics

- Runs south to north along a 700 m stretch
- Stream bed composed of rocks and cobbles with a mean slope over 2 %
- Approximately 11 % of total Stream 1 Sector area
- Approximately 4 % of total Stream 1 Sector tailings

- Runs from east to west over a 1 900 m stretch
- Floodplain varying from 20 to 100 m
- Mean slope in the order of 0.2 %
- Approximately 89 % of total Stream 1 Sector area
- Approximately 96 % of total Stream 1 Sector tailings

- Creation of a settling basin at the end of the first segment
- Excavation of all tailings in second segment and disposal in North Sector
- Liming of excavated zones
- Revegetation of the second segment, including the creation of two flooded zones
