The Flooded Tailings Impoundment at the Equity Silver Mine

W.A. Price¹ and M. Aziz²

THE FLOODED TAILINGS IMPOUNDMENT AT THE EQUITY SILVER MINE

ABSTRACT

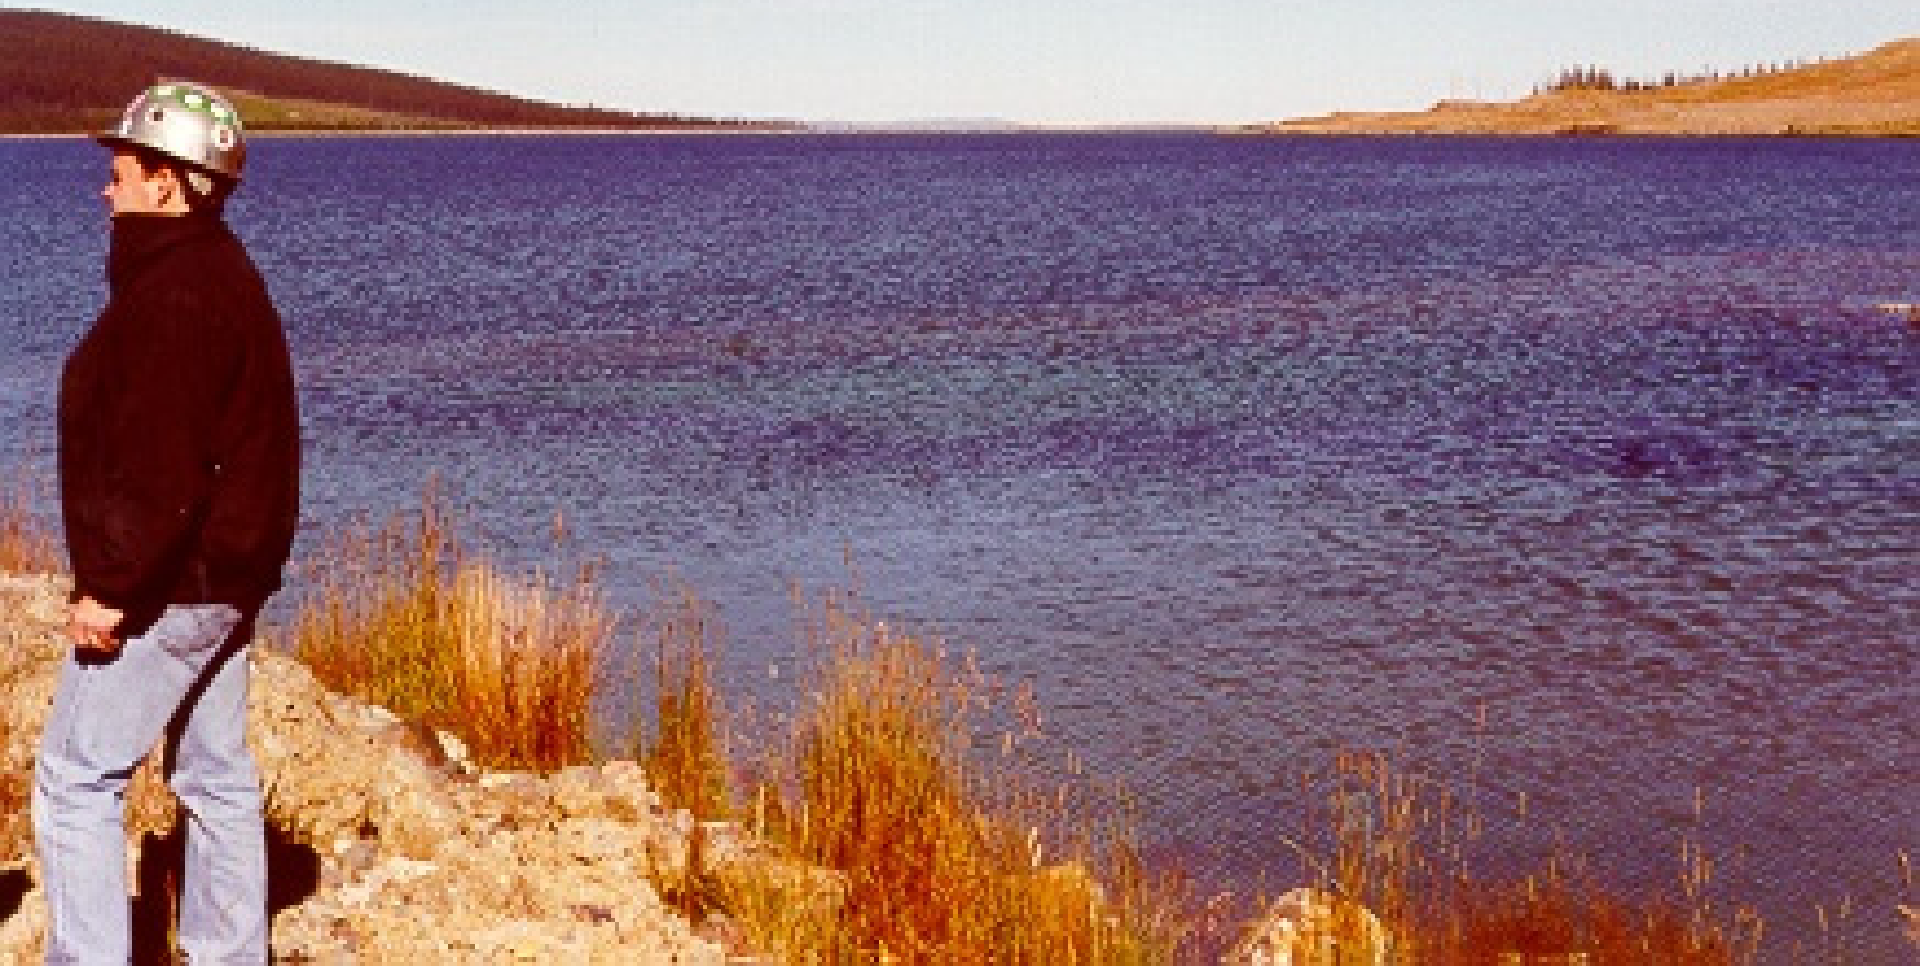
To prevent oxidation, the water cover needs to be deep enough to ensure the tailings remain flooded during a long drought and prevent movement by ice or waves.

The impoundment is wide and wind-swept and large waves are commonly observed.

Ripples on the surface of flooded tailings were used as evidence of the maximum depth of wave-induced tailings movement.

The maximum depth of ripples was 1.4m.

The depth of the water cover is maintained at 1.7 to 7.5 m.

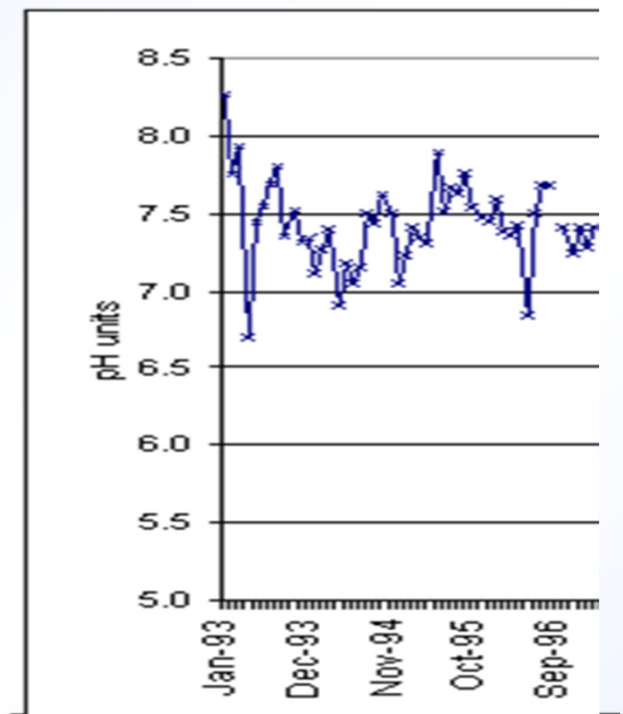
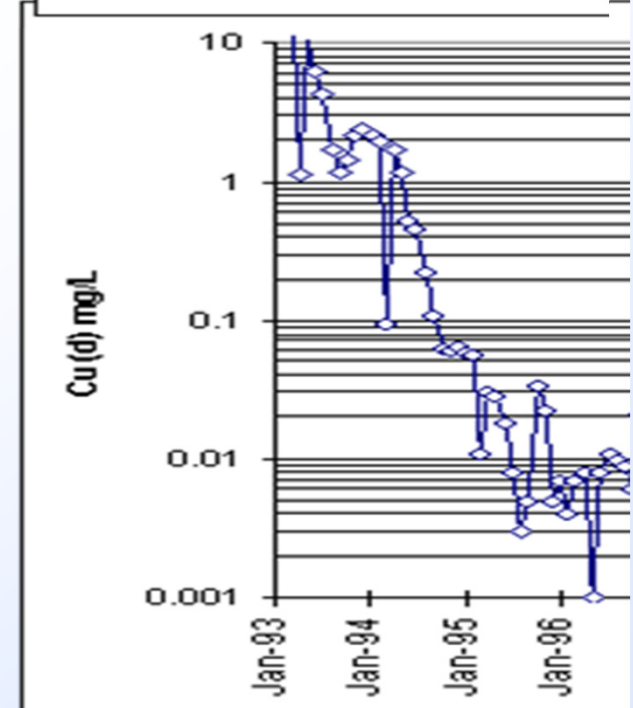
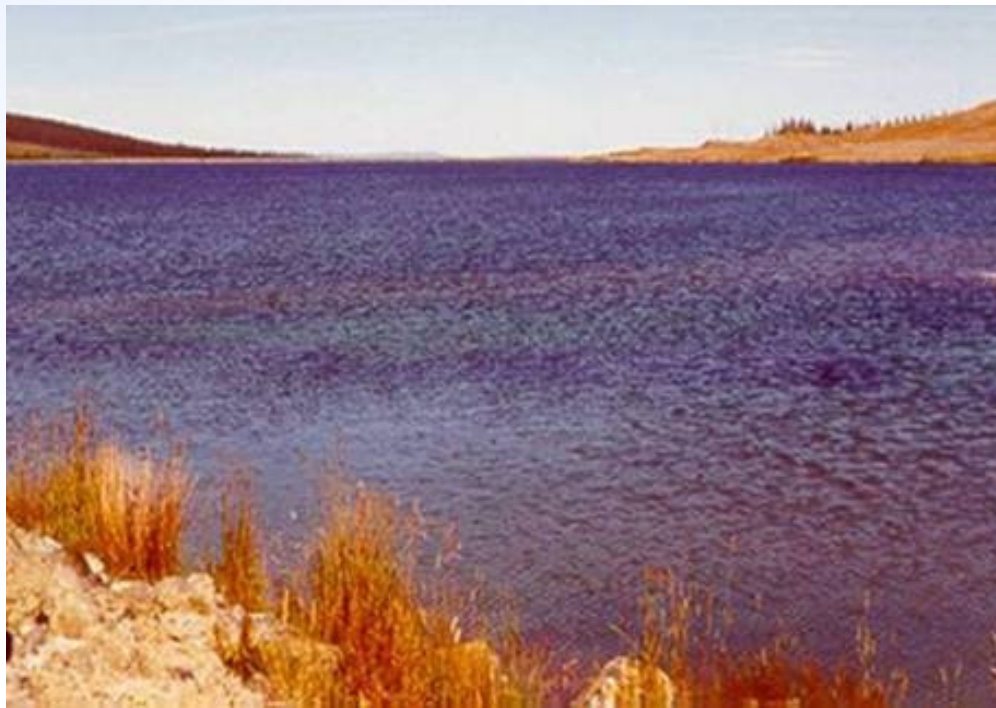
In 1997, the impoundment pH started to decrease and dissolved Cu and Zn started to rise.

By 2000, pH had decreased from 7 to 8 to less than 6.5 and dissolved Cu(d) had increased from 0.01 mg/L to 0.2 mg/L.

A pH decline was attributed to:

- depletion of lime added with process water and treatment sludge when the mine was operating and
- acidity inputs in the pH 5.5 incident precipitation.

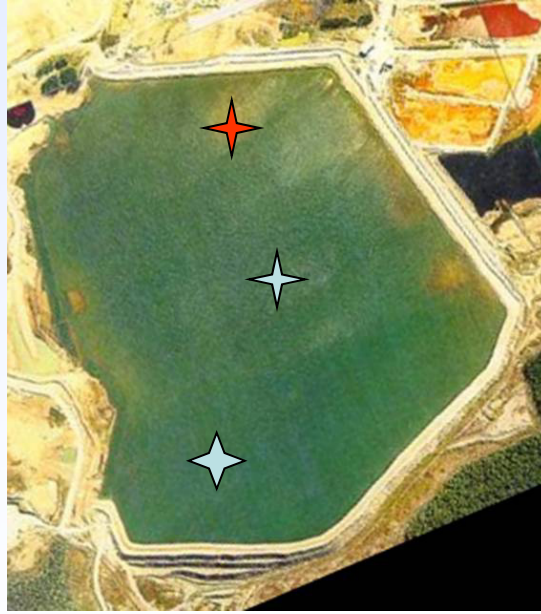
Source of Cu

Three peepers were inserted in tailings to locate the source for increasing Cu. The peeper in the corner of sludge disposal fell over.

Based on results from the peeper near the #1 Dam, it was postulated that the probable source of Cu was remobilization of pH sensitive hydroxides $[\text{Cu}(\text{OH})_2]$ precipitated when the #1 Dam ARD was pumped into and neutralized in the impoundment.

Other potential Cu sources are lime treatment sludge and 738 kg/d of CuSO_4 added in process water.

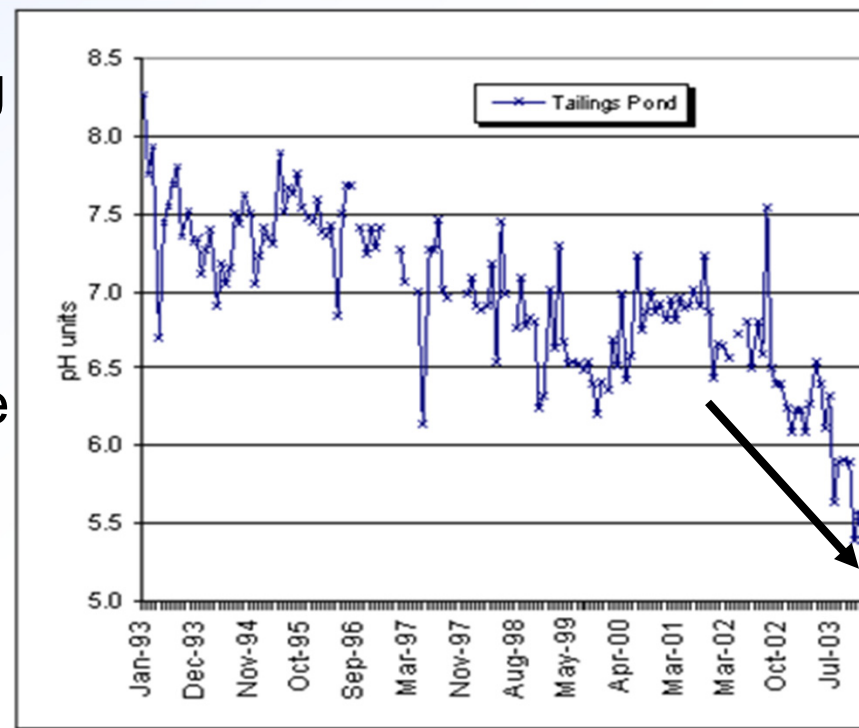
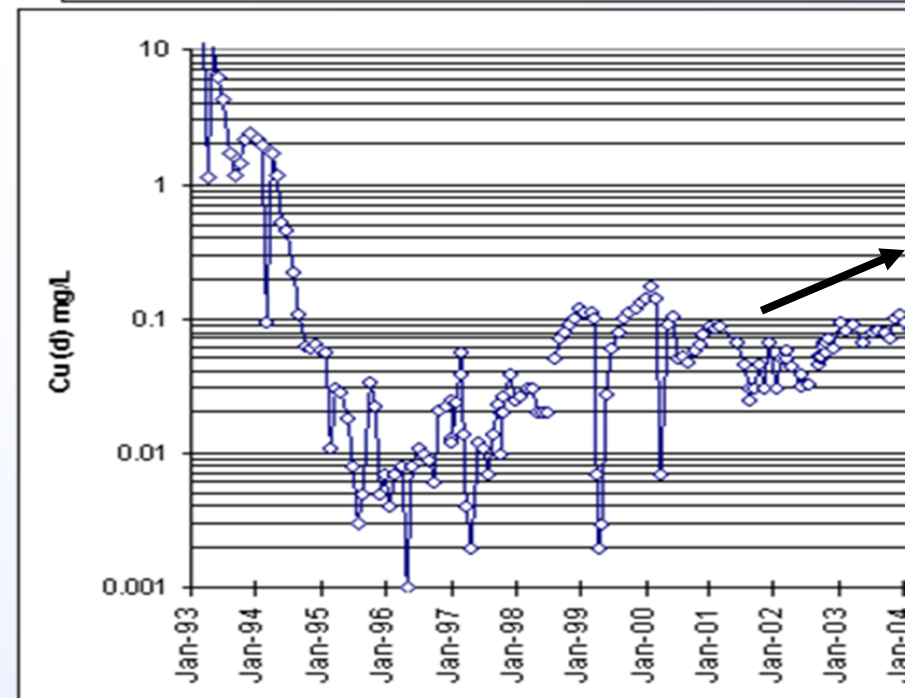
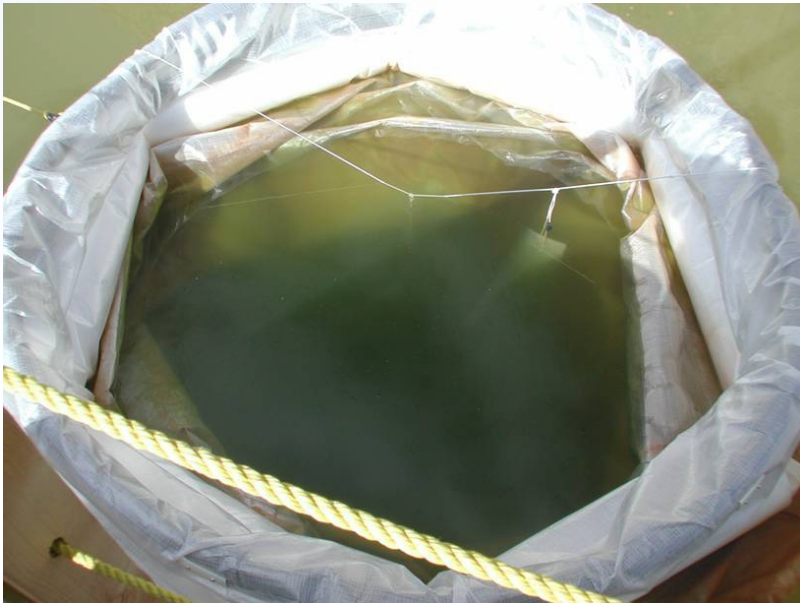
Starting in 2002, the trend of increasing pond pH reversed and decreased to 5.4 and Cu increased to > 0.1 mg/L.

Regulatory suggestions confirmed by limnocorral results indicated the decline in pH resulted from acid produced by the oxidation of NH_4^+ (nitrification).

A modeling exercise was used to predict how much lime was required to neutralize acid from the oxidation of NH_4^+ .

88 and 35 tonnes of lime slurry were added to the tailings pond in 2003 and 2004.

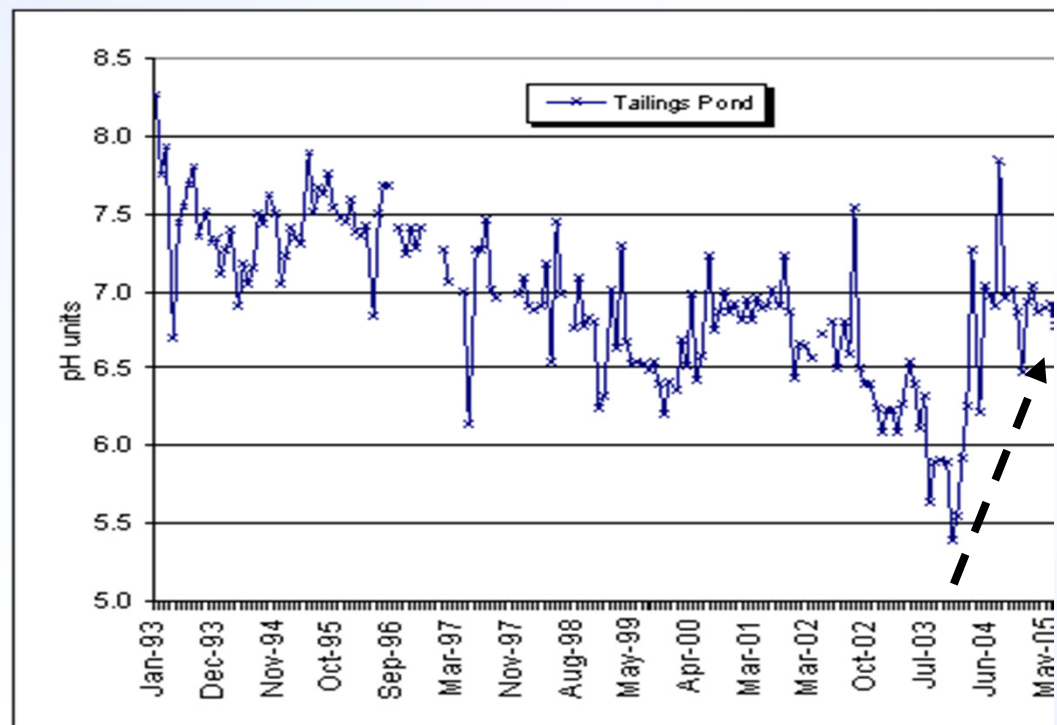
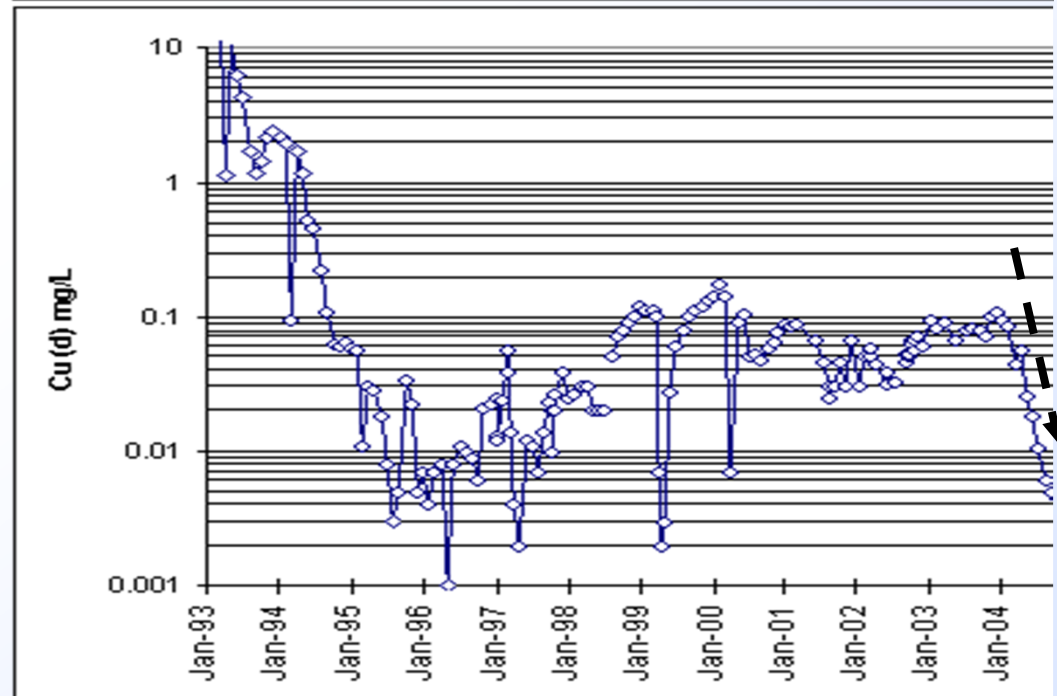
In 05/06, the pH again decreased to < 6.5 and Cu increased to > 0.1 mg/L.

To counteract this, 8 tonnes of lime slurry was added in 2006 and 32 tonnes in 2007.

Since the lime addition in 2007, pH has remained above 6.5, averaging between 6.8 and 7.0.

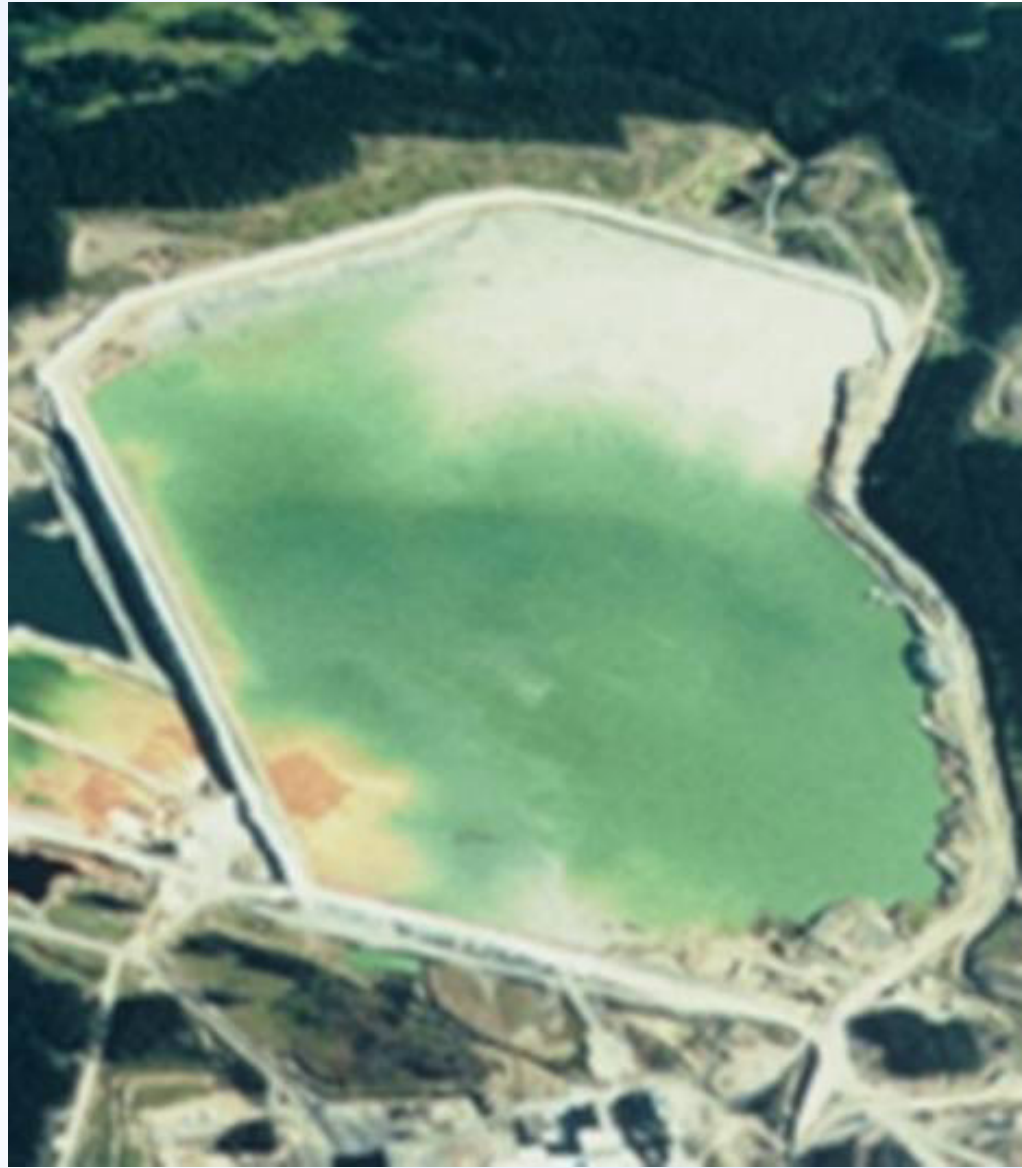
Presently there is very little aquatic vegetation. Future plant invasion is expected to increase the sediment organic content creating more reducing conditions, potentially converting insoluble $\text{Fe}(\text{OH})_3$ in lime treatment sludge into soluble Fe^{2+} .

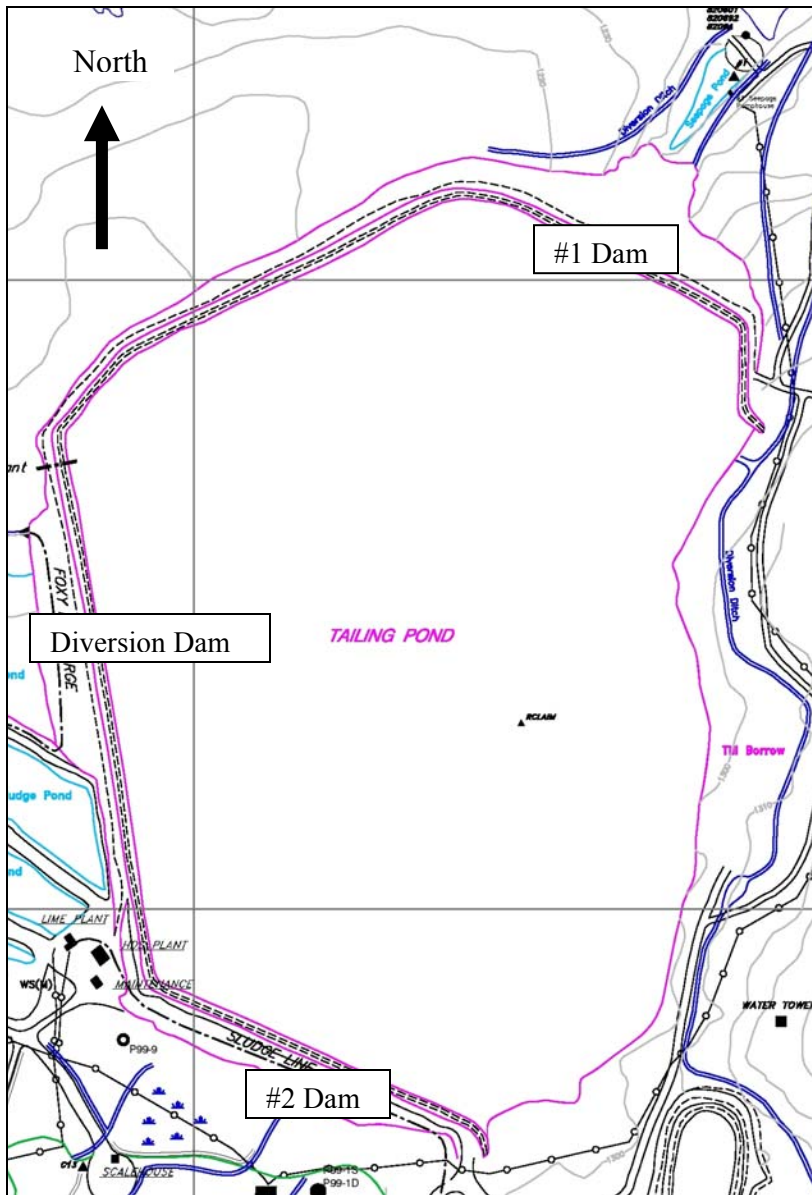
Figure 1. Map of Tailings Impoundment

The tailings impoundment has dams on the north, west and south sides (#1, Diversion, and #2 dams respectively), and is constrained by a natural slope on the eastern side (Figure 1). The impoundment has a surface area of 120 ha. The Berzelius Diversion limits drainage inputs from the higher natural ground on east side above the impoundment. Consequently, there is very little additional catchment beyond the impoundment itself. An emergency spillway capable of passing the probable maximum flood (PMF) is located on natural rock at northeast corner at 1292.5m elevation. The spillway reports to the Berzelius Diversion, which flows into Foxy Creek at the north end of the property.
