TAILINGS FAILURES AND HOW TO AVOID THEM

Samarco, Fundao, Brazil

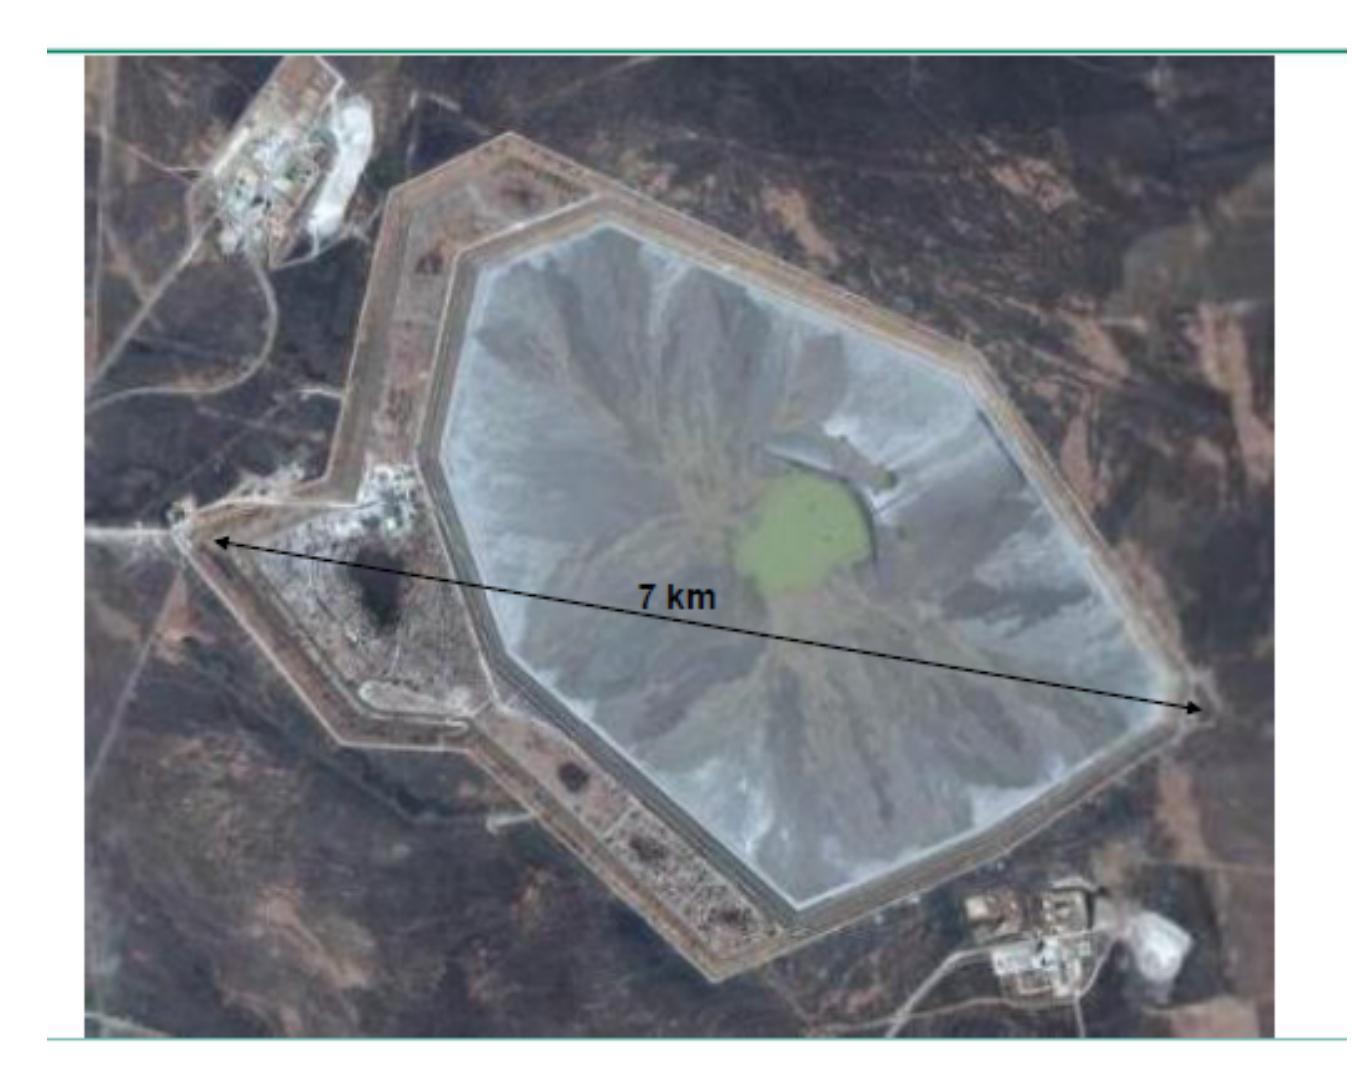
No Water on Top Deck

- Rule:
 - No or very small pool; or
 - Pool distance from crest = 5 x embankment height
- Violations:
 - Bafokeng: pool at crest
 - Mount Polley:
 - No freeboard exacerbated failure consequences

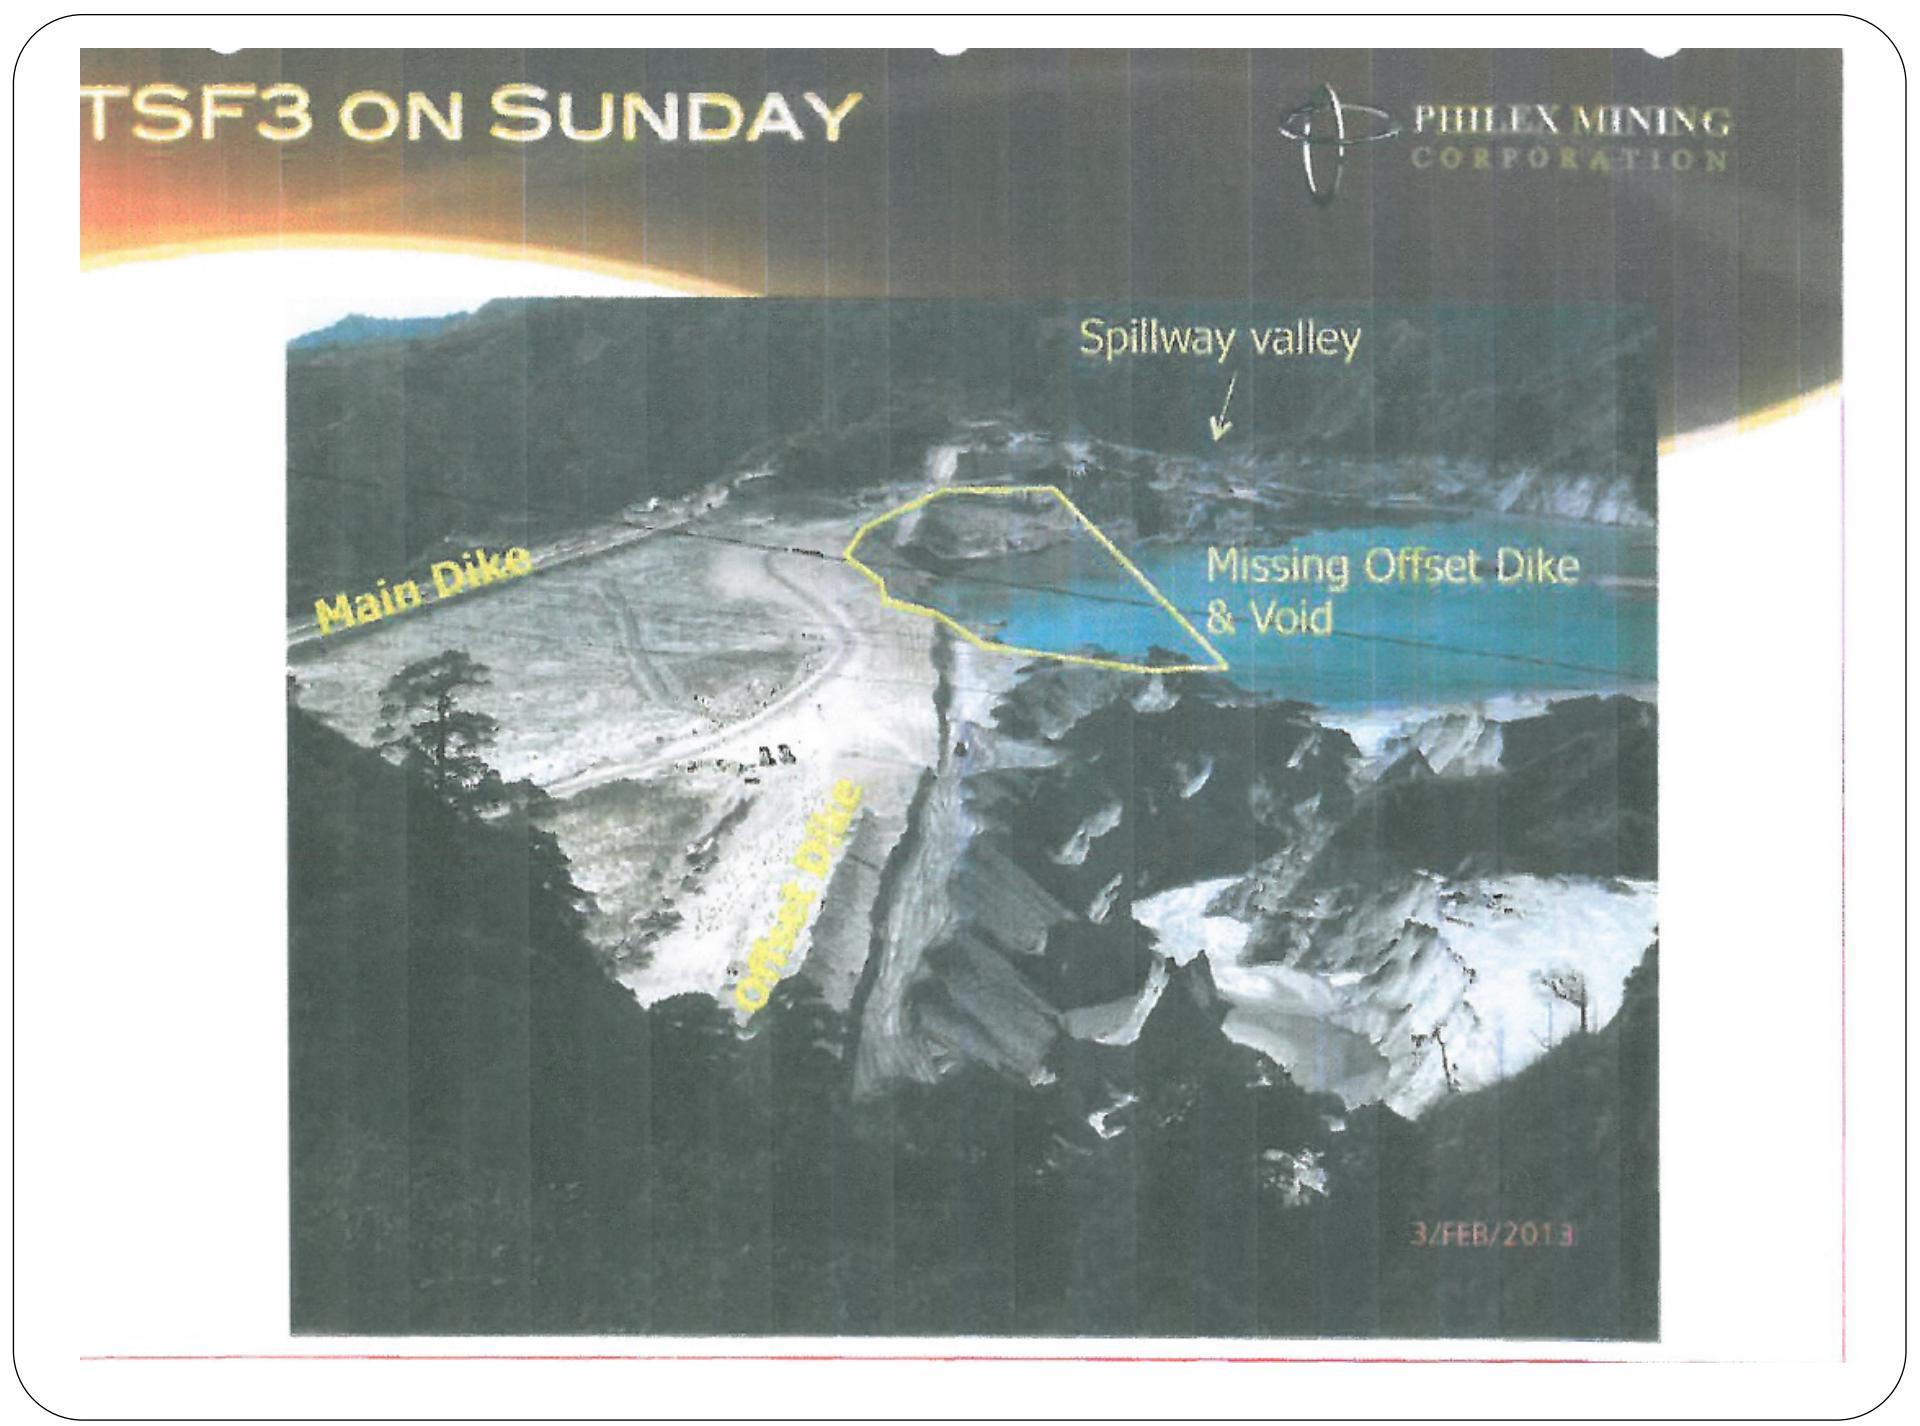
No Penstocks

- Rule: No penstocks through tailings or adjacent abutments
- Violations:
 - Bafokeng: cavitation in penstock suspected as main or contributory cause
 - Padcal: Pipe break lead to large tailings loss
