Innovative Closure Concepts for Xstrata Nickel Onaping Operations

14th Annual BC MEND Workshop November 28 & 29, 2007

Xstrata Nickel – Onaping Operations

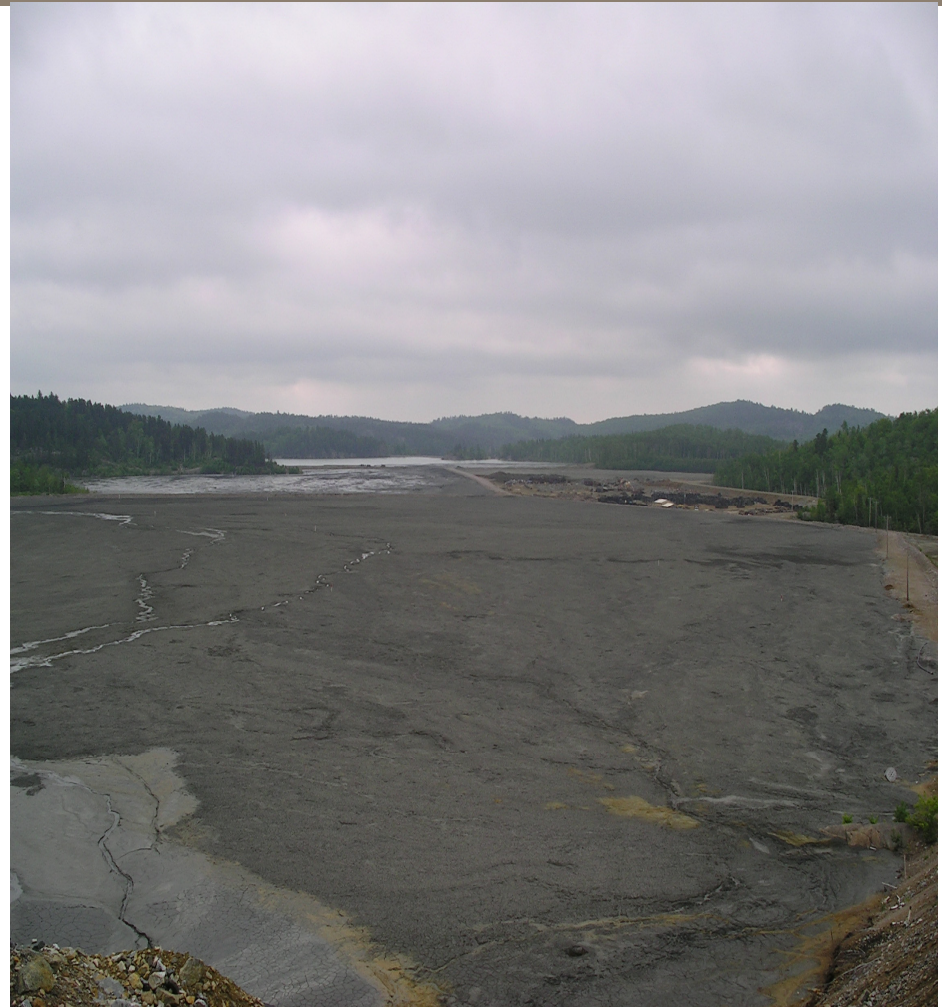
Strathcona Tailings Treatment System - Slimes Thickener

Solution:

- **Construction of slimes thickener to produce 40% solids**
- **Addition of a waste lime kiln dust product from a producer 200 km west**
- **Placement at desired cover thickness, with minimal segregation of particles**
- **Division of area into cells**
- **Maximize utilization of slimes cover material**

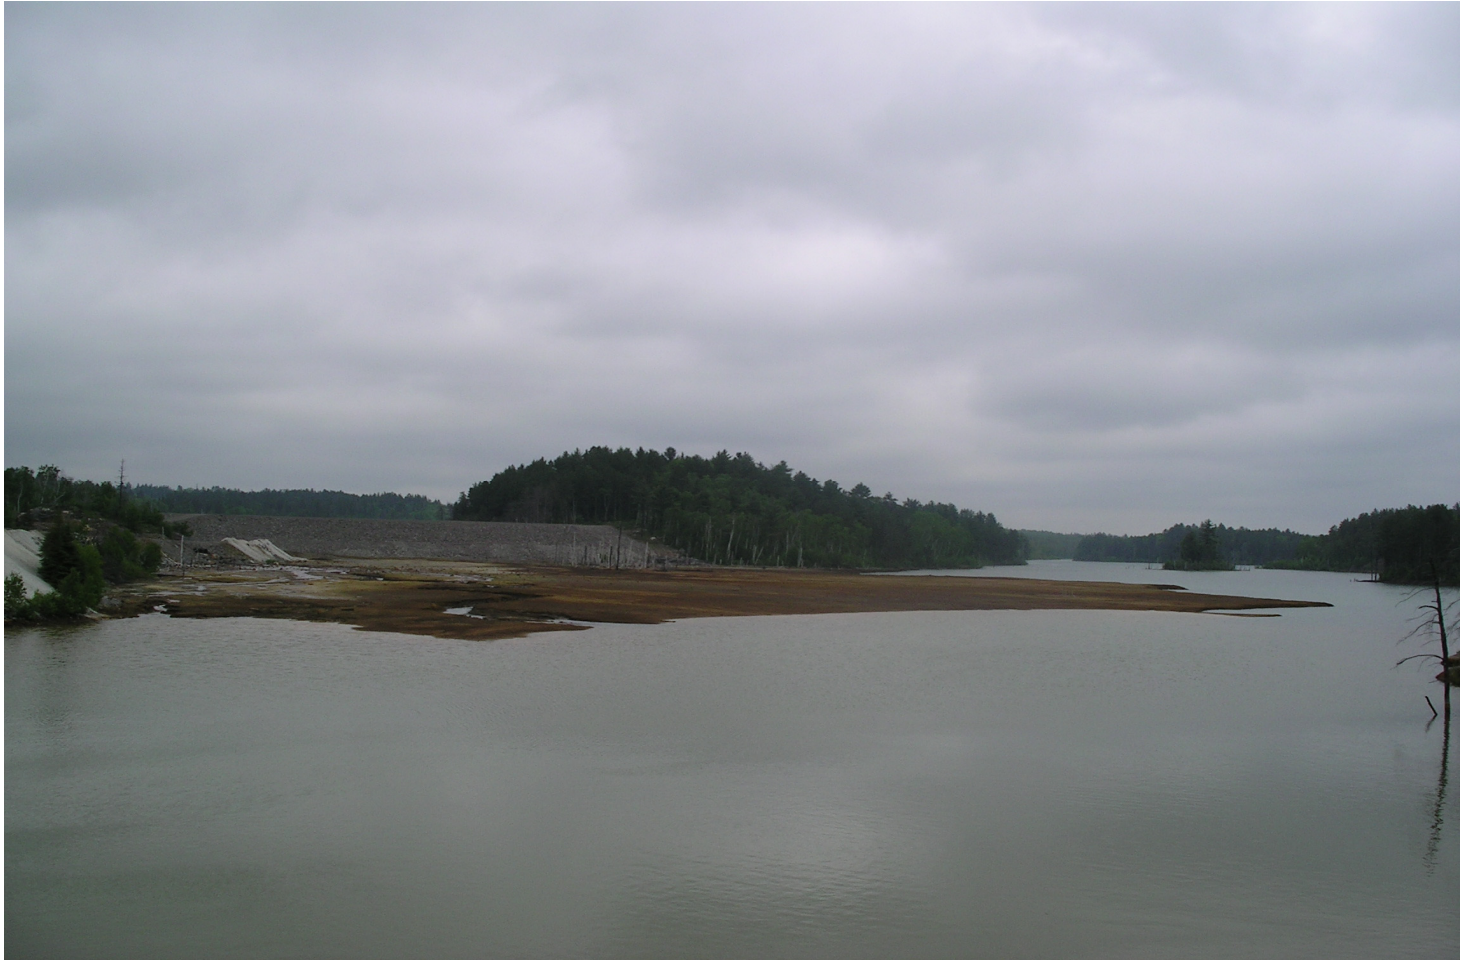
Strathcona Tailings Treatment System

Progressive Rehabilitation

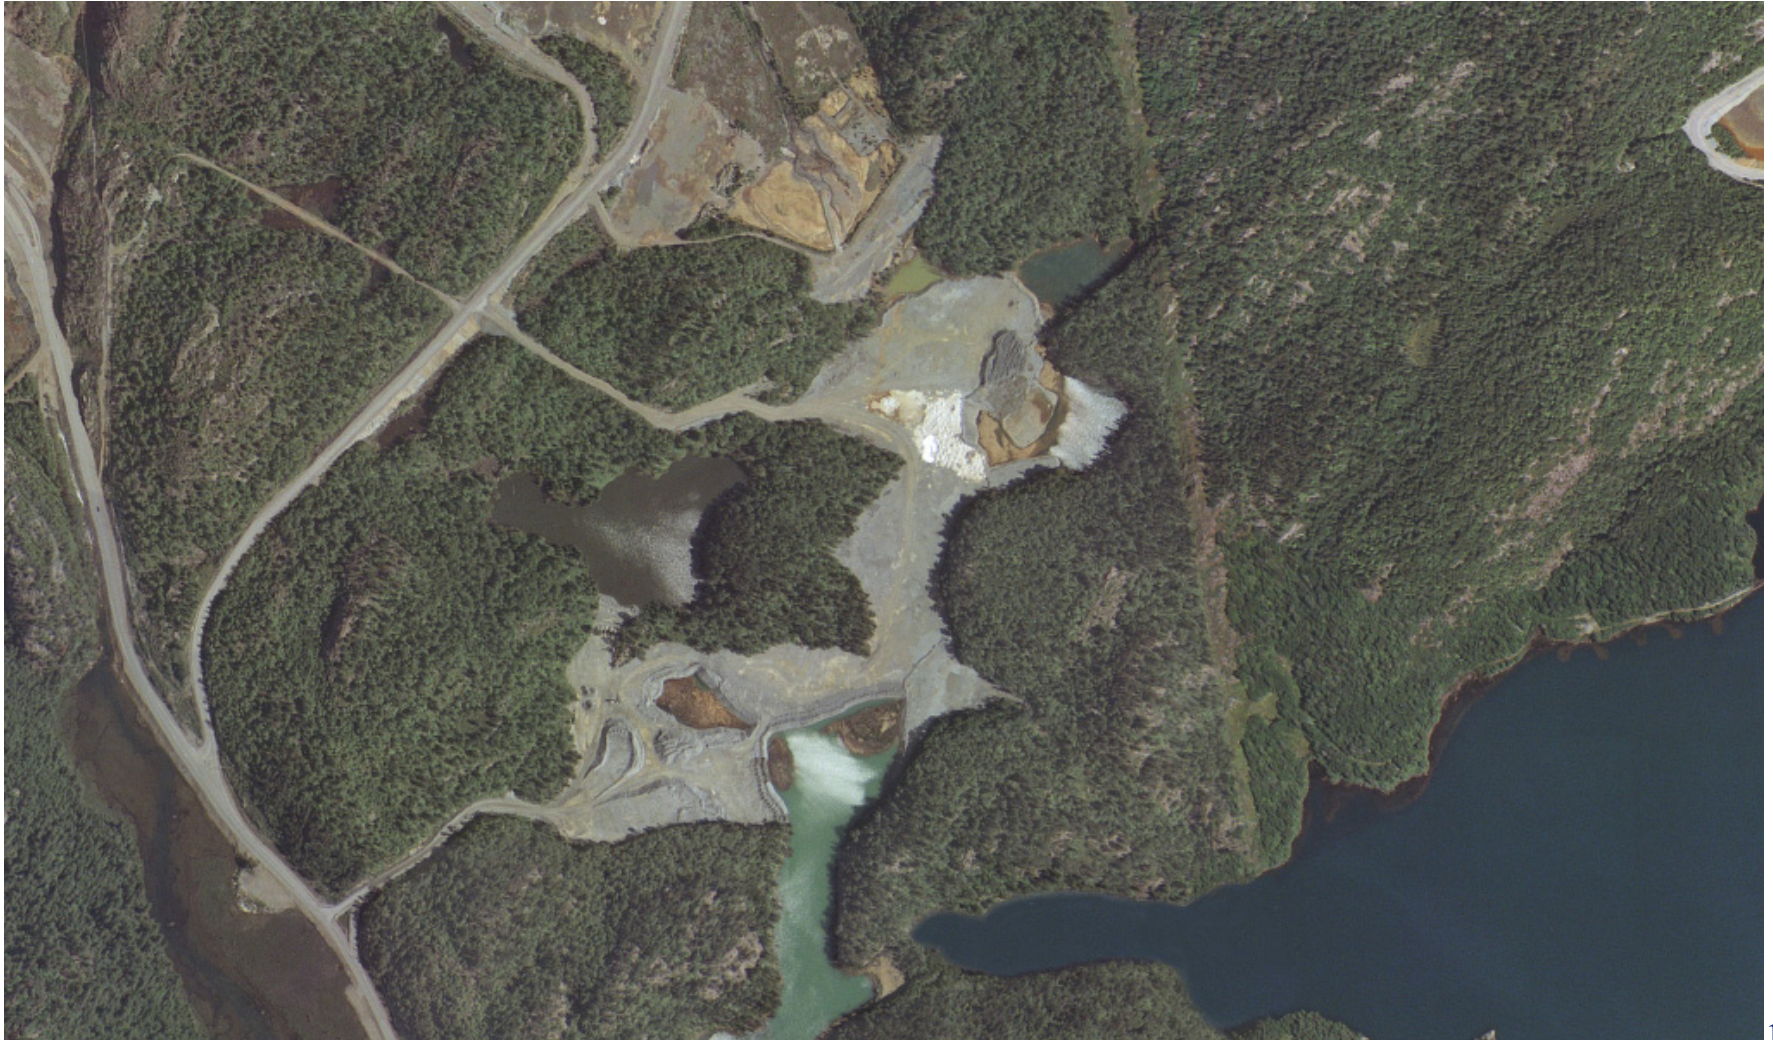
Cranberry Waste Rock Management Area

- **Estimated 6.5 million tonnes in rail bed, roads and yards**
 - Placement of waste rock into a central repository since mid-1980's approximately 10 million tonnes
 - Construction of dams within waste rock area to flood this material; capability to raise dams
 - Other material will be flooded in place by constructing series of dams upon closure
 - Ongoing waste rock removal campaigns
