# Waste Characterization and Predicted Drainage Chemistry at the Antamina Mine after 10 Years of Operations

**Bevin Harrison, Compañía Minera Antamina S.A.  
18<sup>th</sup> Annual ML/ARD Workshop, Vancouver, BC**

**Dec 1, 2011**

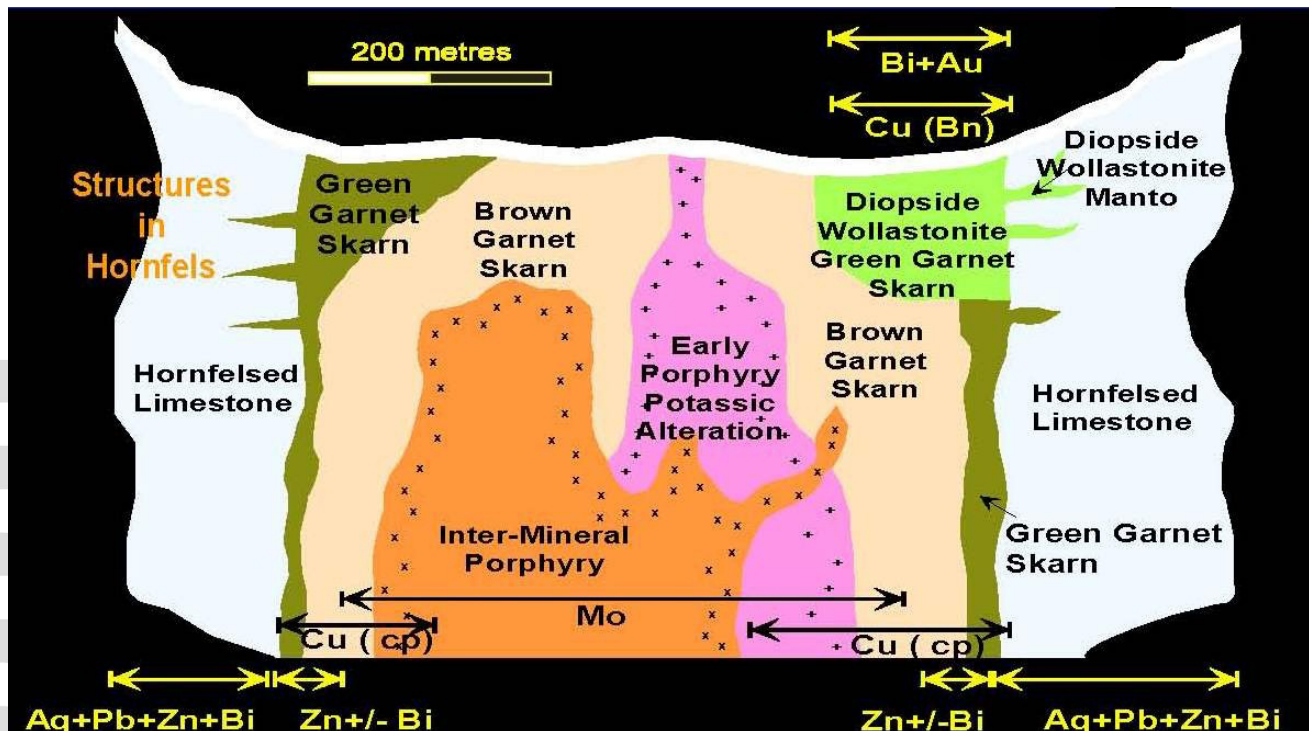
# Geology

1. 5 general rock groups, 22 waste types
  - Intrusive
  - Skarns (brown garnet endoskarn, green garnet exoskarn)
  - Hornfels, Marble, Limestones

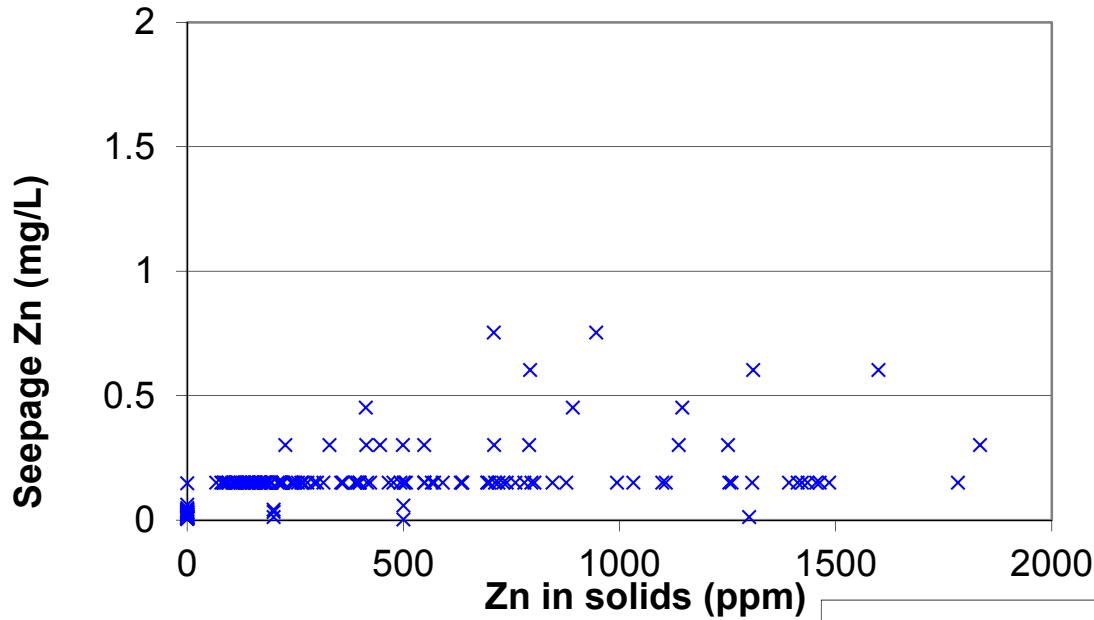
**EIA Discharge Limit  
= 0.5 mg/L**

**New LMP  
= 1.5 mg/L**

**EIA Receiving Water Limit  
= 0.13 mg/L**

**New ECA  
= 2 mg/L**
